## STRUCTURAL ASSESSMENT REPORT

## Structural Assessment Report

January 10, 2026

FEI Project Number: 1710  
Site Address: 907 E. 13th St.  
Austin, TX

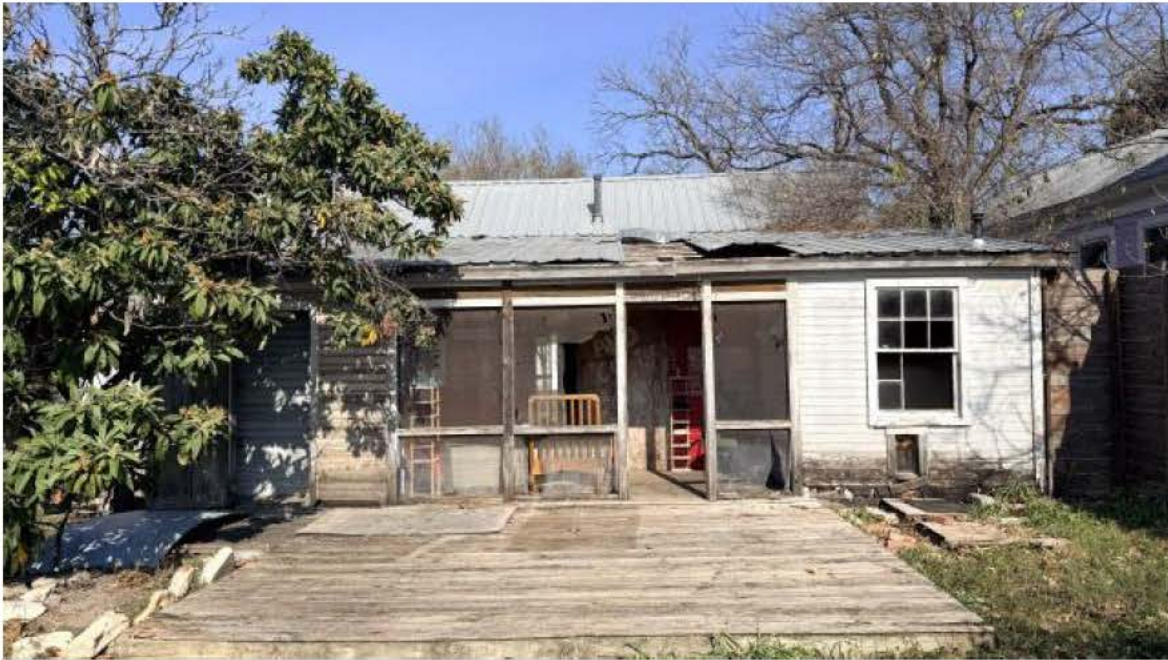
Photo 3

- Sagging was observed across all roof slopes on both the main structure and the addition (see Photographs #1 through #3).
- Deterioration of the foundation cover was observed around the perimeter of the structure (see Photograph #5).

Overview of the rear (south) elevation.

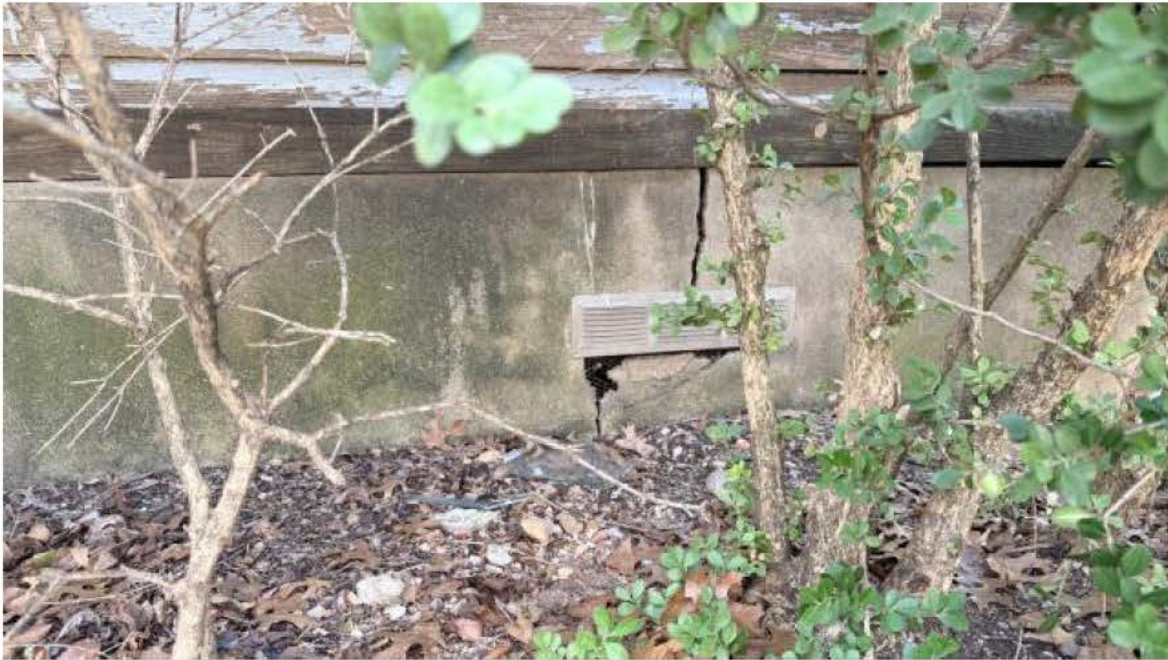
Photo 5

Exterior view showing cracked concrete and deterioration of the foundation cover.

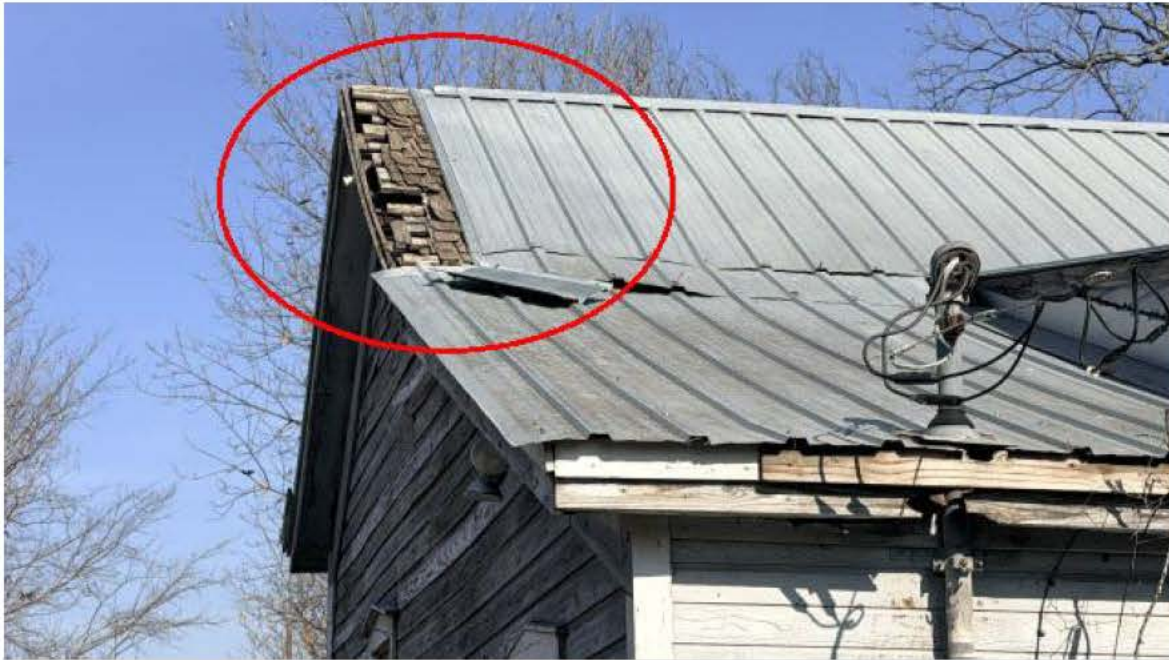
Photo 7

- Detached, peeled-back, and missing roof panels were documented (see Photographs #6 and #7).
- Evidence of prior fire-related damage was observed (see Photographs #8 and #9).

Roof view. Detached and missing roof panels observed, consistent with wind-related uplift from an elevated wind event.

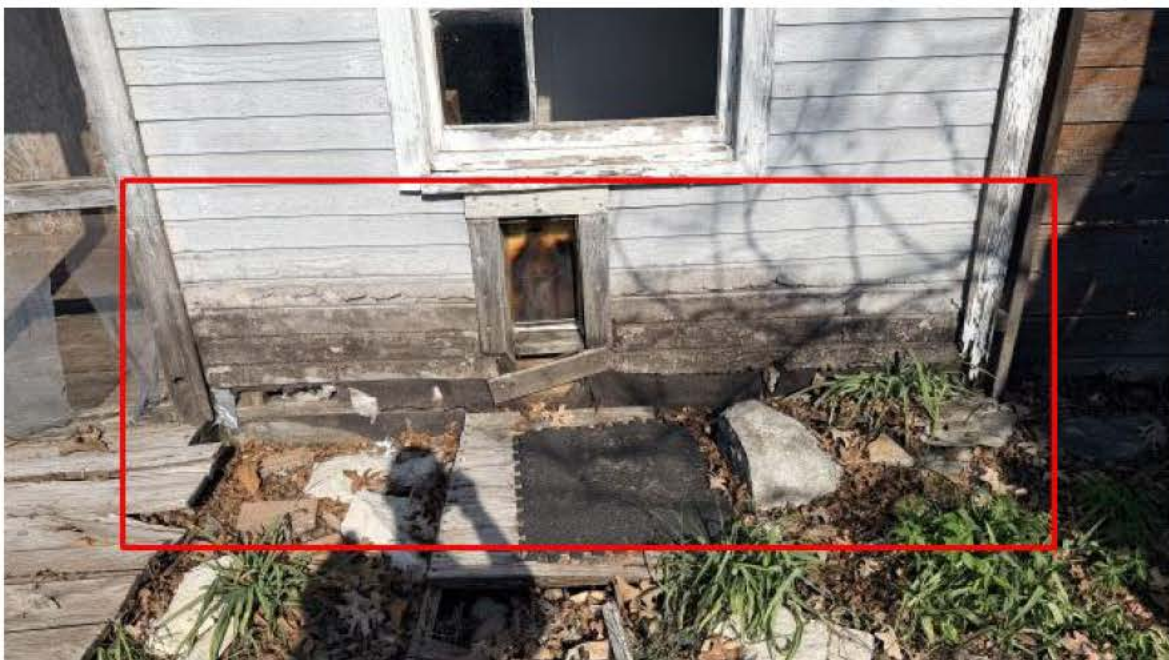
Photo 8

Exterior view. Evidence of prior fire-related damage observed.

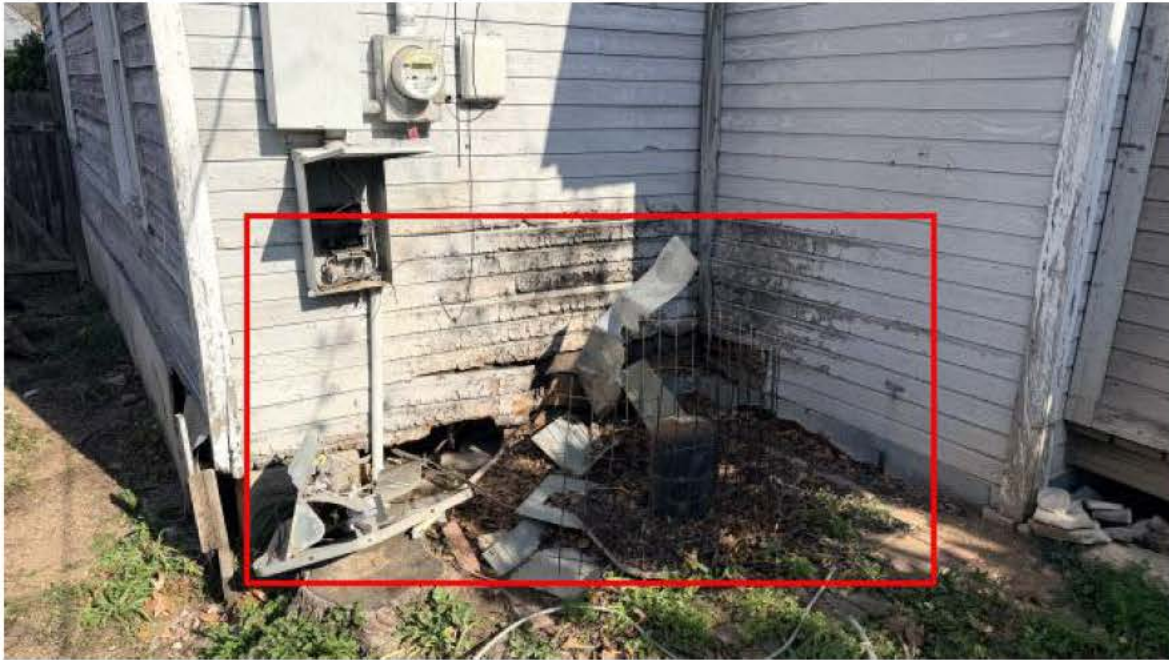
Photo 9

Exterior view. Evidence of prior fire-related damage observed.

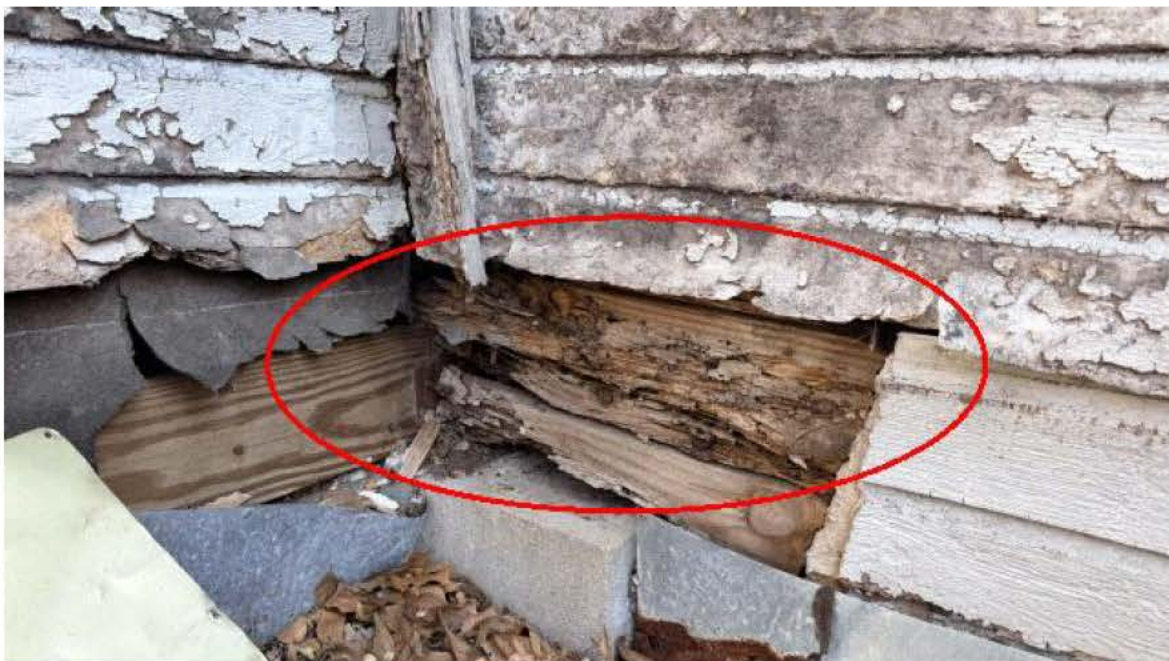
Photo 10

- Advanced deterioration was documented along the perimeter foundation beam (see Photograph #10).
- Advanced wood deterioration was observed at wall-to-ceiling, and wall-to-floor framing along exterior wall locations (see Photographs #13, through #17, and #24).

Exterior view showing advanced deterioration of the foundation beam.

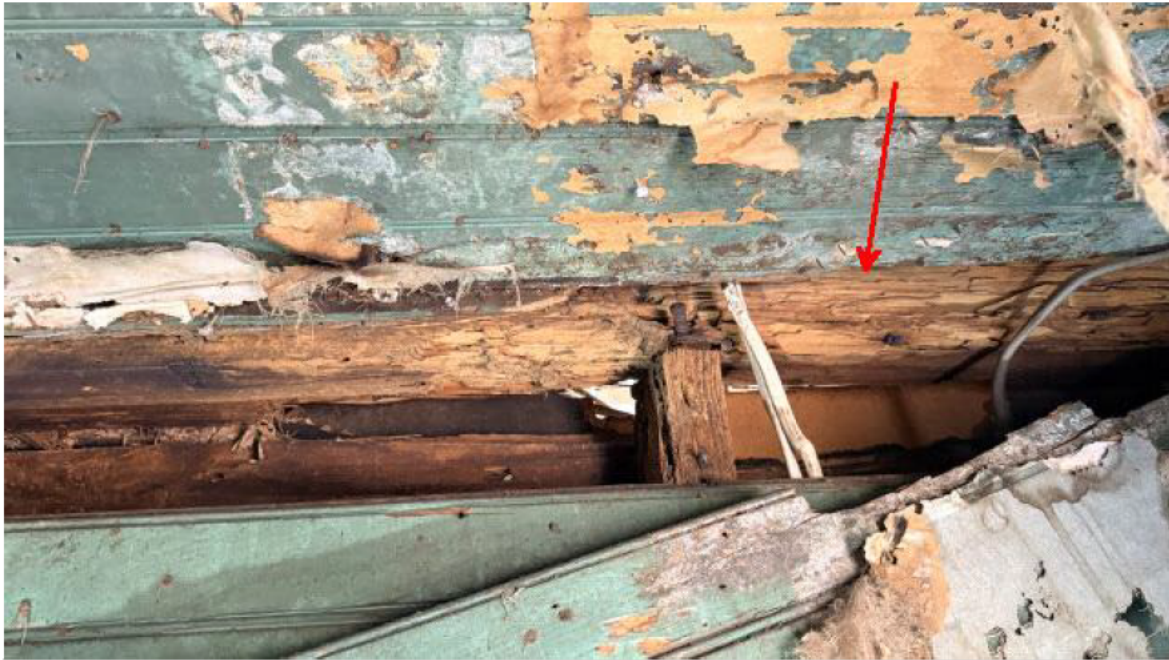
Photo 13

Significant structural deficiencies were observed throughout the building envelope and primary framing systems. The ceiling and wall framing across the residence, and particularly within the addition, exhibited advanced wood decay and deterioration consistent with prolonged moisture exposure. Evidence of chronic moisture intrusion included material degradation, loss of cross-sectional capacity, and conditions conducive to biological growth. Additionally, existing structural attachment and connection details were observed to be substandard and inadequate, contributing to ineffective load transfer and a reduction in overall structural integrity.

View of wall-to-ceiling framing showing advanced wood deterioration along the exterior wall.

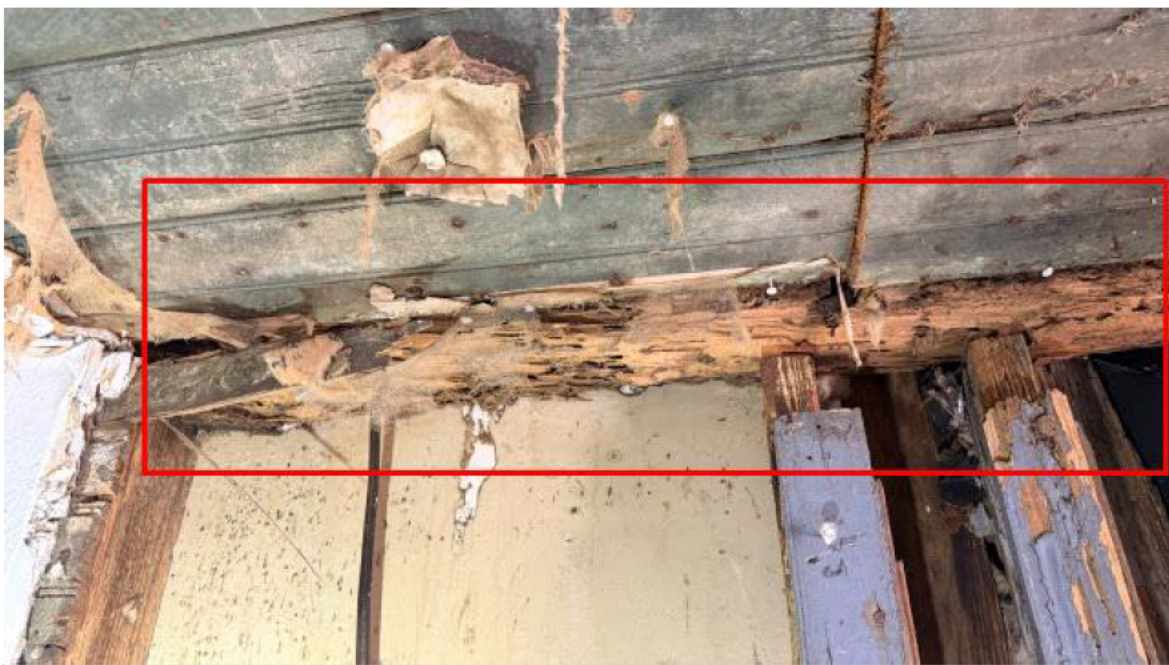
Photo 14

View of wall-to-ceiling framing showing advanced wood deterioration along the exterior wall.

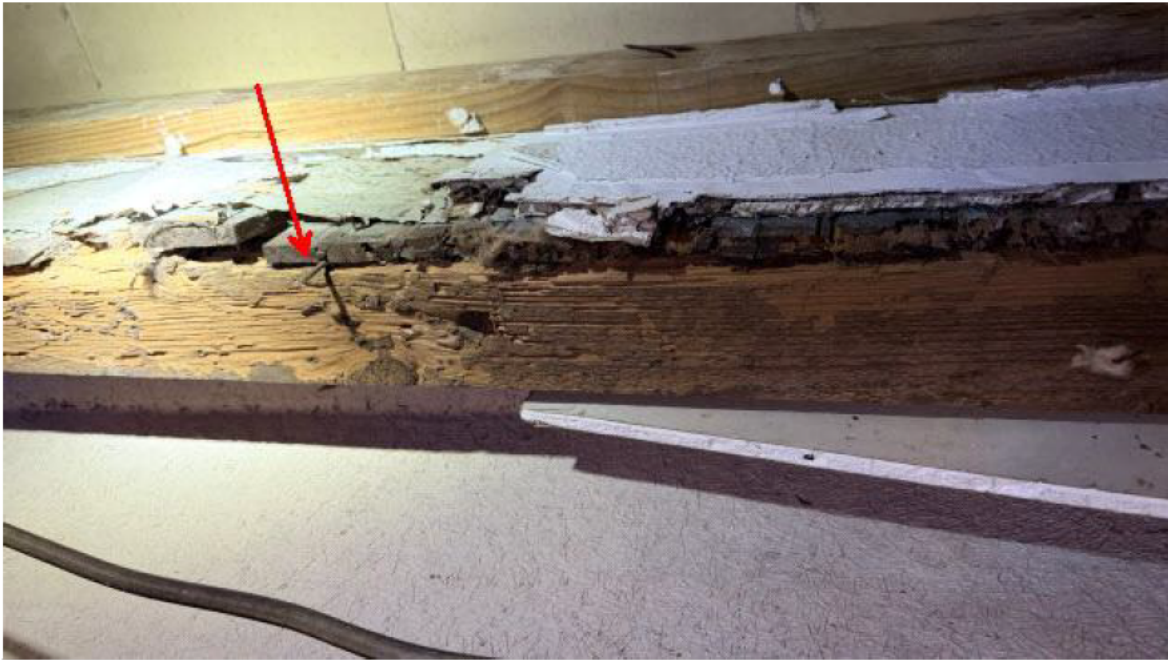
Photo 15

View of wall-to-ceiling framing showing advanced wood deterioration along the exterior wall.

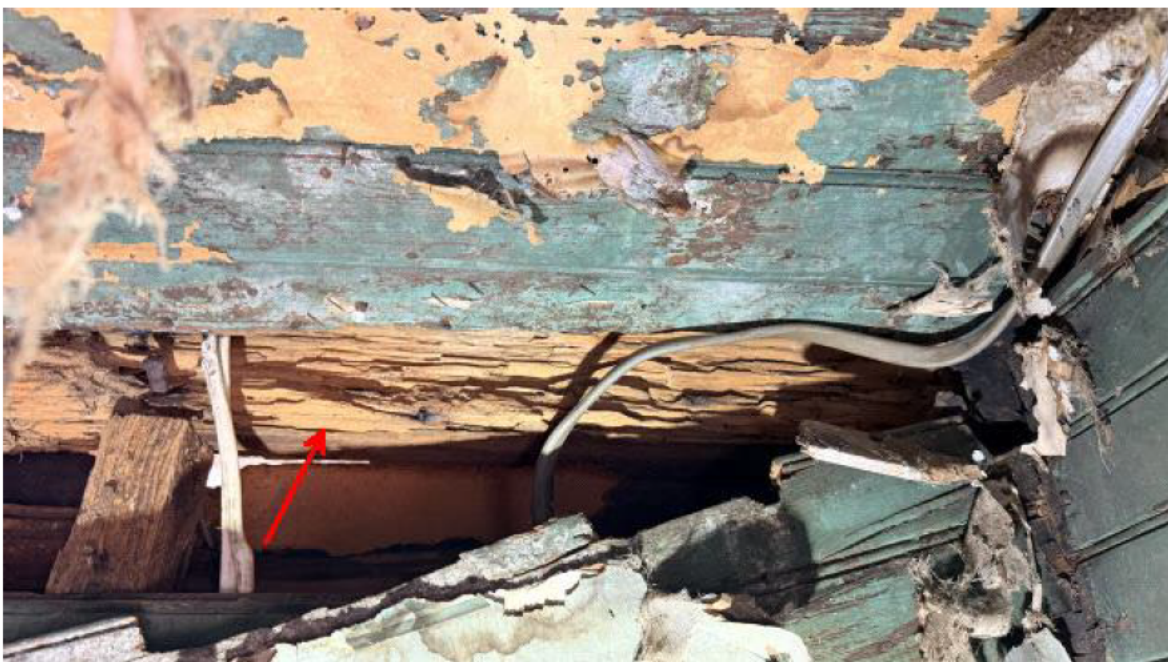
Photo 16

View of wall-to-ceiling framing showing advanced wood deterioration along the exterior wall.

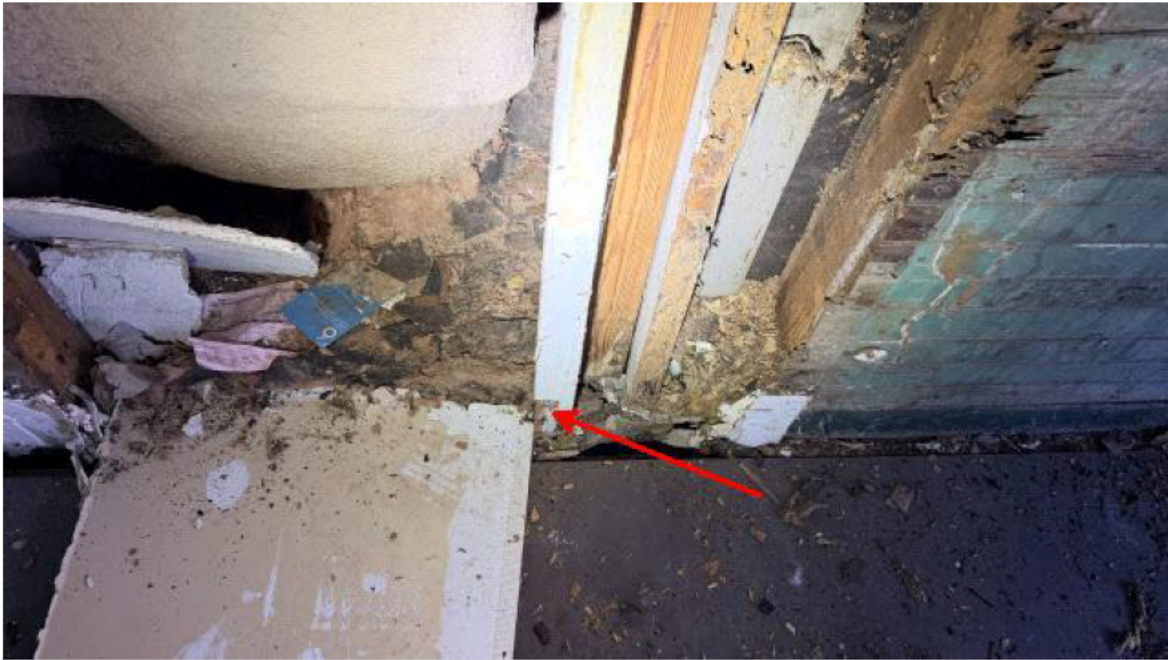
Photo 17

View of wall-to-floor framing showing advanced wood deterioration along the exterior wall.

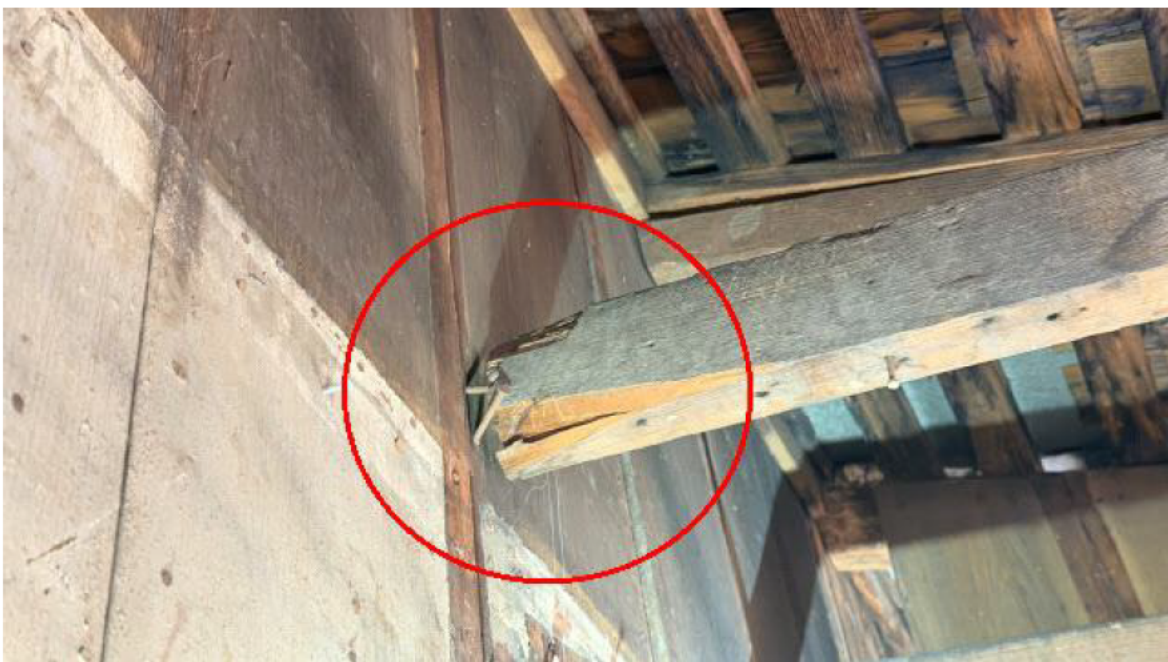
Photo 18

- Improper attachment conditions were observed at wall-to-ceiling connections at multiple locations (see Photographs #18 through #23).
- Efflorescence, likely resulting from prolonged water intrusion through the roof, was observed at wall-to-ceiling junctions and within the attic space (see Photographs #21, #22, and #25).

View of wall-to-ceiling framing showing improper attachment conditions.

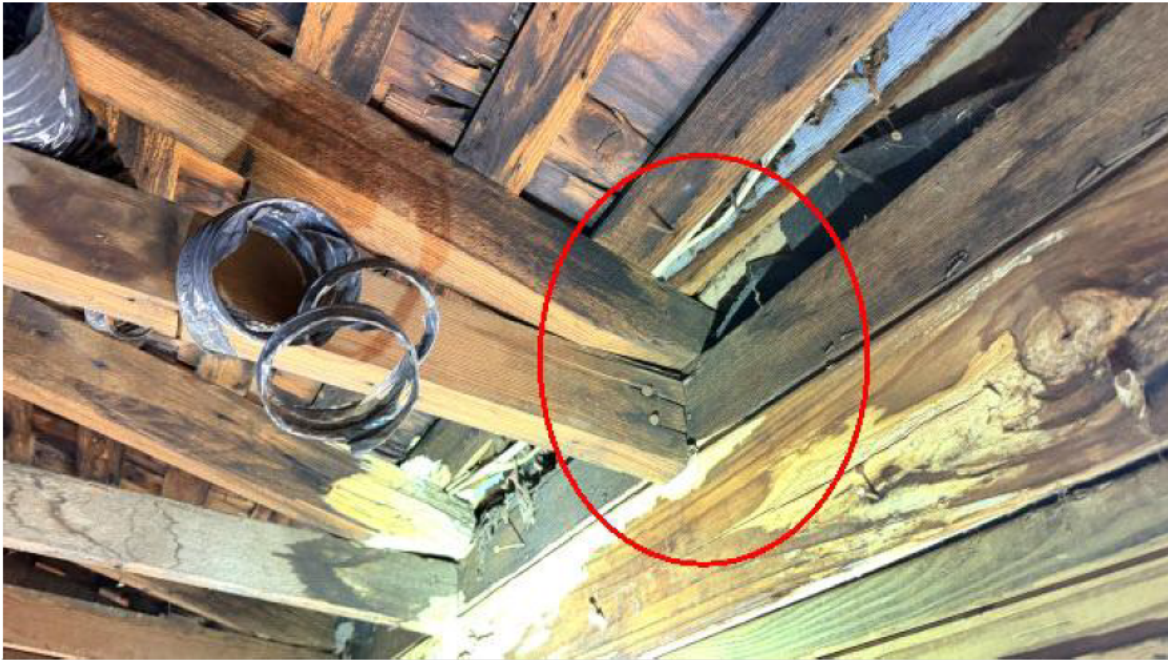
Photo 19

View of wall-to-ceiling framing showing improper attachment conditions.

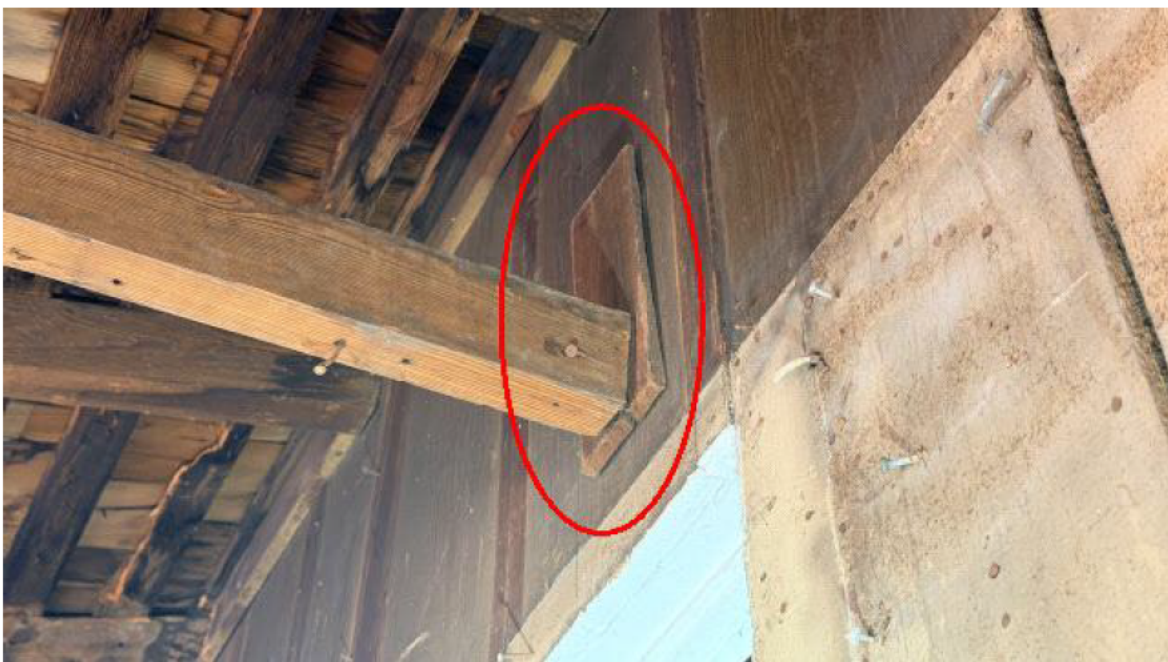
Photo 20

View of wall-to-ceiling framing showing improper attachment conditions.

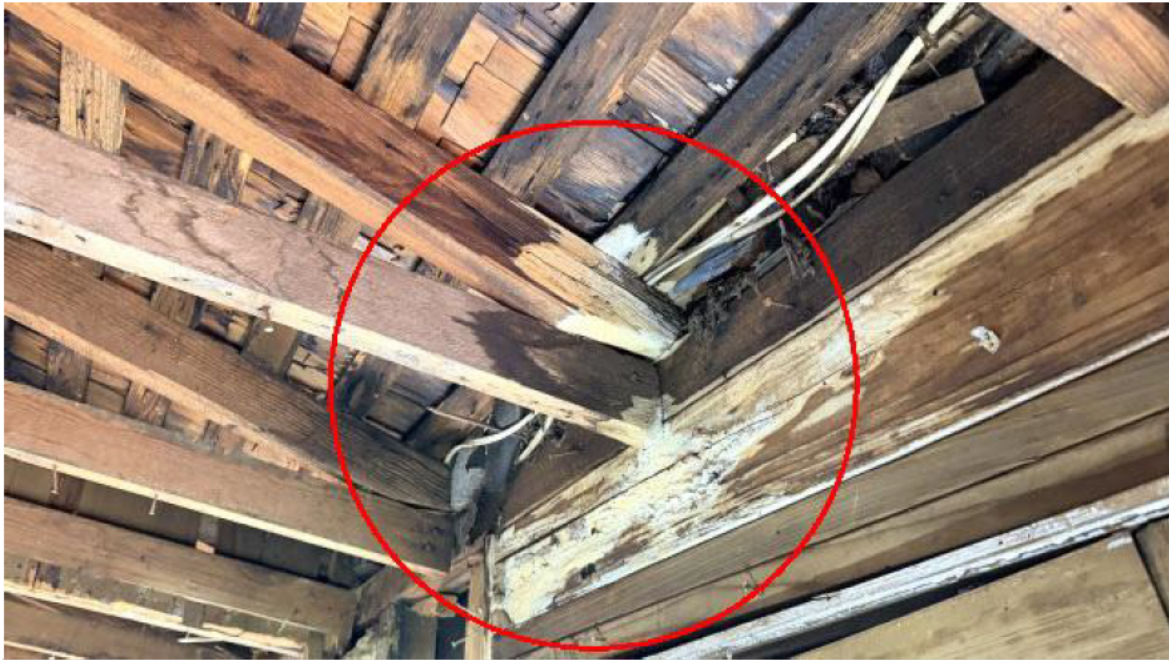
Photo 21

View of wall-to-ceiling framing showing improper attachment conditions.

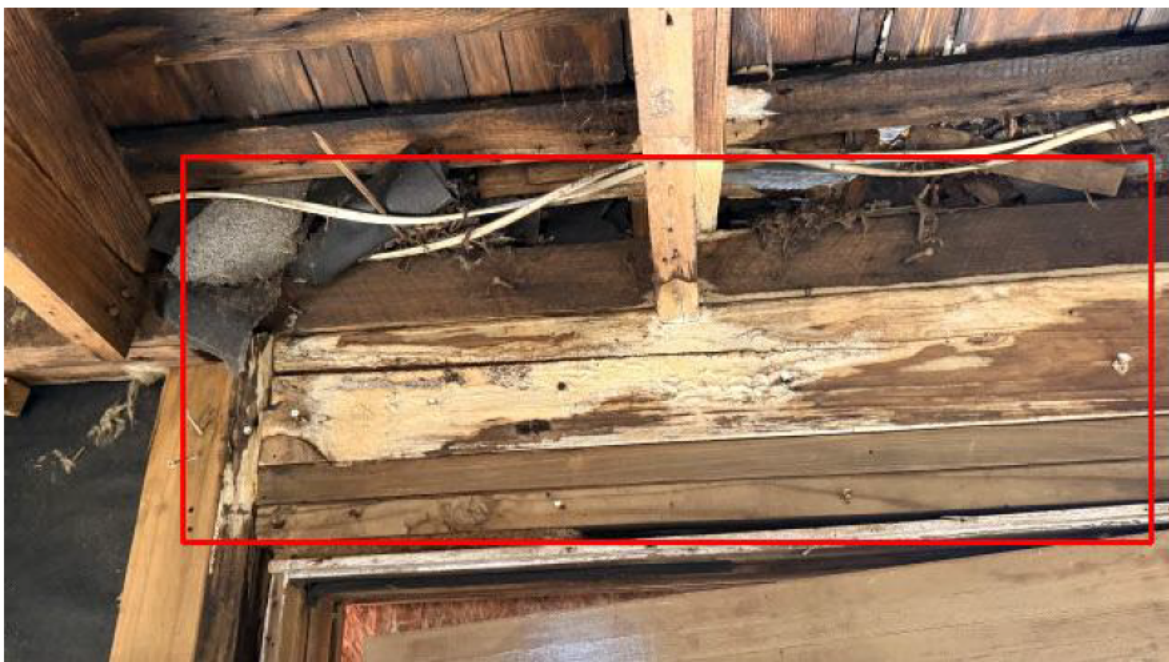
Photo 22

View of wall-to-ceiling framing showing efflorescence, likely resulting from prolonged water intrusion through the roof.
