**City of Austin**

# Parks and Recreation Department Security Audit

## Findings and Recommendations Report

Version 2 | July 18, 2025

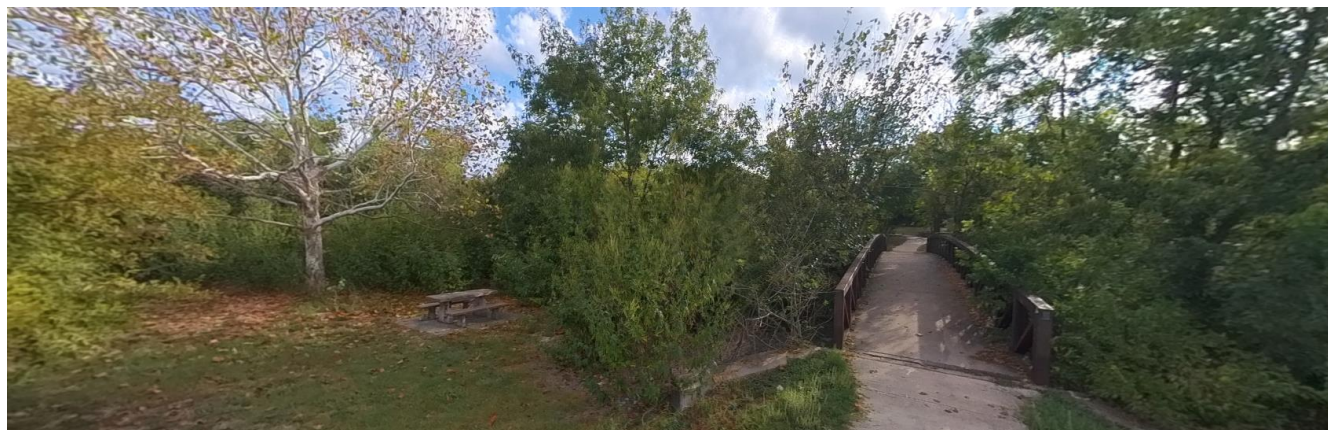
**Picture 5. Ineffective placement of activity generator to encourage increased natural surveillance; the picnic table is isolated from other areas of the park, and the dense vegetation obstructs sightlines of the surrounding area**

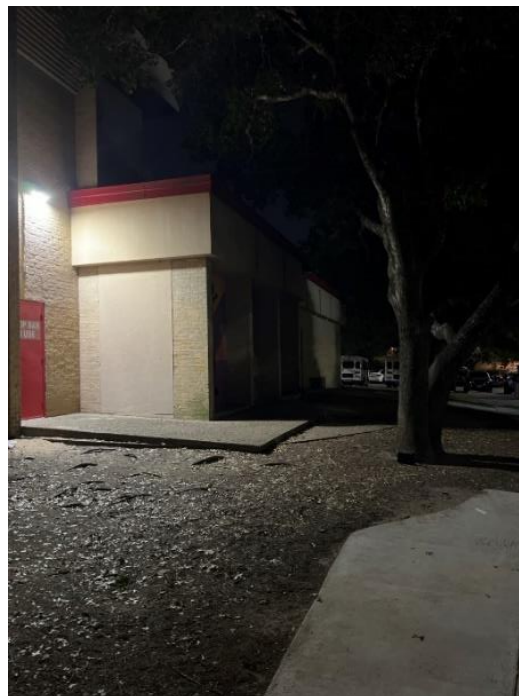
**Picture 9. Secondary entry for the South Austin Recreation Center featuring a bright wall-pack and dark corners (taken with phone, no flash)**

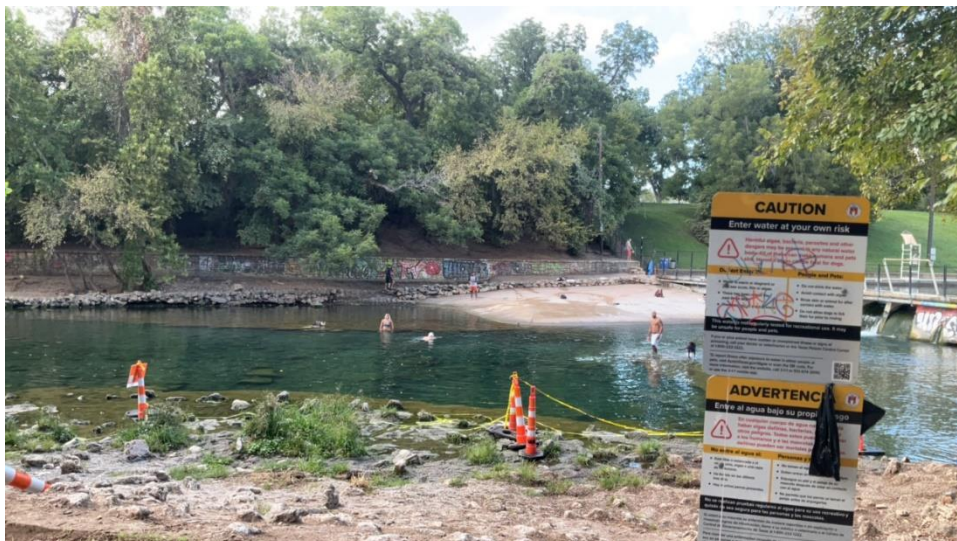
The Spillway of Zilker Park (public facing side of Barton Springs) scored poorly across the natural access control, image management / maintenance, and territorial reinforcement CPTED categories. The public side of Barton Springs had extensive trash and graffiti as shown in Picture C-7. Additionally, traffic cones with yellow barricade tape used to restrict public access to the area were disregarded and torn down.

**Picture C-7. Zilker Metropolitan Park (Spillway) - Natural Access Control, Image Management / Maintenance**

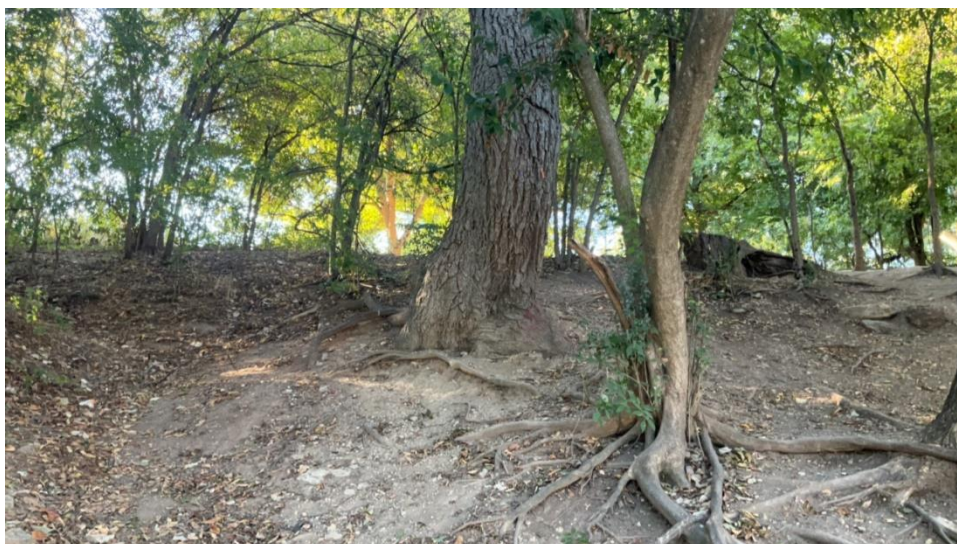
At the time of the site visit, the public side of Barton Springs was closed for repairs. However, park users still accessed the location despite the temporary barriers, as shown in Picture C-7. While security signage was present, park users ignored these warnings and accessed the area via the southern side of Barton Creek and through the greenway on the northern side.

**Picture C-8. Zilker Metropolitan Park (Spillway) - Natural Access Control**

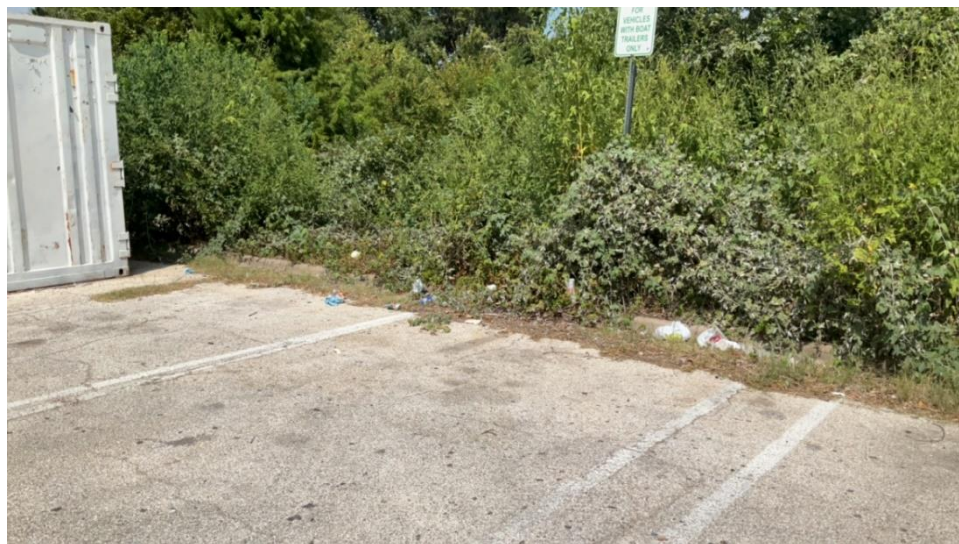
Festival Beach was the only metropolitan park to score on the lowest end of the rating scale, due to lower average ratings across all CPTED categories—most notably in site / target hardening. The boat access point on Nash Hernandez Sr. Road had extensive trash, blind spots due to shipping containers, and overgrown vegetation as shown in Picture C-14. Additionally, fencing and vehicle barriers were not observed at the vehicle access points and parking lots surveyed.

**Picture C-14. Festival Beach – Natural Surveillance, Image Management / Maintenance**

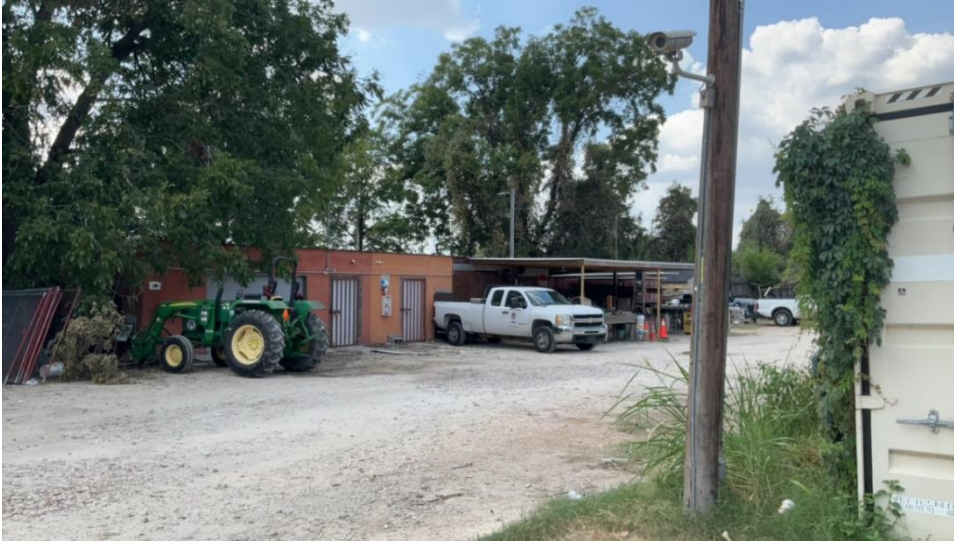
The PARD maintenance facility on Jessie E. Segovia Street was included in the assessment grouping for Festival Beach. This facility had elevated access control measures, target hardening methods such as vehicle gates and fencing, constant monitoring during the daytime from PARD employees, and security cameras as a deterrent, as shown in Picture C-15 and Picture C-16. Facility staff noted that storage containers and loose maintenance equipment are targets for burglaries, and they have implemented measures such as extra locks and blocking shipping containers (where equipment is stored) with vehicles during non-operational hours.

**Picture C-15. Festival Beach – Natural Surveillance**

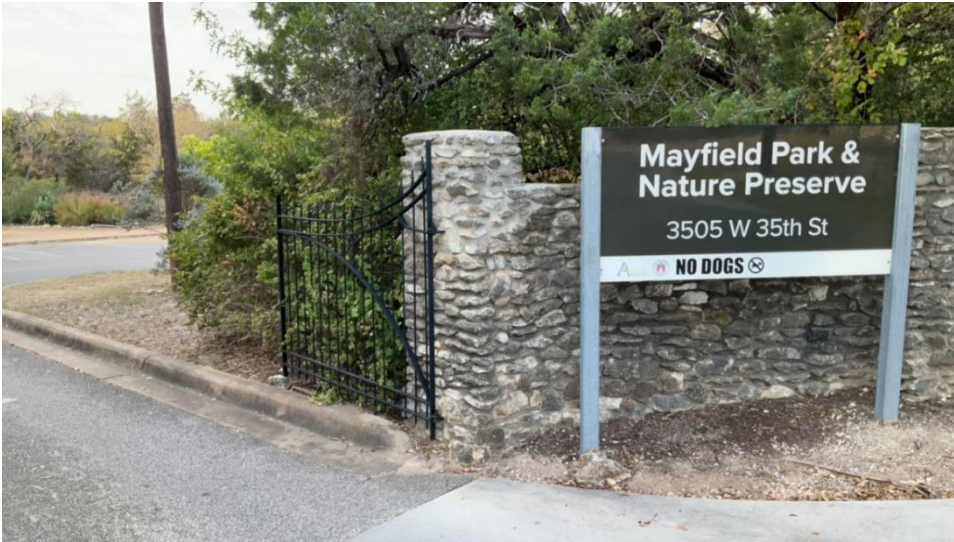
**Picture C-21. Mayfield Park – Natural Access Control, Site / Target Hardening**

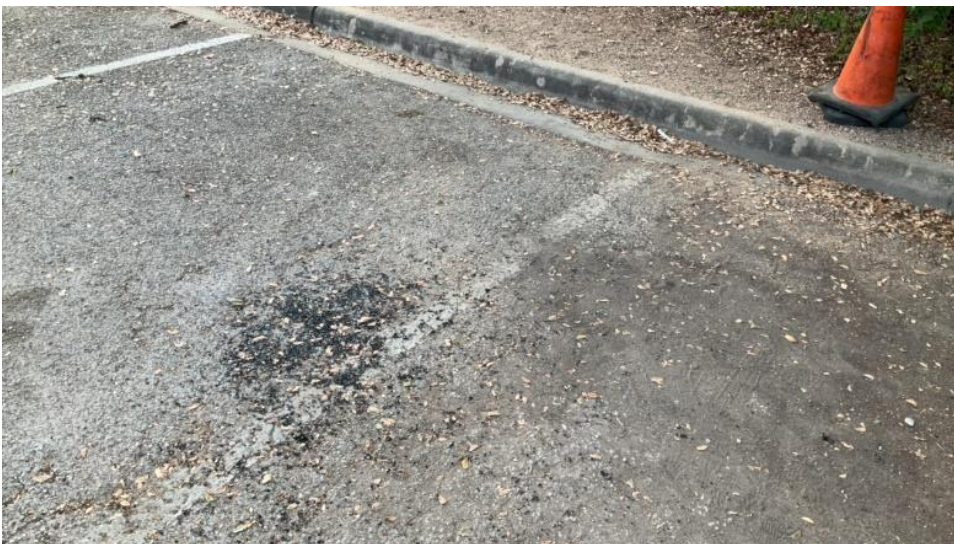
**Picture C-22 Mayfield Park – Security Observation: Evidence of Motor Vehicle Theft**

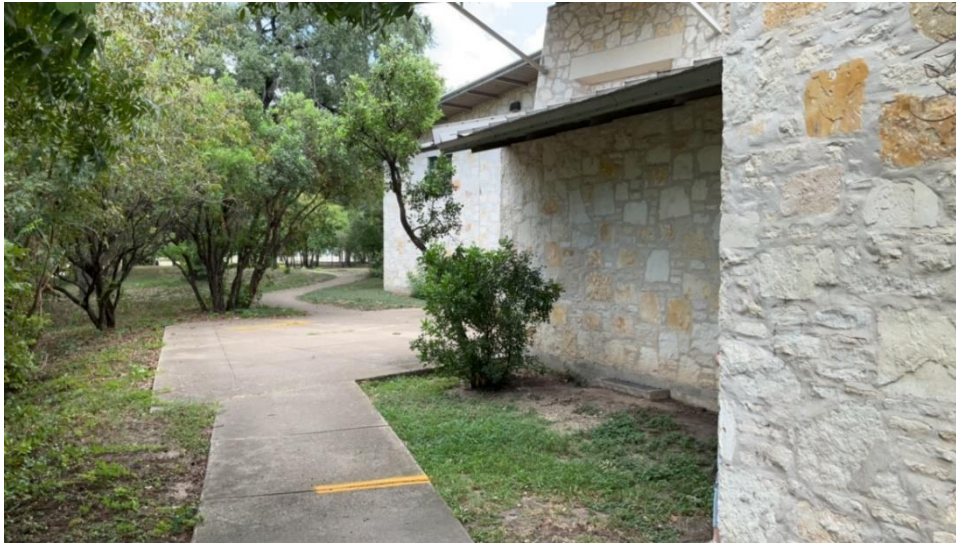
**Picture C-25. Parque Zaragoza Neighborhood Park - Natural Surveillance**

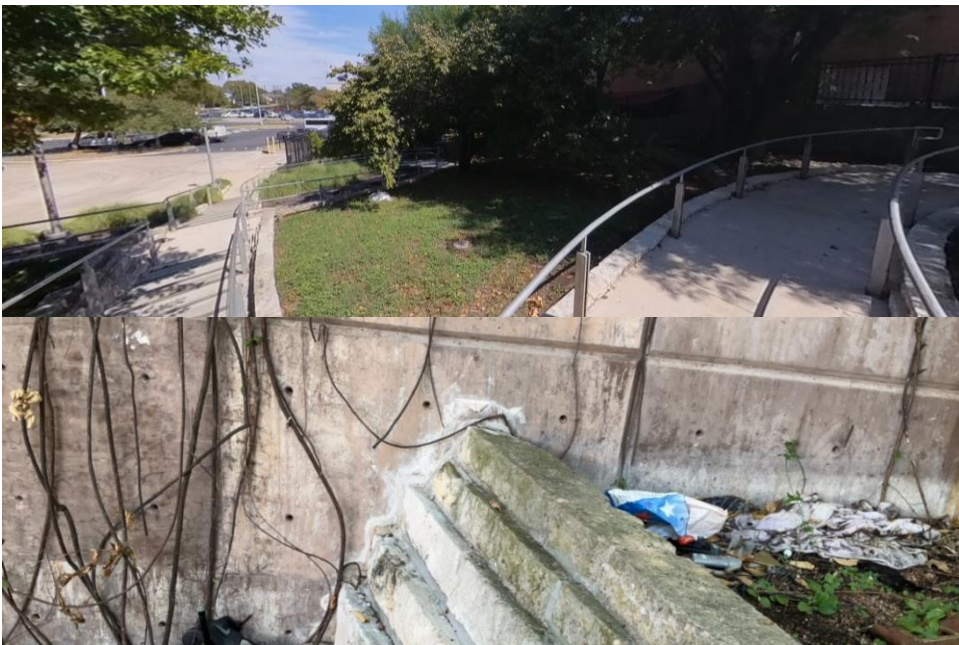
**Picture C-41. George Washington Carver Museum and Cultural Center - Image Management / Maintenance**

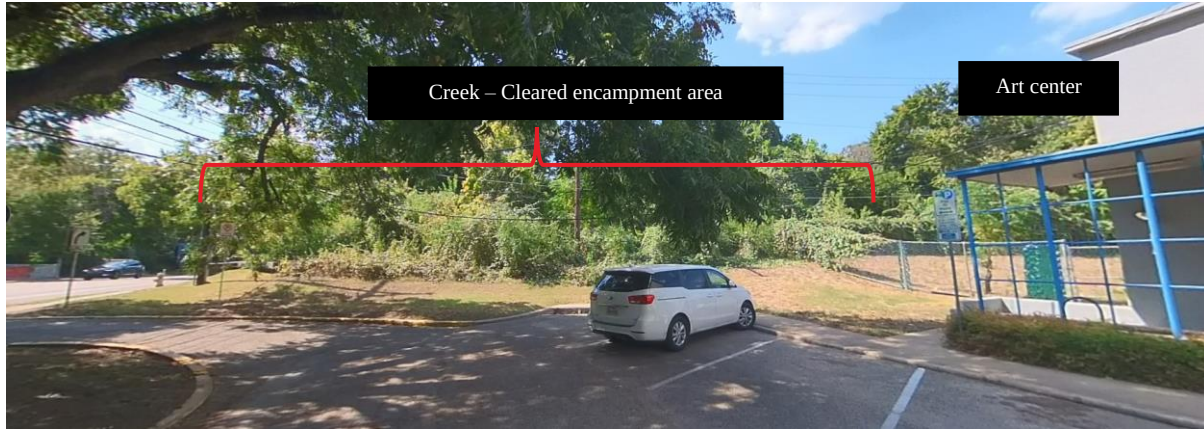
**Picture C-44. Dougherty Arts Center - Creek directly adjacent to the arts center. This was the location of a large encampment which has since been cleared. It is regularly patrolled by APD to keep it cleared**

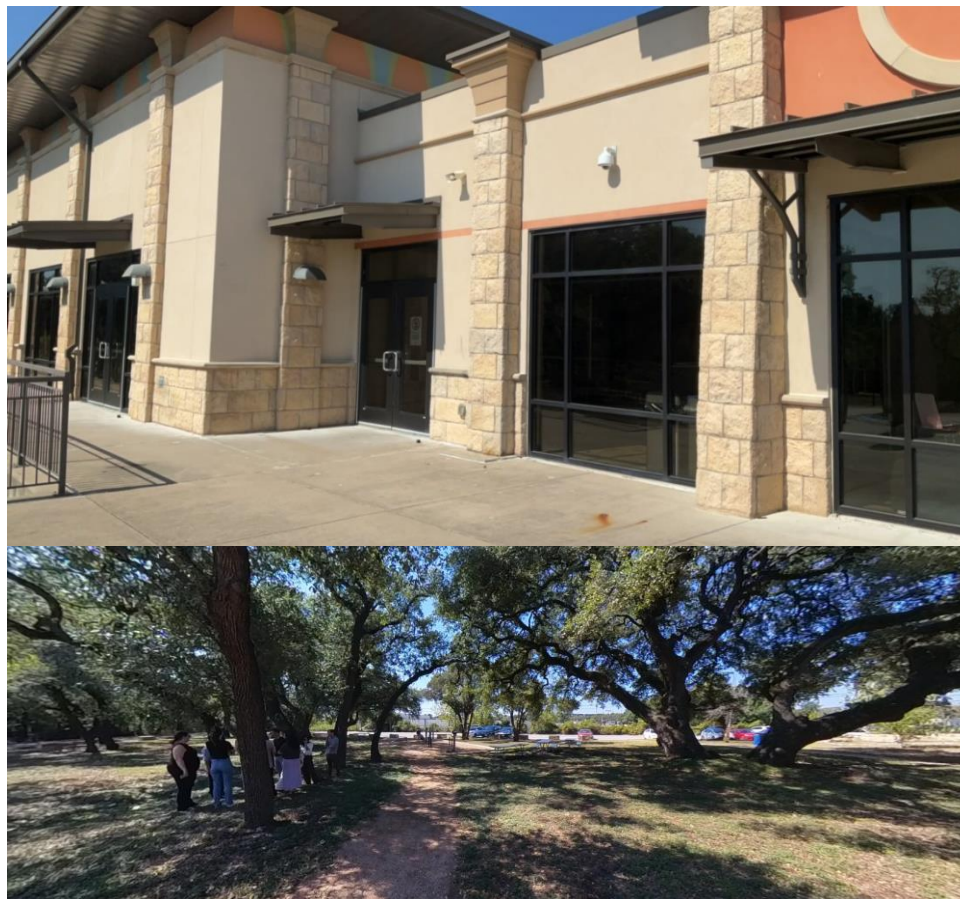
**Picture C-46. Asian American Resource Center - Natural Surveillance, Activity Support**

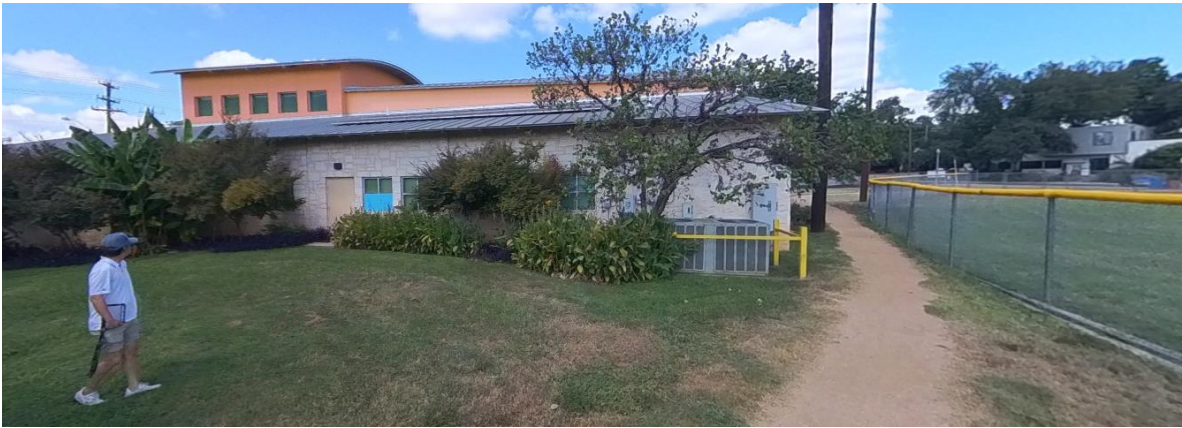
**Picture C-58. Lorraine “Grandma” Camacho Recreation Center - Break-in Location**

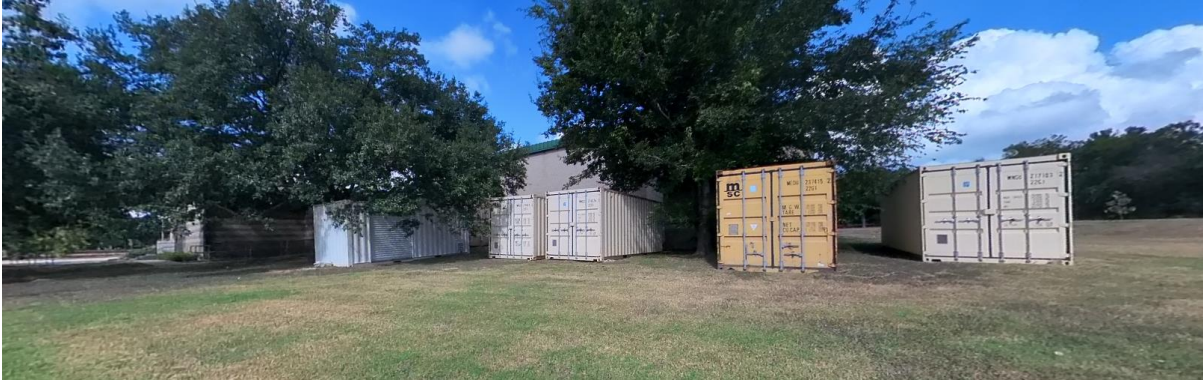
**Picture C-61. George Morales Dove Springs Recreation Center - Natural Surveillance**

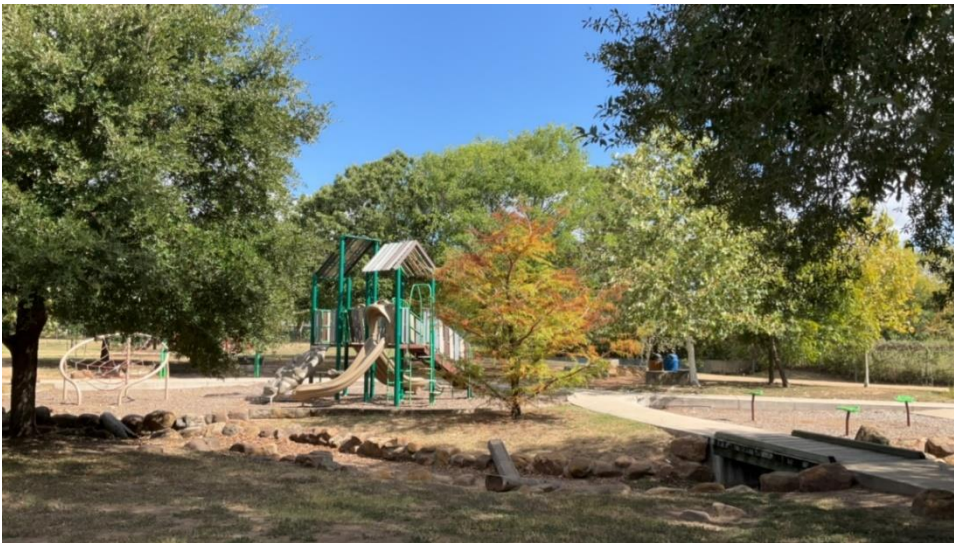
**Picture C-62. George Morales Dove Springs Recreation Center - Activity Support**

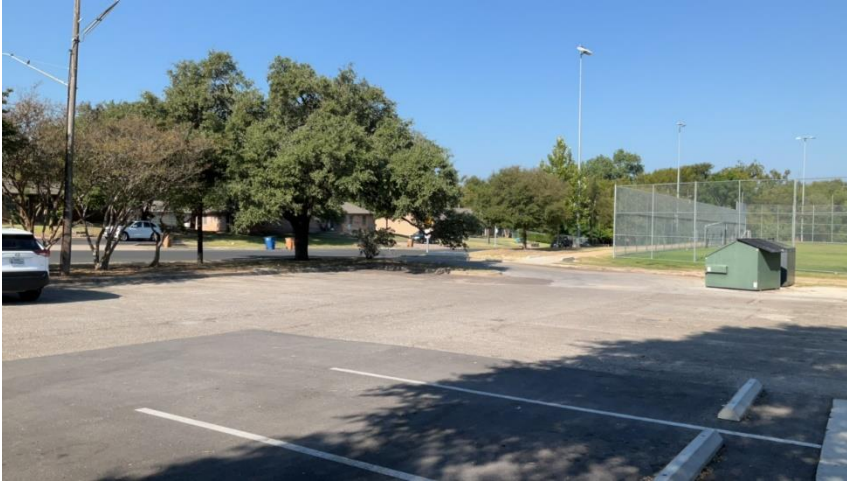
**Picture C-63. South Austin Recreation Center - Natural Surveillance**

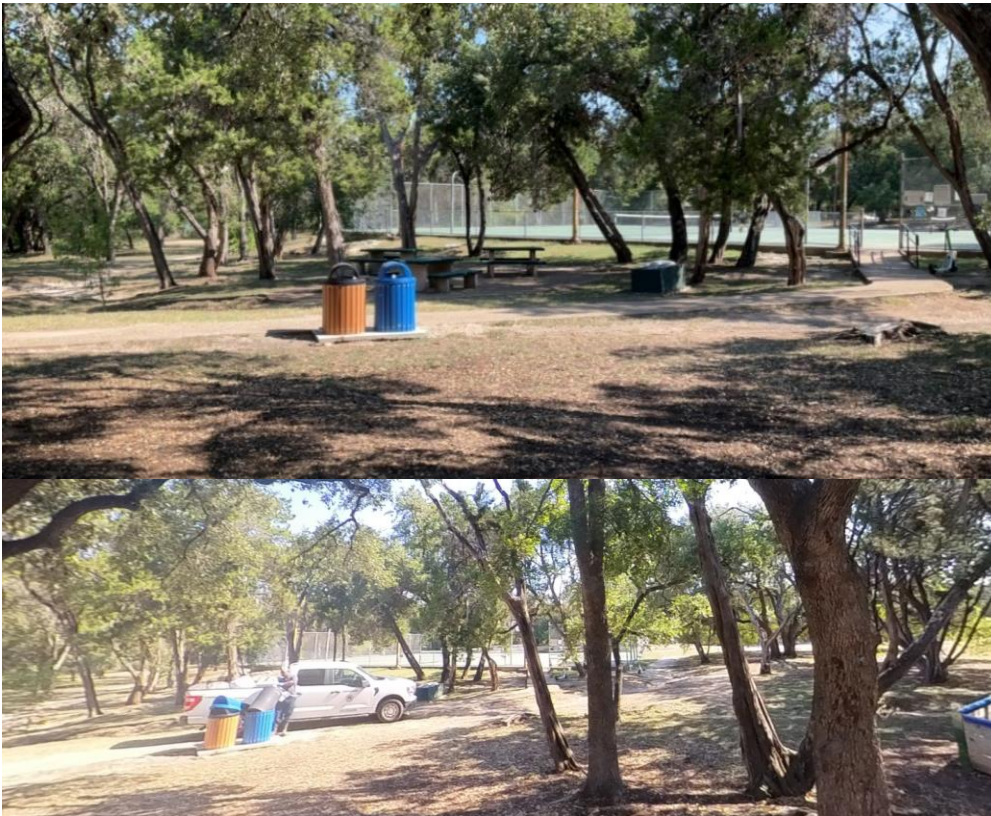
**Picture C-64. South Austin Recreation Center - Image Management / Maintenance**

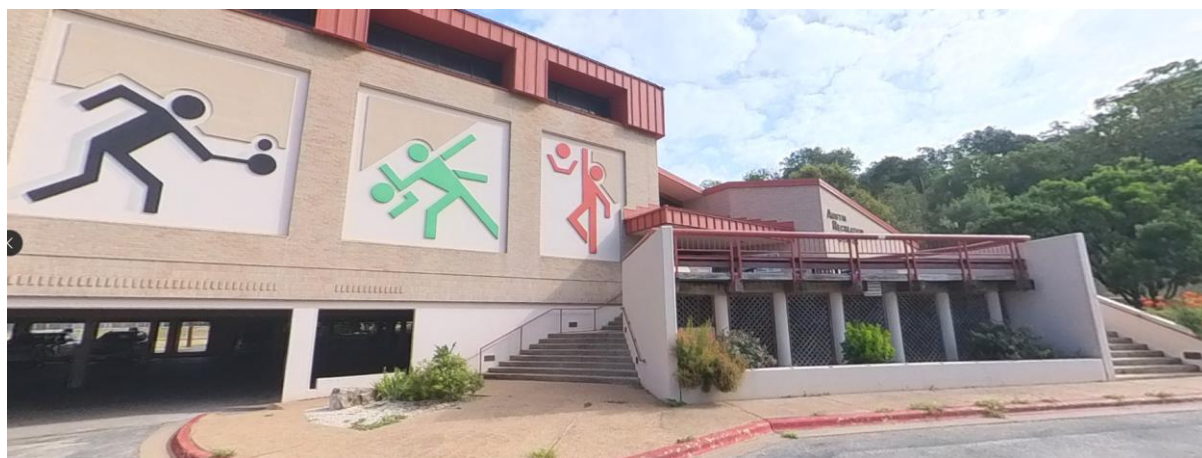
**Picture C-66. Austin Recreation Center and Skate Park - Natural Access Control**

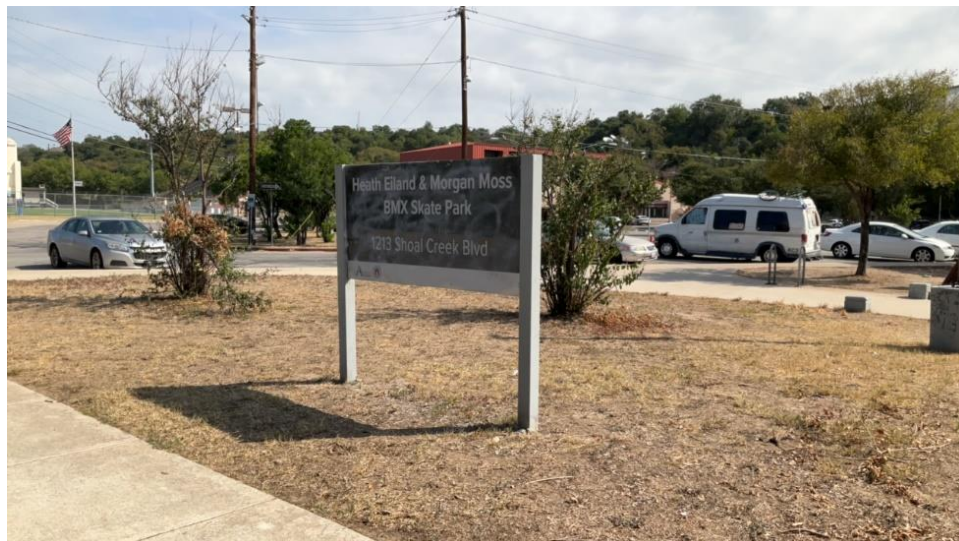
**Picture C-67. Austin Recreation Center and Skate Park - Site / Target Hardening**

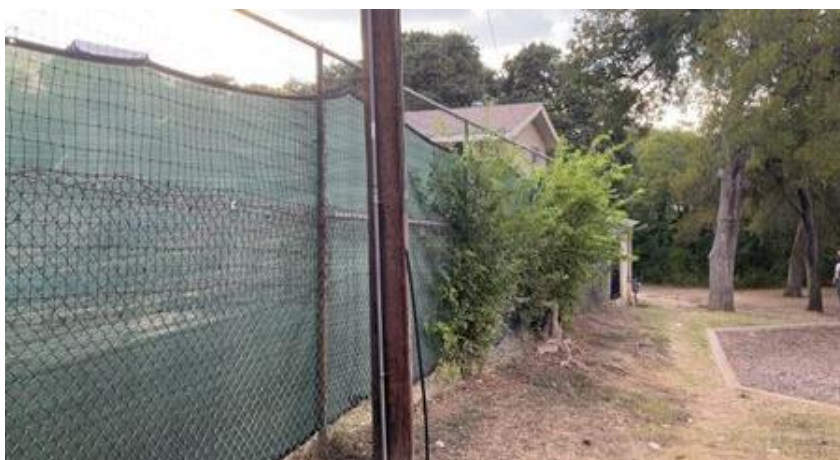
**Picture C-71. Big Stacy Pool - Natural Surveillance**

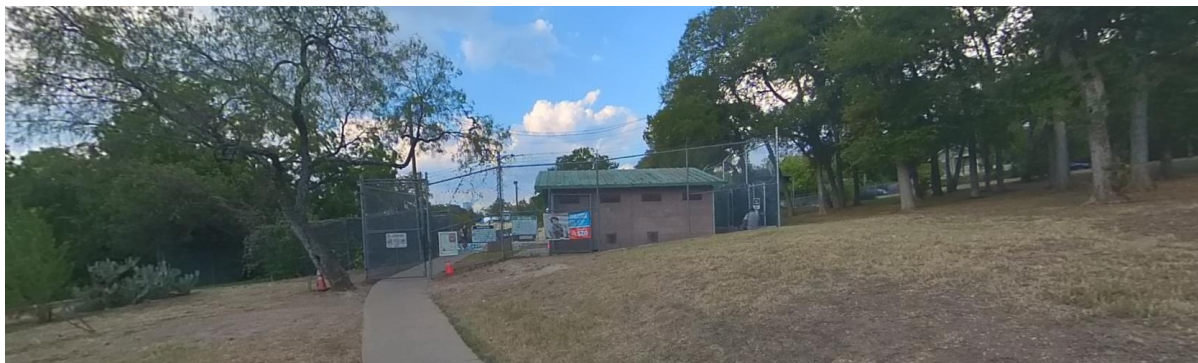
At Big Stacy Pool, the restroom and shower facilities are frequently used by individuals experiencing homelessness. Sleeping individuals are regularly found behind or in the restrooms in the morning and throughout the day. Drug users also frequently use the facility and leave behind needles and other drug paraphernalia. The high level of illicit activities at the restroom and shower regularly prevents pool users from using them.

**Picture C-72. Big Stacy Pool - Natural Access Control - At the front are the public restroom and shower facility frequently misused by the unhouse population or drug users**

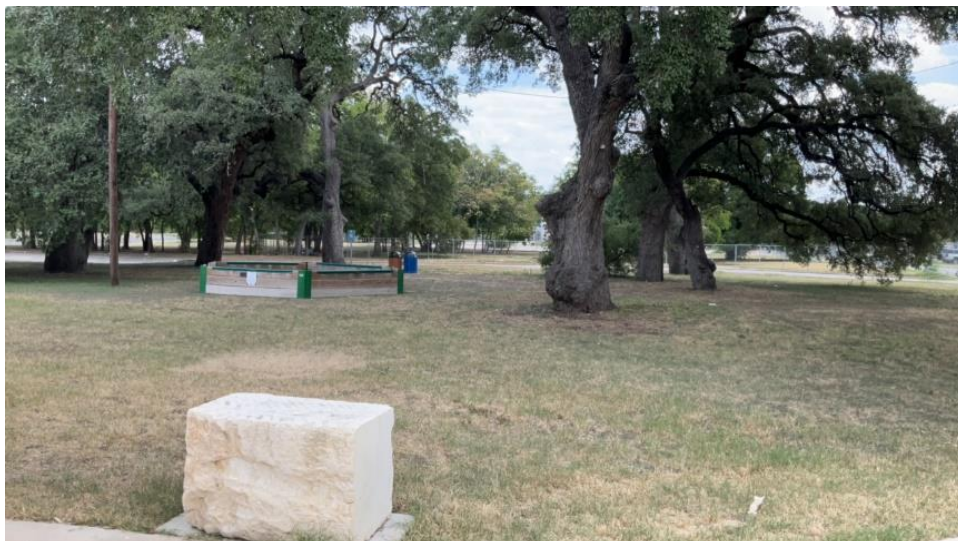
**Picture C-76. Parque Zaragoza Recreation Center - Site / Target Hardening**

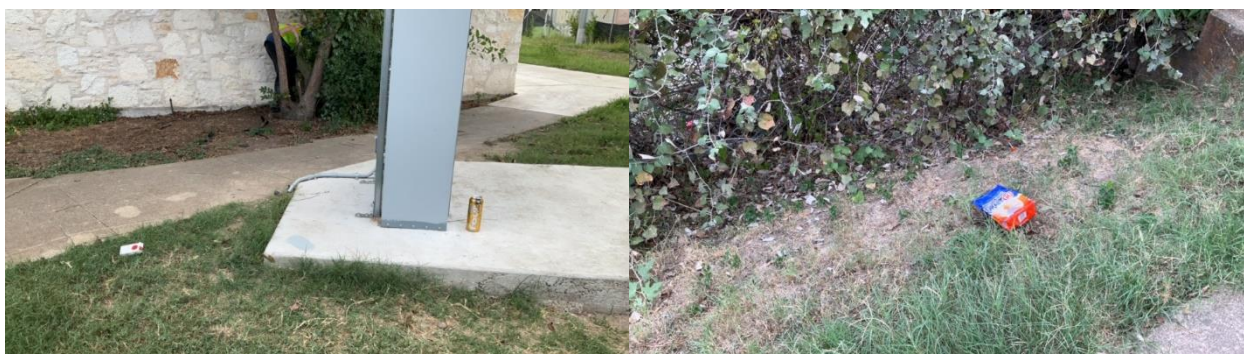
**Picture C-77. Parque Zaragoza Recreation Center - Image Management / Maintenance**

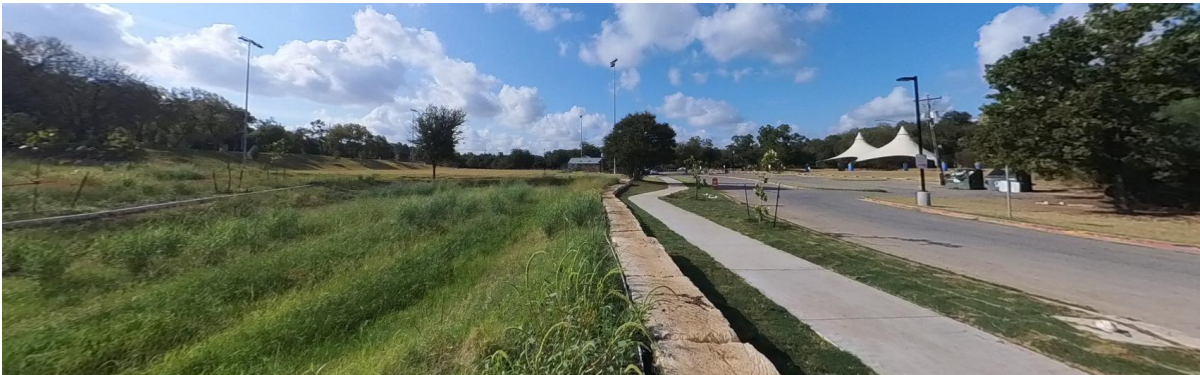
**Picture C-81. Givens Recreation Center - Activity Support**

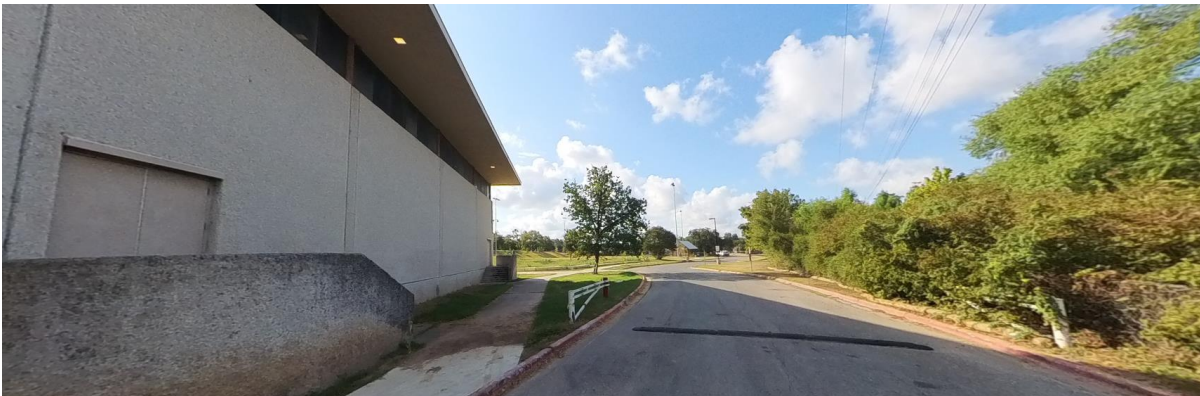
**Picture C-82. Givens Recreation Center - Vehicle gates at one side of the district park; the gate on the right has vegetation growing over it, indicating it has not been used in a long time**
