**City of Austin**

# Parks and Recreation Department Security Audit

## Findings and Recommendations Report

Version 2 | July 18, 2025

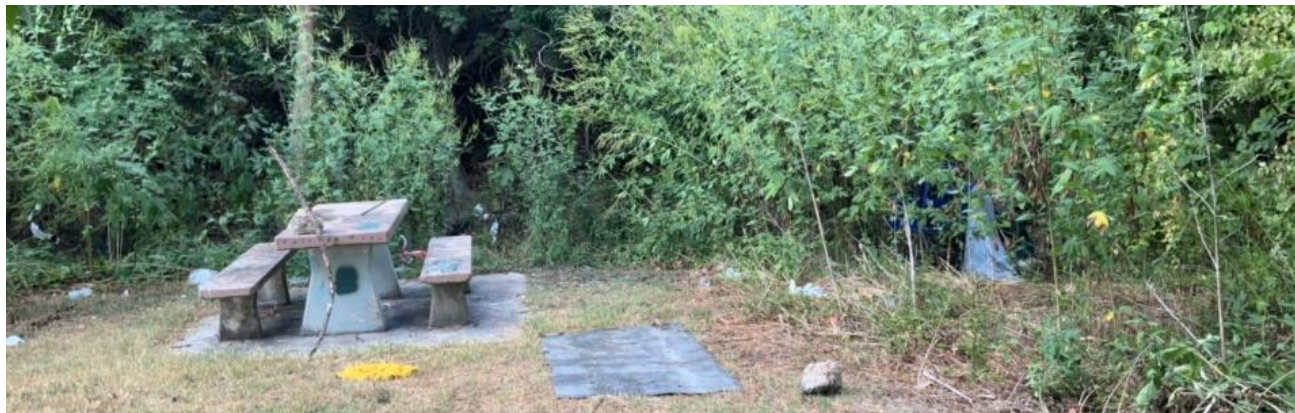
Individuals experiencing homelessness are also often observed in areas of the park where they are less likely to be seen. These areas typically have heavy vegetation, are at the perimeter of the site, and are dark. These areas have decreased perceptions of safety due to low visibility and low facial recognition. At nighttime, it is hard to identify these individuals from afar.

**Picture 1. Individuals experiencing homelessness are often observed at the park perimeter where there is heavy vegetation, and they are less likely to be seen**

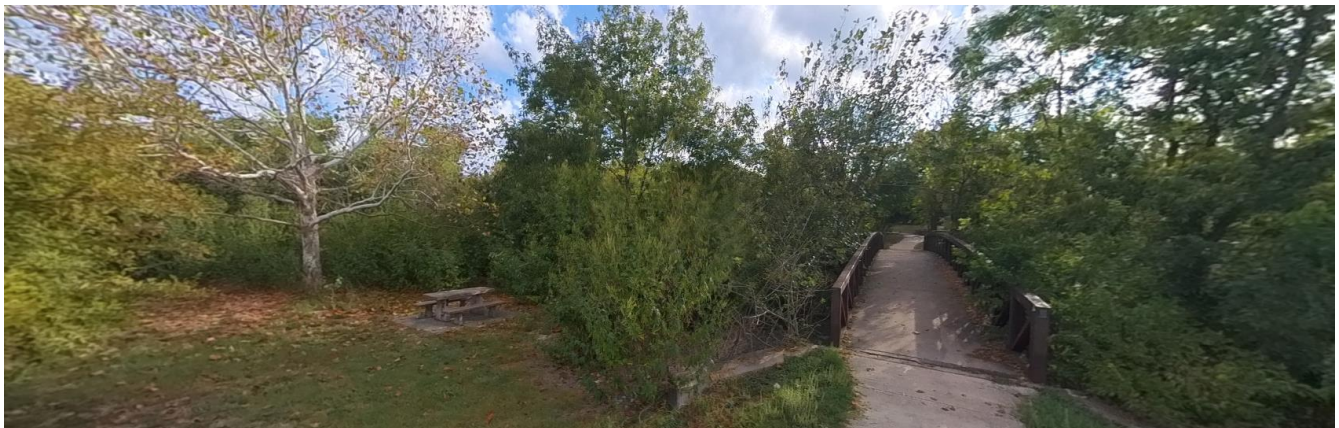
Similarly, at Bartholomew District Park, active use of both the disc golf course located throughout the forested area and passive recreation structures in open green areas improve natural surveillance for both types of terrain. Despite observations of individuals experiencing homelessness in the park and an abundance of household trash found along the tree lines, active and legitimate use by other community members help to alleviate the perception that the park is unsafe to be in.

**Picture 5. Ineffective placement of activity generator to encourage increased natural surveillance; the picnic table is isolated from other areas of the park, and the dense vegetation obstructs sightlines of the surrounding area**

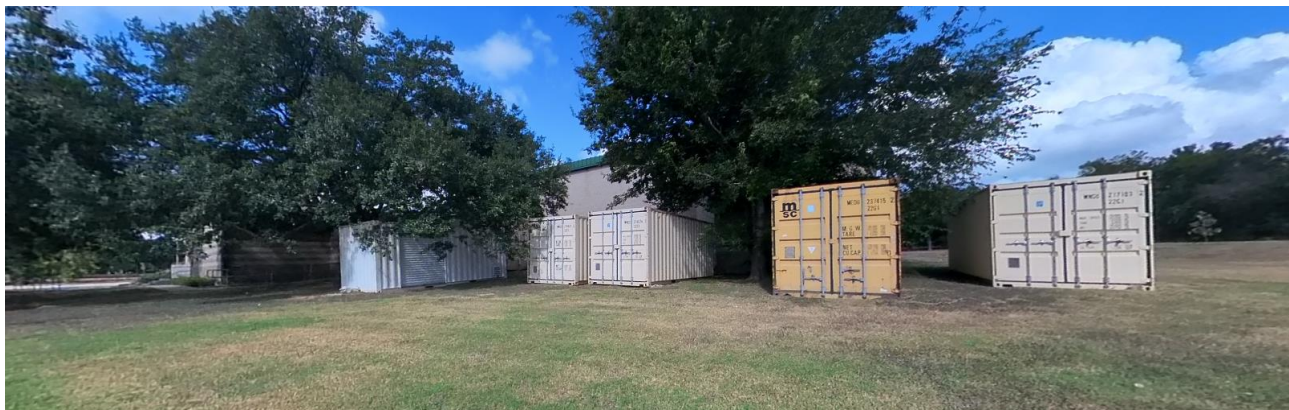
PARD parks and facilities rely heavily on rented shipping containers for long-term storage. However, shipping containers obstruct visibility at sites, negatively impact natural surveillance, and create blind spots at the facility or site perimeter.

**Picture 7. Shipping containers at George Morales Recreation Center**

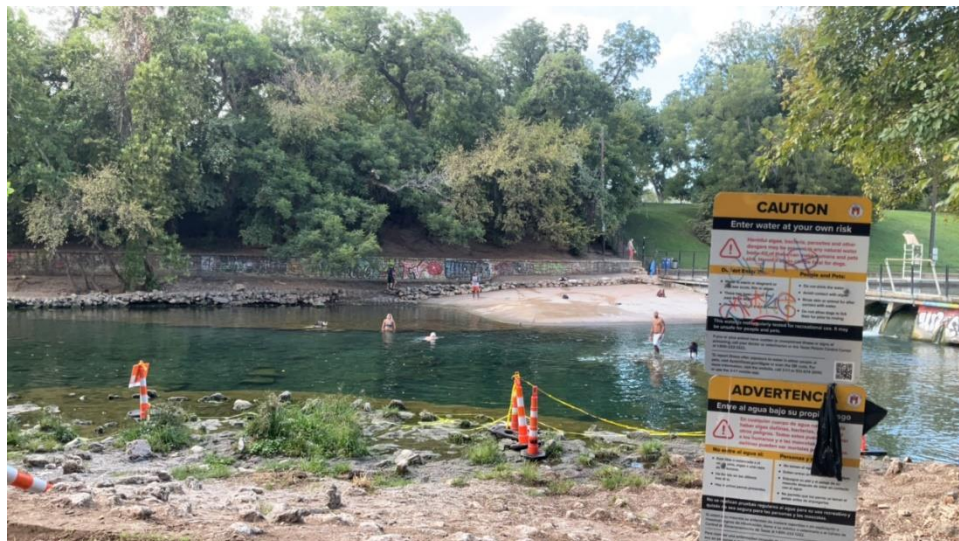
The Spillway of Zilker Park (public facing side of Barton Springs) scored poorly across the natural access control, image management / maintenance, and territorial reinforcement CPTED categories. The public side of Barton Springs had extensive trash and graffiti as shown in Picture C-7. Additionally, traffic cones with yellow barricade tape used to restrict public access to the area were disregarded and torn down.

**Picture C-7. Zilker Metropolitan Park (Spillway) - Natural Access Control, Image Management / Maintenance**

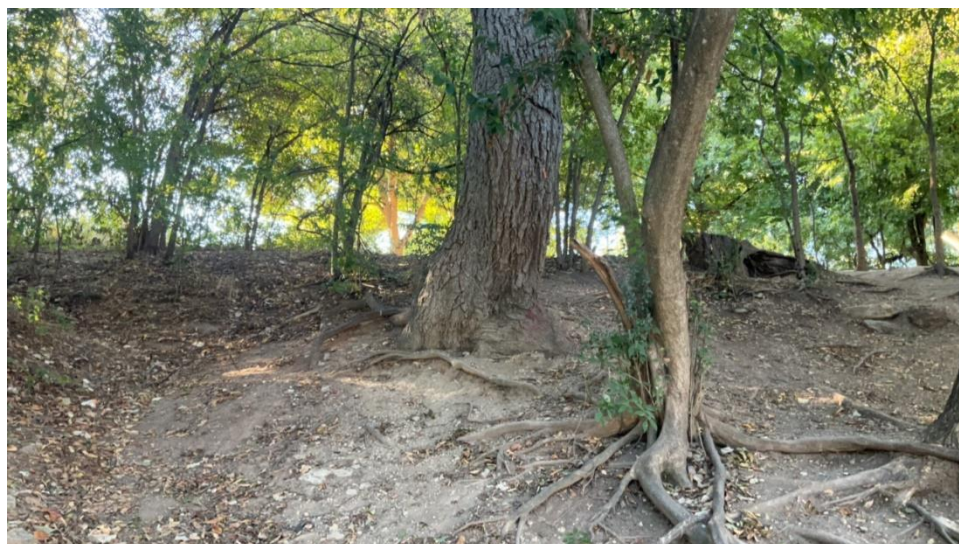
At the time of the site visit, the public side of Barton Springs was closed for repairs. However, park users still accessed the location despite the temporary barriers, as shown in Picture C-7. While security signage was present, park users ignored these warnings and accessed the area via the southern side of Barton Creek and through the greenway on the northern side.

**Picture C-8. Zilker Metropolitan Park (Spillway) - Natural Access Control**

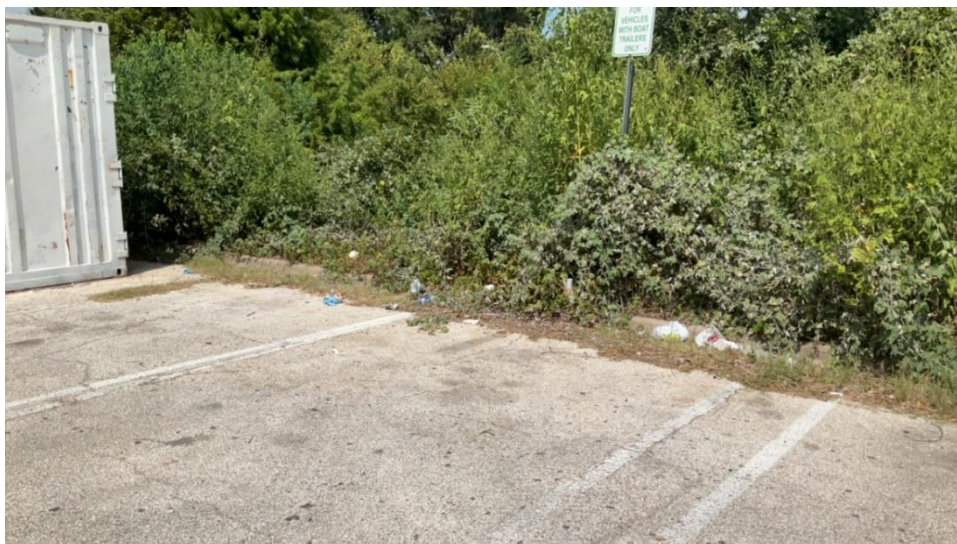
Festival Beach was the only metropolitan park to score on the lowest end of the rating scale, due to lower average ratings across all CPTED categories—most notably in site / target hardening. The boat access point on Nash Hernandez Sr. Road had extensive trash, blind spots due to shipping containers, and overgrown vegetation as shown in Picture C-14. Additionally, fencing and vehicle barriers were not observed at the vehicle access points and parking lots surveyed.

**Picture C-14. Festival Beach – Natural Surveillance, Image Management / Maintenance**

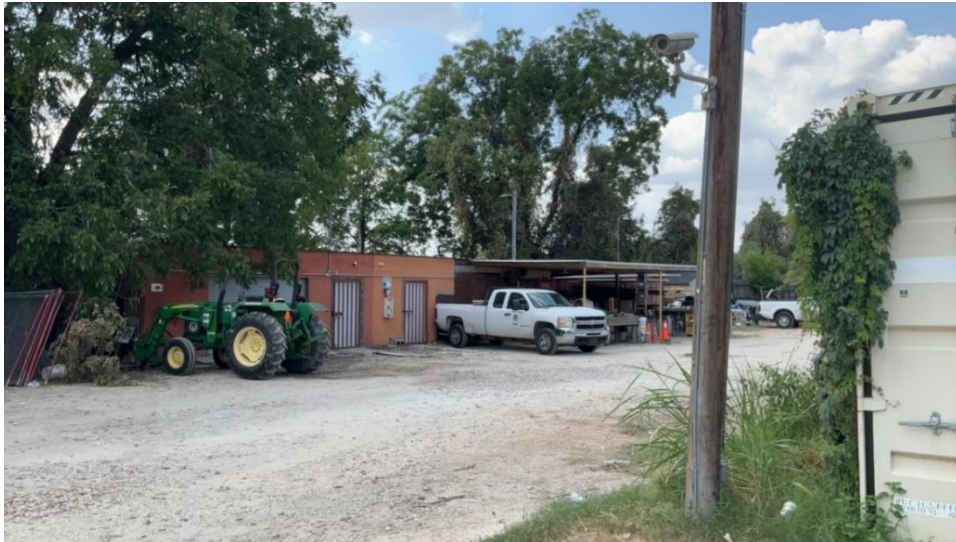
The PARD maintenance facility on Jessie E. Segovia Street was included in the assessment grouping for Festival Beach. This facility had elevated access control measures, target hardening methods such as vehicle gates and fencing, constant monitoring during the daytime from PARD employees, and security cameras as a deterrent, as shown in Picture C-15 and Picture C-16. Facility staff noted that storage containers and loose maintenance equipment are targets for burglaries, and they have implemented measures such as extra locks and blocking shipping containers (where equipment is stored) with vehicles during non-operational hours.

Picture C-15. Festival Beach – Natural Surveillance

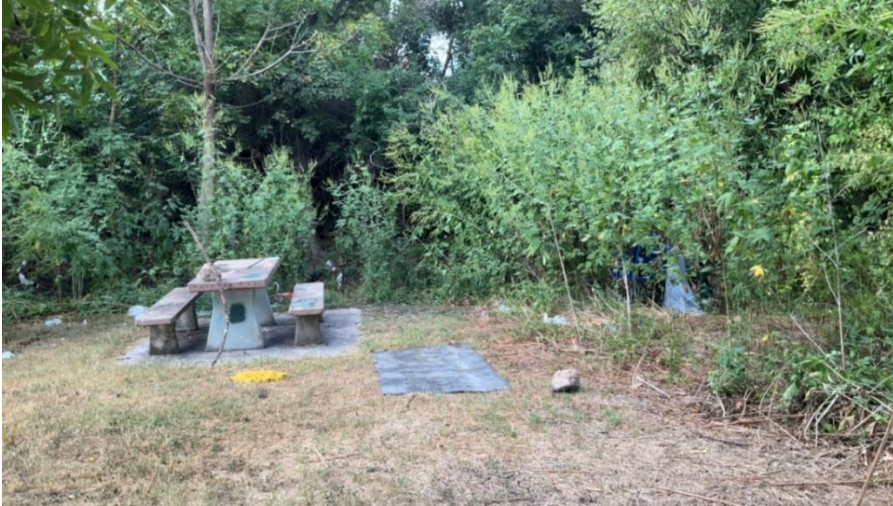
Bartholomew District Park had extensive amounts of trash and poorly maintained vegetation throughout the southern side of the park along Tannehill Creek. Overgrown vegetation, blind spots, and trash were observed, causing low ratings for natural surveillance and image management / maintenance as shown in Picture C-18.

**Picture C-18. Bartholomew District Park – Natural Surveillance, Image Management / Maintenance**

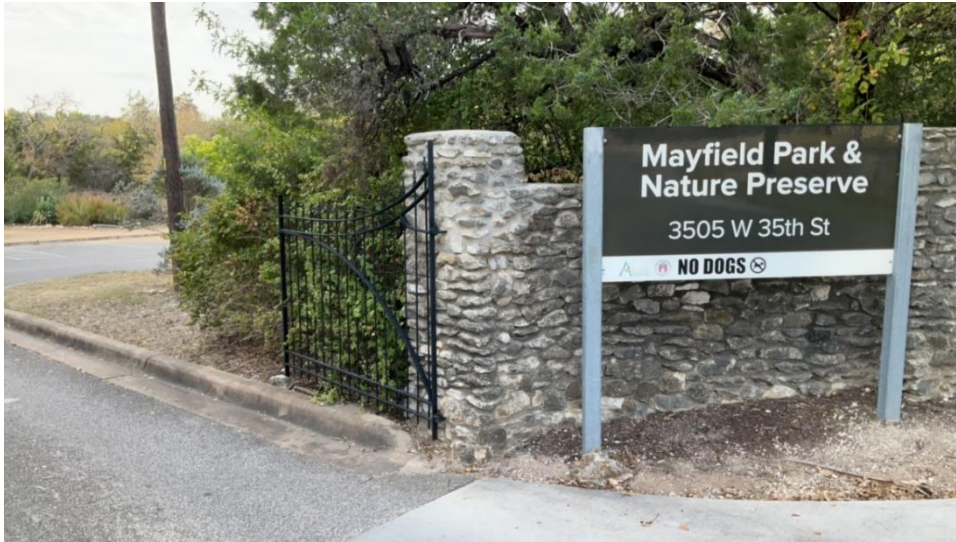
**Picture C-21. Mayfield Park – Natural Access Control, Site / Target Hardening**

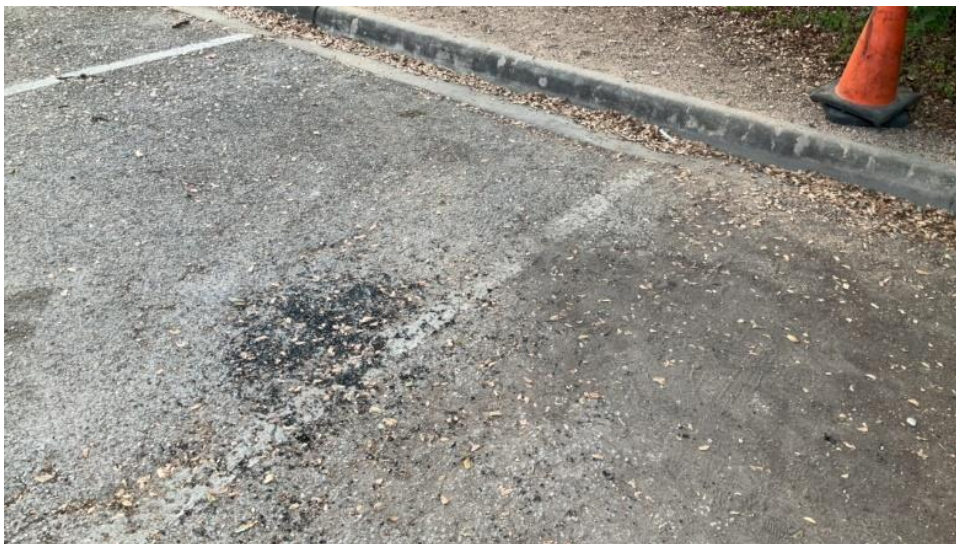
**Picture C-22 Mayfield Park – Security Observation: Evidence of Motor Vehicle Theft**

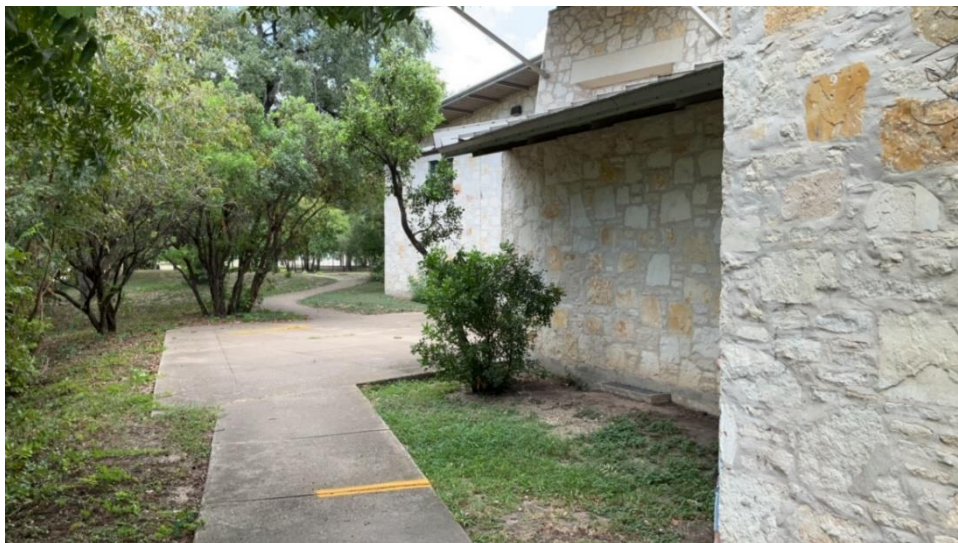
**Picture C-25. Parque Zaragoza Neighborhood Park - Natural Surveillance**

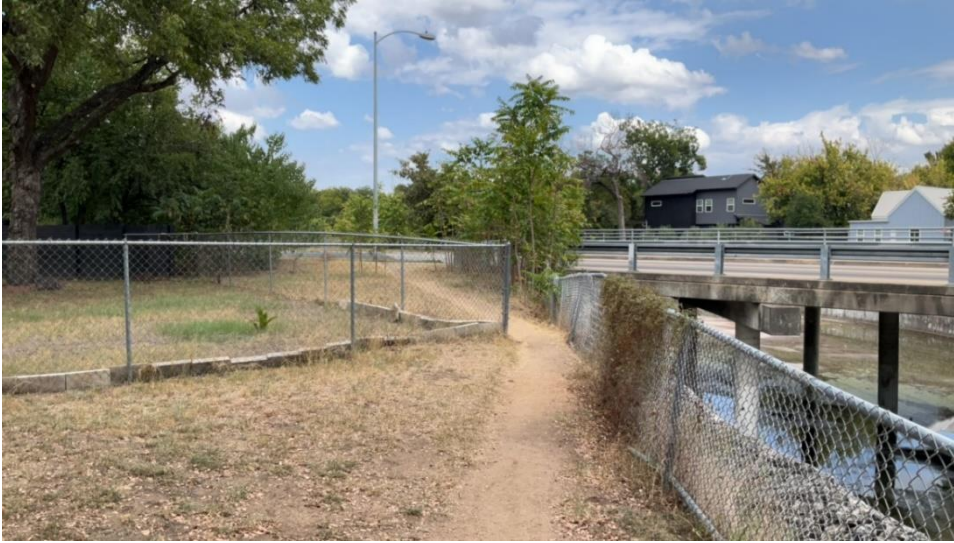
**Picture C-27. Parque Zaragoza Neighborhood Park - Natural Access Control**

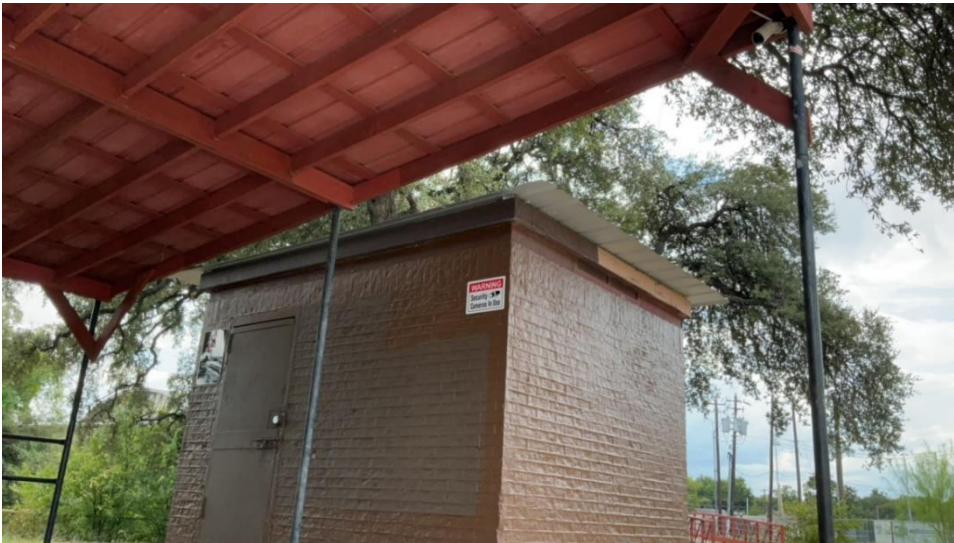
**Picture C-28. Parque Zaragoza Neighborhood Park - Image Management / Maintenance**

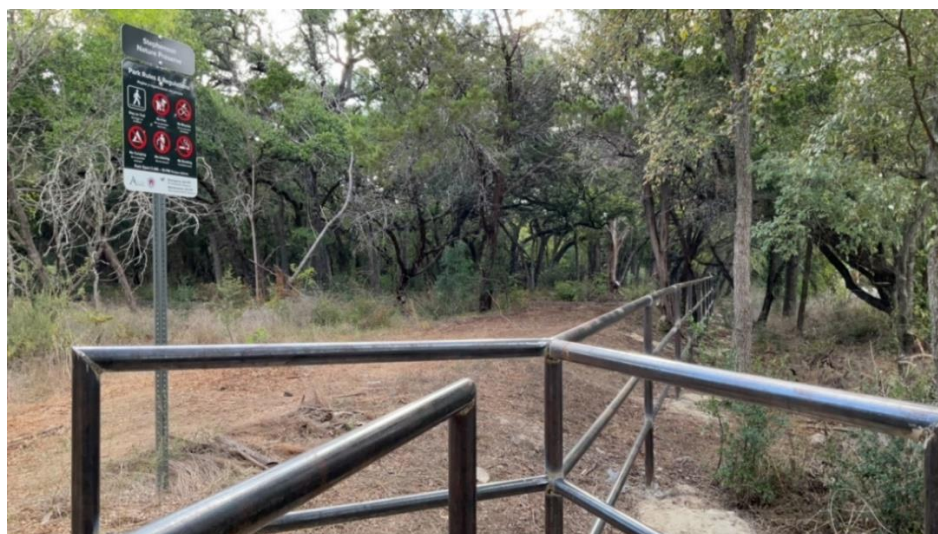
**Picture C-29. Stephenson Nature Preserve - Natural Access Control**

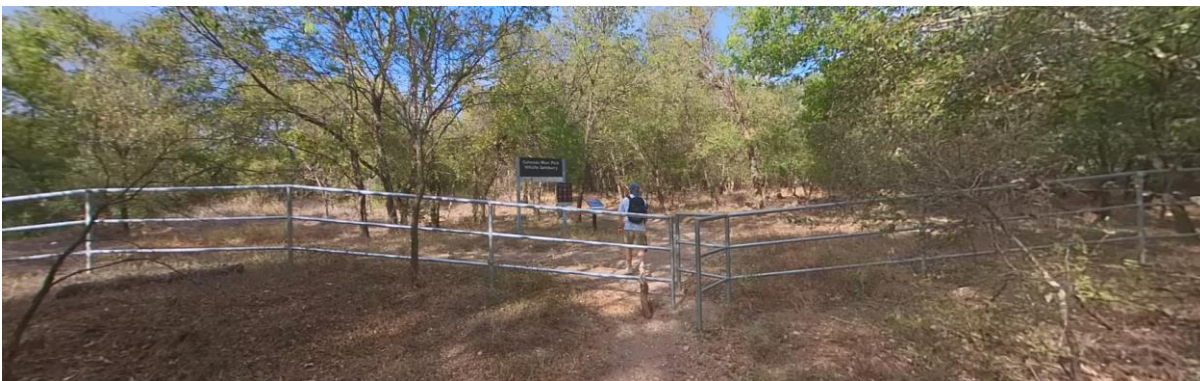
**Picture C-37. Colorado River Wildlife Sanctuary - metal barriers along the trail**

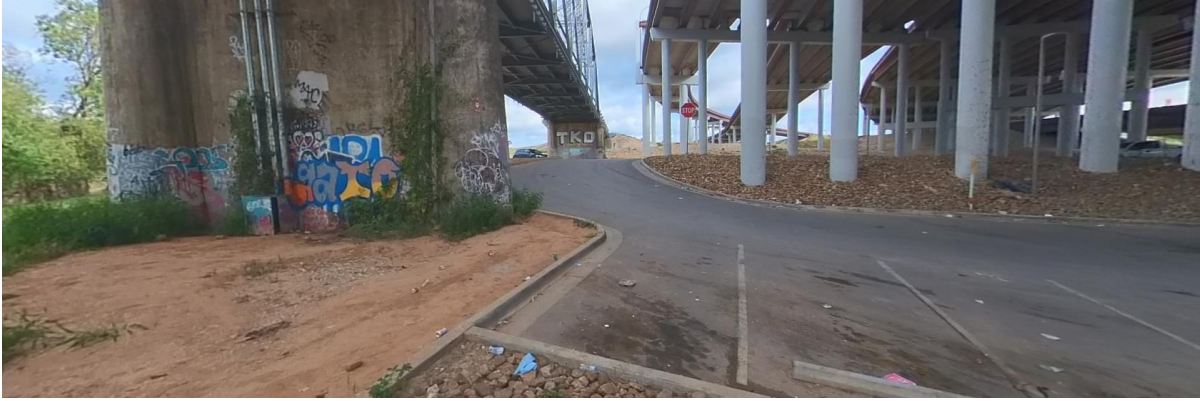
**Picture C-38. Colorado River Wildlife Sanctuary - trash littered throughout the parking lot, including extensive graffiti on the pedestrian bridge pillar**

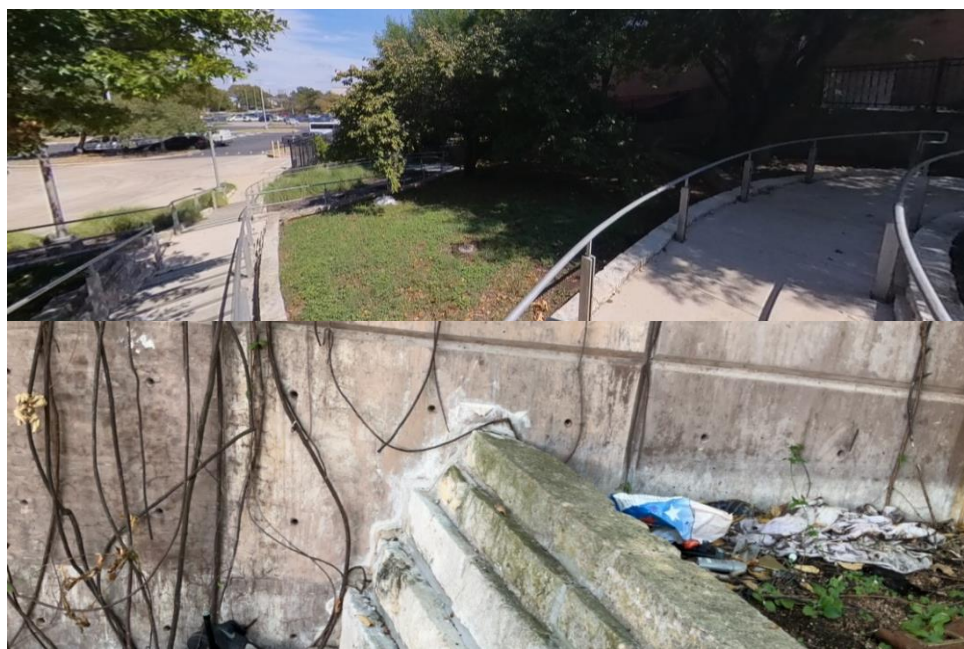
**Picture C-41. George Washington Carver Museum and Cultural Center - Image Management / Maintenance**

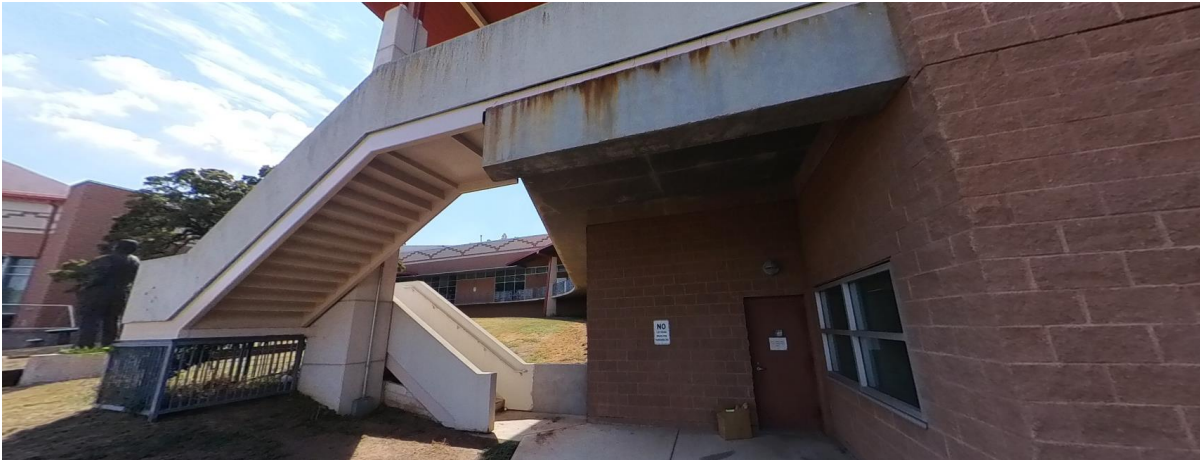
**Picture C-42. George Washington Carver Museum and Cultural Center - Natural Surveillance - Back area of the museum with stairs leading up to the main level of the museum**

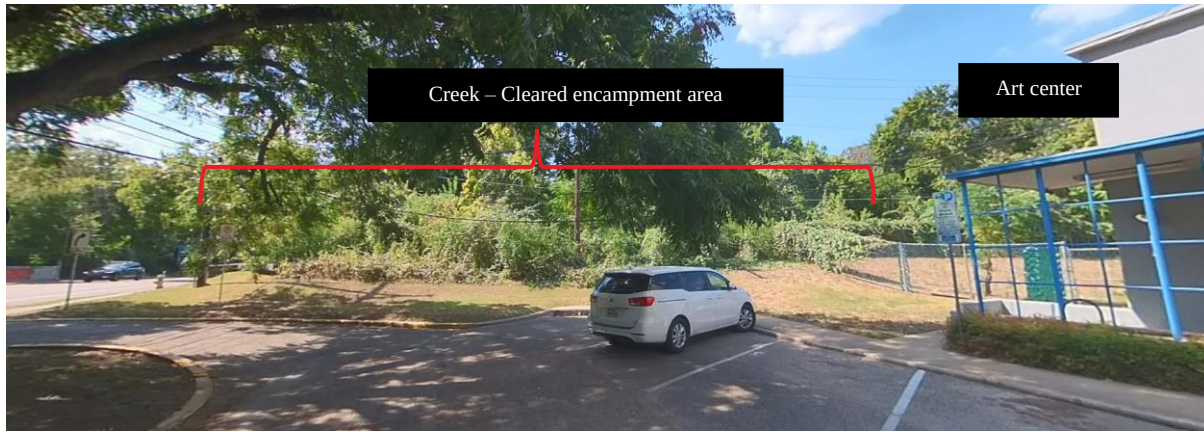
**Picture C-44. Dougherty Arts Center - Creek directly adjacent to the arts center. This was the location of a large encampment which has since been cleared. It is regularly patrolled by APD to keep it cleared**

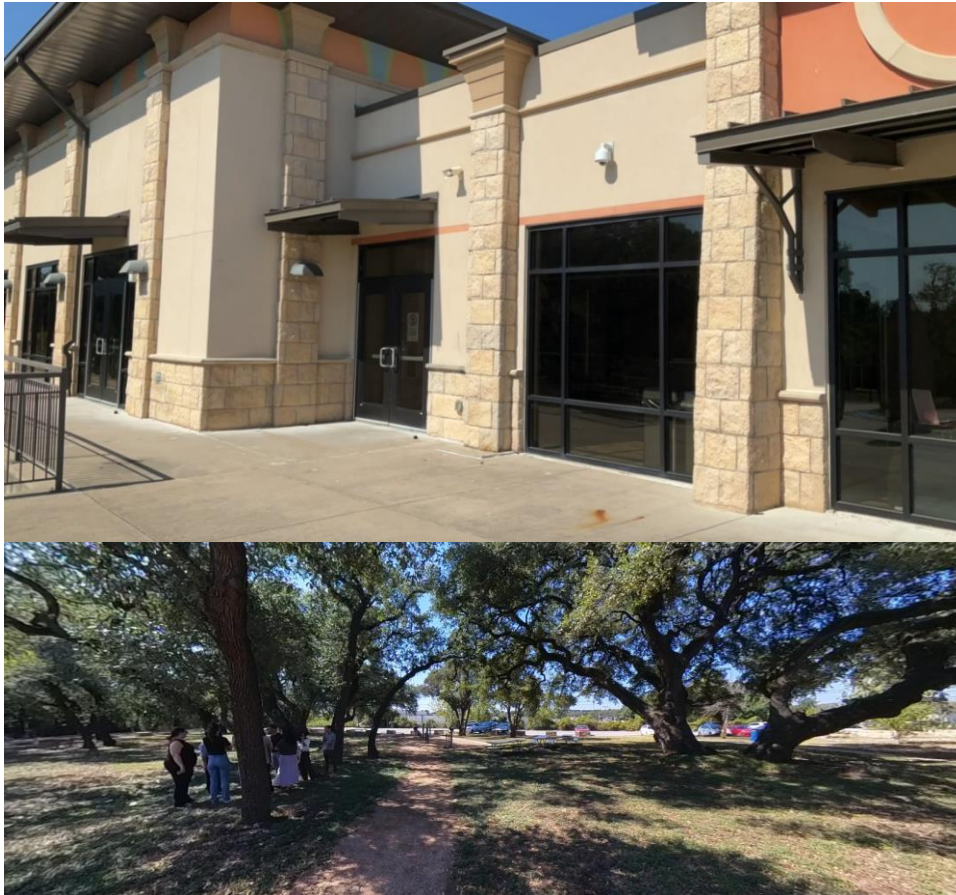
**Picture C-46. Asian American Resource Center - Natural Surveillance, Activity Support**

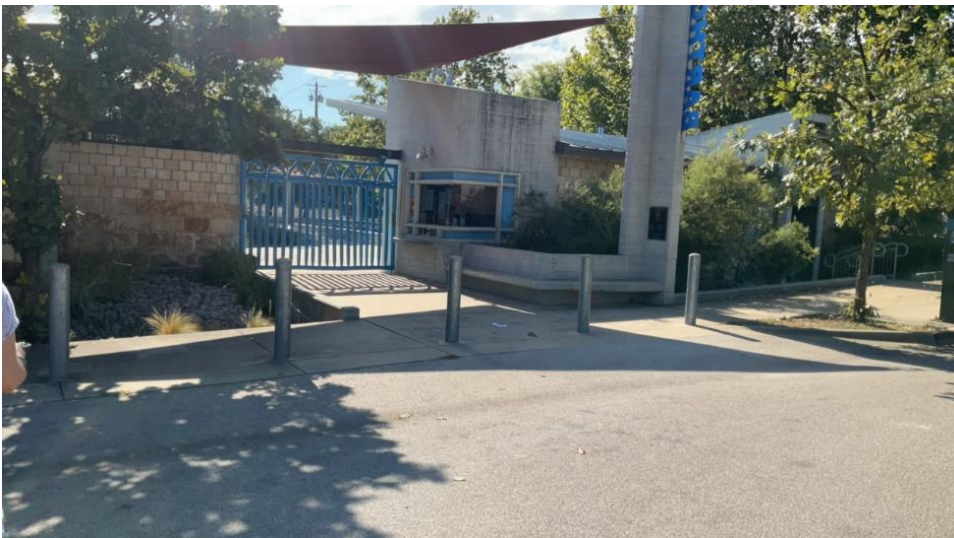
**Picture C-54. Bartholomew Pool - Site / Target Hardening**

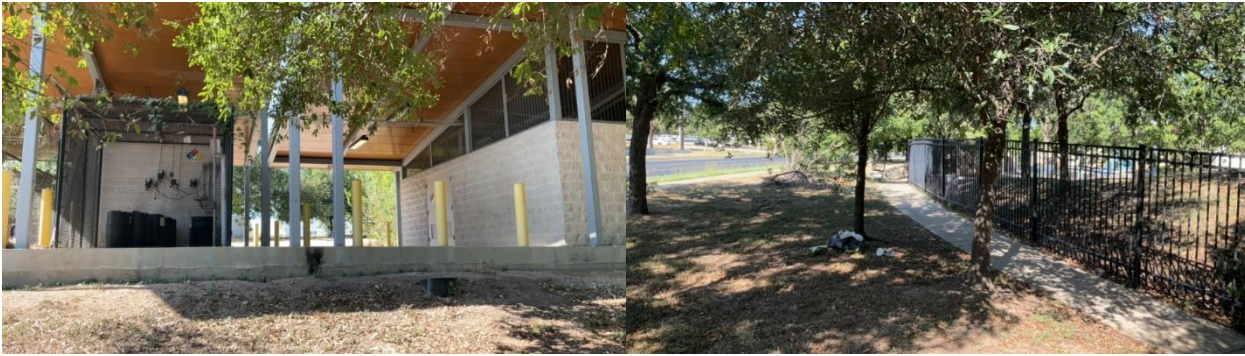
**Picture C-55. Bartholomew Pool - Image Management / Maintenance**

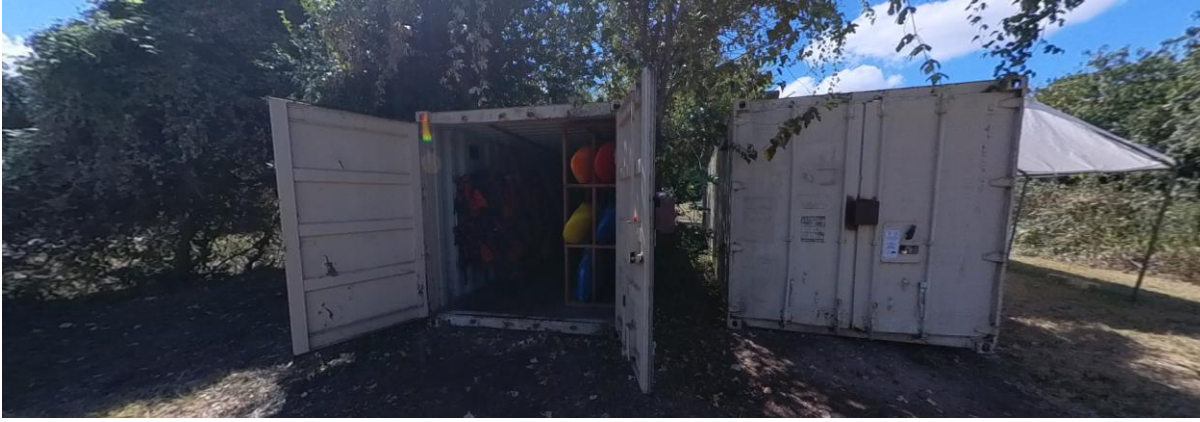
**Picture C-57. Lorraine “Grandma” Camacho Recreation Center - External Storage in Shipping Containers**

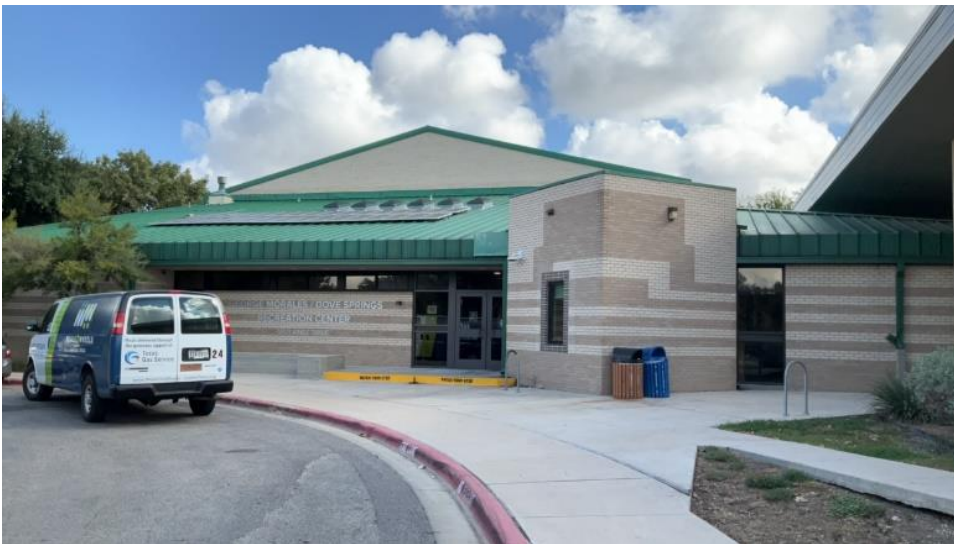
**Picture C-60. George Morales Dove Springs Recreation Center - Natural Surveillance**

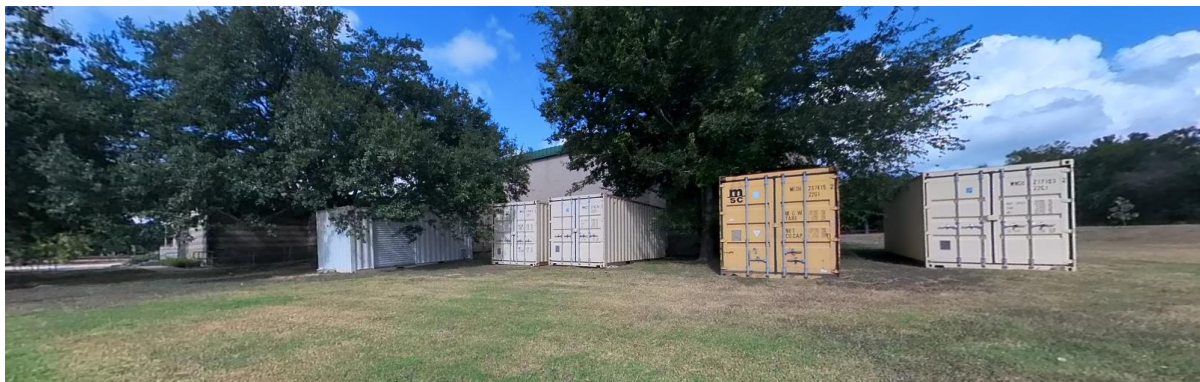
**Picture C-61. George Morales Dove Springs Recreation Center - Natural Surveillance**

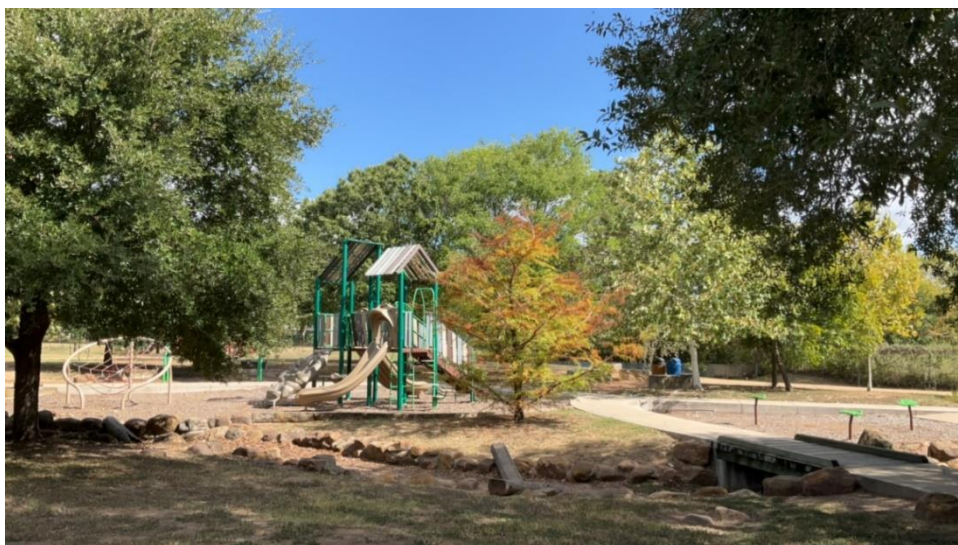
**Picture C-62. George Morales Dove Springs Recreation Center - Activity Support**

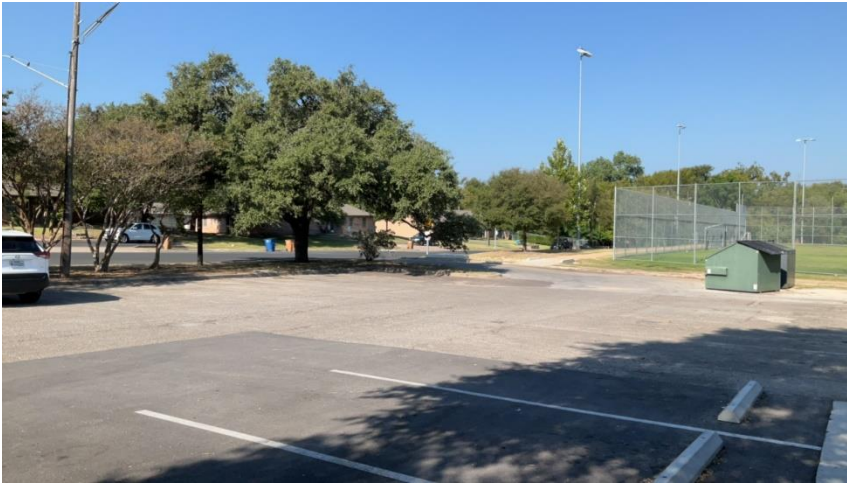
**Picture C-63. South Austin Recreation Center - Natural Surveillance**

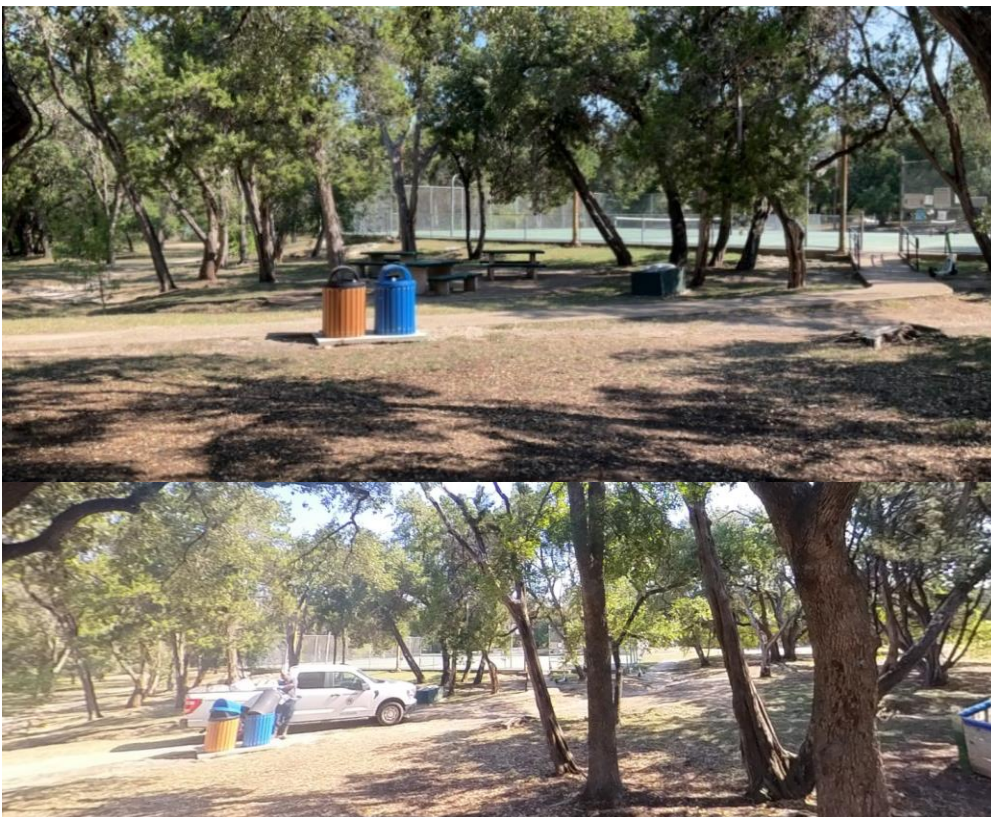
**Picture C-64. South Austin Recreation Center - Image Management / Maintenance**

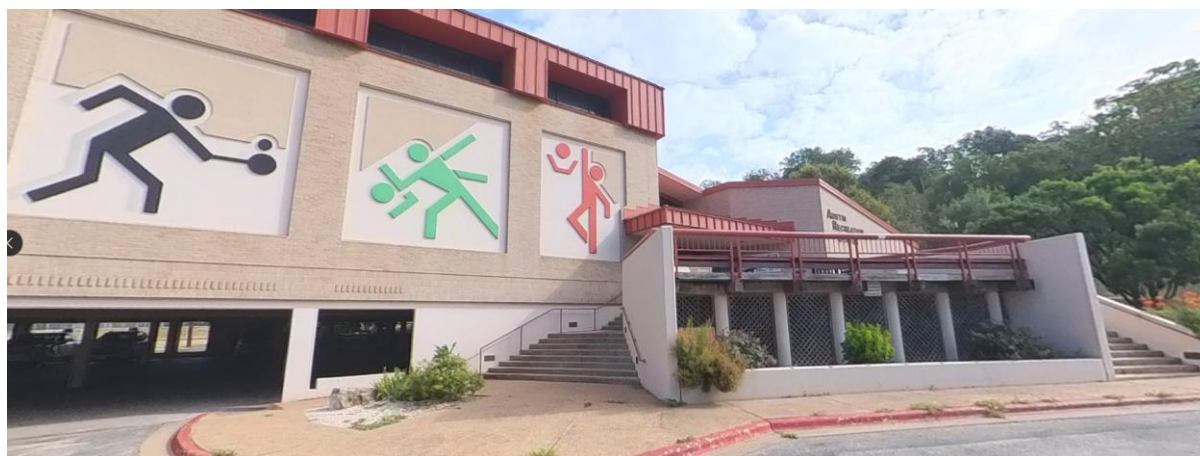
**Picture C-66. Austin Recreation Center and Skate Park - Natural Access Control**

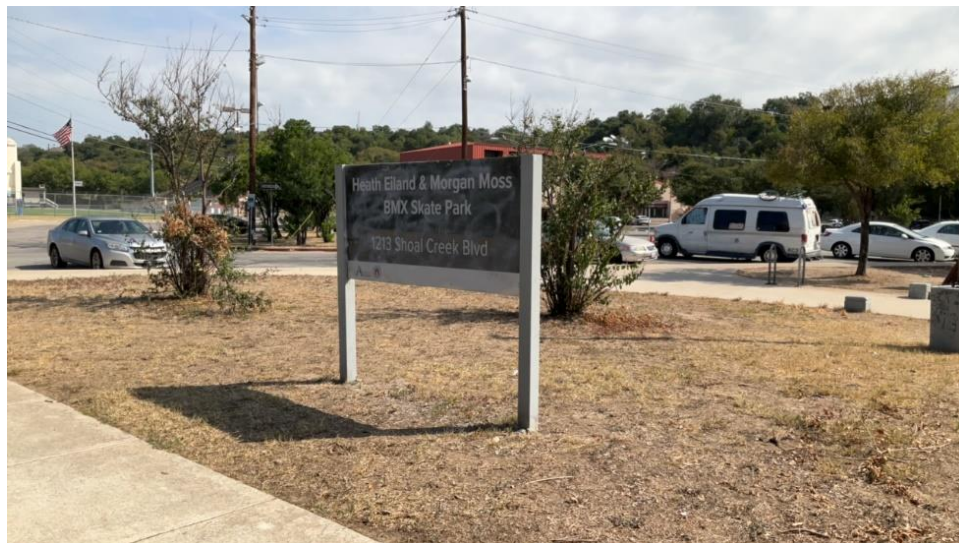
**Picture C-67. Austin Recreation Center and Skate Park - Site / Target Hardening**

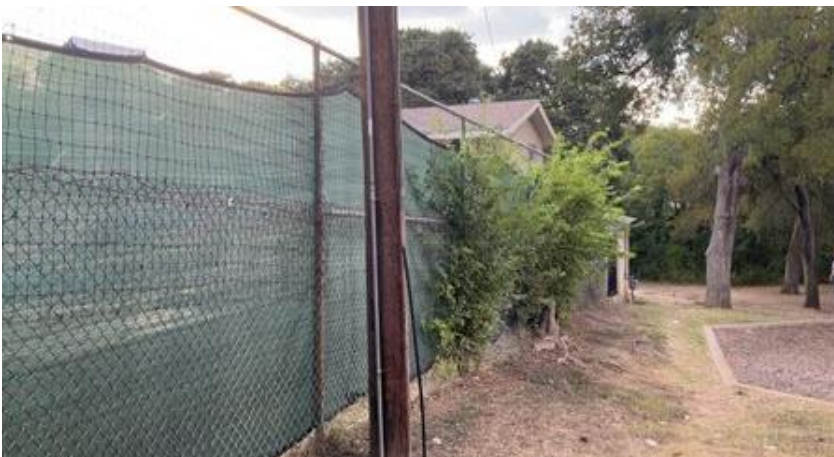
**Picture C-71. Big Stacy Pool - Natural Surveillance**

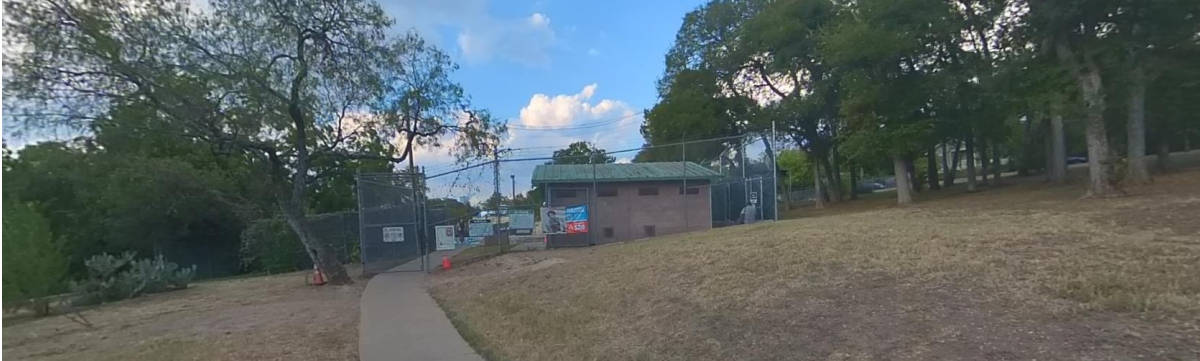
At Big Stacy Pool, the restroom and shower facilities are frequently used by individuals experiencing homelessness. Sleeping individuals are regularly found behind or in the restrooms in the morning and throughout the day. Drug users also frequently use the facility and leave behind needles and other drug paraphernalia. The high level of illicit activities at the restroom and shower regularly prevents pool users from using them.

**Picture C-72. Big Stacy Pool - Natural Access Control - At the front are the public restroom and shower facility frequently misused by the unhouse population or drug users**

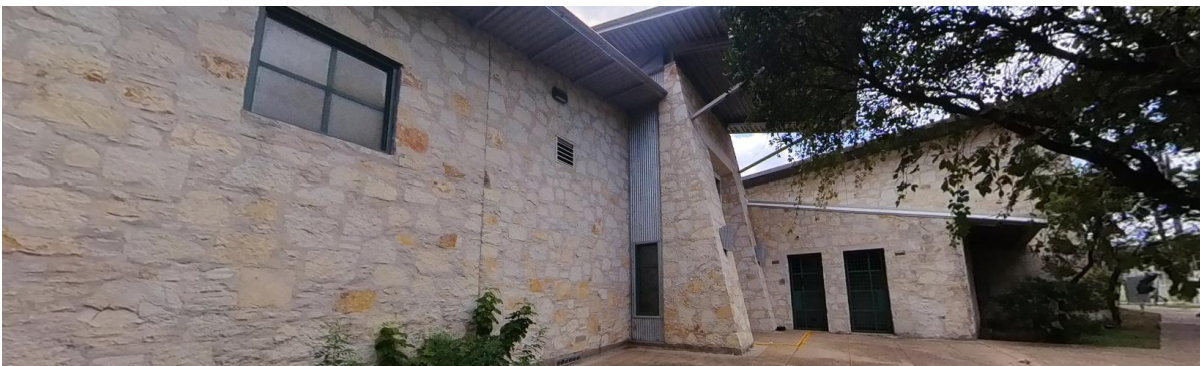
**Picture C-75. Parque Zaragoza Recreation Center - Natural Surveillance**

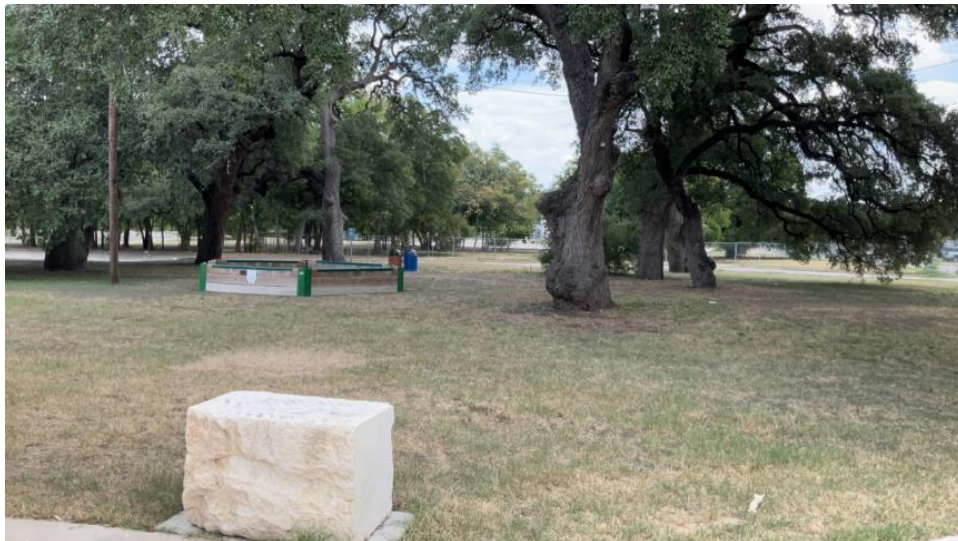
**Picture C-76. Parque Zaragoza Recreation Center - Site / Target Hardening**

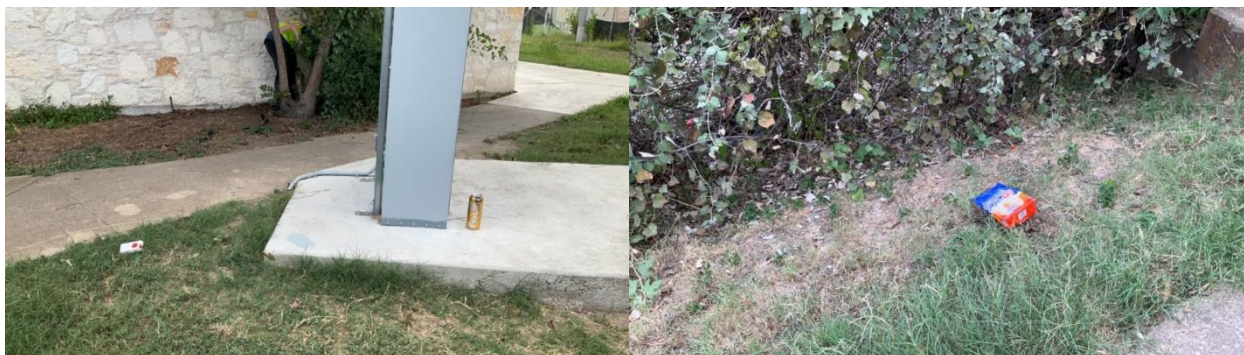
**Picture C-77. Parque Zaragoza Recreation Center - Image Management / Maintenance**

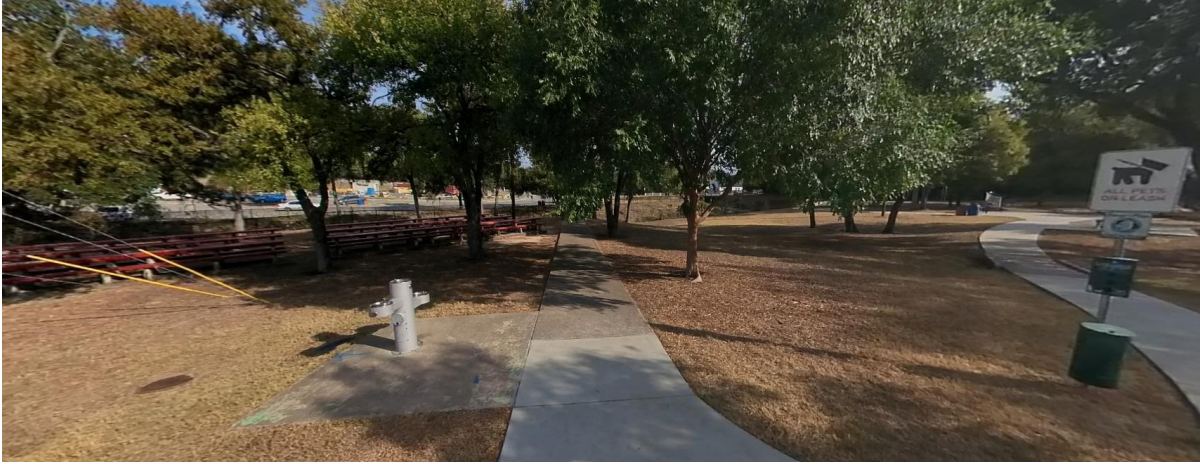
**Picture C-78. Givens Recreation Center - Natural Surveillance / Activity Support**

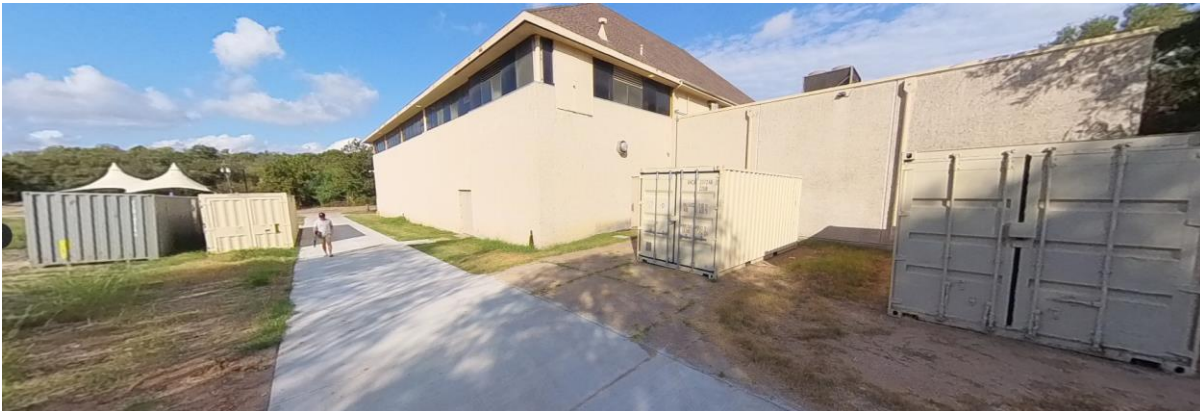
**Picture C-79. Givens Recreation Center - Natural Surveillance**

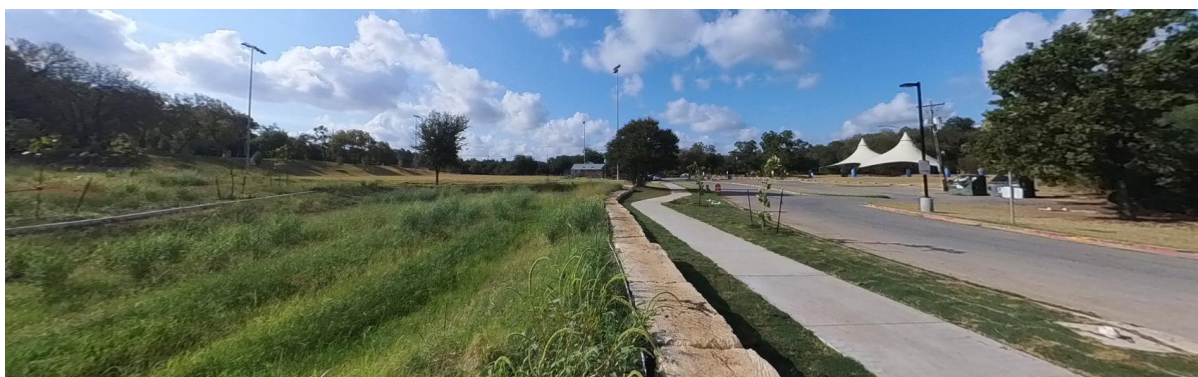
**Picture C-81. Givens Recreation Center - Activity Support**

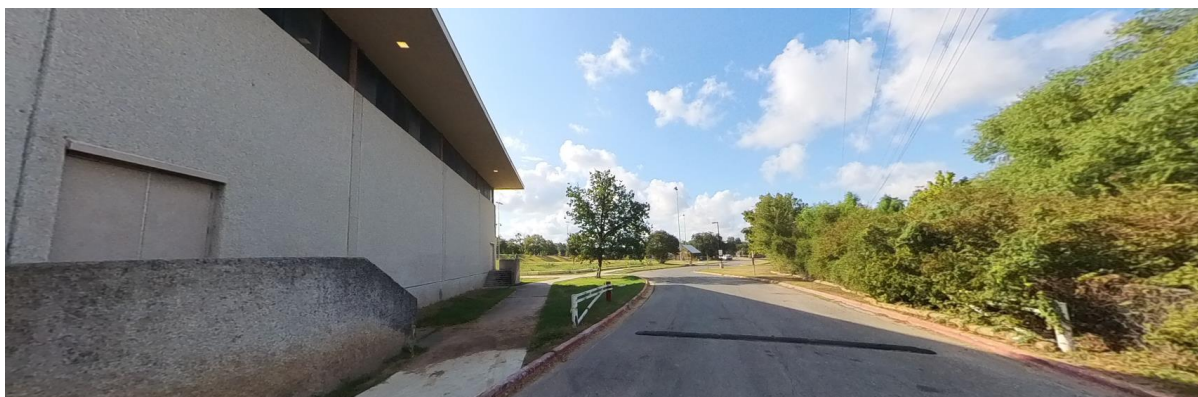
**Picture C-82. Givens Recreation Center - Vehicle gates at one side of the district park; the gate on the right has vegetation growing over it, indicating it has not been used in a long time**
