## Structural Assessment Report

Prepared for: Eureka Holdings

January 10, 2026

FEI Project Number: 1710  
Site Address: 907 E. 13th St.  
Austin, TX

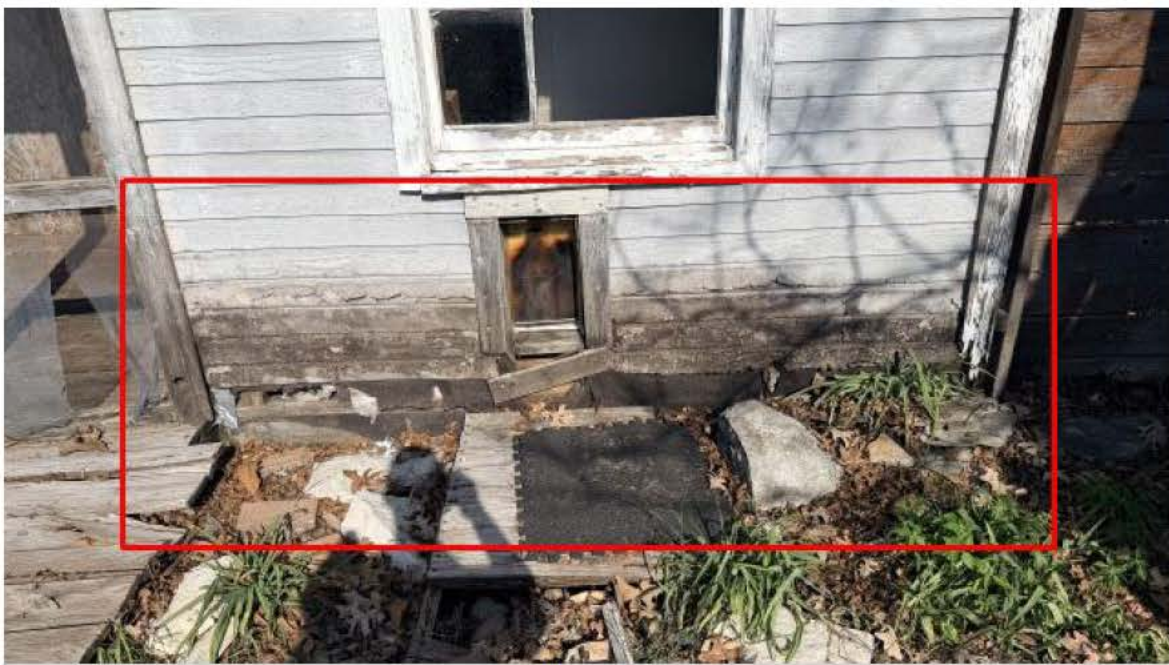
Photo 8

- Detached, peeled-back, and missing roof panels were documented (see Photographs #6 and #7).
- Evidence of prior fire-related damage was observed (see Photographs #8 and #9).

Exterior view. Evidence of prior fire-related damage observed.

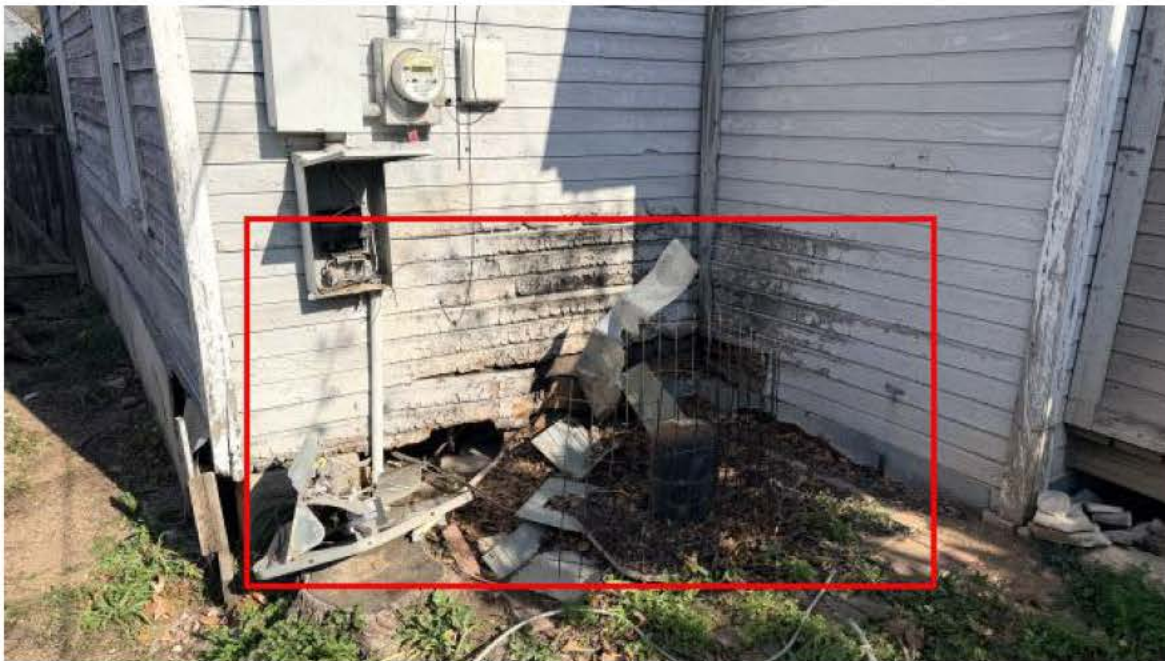
Photo 9

Exterior view. Evidence of prior fire-related damage observed.

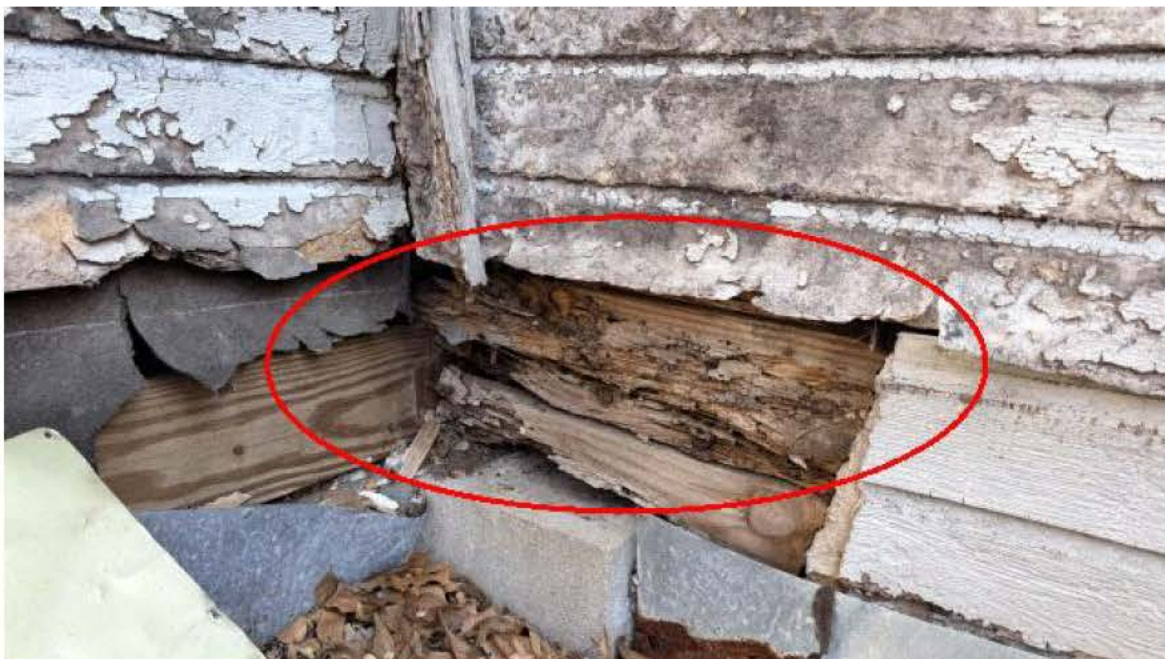
Photo 10

- Advanced deterioration was documented along the perimeter foundation beam (see Photograph #10).
- Advanced wood deterioration was observed at wall-to-ceiling, and wall-to-floor framing along exterior wall locations (see Photographs #13, through #17, and #24).

Exterior view showing advanced deterioration of the foundation beam.

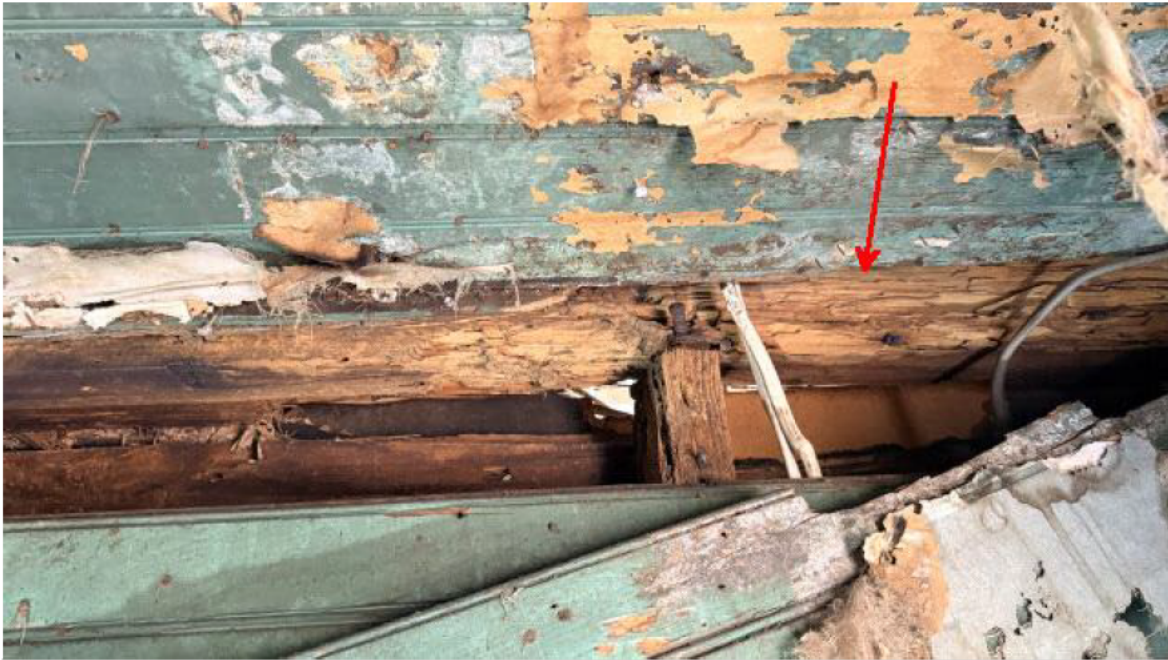
Photo 13

View of wall-to-ceiling framing showing advanced wood deterioration along the exterior wall.

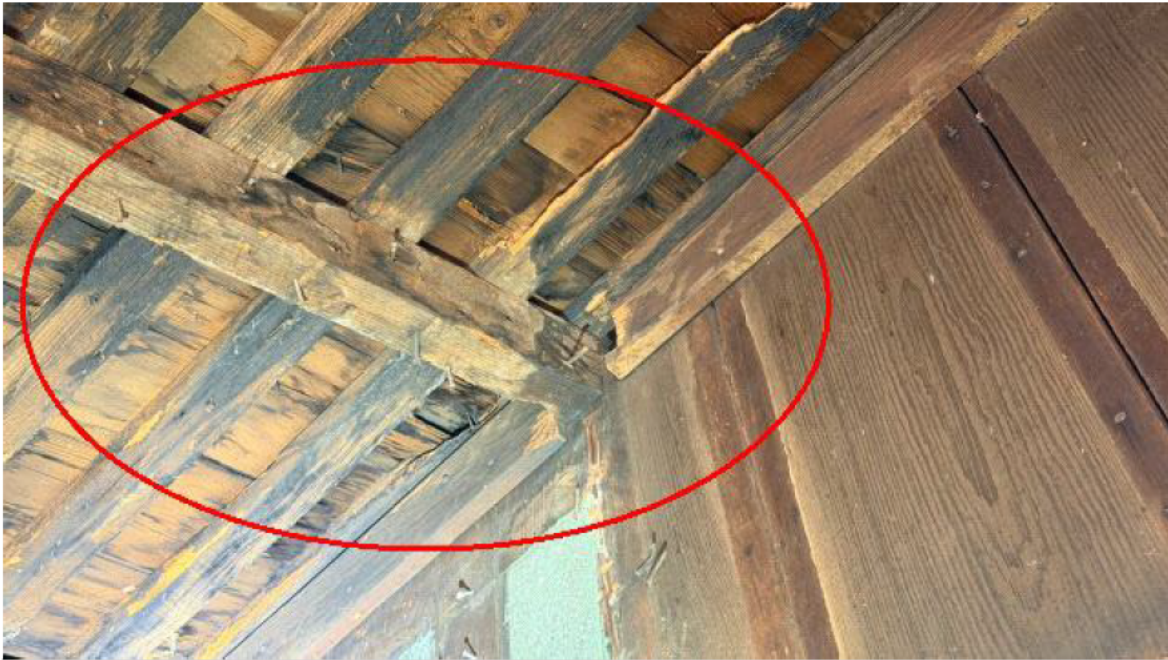
Photo 23

- Improper attachment conditions were observed at wall-to-ceiling connections at multiple locations (see Photographs #18 through #23).
- Efflorescence, likely resulting from prolonged water intrusion through the roof, was observed at wall-to-ceiling junctions and within the attic space (see Photographs #21, #22, and #25).

View of wall-to-ceiling framing showing improper attachment and advanced wood deterioration.

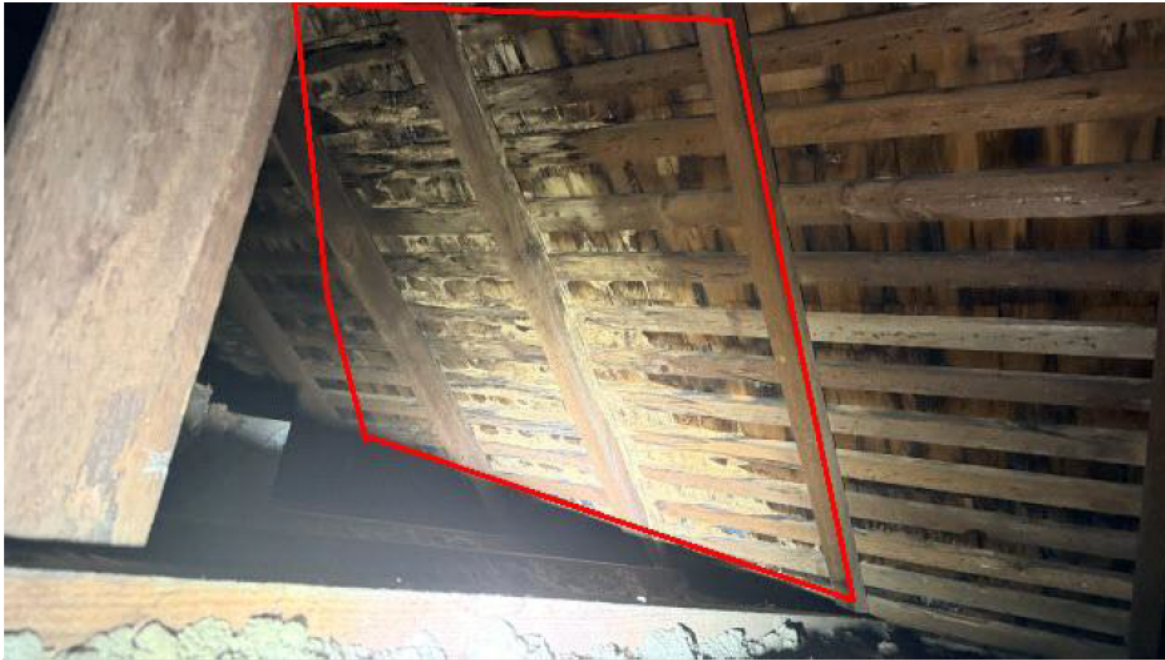
Photo 25

View of attic roof framing showing efflorescence, likely resulting from prolonged water intrusion through the roof.

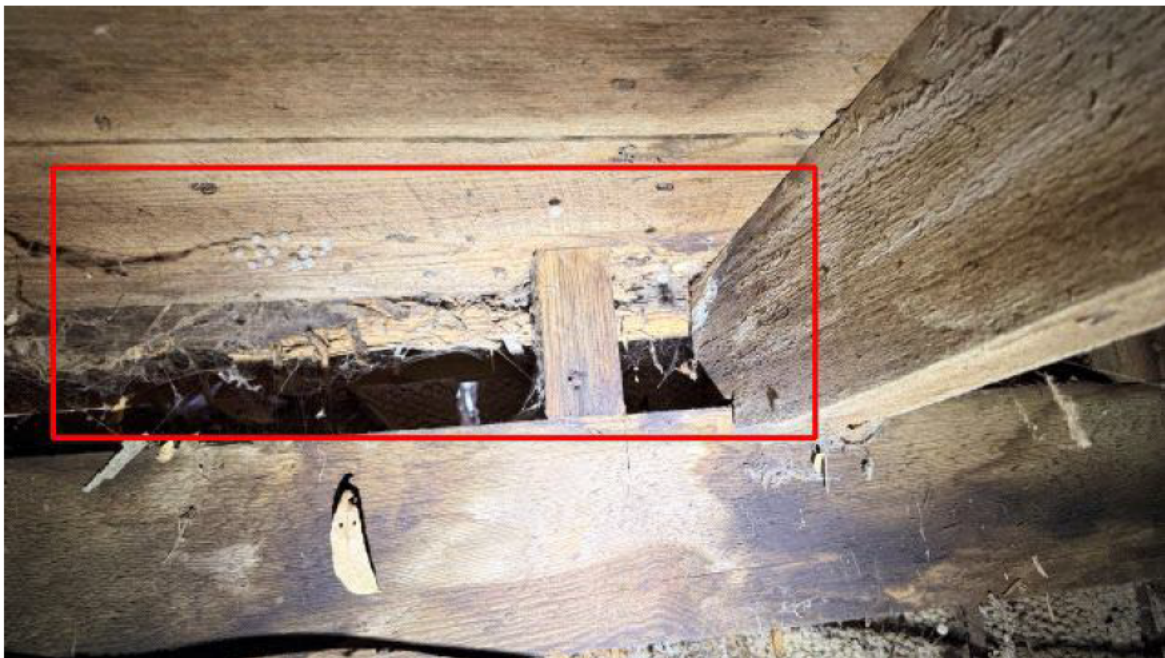
Photo 26

- Advanced wood deterioration and broken structural elements were observed throughout the pier-and-beam foundation system within the crawl space (see Photographs #26 and #31 through #34).

Crawl space view showing advanced wood deterioration (typical).

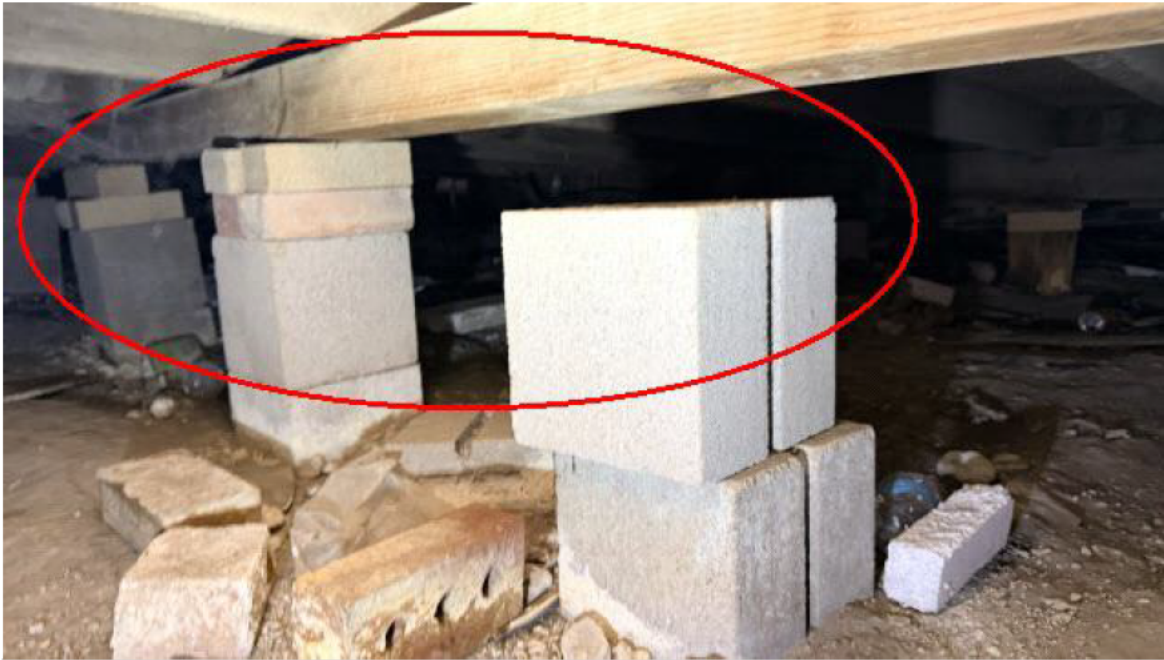
Photo 27

- Substandard footings, evidence of footing settlement, support elements lacking footings, and rotated footings were observed within the foundation system (see Photographs #27 through #31).

Crawl space view showing loose support elements lacking attachment to the framing.

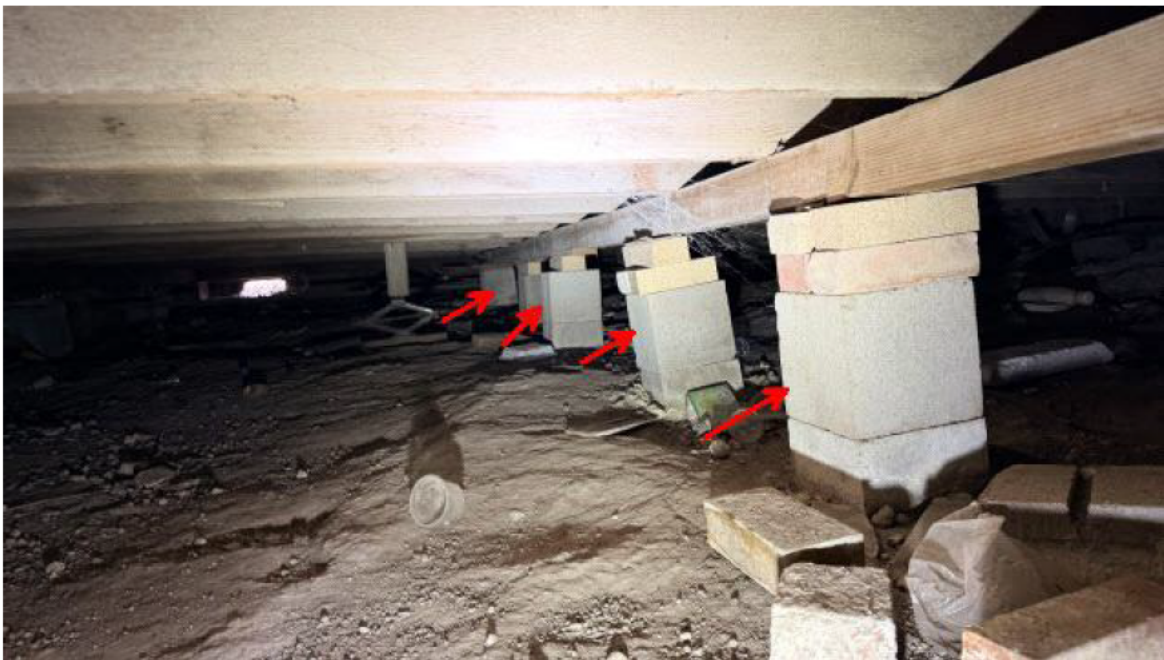
Photo 28

Crawl space view showing loose and rotated support elements lacking footings (typical condition).

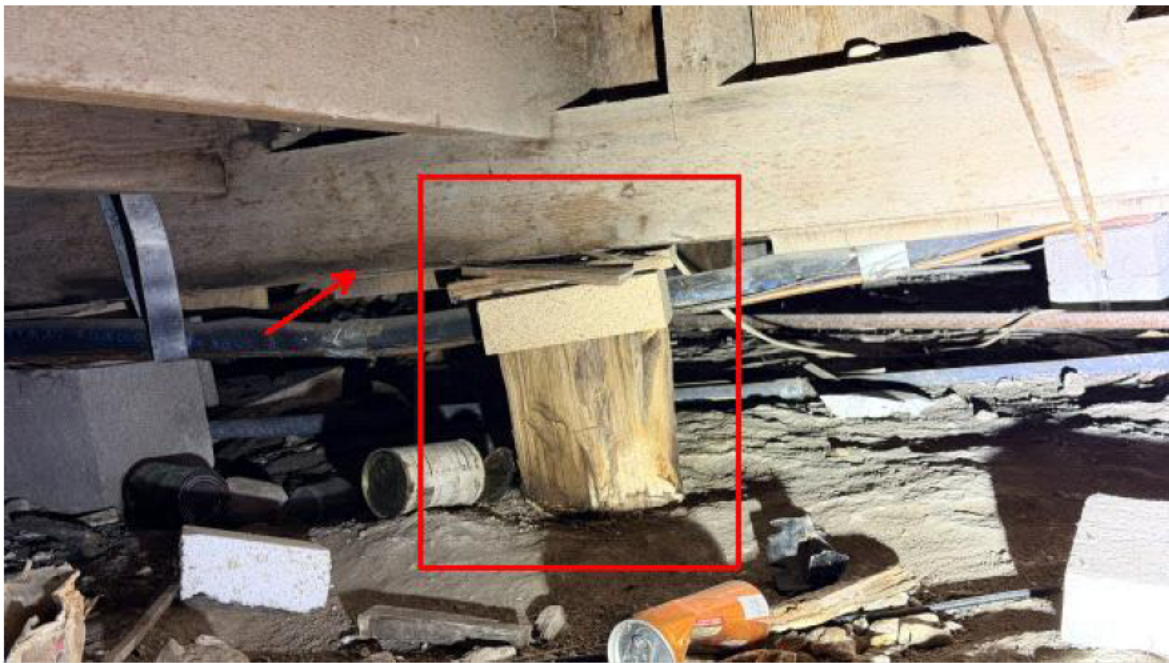
Photo 29

Crawl space view showing substandard footing and a rotated beam (typical).

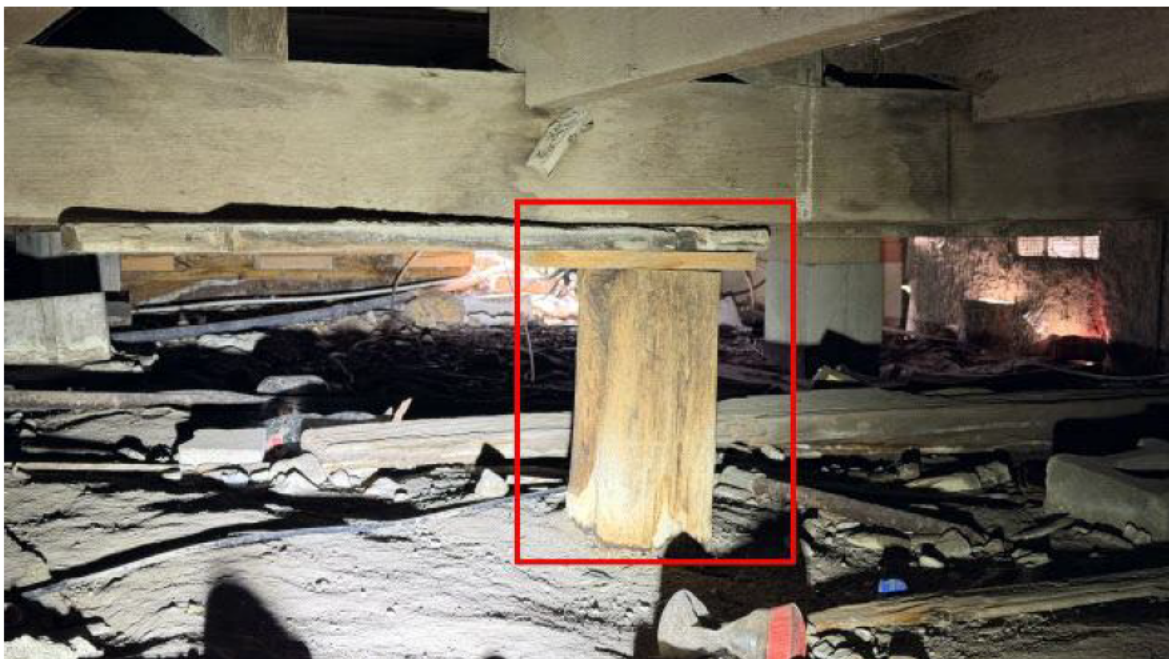
Photo 30

Crawl space view showing substandard footing (typical).

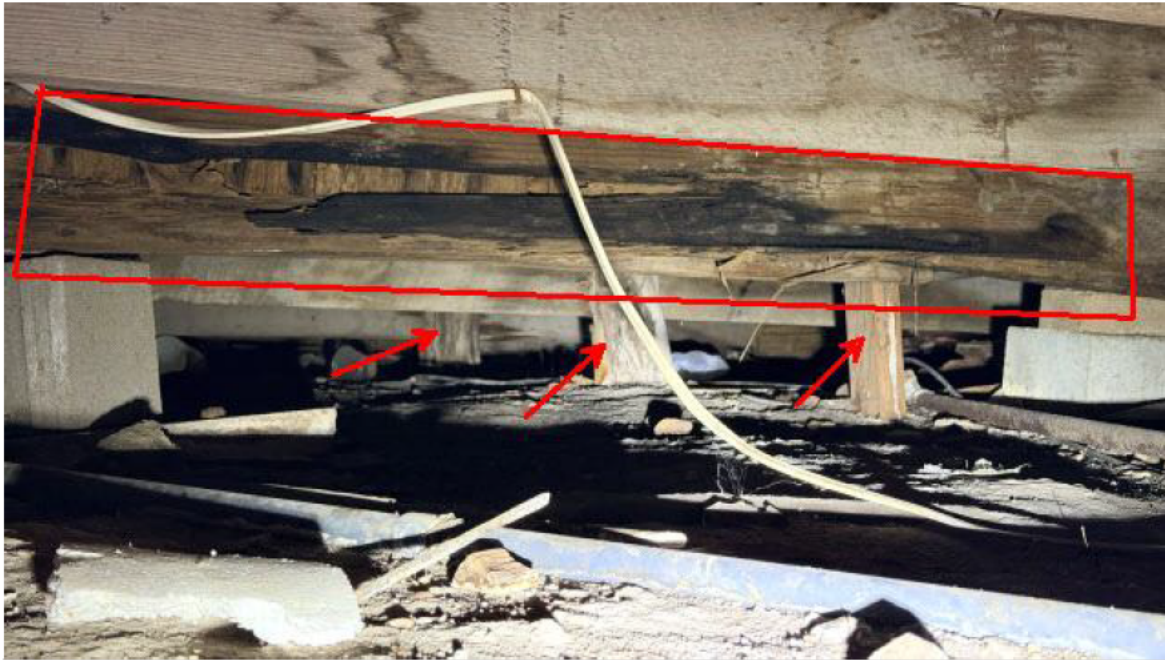
Photo 31

Crawl space view showing substandard footing and advanced wood deterioration (typical).

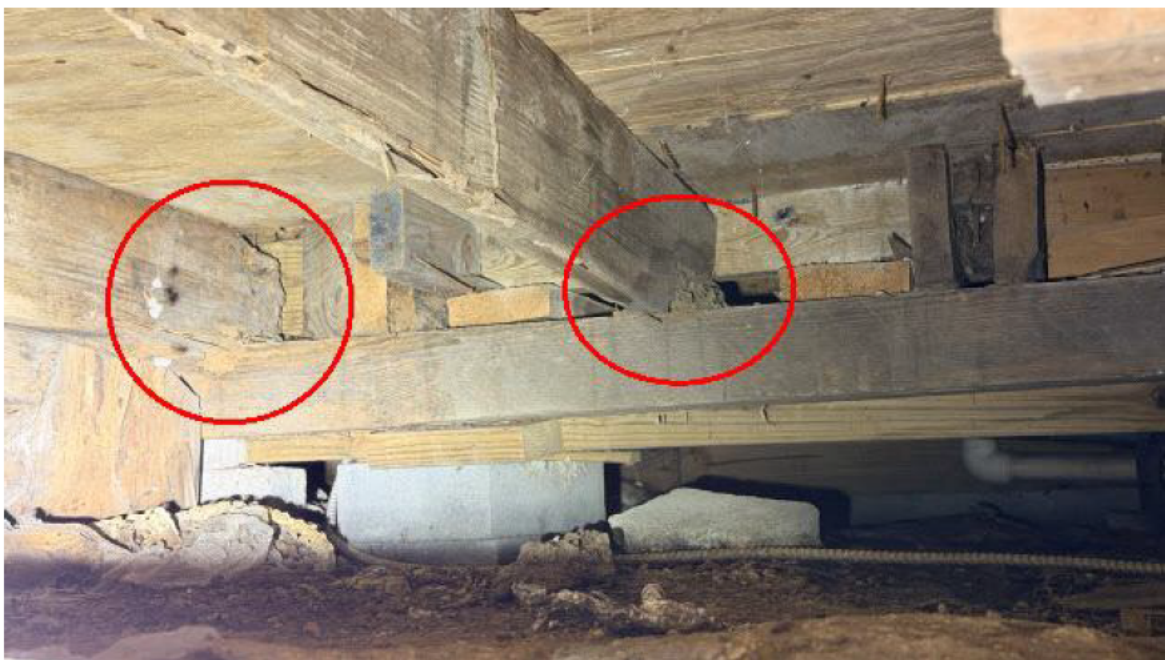
Photo 32

Crawl space view showing advanced wood deterioration (typical).

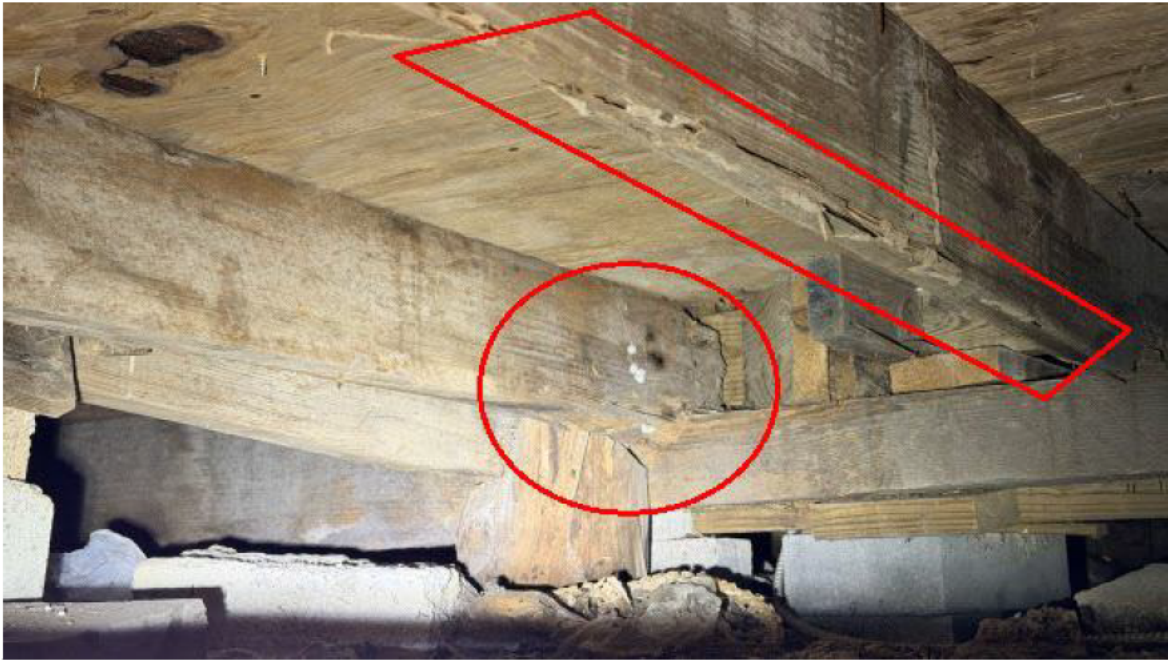
Photo 33

Crawl space view showing advanced wood deterioration (typical).

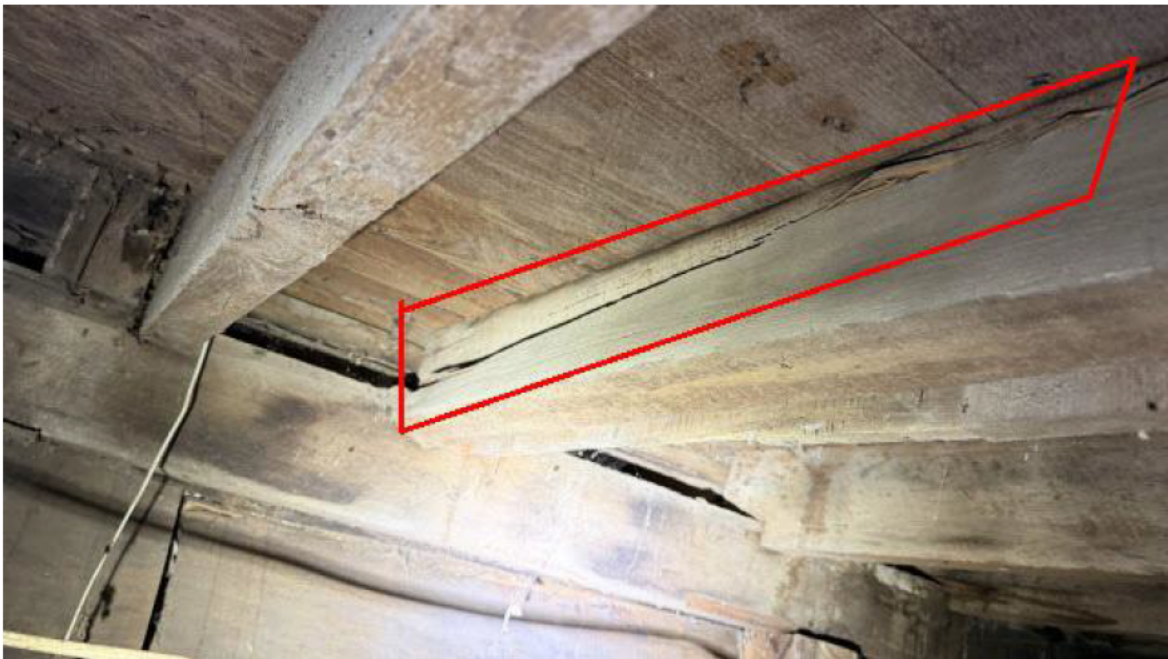
Photo 34

Crawl space view showing broken floor joist.
