**City of Austin**

# Parks and Recreation Department Security Audit

## Findings and Recommendations Report

Version 2 | July 18, 2025

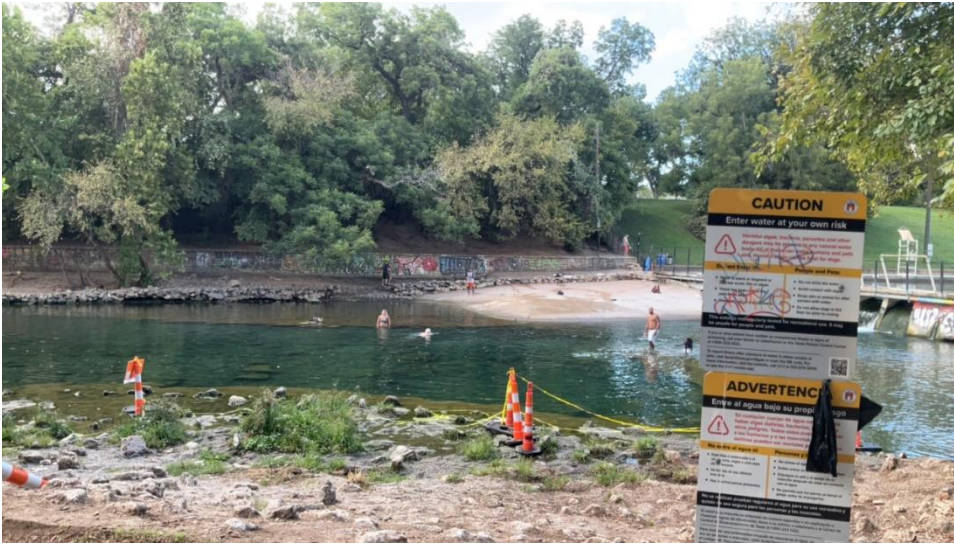
The Spillway of Zilker Park (public facing side of Barton Springs) scored poorly across the natural access control, image management / maintenance, and territorial reinforcement CPTED categories. The public side of Barton Springs had extensive trash and graffiti as shown in Picture C-7. Additionally, traffic cones with yellow barricade tape used to restrict public access to the area were disregarded and torn down.

**Picture C-7. Zilker Metropolitan Park (Spillway) - Natural Access Control, Image Management / Maintenance**

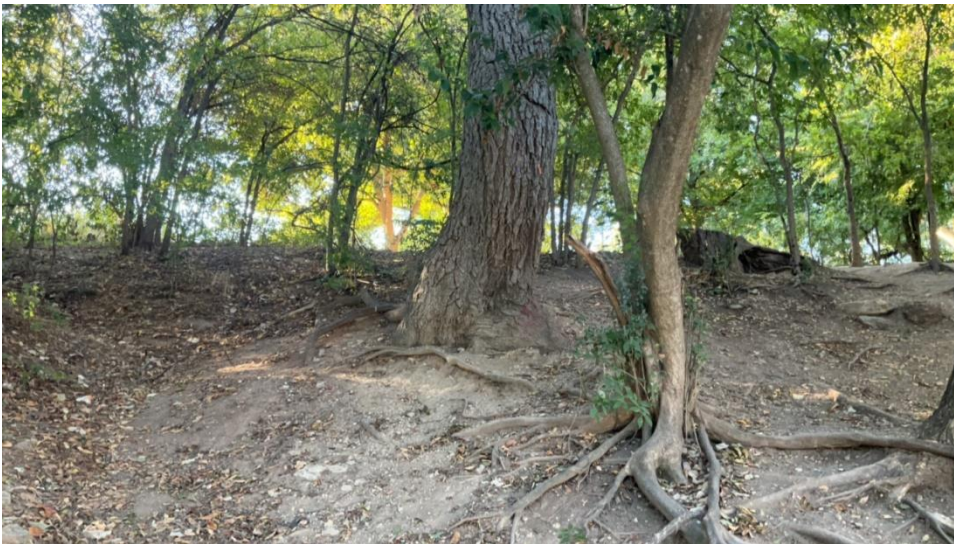
At the time of the site visit, the public side of Barton Springs was closed for repairs. However, park users still accessed the location despite the temporary barriers, as shown in Picture C-7. While security signage was present, park users ignored these warnings and accessed the area via the southern side of Barton Creek and through the greenway on the northern side.

**Picture C-8. Zilker Metropolitan Park (Spillway) - Natural Access Control**

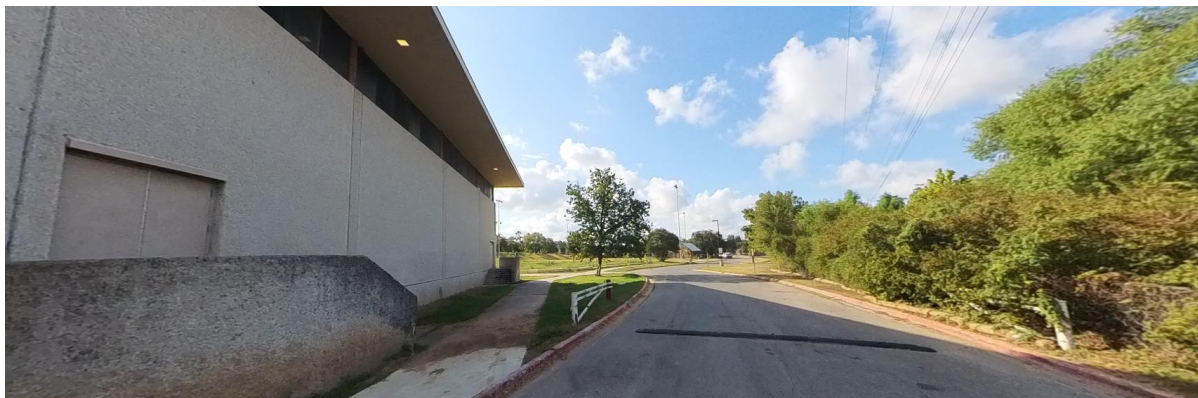
**Picture C-82. Givens Recreation Center - Vehicle gates at one side of the district park; the gate on the right has vegetation growing over it, indicating it has not been used in a long time**

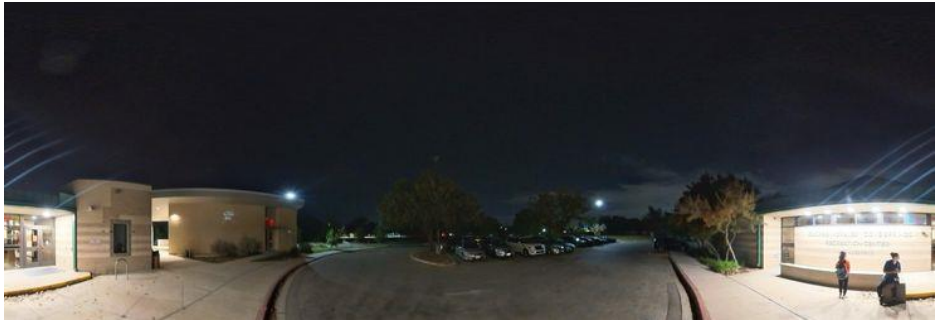
| <p><u><b>58 - Facility Entry (Safety Score 48)</b></u></p> <p>At the entry of the facility, there are downlights that light the sign and there is also light shining through the window from the inside of the facility. Some fixtures were broken including the wall pack above a window and a light pole in the parking lot.</p> | <p><b>Picture C-169. 360 Image near facility entryway</b></p> |

**Safety Score Rationale:**  
Perception of safety: Average/High  
Reflectance: Neutral  
Specularity: Neutral  
Visual Transparency: Average  
Physical Transparency: Average  
Scale: Average
