STRUCTURAL ASSESSMENT REPORT

Structural Assessment Report

January 10, 2026

FEI Project Number: 1710
Site Address: 907 E. 13th St.
Austin, TX

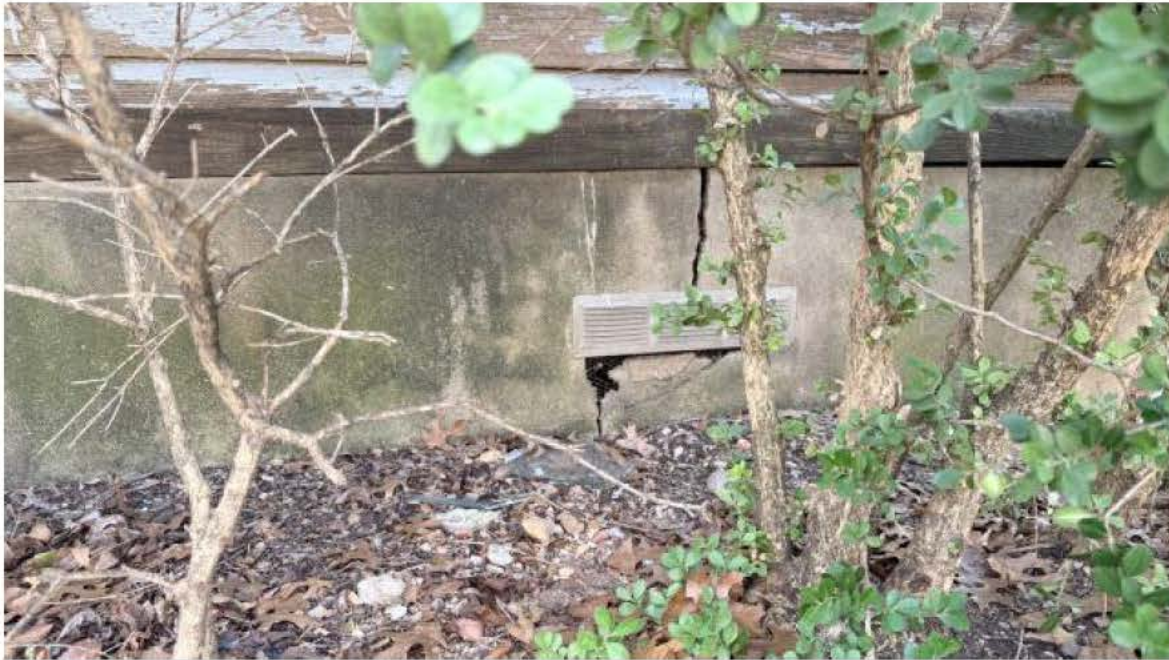
Photo 5

- Sagging was observed across all roof slopes on both the main structure and the addition (see Photographs #1 through #3).
- Deterioration of the foundation cover was observed around the perimeter of the structure (see Photograph #5).

Exterior view showing cracked concrete and deterioration of the foundation cover.

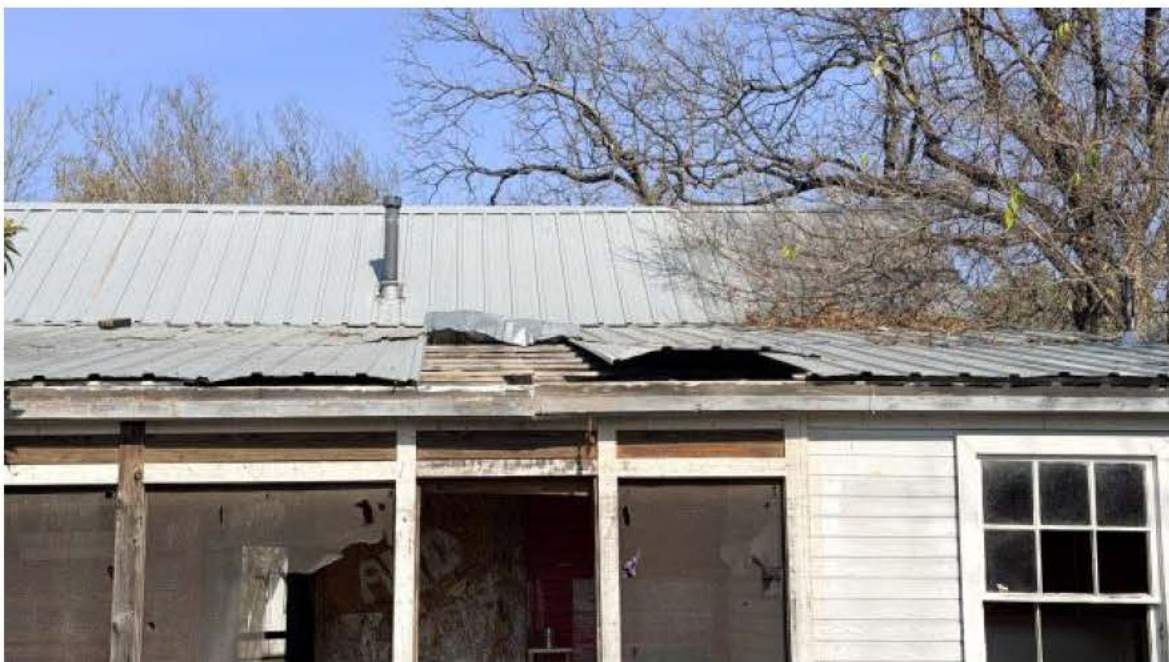
Photo 6

- Detached, peeled-back, and missing roof panels were documented (see Photographs #6 and #7).
- Evidence of prior fire-related damage was observed (see Photographs #8 and #9).

Roof view. Detached and peeled roof panels observed, consistent with wind-related uplift from an elevated wind event.

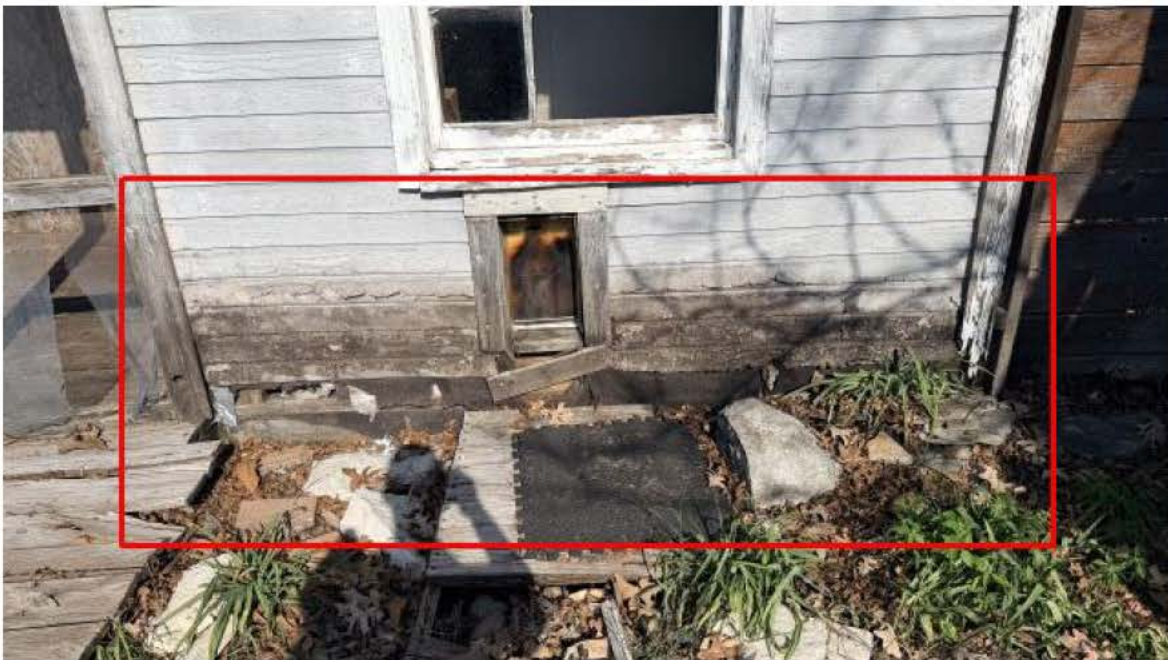
Photo 8

Exterior view. Evidence of prior fire-related damage observed.

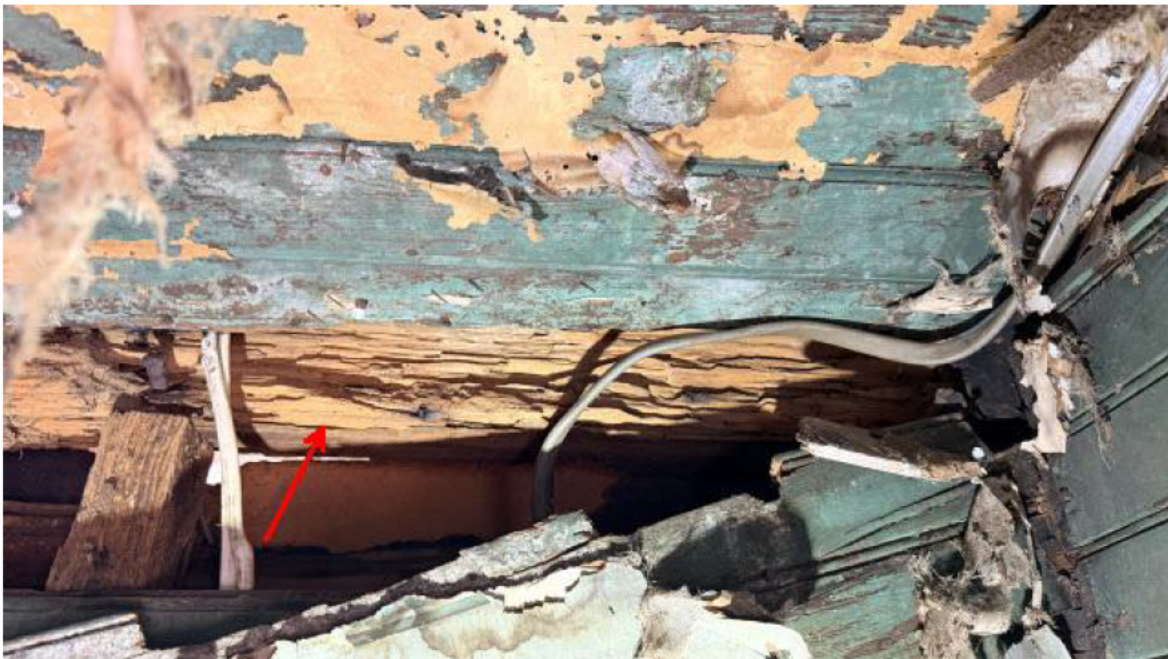
Photo 16

- Advanced deterioration was documented along the perimeter foundation beam (see Photograph #10).
- Advanced wood deterioration was observed at wall-to-ceiling, and wall-to-floor framing along exterior wall locations (see Photographs #13, through #17, and #24).

View of wall-to-ceiling framing showing advanced wood deterioration along the exterior wall.

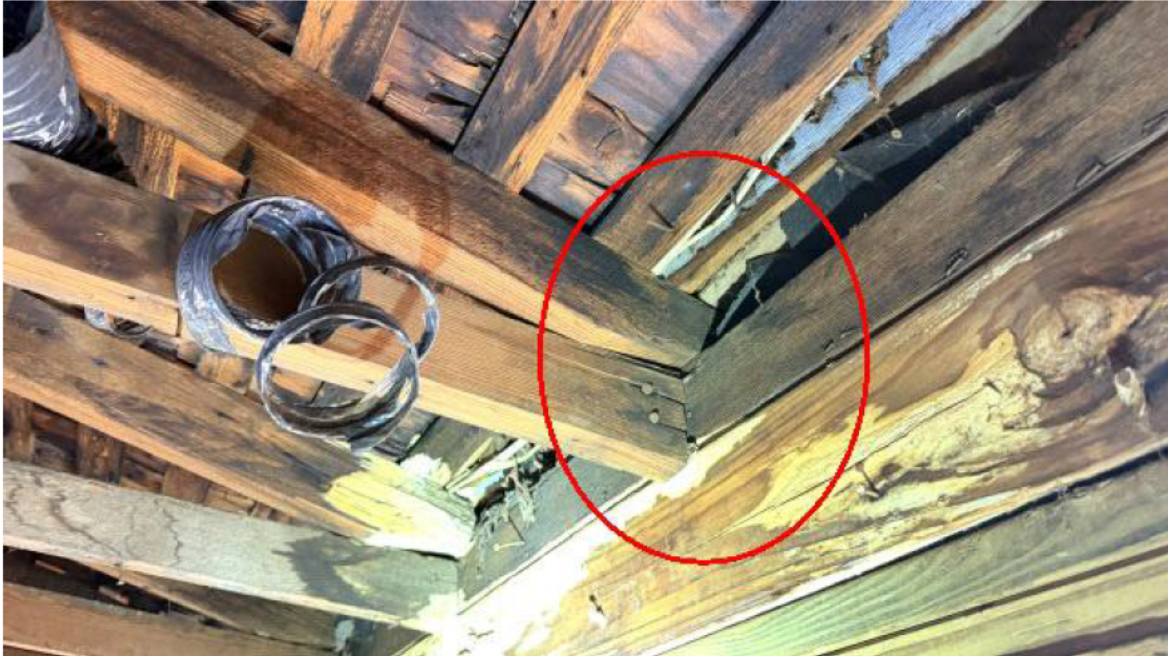
Photo 19

- Improper attachment conditions were observed at wall-to-ceiling connections at multiple locations (see Photographs #18 through #23).
- Efflorescence, likely resulting from prolonged water intrusion through the roof, was observed at wall-to-ceiling junctions and within the attic space (see Photographs #21, #22, and #25).

View of wall-to-ceiling framing showing improper attachment conditions.

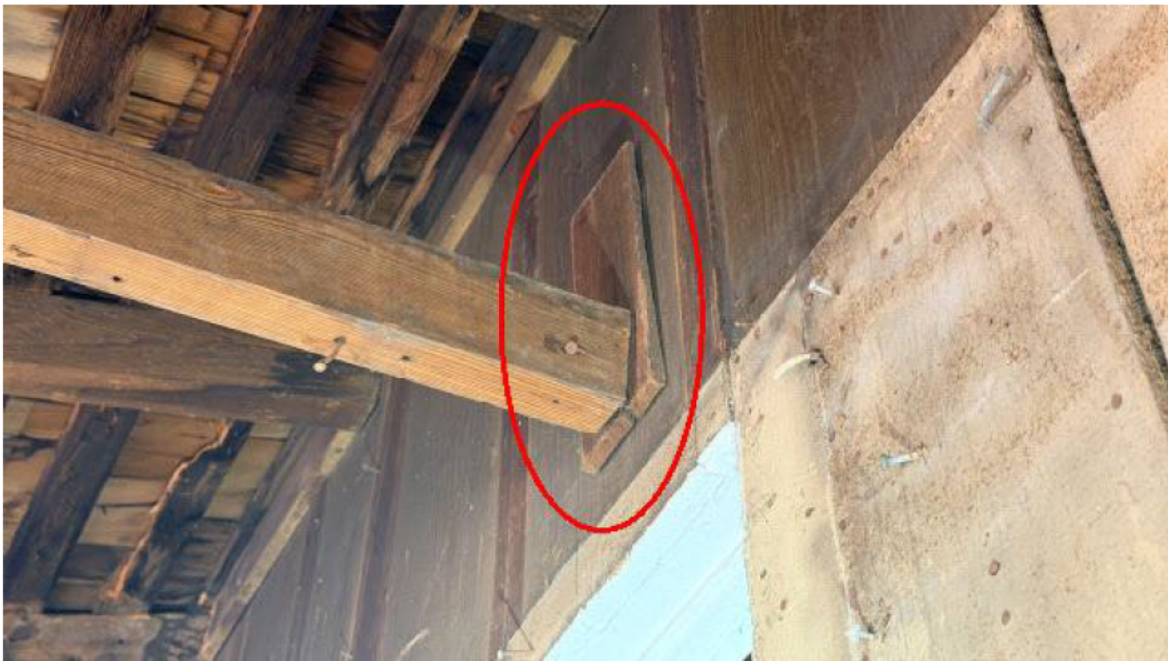
Photo 20

View of wall-to-ceiling framing showing improper attachment conditions.

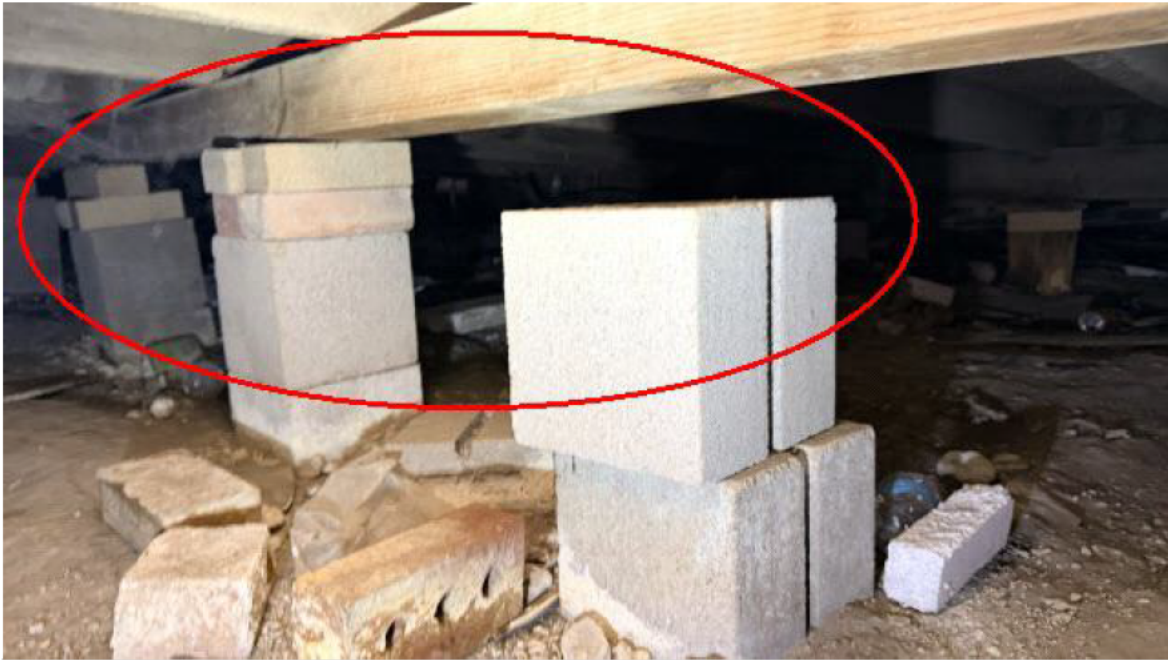
Photo 27

- Substandard footings, evidence of footing settlement, support elements lacking footings, and rotated footings were observed within the foundation system (see Photographs #27 through #31).

Crawl space view showing loose support elements lacking attachment to the framing.

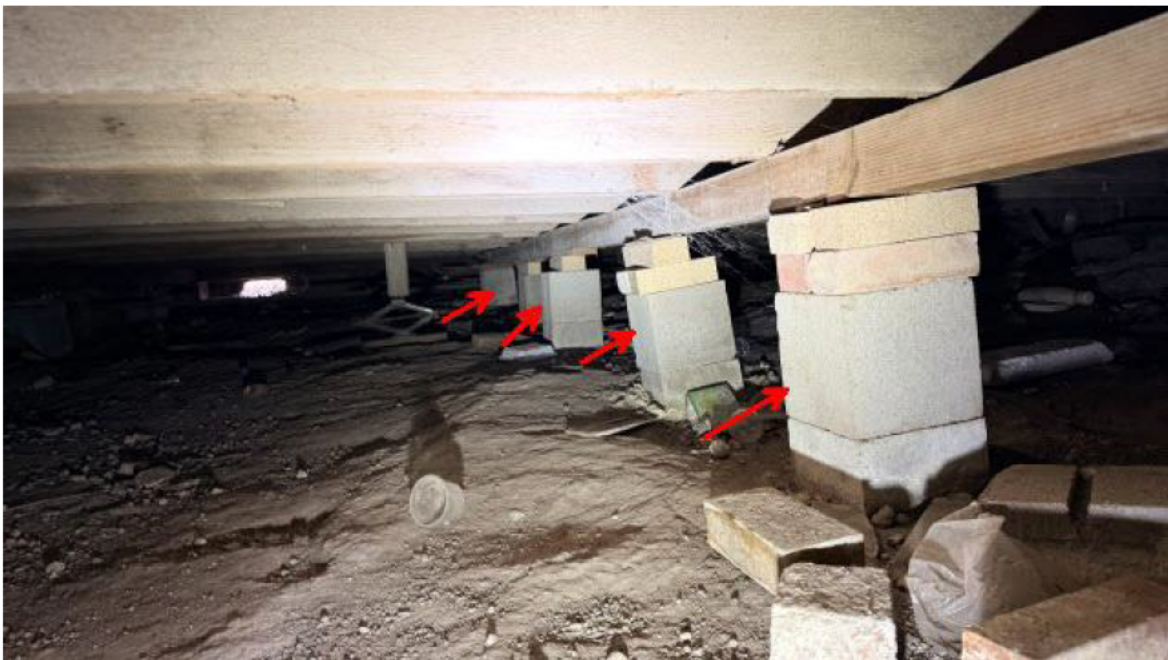
Photo 28

Crawl space view showing loose and rotated support elements lacking footings (typical condition).
