Re: Owner Opposition to Historic Zoning/Designation – 907 E. 13th St.

STRUCTURAL ASSESSMENT REPORT

Structural Assessment Report

FEI Project Number: 1710
Site Address: 907 E. 13th St.
Austin, TX

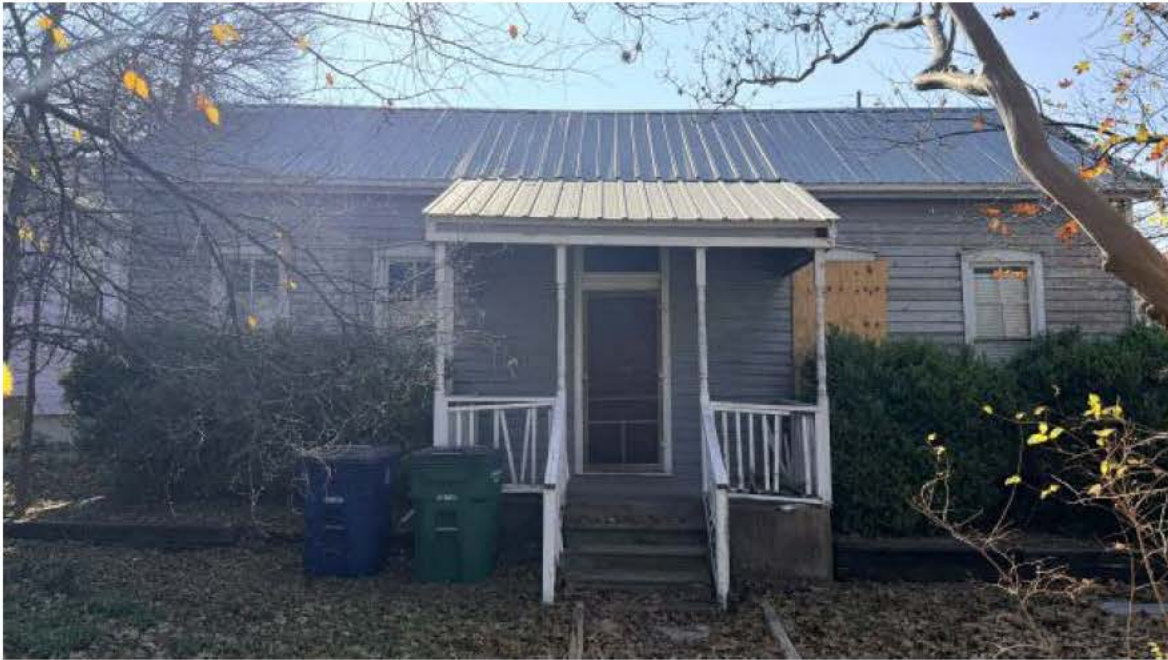
Photo 1

- Sagging was observed across all roof slopes on both the main structure and the addition (see Photographs #1 through #3).
- Deterioration of the foundation cover was observed around the perimeter of the structure (see Photograph #5).

During the exterior inspection, pronounced sagging was observed across roof slopes. Excessive deflection of the roof planes is generally indicative of inadequate structural capacity within the roof framing system. Such conditions may result from original design or construction deficiencies, long-term deterioration associated with prolonged environmental exposure, or acute loading events such as wind or snow.

Overview of the front (north) elevation.

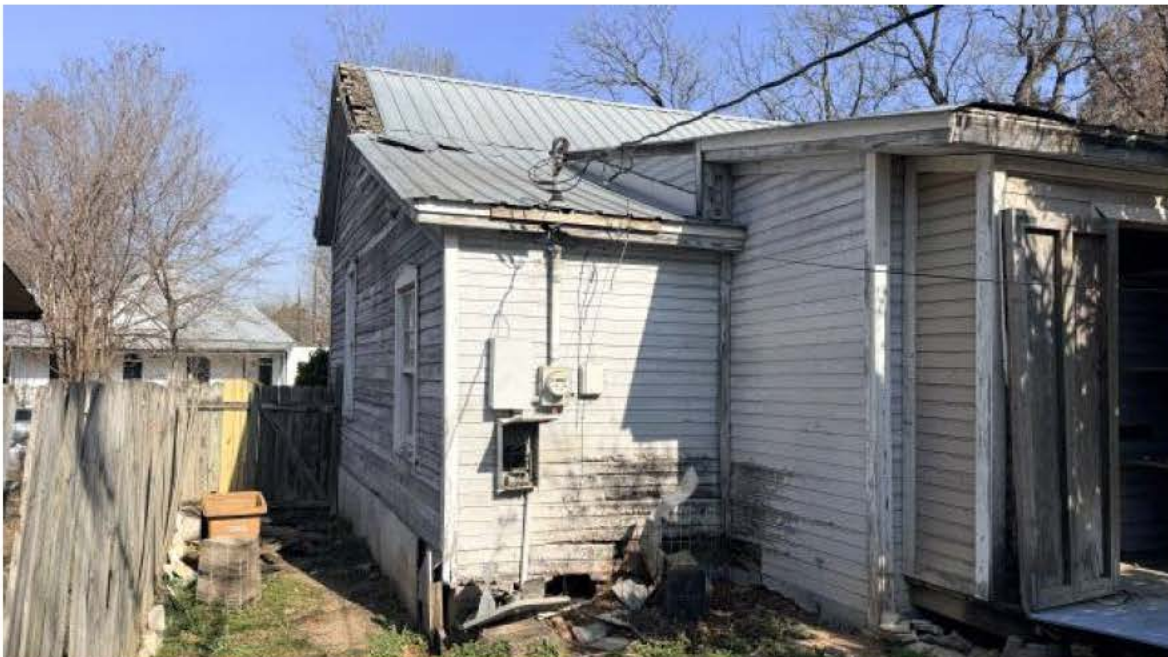
Photo 2

Overview of the right (west) elevation.

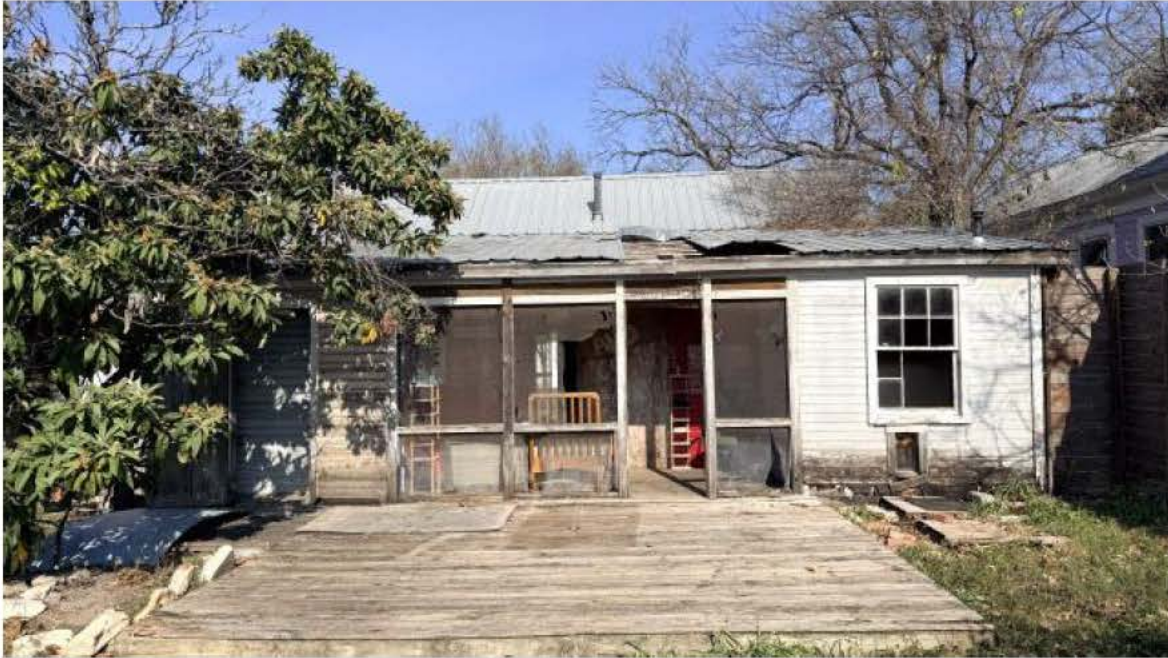
Photo 3

Overview of the rear (south) elevation.

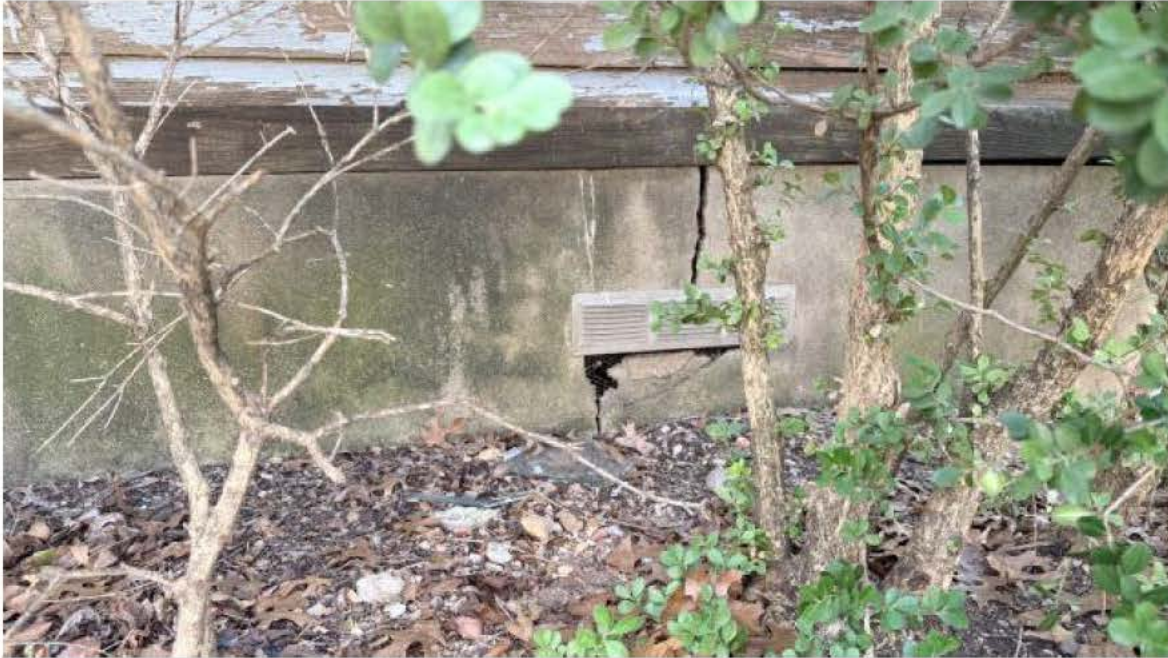
Photo 5

Exterior view showing cracked concrete and deterioration of the foundation cover.

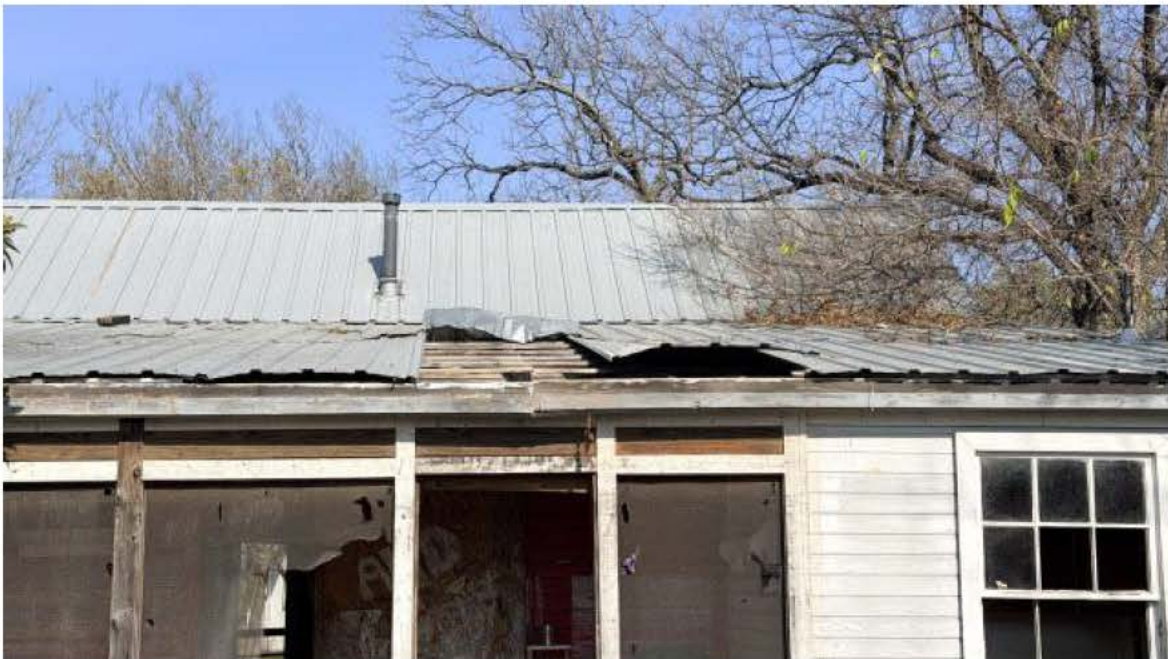
Photo 6

- Detached, peeled-back, and missing roof panels were documented (see Photographs #6 and #7).
- Evidence of prior fire-related damage was observed (see Photographs #8 and #9).

Roof view. Detached and peeled roof panels observed, consistent with wind-related uplift from an elevated wind event.

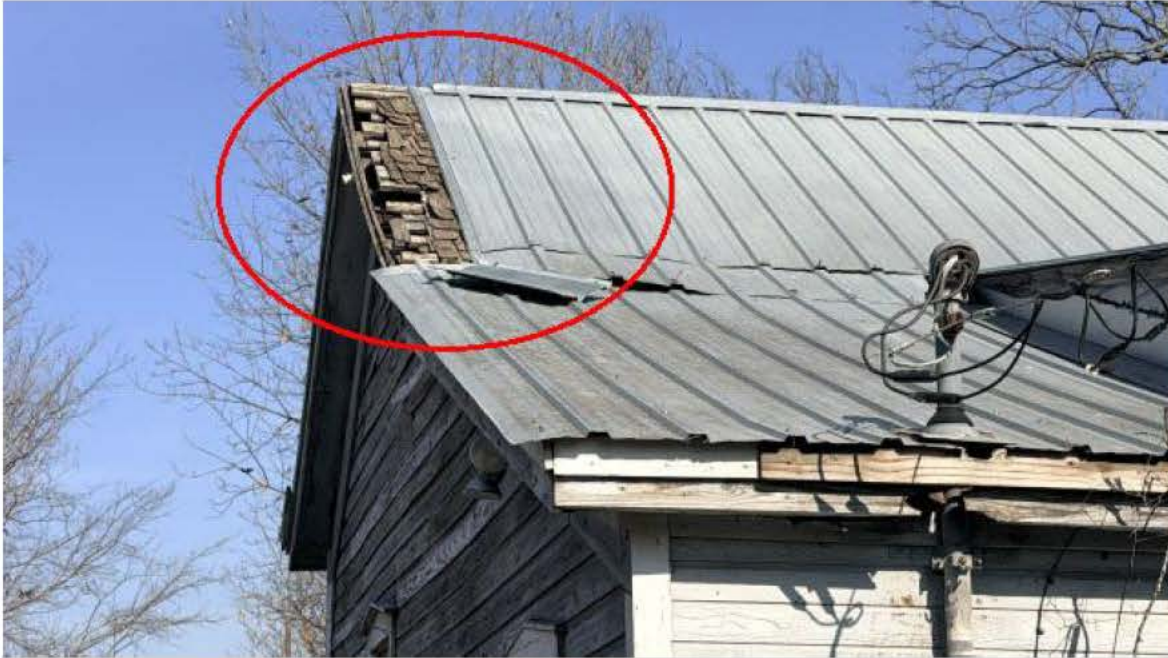
Photo 7

Roof view. Detached and missing roof panels observed, consistent with wind-related uplift from an elevated wind event.

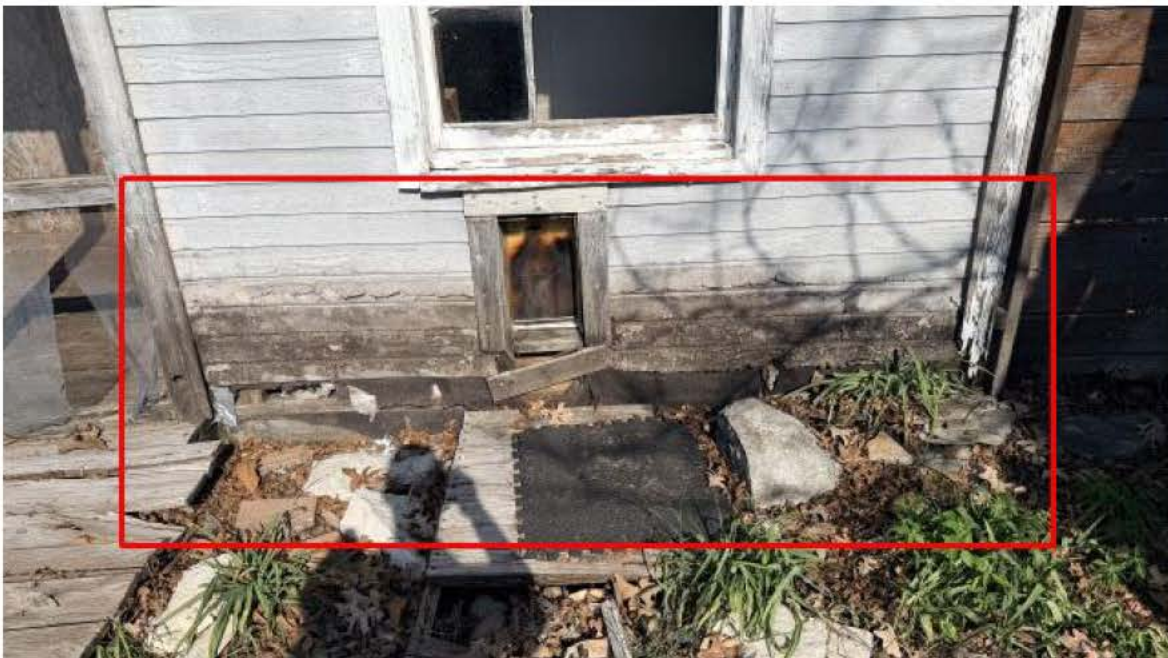
Photo 8

Exterior view. Evidence of prior fire-related damage observed.

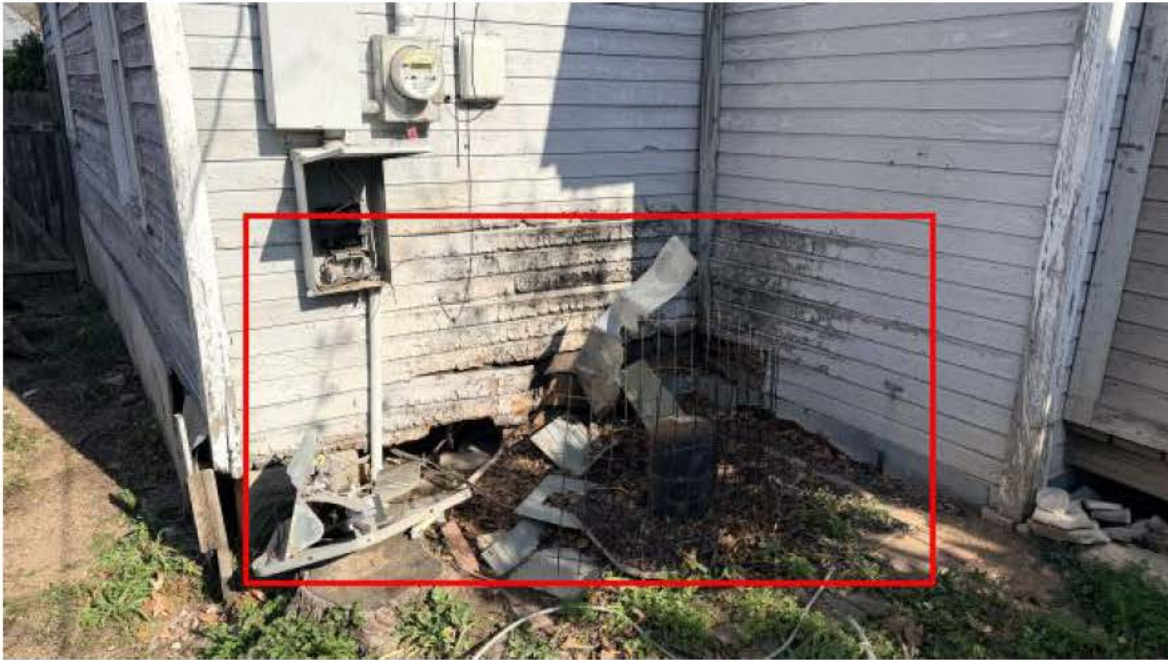
Photo 9

Exterior view. Evidence of prior fire-related damage observed.

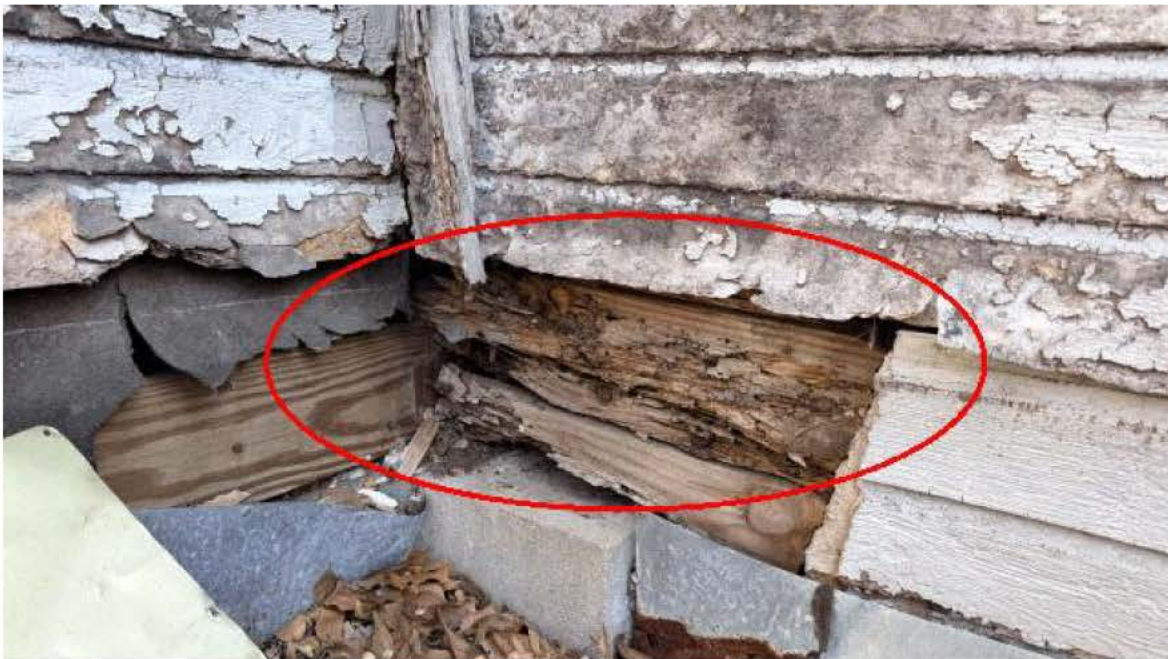
Photo 10

- Advanced deterioration was documented along the perimeter foundation beam (see Photograph #10).
- Advanced wood deterioration was observed at wall-to-ceiling, and wall-to-floor framing along exterior wall locations (see Photographs #13, through #17, and #24).

Exterior view showing advanced deterioration of the foundation beam.

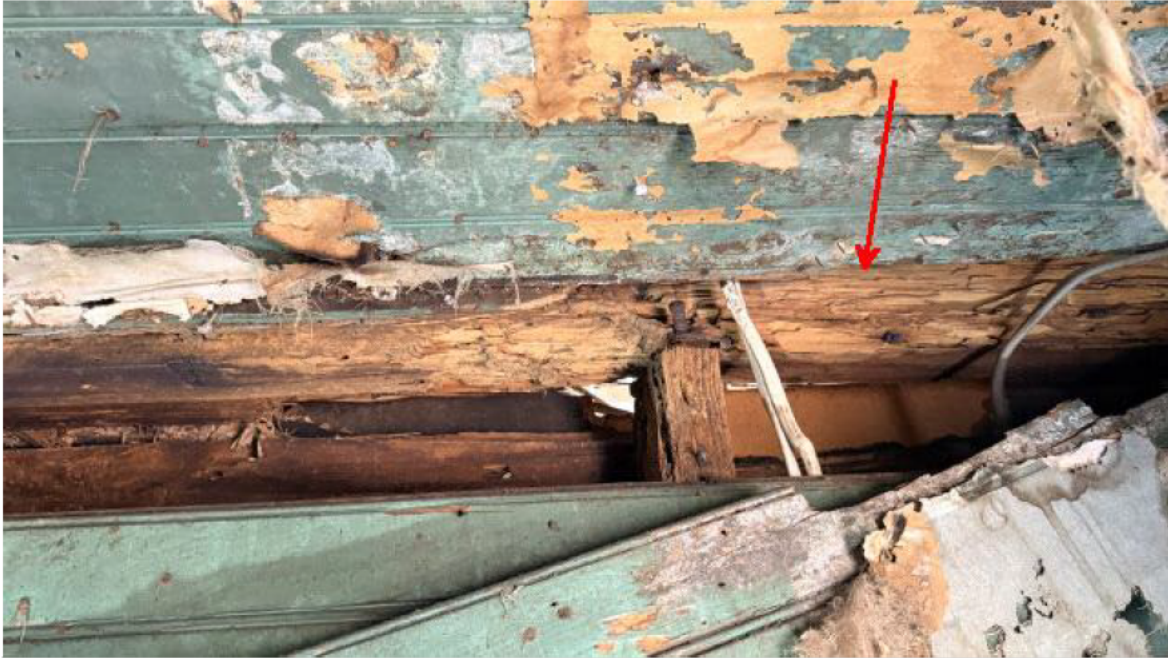
Photo 13

View of wall-to-ceiling framing showing advanced wood deterioration along the exterior wall.

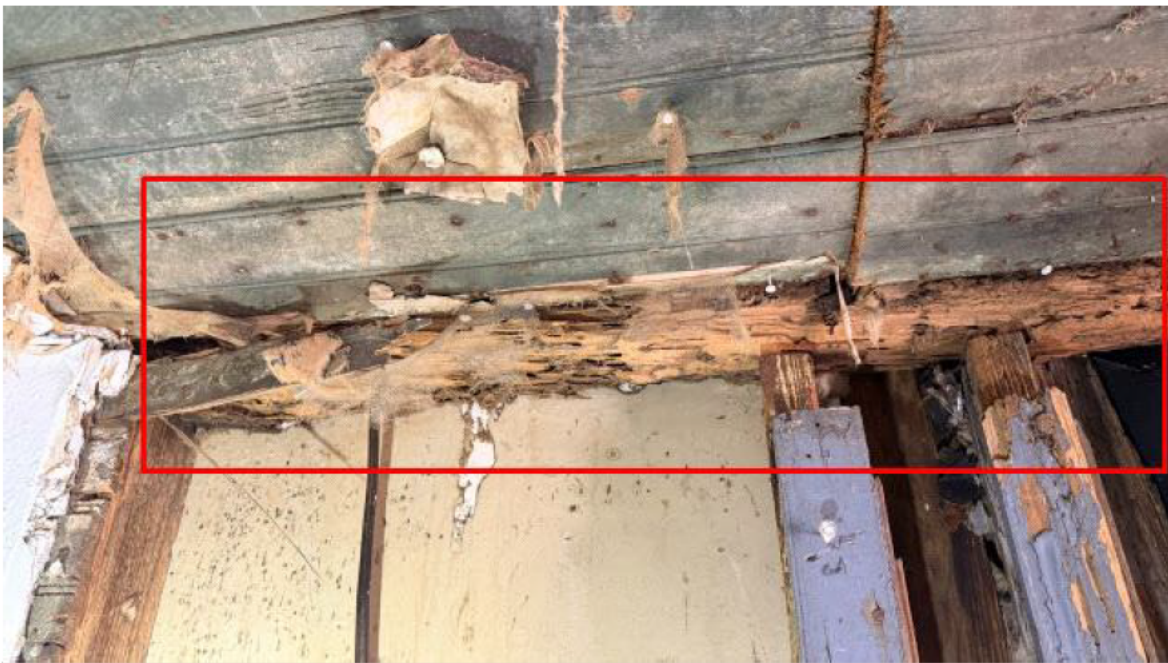
Photo 14

View of wall-to-ceiling framing showing advanced wood deterioration along the exterior wall.

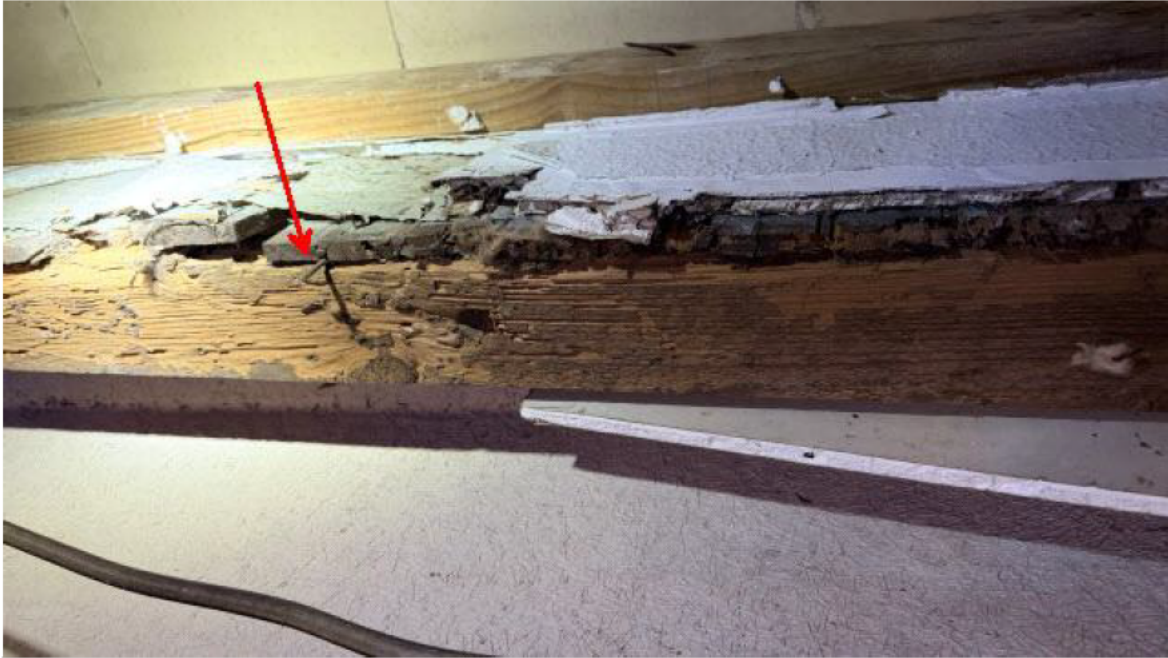
Photo 15

View of wall-to-ceiling framing showing advanced wood deterioration along the exterior wall.

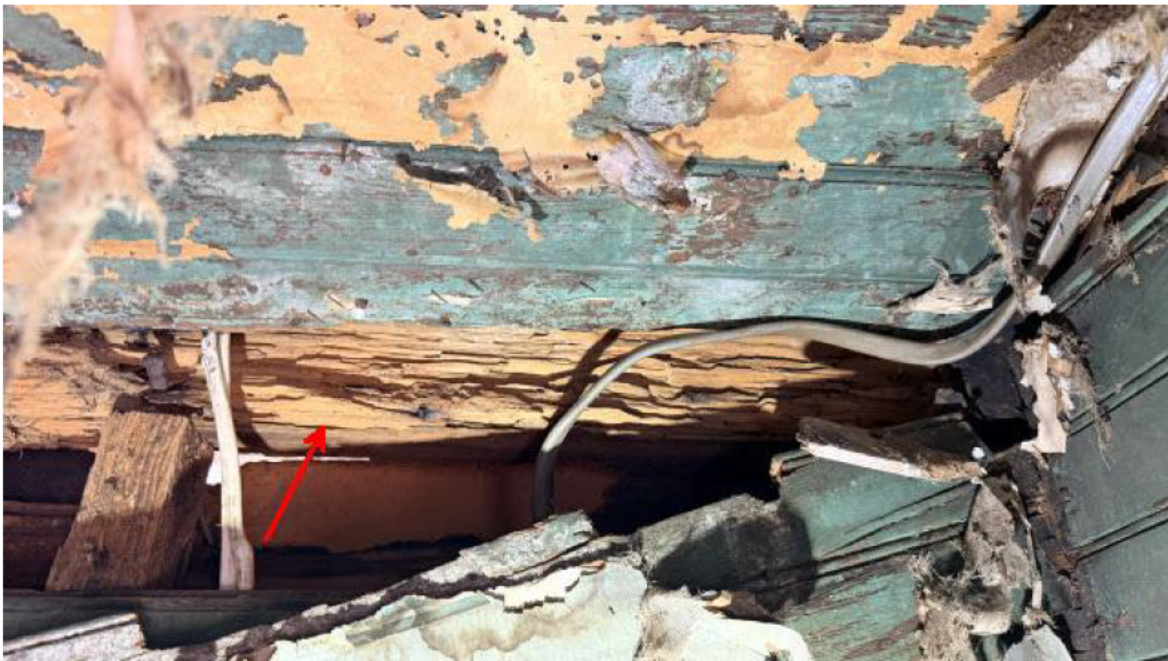
Photo 16

View of wall-to-ceiling framing showing advanced wood deterioration along the exterior wall.

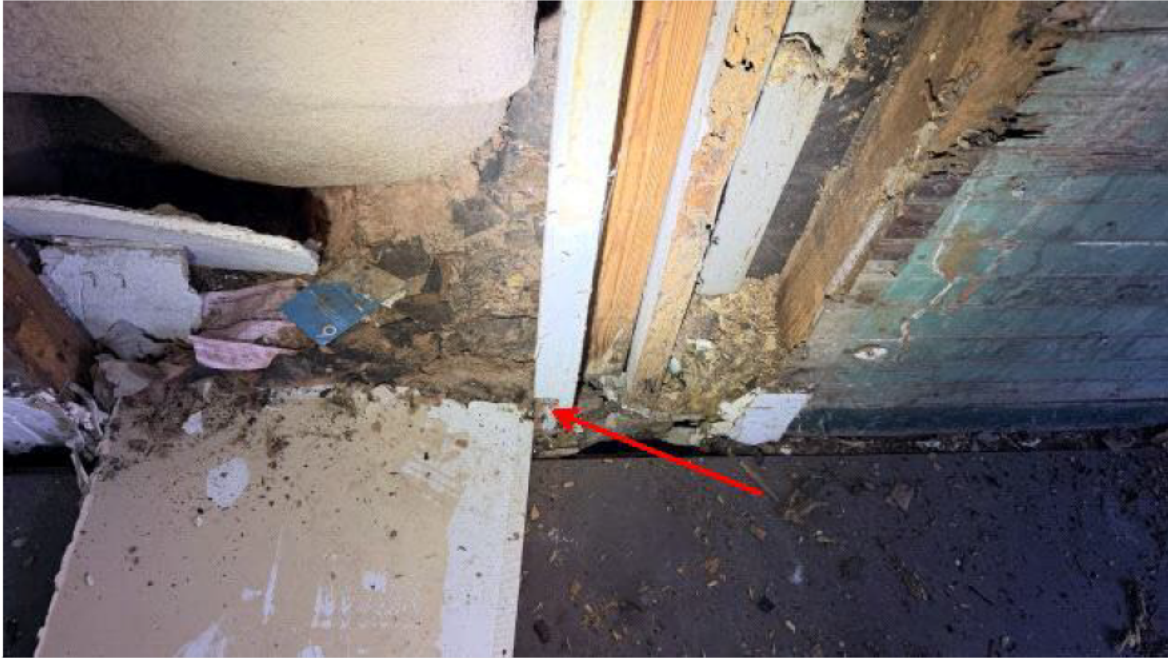
Photo 17

View of wall-to-floor framing showing advanced wood deterioration along the exterior wall.

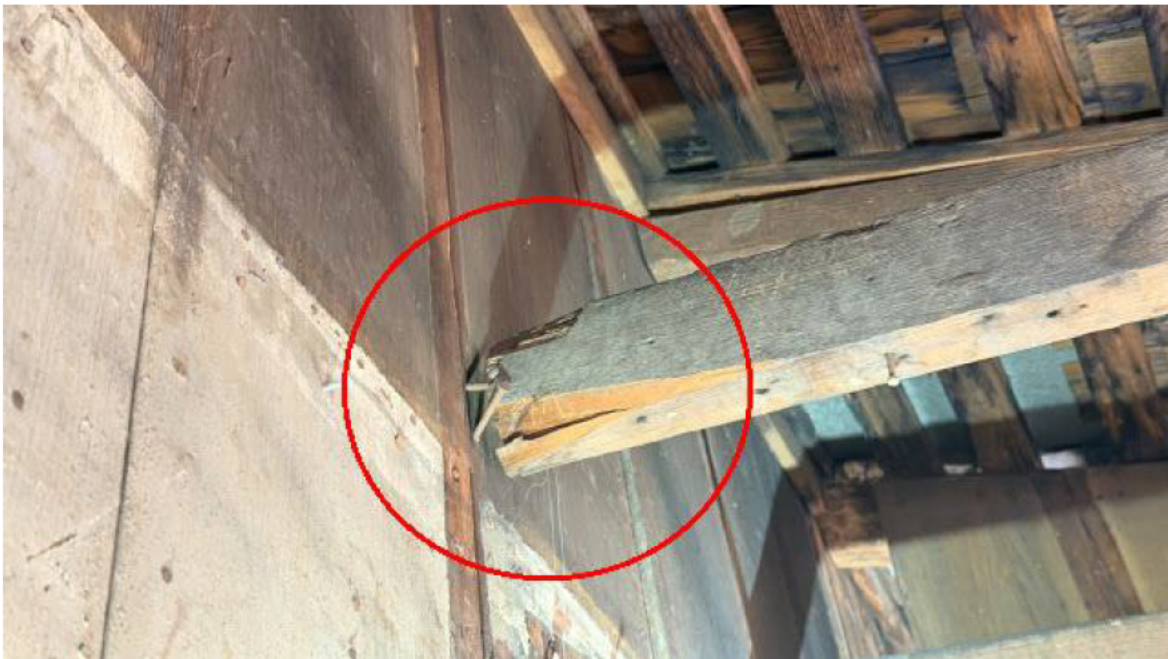
Photo 18

- Improper attachment conditions were observed at wall-to-ceiling connections at multiple locations (see Photographs #18 through #23).
- Efflorescence, likely resulting from prolonged water intrusion through the roof, was observed at wall-to-ceiling junctions and within the attic space (see Photographs #21, #22, and #25).

View of wall-to-ceiling framing showing improper attachment conditions.

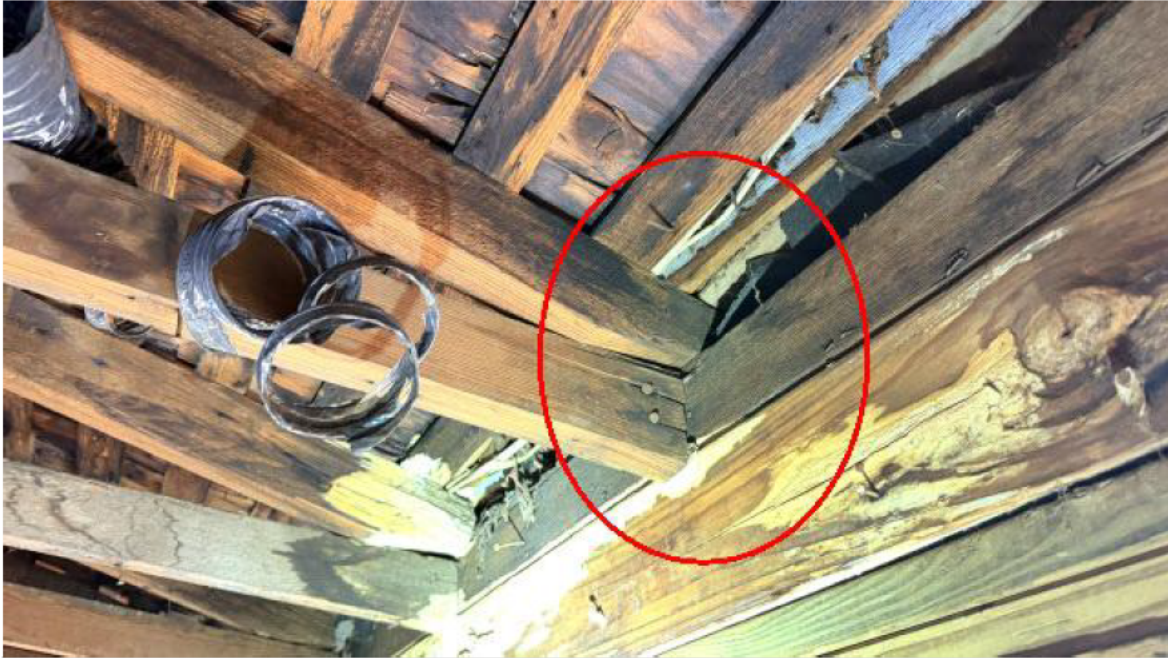
Photo 19

View of wall-to-ceiling framing showing improper attachment conditions.

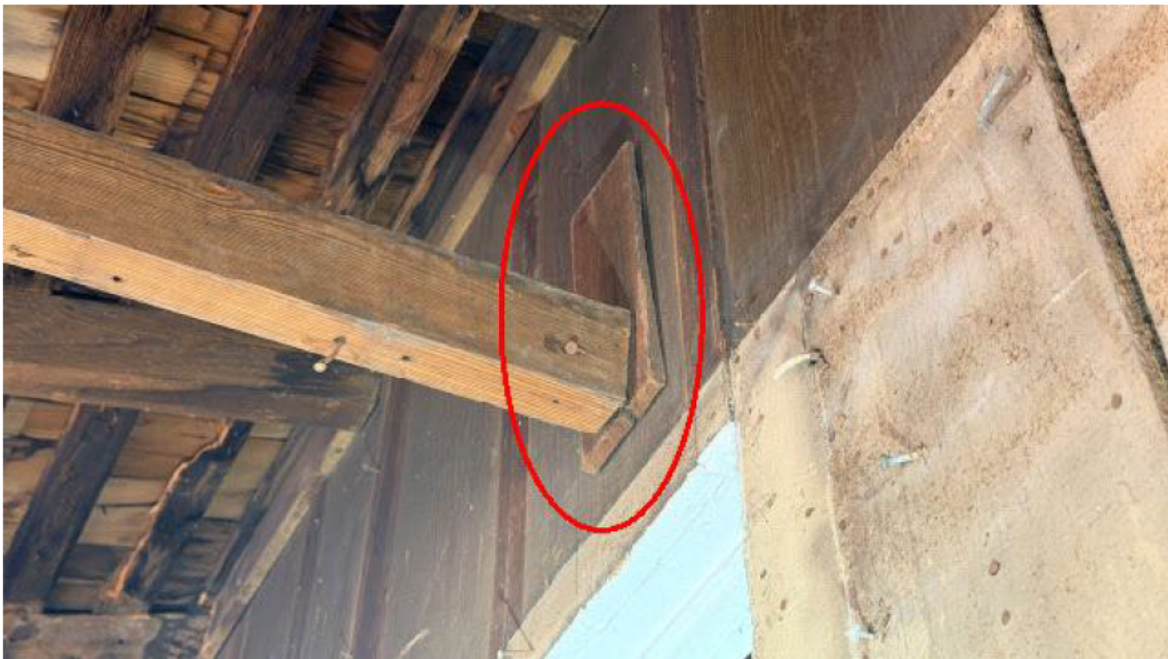
Photo 20

View of wall-to-ceiling framing showing improper attachment conditions.

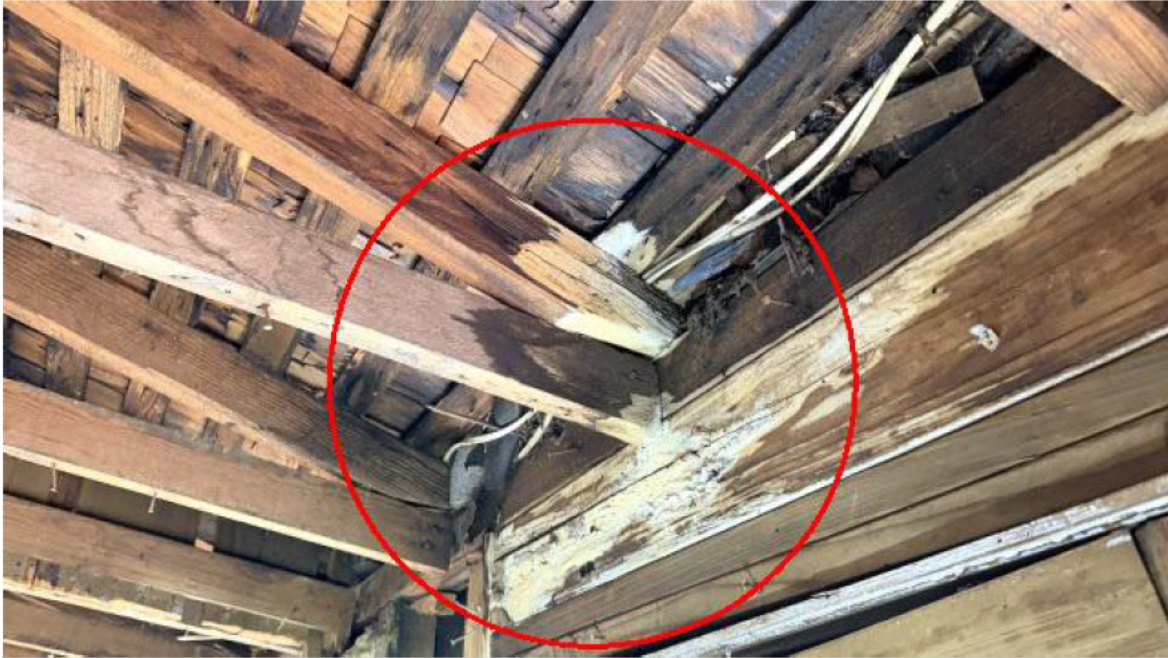
Photo 21

View of wall-to-ceiling framing showing improper attachment conditions.

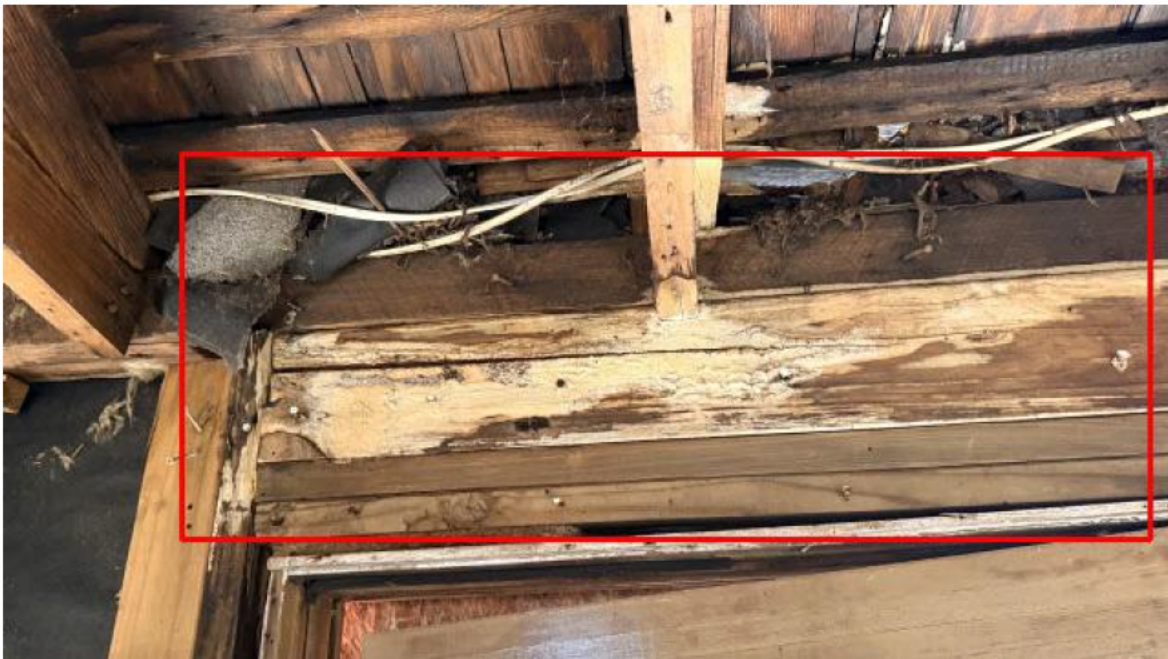
Photo 22

View of wall-to-ceiling framing showing efflorescence, likely resulting from prolonged water intrusion through the roof.

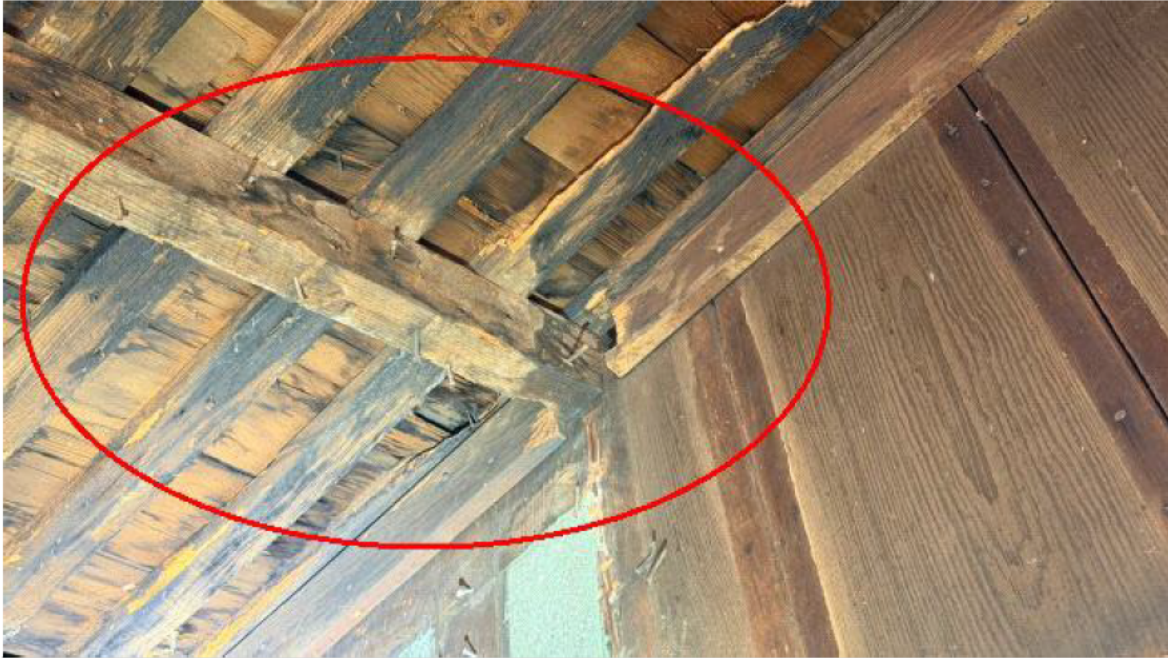
Photo 23

View of wall-to-ceiling framing showing improper attachment and advanced wood deterioration.

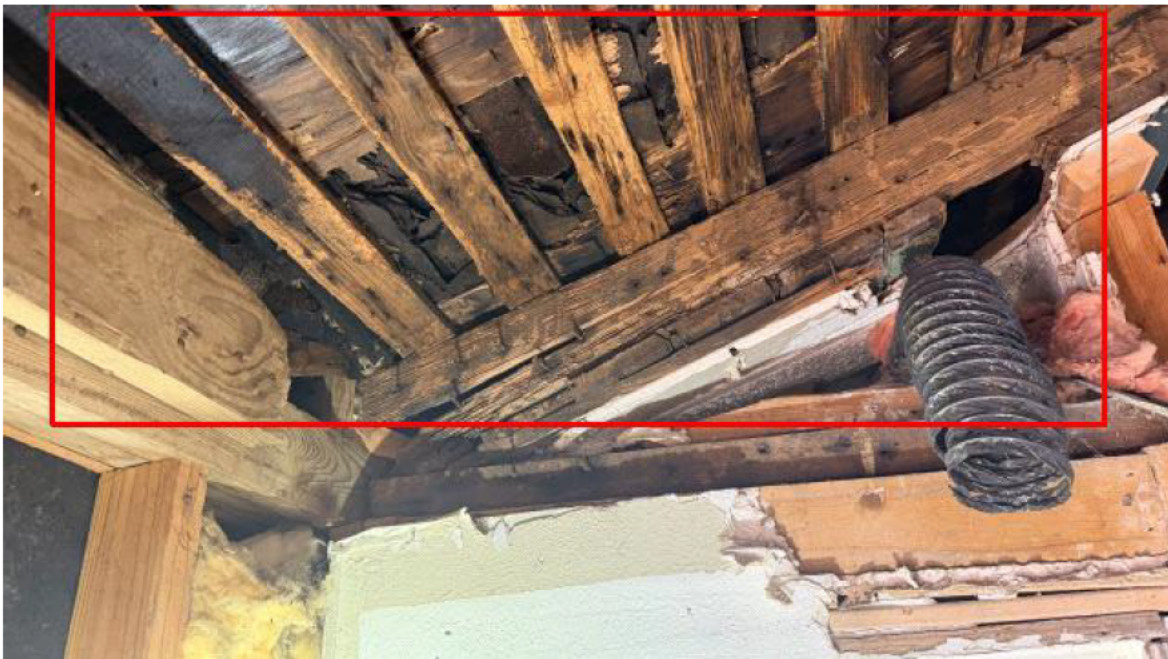
Photo 24

View of wall-to-ceiling framing showing improper attachment and advanced wood deterioration.

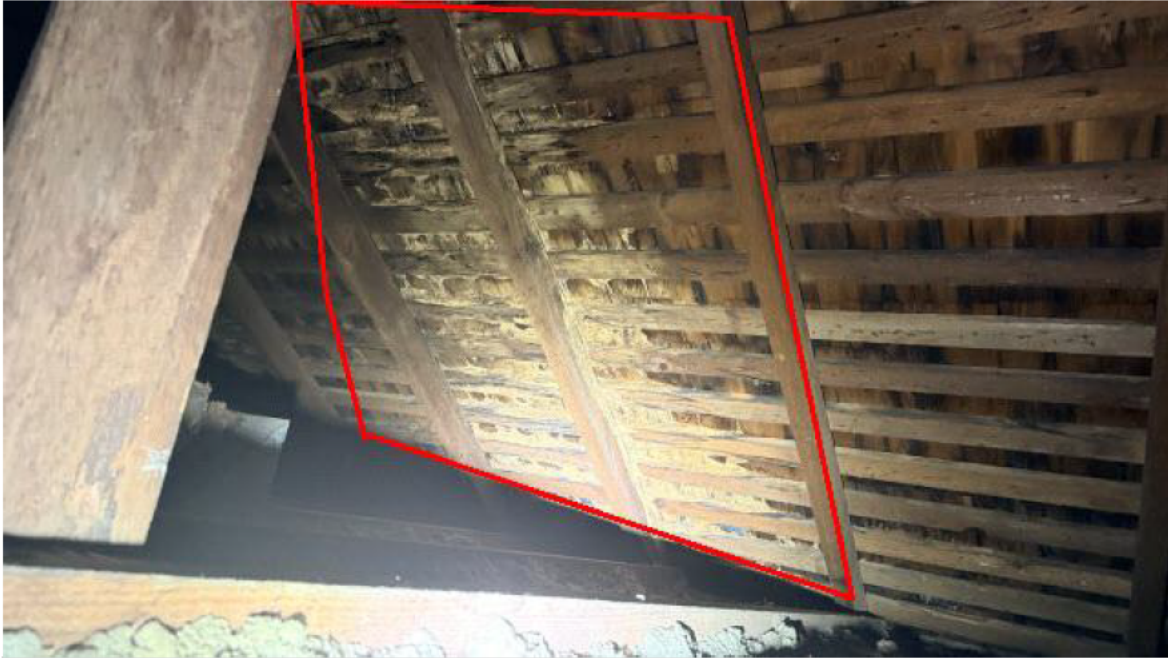
Photo 25

View of attic roof framing showing efflorescence, likely resulting from prolonged water intrusion through the roof.

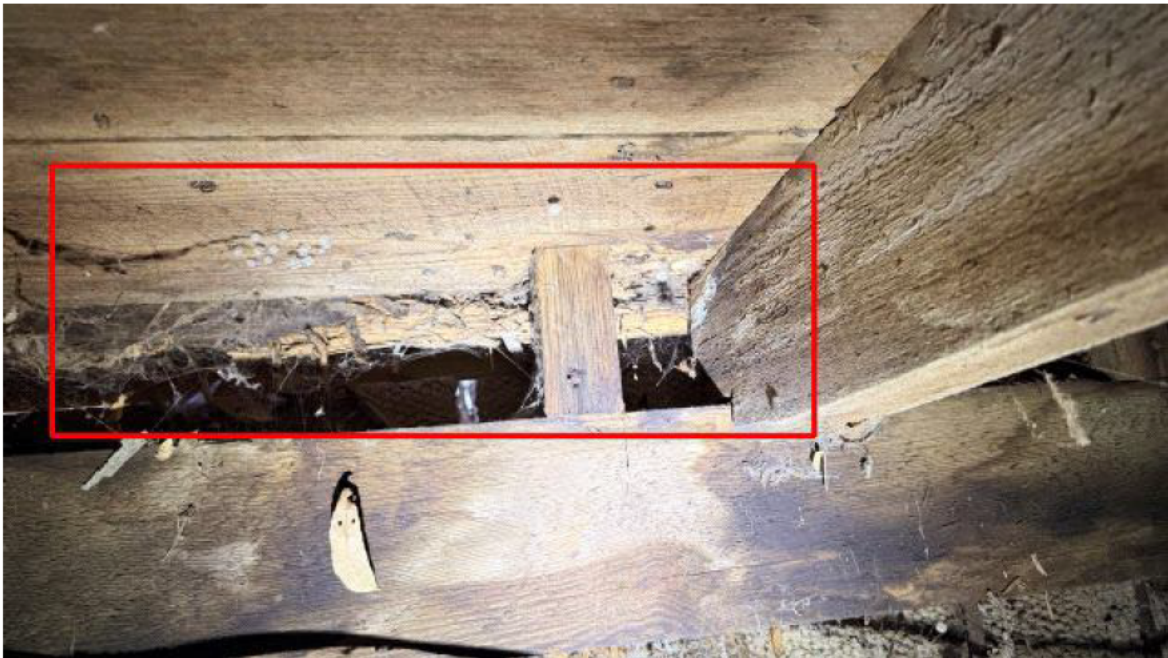
Photo 26

- Advanced wood deterioration and broken structural elements were observed throughout the pier-and-beam foundation system within the crawl space (see Photographs #26 and #31 through #34).

Crawl space view showing advanced wood deterioration (typical).

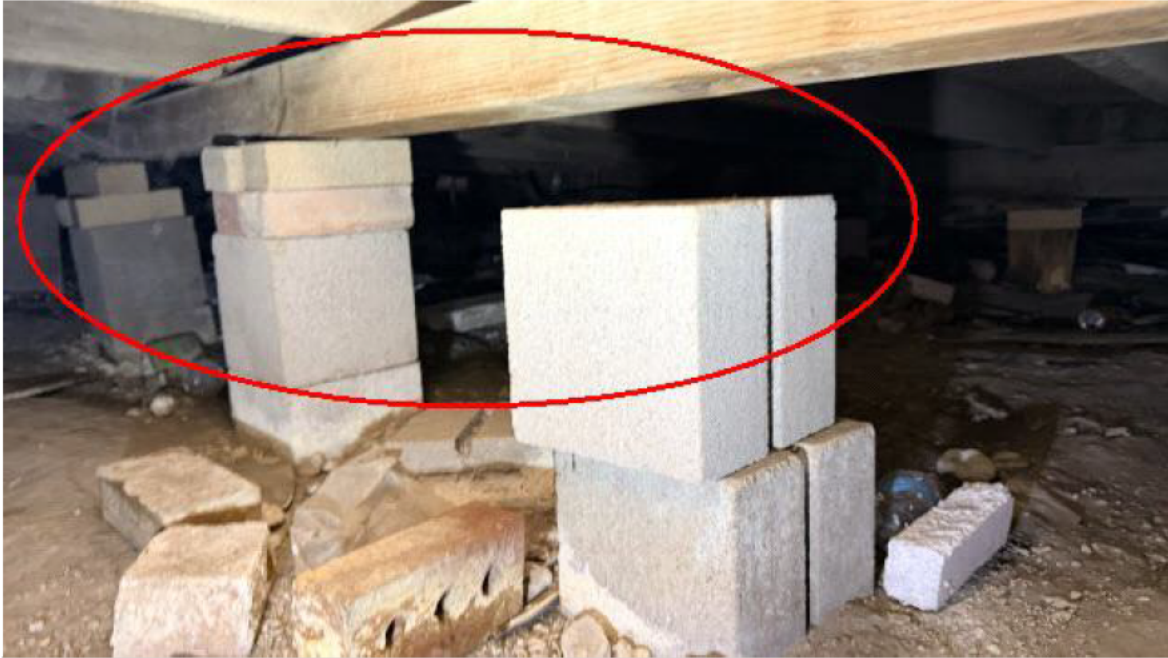
Photo 27

- Substandard footings, evidence of footing settlement, support elements lacking footings, and rotated footings were observed within the foundation system (see Photographs #27 through #31).

Crawl space view showing loose support elements lacking attachment to the framing.

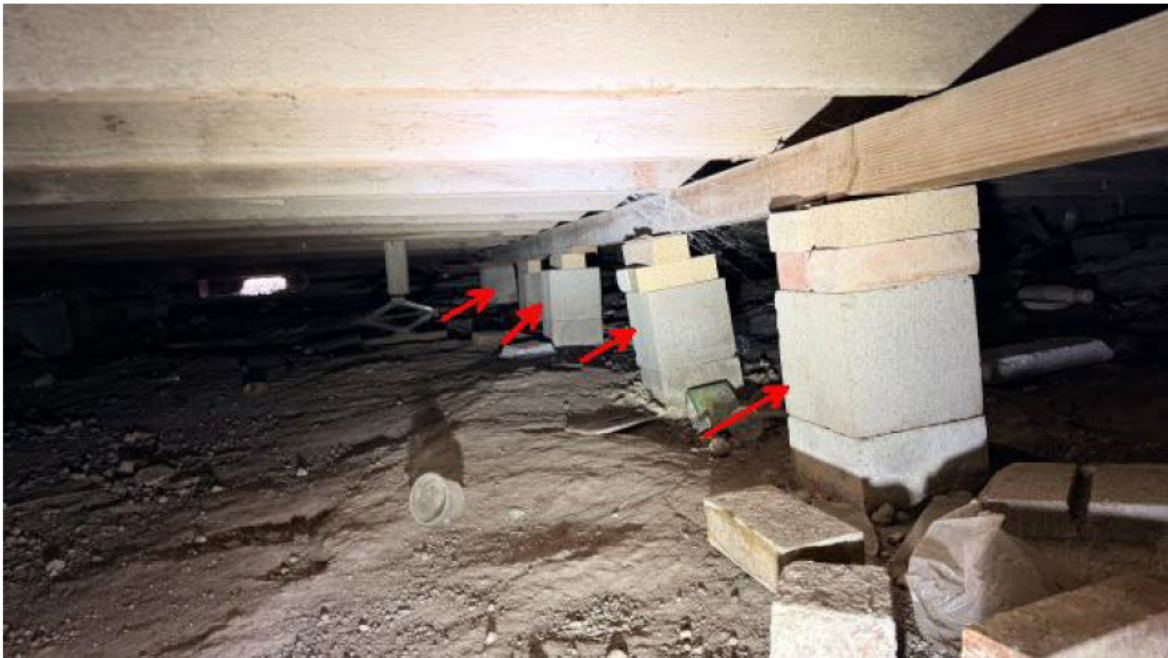
Photo 28

Crawl space view showing loose and rotated support elements lacking footings (typical condition).

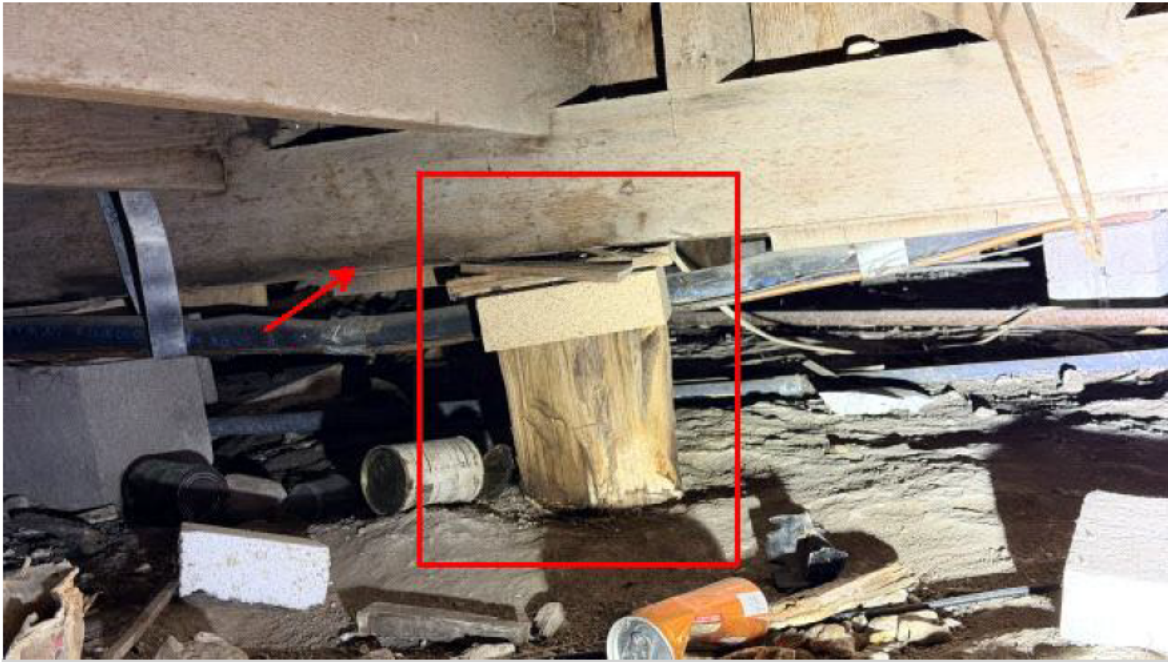
Photo 29

Crawl space view showing substandard footing and a rotated beam (typical).

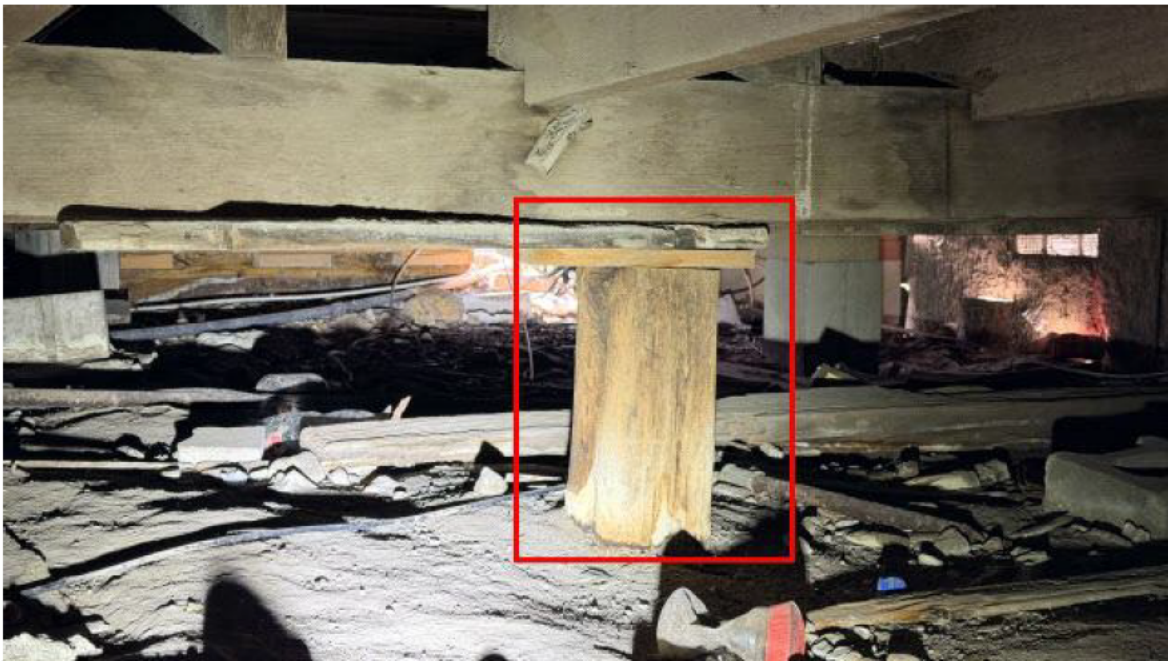
Photo 30

Crawl space view showing substandard footing (typical).

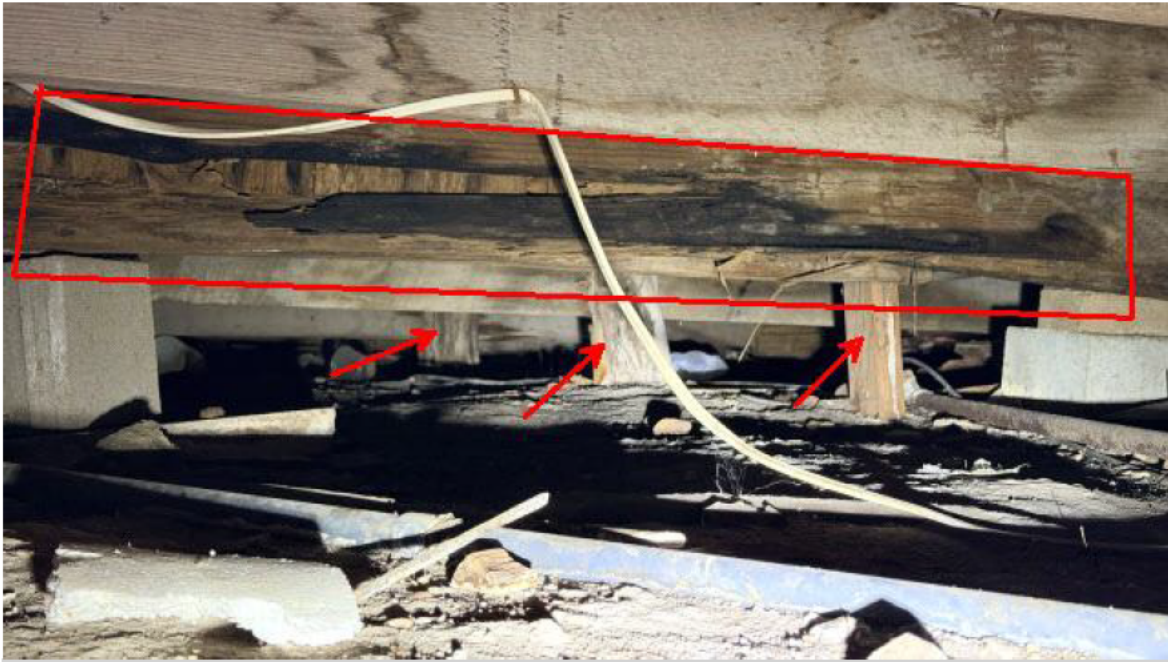
Photo 31

Crawl space view showing substandard footing and advanced wood deterioration (typical).
