Re: Owner Opposition to Historic Zoning/Designation – 907 E. 13th St.

STRUCTURAL ASSESSMENT REPORT

Structural Assessment Report

FEI Project Number: 1710
Site Address: 907 E. 13th St.
Austin, TX

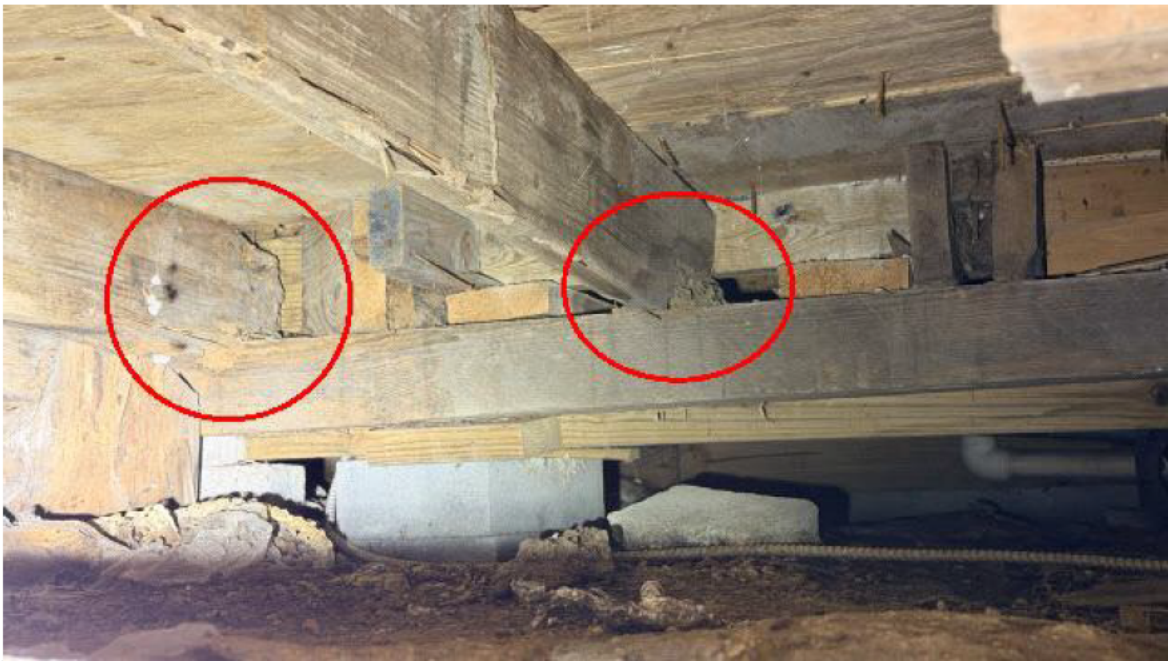
Photo 32

- Advanced wood deterioration and broken structural elements were observed throughout the pier-and-beam foundation system within the crawl space (see Photographs #26 and #31 through #34).

Crawl space view showing advanced wood deterioration (typical).

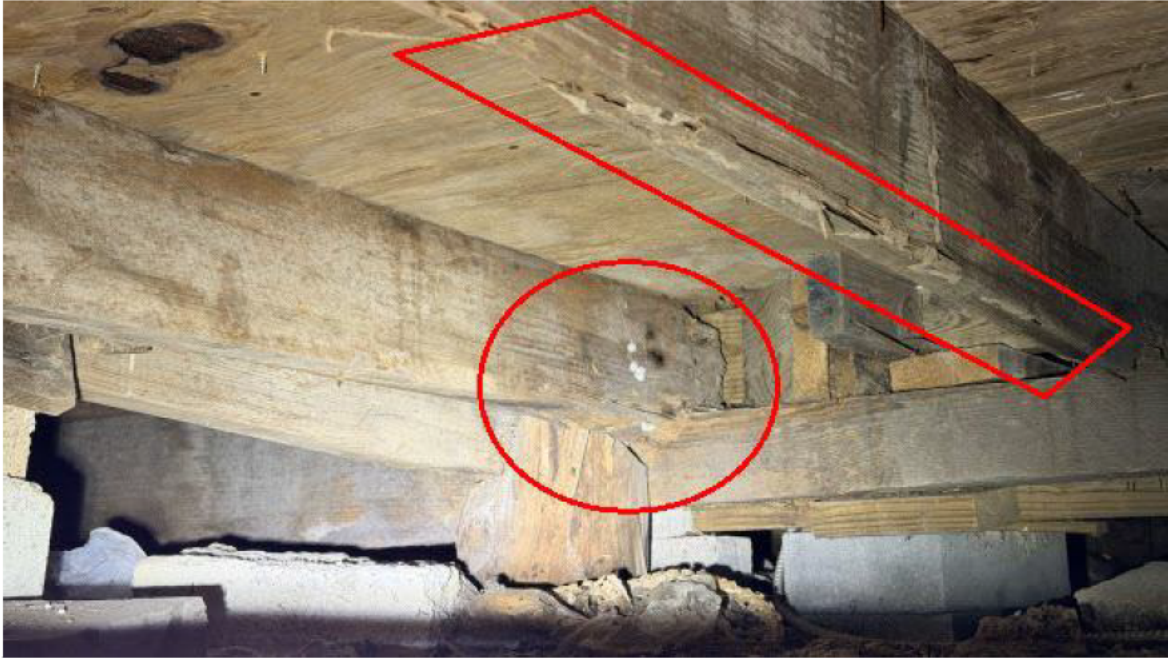
Photo 33

Crawl space view showing advanced wood deterioration (typical).

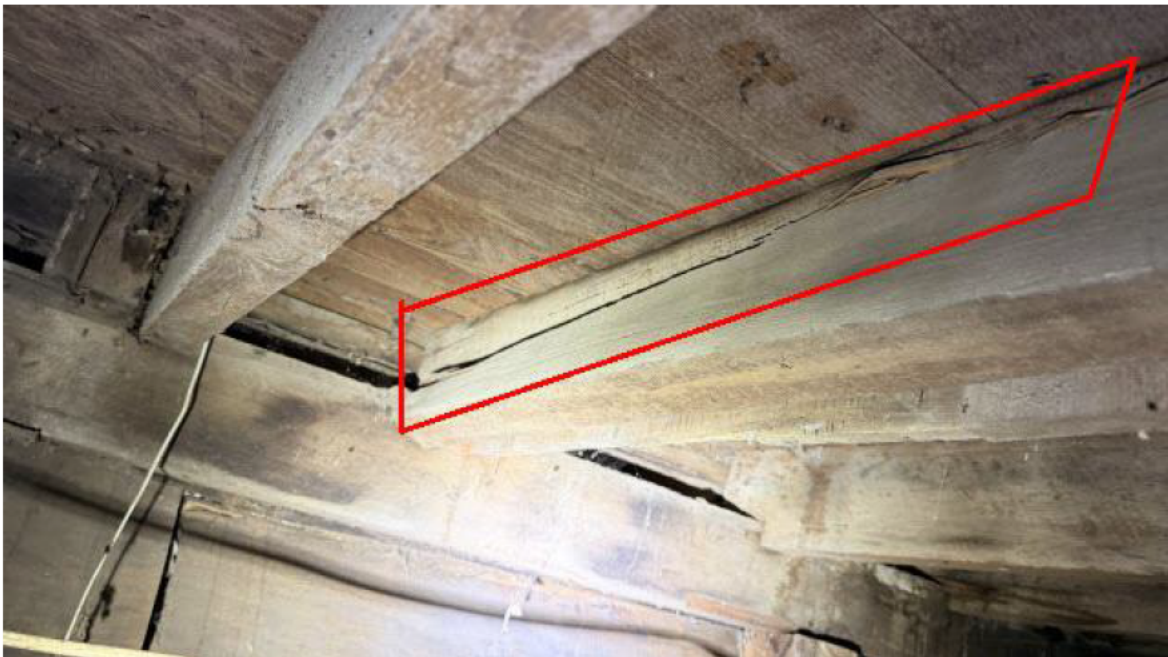
Photo 34

Crawl space view showing broken floor joist.
