# ANN and ROY BUTLER HIKE AND BIKE TRAIL SITE ANALYSIS and RECOMMENDATION

## Executive Summary

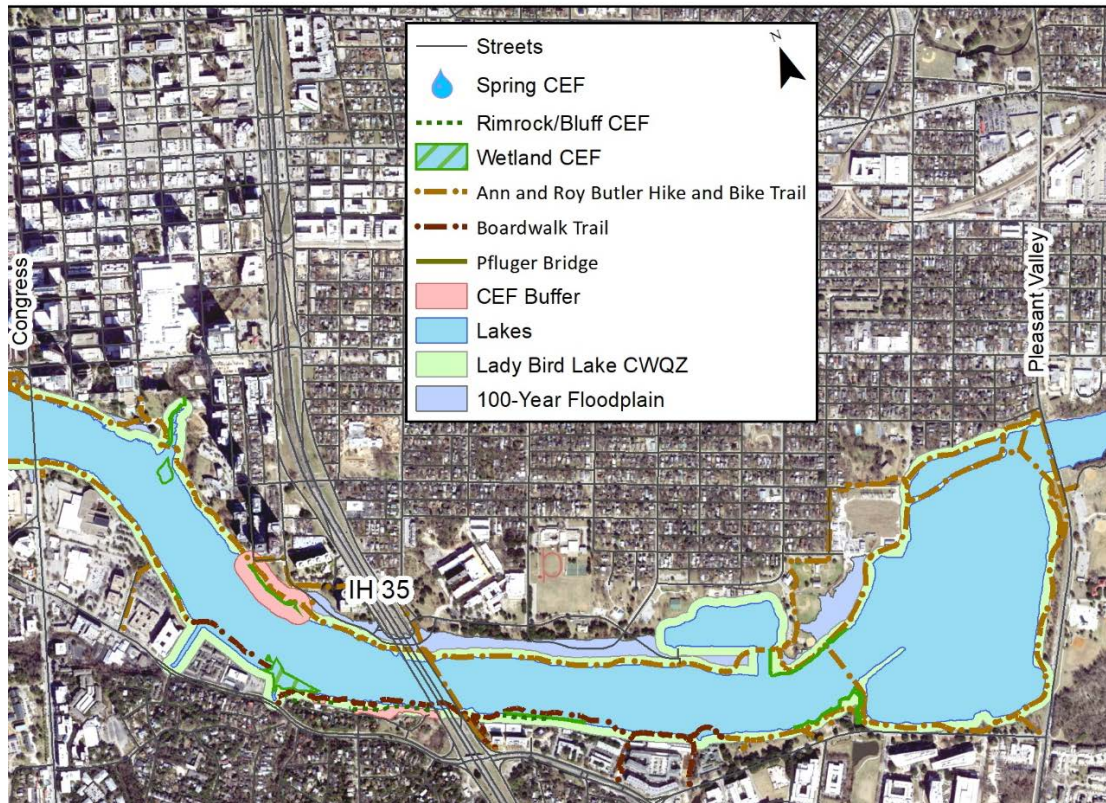
In several areas along the 10-mile loop, the Trail has slopes in excess of 15%. Particularly in the parkland around Zilker Park and in the Downtown region, slopes adjacent to the trail may exceed 35%, impeding relocation or modification of the Trail. The northwest and eastern portions of the Trail are in areas that are relatively flat.

Eastern portion of Butler Trail (Congress Ave to Pleasant Valley)

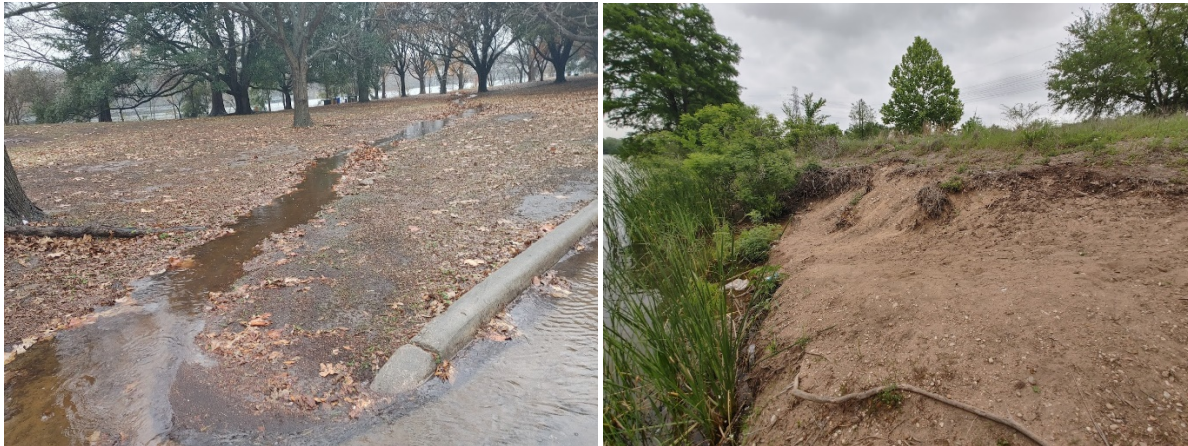
Heavy seasonal rain events bring high velocity stormwater flows through the parkland and onto the Butler Trail when water is diverted from adjacent impervious surfaces and directed into Lady Bird Lake as part of Austin's drainage conveyance system. Hard armored surface drainage structures, including concrete channels, drainage pipes, and culverts, are installed around the Trail and adjacent parkland to manage the impact of stormwater. However, the decomposed granite trail surface along with erosive storm

flows have created erosion issues for the Trail that can worsen without improvements to the Trail, surrounding parkland, and stormwater infrastructure. Additionally, the erosive conveyance of storm flows through riparian and wetland areas degrades the condition of those habitats.

Photo taken at Festival Beach (LEFT) and Longhorn Shores (RIGHT)
