**Subject:** **State of Austin Bridges Report**

# STATE OF AUSTIN BRIDGES

## February 2026

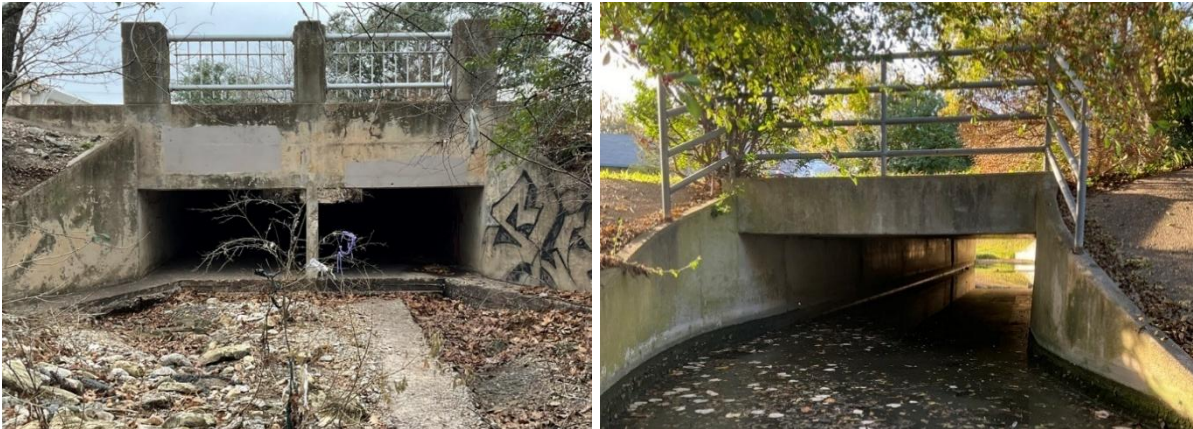
*Figure 3. Small Bridge Examples – Box Culverts*

Smaller bridges have spans of 20 feet or less. Figure 3 and Figure 4 show examples of typical small bridges and culverts. There are about 810 locations where water crosses the right-of-way

These small bridges or structures are typically comprised of one or more buried pipes/culverts, minor safety systems (guardrail) and small entrance and exit headwalls/aprons. These structures have no decks, superstructures, substructures or underlying channels. Conveyance of water under the roadway is entirely contained within the pipes. Also, no bridge signage, approach slabs or any other special roadway elements are usually needed. The roadway pavement is typically separate and maintained as part of the street preventive maintenance program. It will not be considered part of the small bridge structure – unless it has a true deck and superstructure which very few do.

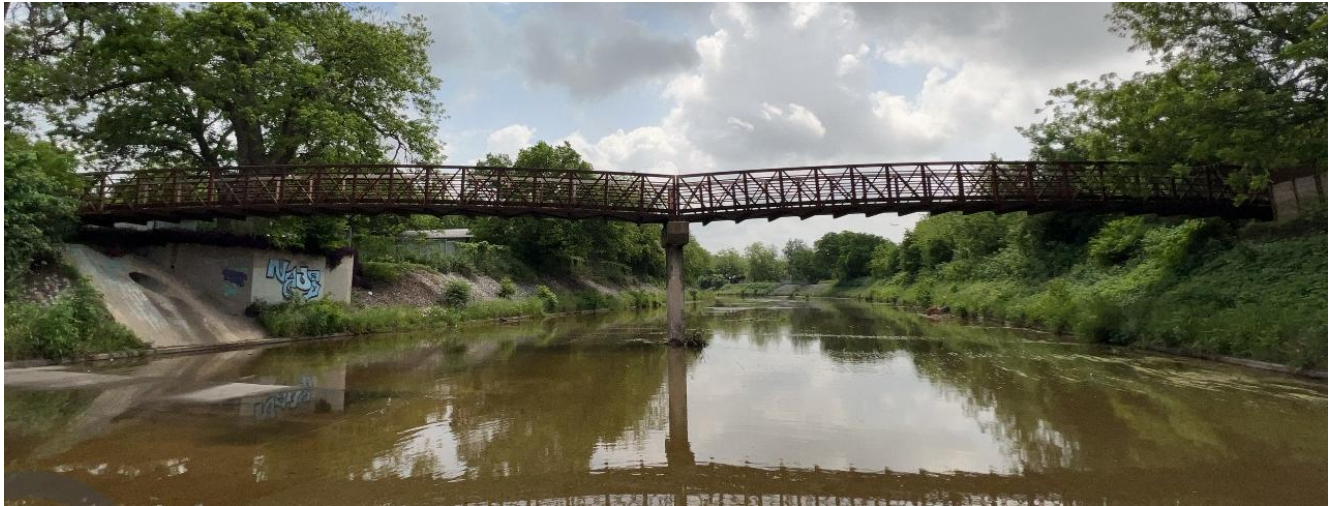
*Figure 5. Pedestrian/Bike Bridge*

TPW is also responsible for maintaining pedestrian and bike bridges (1) in the public ROW and (2) on the Urban Trails network outside of parks. An example of a pedestrian/bike bridge is presented in Figure 5. There are 20 pedestrian bridges in the ROW. Routine inspections of these structures were completed in 2023. TPW is currently updating the inventory of trail bridges. The inspection of Urban Trail bridges is scheduled for completion in FY27. The inspection interval follows a 5-year cycle.

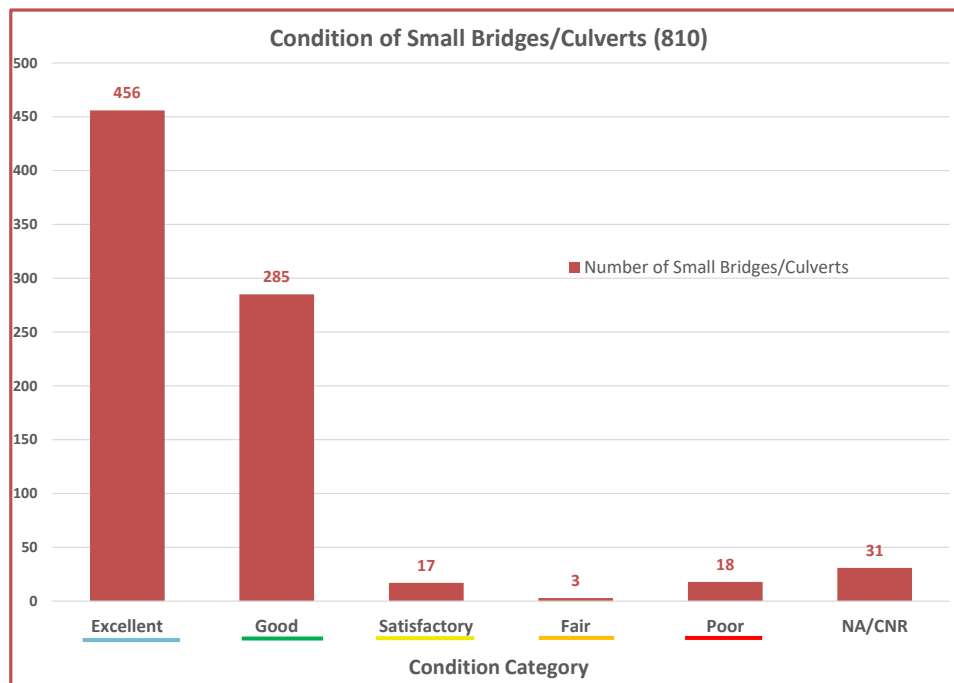
*Figure 8. Condition – Small Bridges/Culverts*

Of the 840 small bridges and culverts, 97% are in Satisfactory or better condition (Table 6, Figure 8 **Error! Reference source not found.**). Two structures are rated as Poor based on their CSR score. Another 16 have structural elements in poor enough condition to require rehabilitation or replacement. Therefore, a total of 18 small bridges/culverts need rehabilitation or replacement and are categorized as Poor. These structures are safe for public use.

Condition Category	# of Bridges	%
Poor	18	2
Fair	3	<1
Satisfactory	17	2
Good	285	35
Excellent	456	56
NA/CNR	31	4

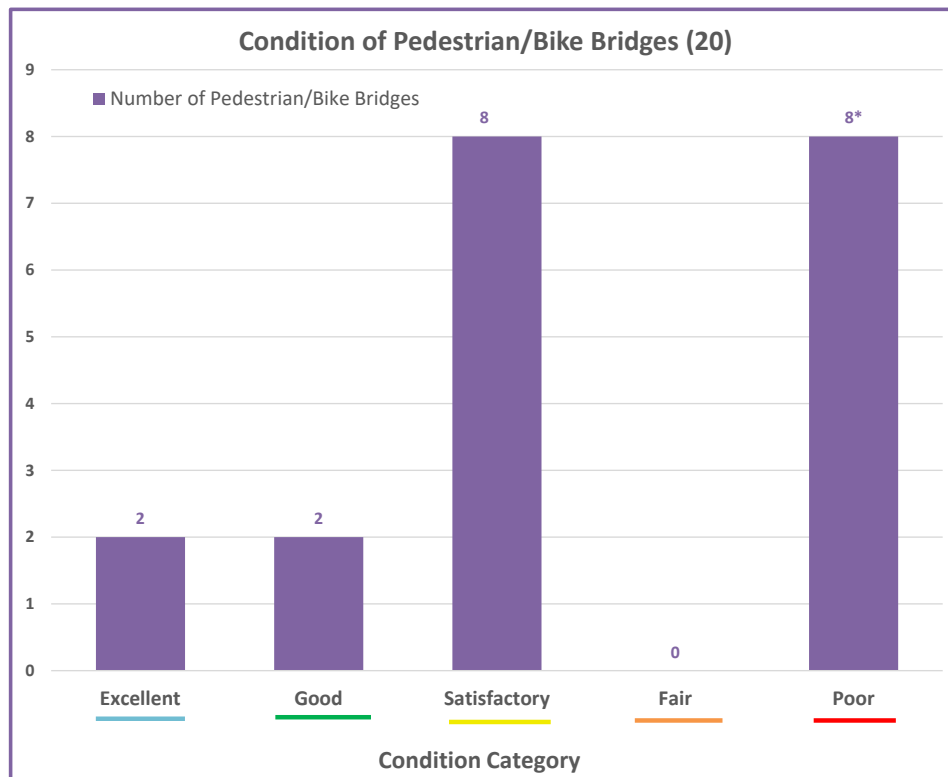
Figure 10. Condition – Pedestrian/Bike bridges

Of 20 pedestrian/bike bridges, 60% are rated as in Satisfactory or better condition (Table 9, Figure 10 **Error! Reference source not found.**). Eight pedestrian/bike bridges need rehabilitation or replacement and are categorized as Poor. Among these, Landon Ln. bridge at Lee Elementary (Poor condition) was closed after a follow-up inspection due to safety concerns; however, an alternate route is available for school access. These assessment results do not include the Urban Trail bridges.

Condition Category	# of Bridges	%
Poor	8	40
Fair	0	0
Satisfactory	8	40
Good	2	10
Excellent	2	10

\*One bridge closed after a follow-up inspection
