**City of Austin**

# Parks and Recreation Department Security Audit

## Findings and Recommendations Report

Version 2 | July 18, 2025

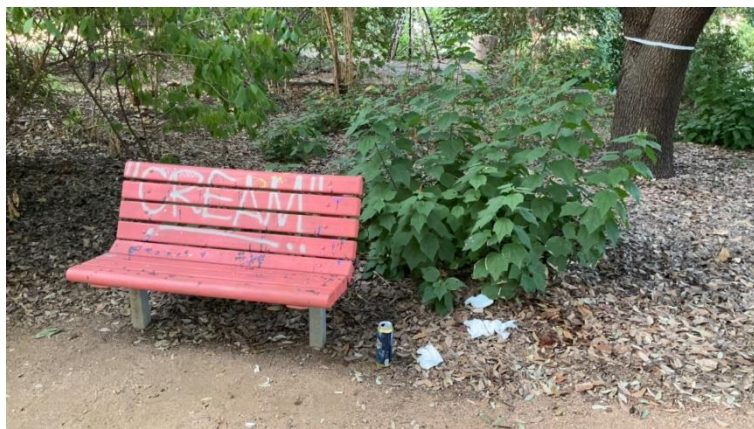
**Picture 4. Vandalized park bench, nearby empty alcohol container and trash, and poor visibility due to dense vegetation all negatively impacts perception of safety**

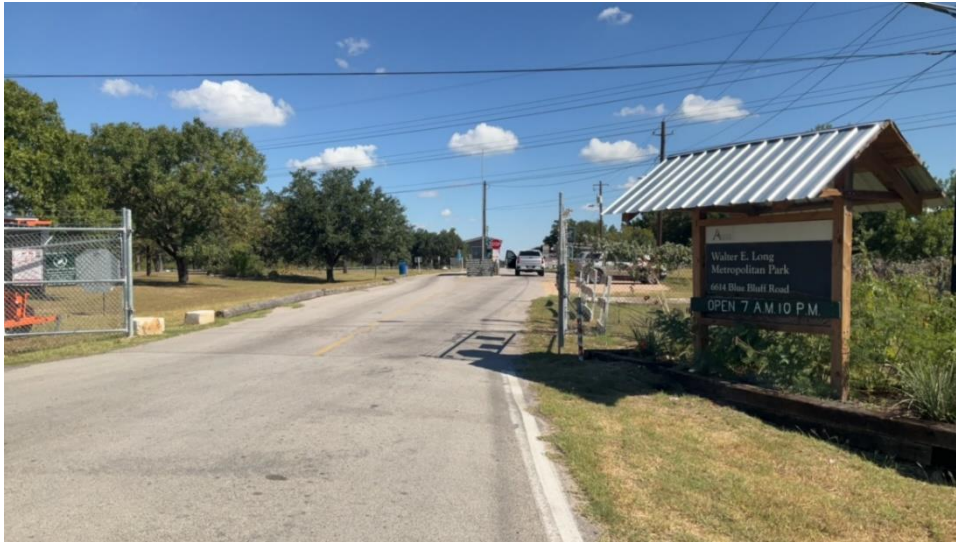
**Picture C-3. Walter E. Long Metropolitan Park – Natural Access Control, Territorial Reinforcement, and Site / Target Hardening**

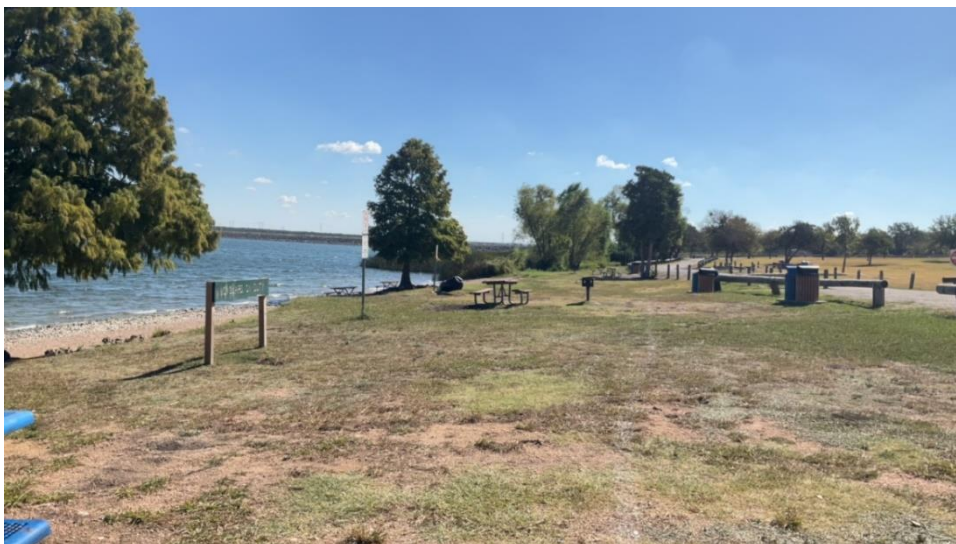
Walter E. Long Metropolitan Park scored highly among the natural access control, territorial reinforcement, image management / maintenance, and site / target hardening categories. Signage, wayfinding, fencing, and vehicle barriers were present throughout publicly accessible areas of the park. The main point of entry is fenced as shown in Picture C-3, and a staffed ticketing booth manages entry into the park. The park is enclosed with fencing enhancements (barbed wire), locked vehicle gates designated for PARD staff, and fencing with signage designating private areas on the eastern side of the vehicle path. There is extensive park rules signage, maintained landscaping and vegetation, and activity generators such as picnic tables and pavilions throughout as shown in Picture C-4.

**Picture C-4. Walter E. Long Metropolitan Park – Image Management / Maintenance, Activity Support**

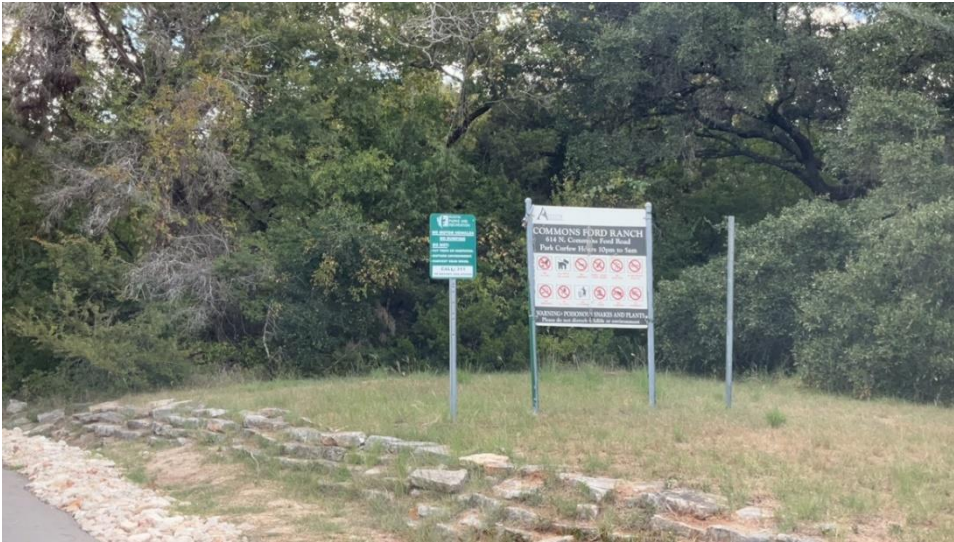
**Picture C-5. Commons Ford Ranch Metropolitan Park – Image Management / Maintenance, Territorial Reinforcement**

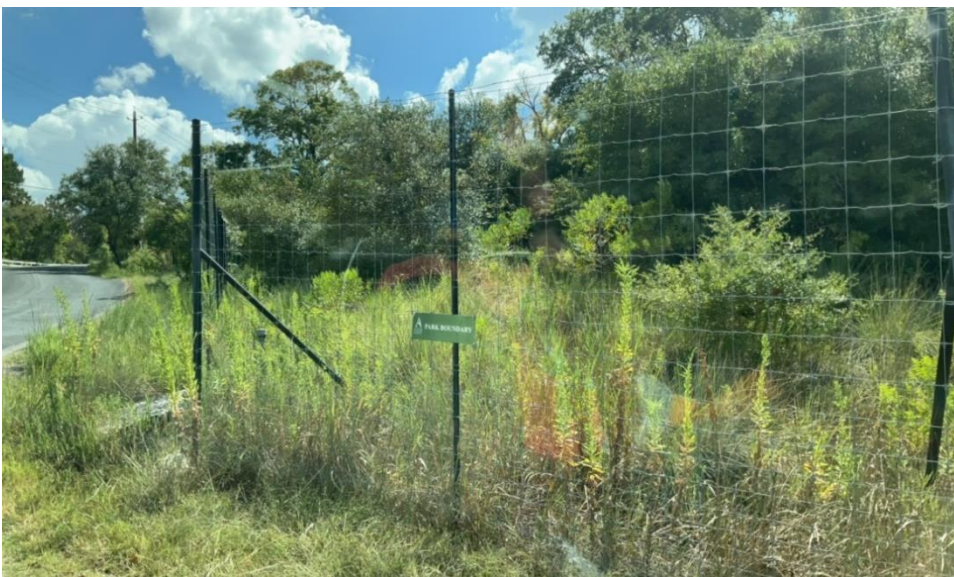
**Picture C-6. Commons Ford Ranch Metropolitan Park – Territorial Reinforcement, Site / Target Hardening**

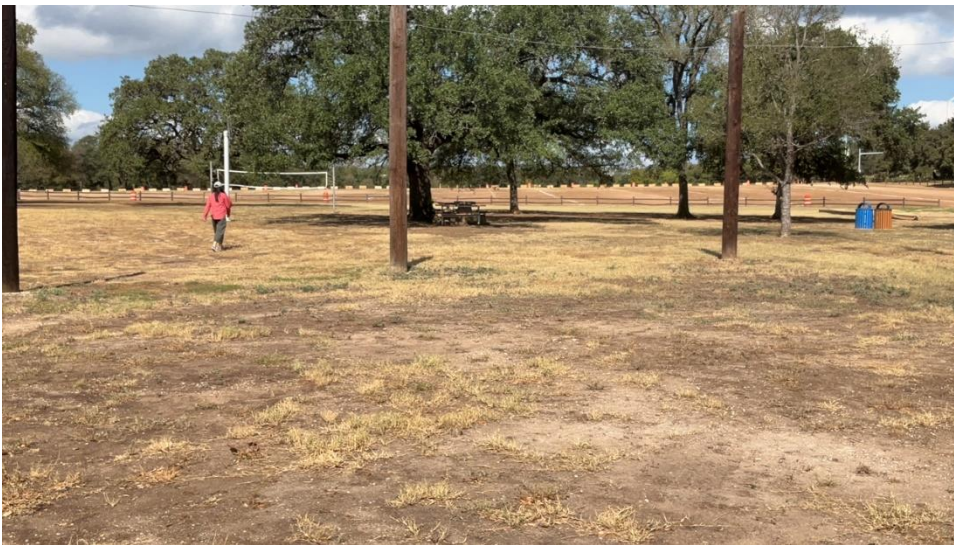
Zilker’s “park center” south of Barton Springs Road scored well across all CPTED categories. While this area had less usage than other parts of the park, the area was well maintained, had activity generators such as volleyball courts and park benches, and PARD staff traversing the area, as shown in Picture C-9. The parking lot along Andrew Zilker Road had a security camera trailer, with no evidence of vandalism or vehicle break ins at the time of the site visit.

**Picture C-9. Zilker Metropolitan Park (Park Center, South) - Activity Support**

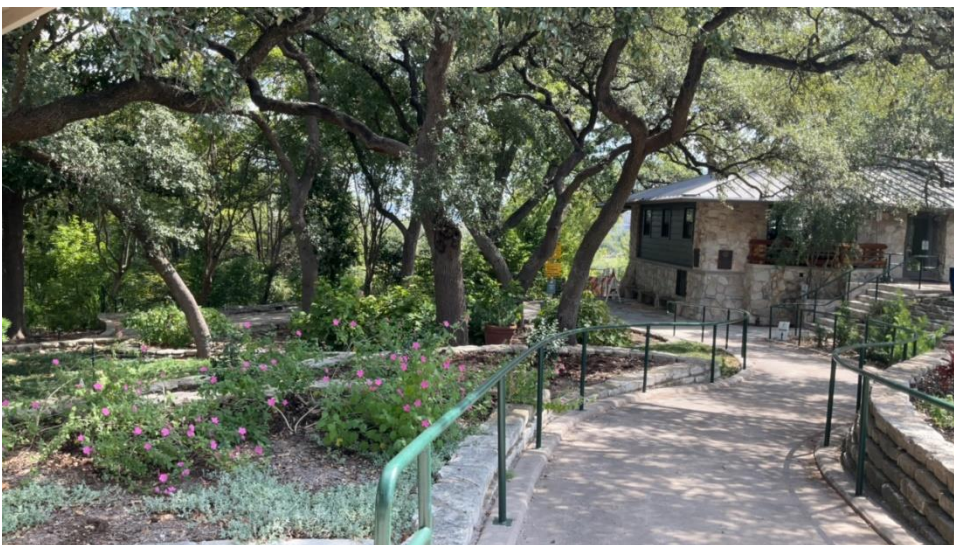
The Zilker Botanical Garden was well-secured, ticketed, and actively monitored by staff. The garden had activity generators such as a museum, benches, and food/beverage trucks as shown in Picture C-10.

**Picture C-10. Zilker Metropolitan Park (Park Center, North) - Natural Access Control, Activity Support**

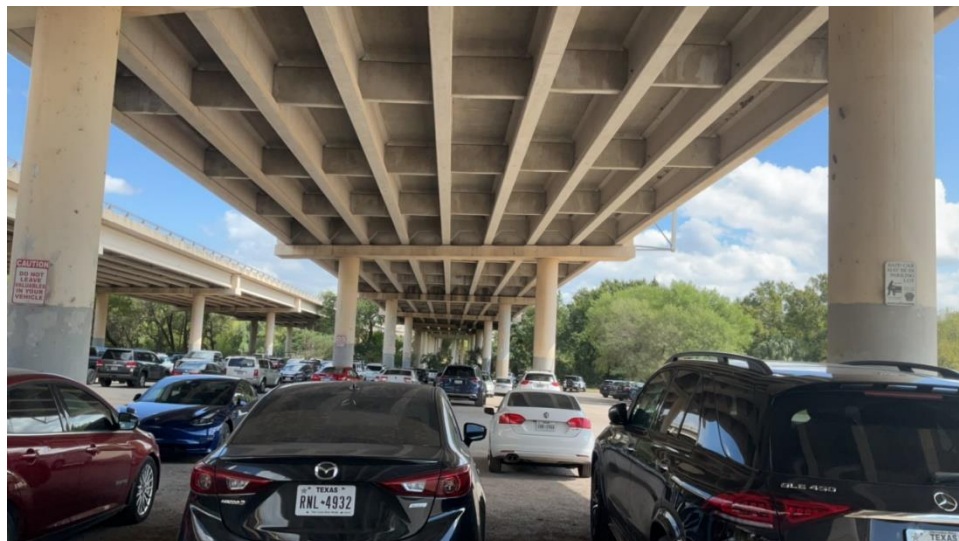
The northwest area of Zilker Park was surveyed at the MoPac Expressway underpass parking lot. The area adjacent to this site was not accessible due to Austin City Limits setup activities. This area was accessible by Strafford Drive by car, and the greenway running adjacent by foot. This area lacked clear demarcation and signage, access control features such as bollards or vehicle gates, and was poorly maintained (unpaved, gravel parking lot). PARD staff had reported multiple vehicle break-ins at this site, with signage throughout to warn park users, as shown in Picture C-13. There were no security camera trailers or other deterrents to vehicle break ins at the time of the site visit.

**Picture C-13. Zilker Metropolitan Park (Park Center, North) - Image Management / Maintenance**

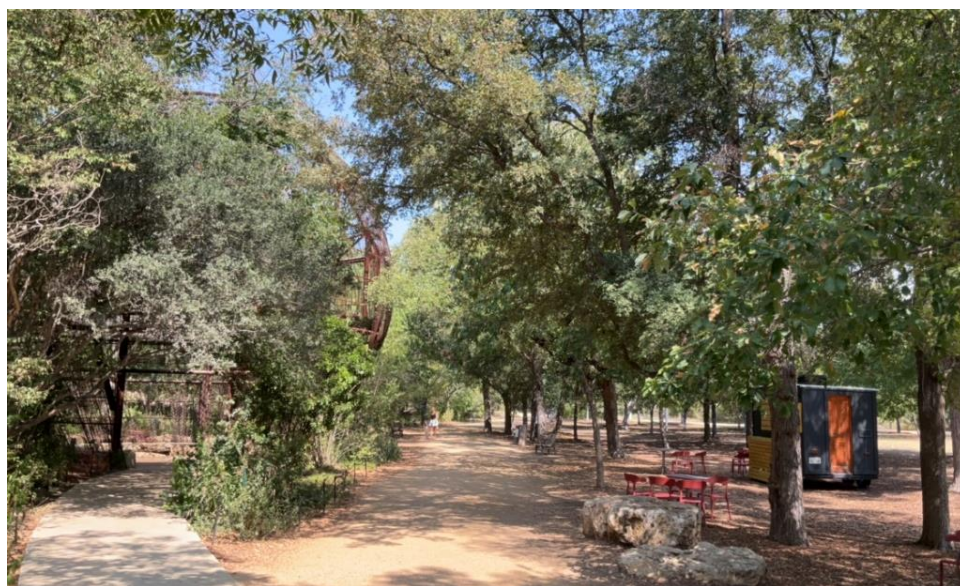
Pease Park Conservancy scores highly across all categories, with clear sightlines, maintained landscaping and pathways, extensive wayfinding and rules signage, and activity generators. Sightlines were supported by clearly defined pathways free of trash, a lack of shipping containers and blind spots, and maintained vegetation and trees along pathways as shown Picture C-17. Activity generators such as interactive art installation, seating and tables, and beverage / food trucks lead to a high activity support category rating (see Picture C-17).

**Picture C-17. Pease Park Conservancy – Natural Surveillance, Image Management / Maintenance, Activity Support**

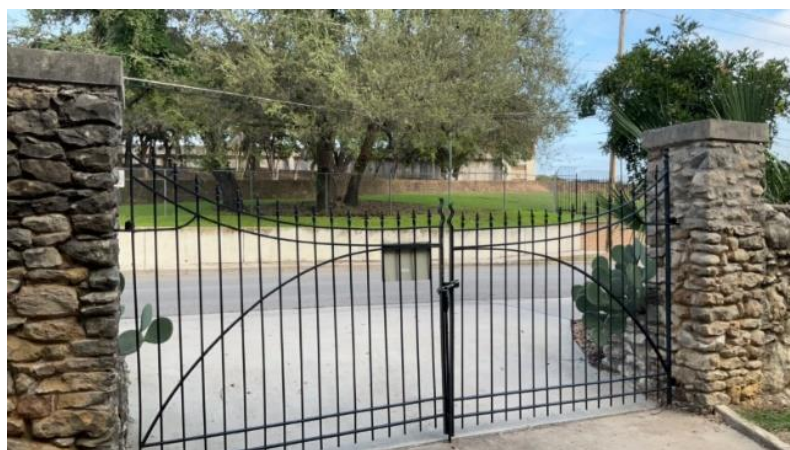
Picture C-24. Mayfield Park – Natural Surveillance / Site / Target Hardening

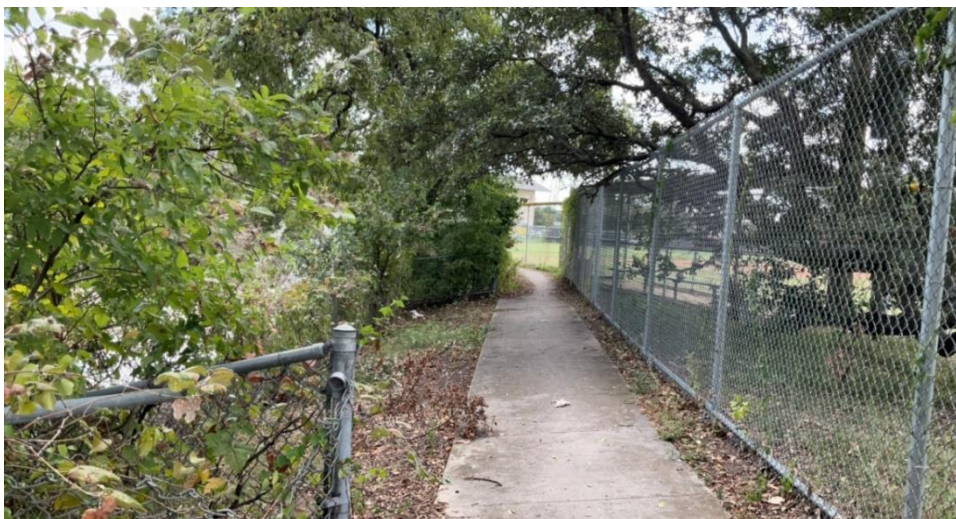
**Picture C-26. Parque Zaragoza Neighborhood Park - Natural Surveillance**

The westernmost entry point of Parque Zaragoza is concealed from passive surveillance from nearby traffic and has extensive overgrown vegetation in and around the fencing of the baseball field and creek as shown in Picture C-26. This area had blind spots from the vegetation and curved pathway and is detached from any potential passive surveillance from pedestrians or the roadway.

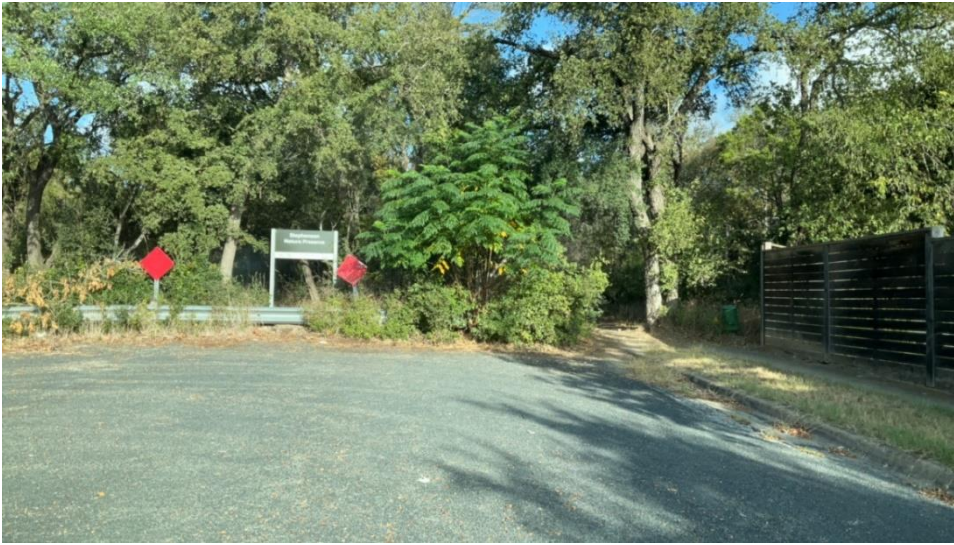
The three access points on the eastern side of the park border the front yard of houses, have signage designating park property, and have some access control feature such as a vehicle barrier, fencing, and/or a designated pedestrian entryway, as shown in Picture C-30.

**Picture C-30. Stephenson Nature Preserve - Natural Access Control**

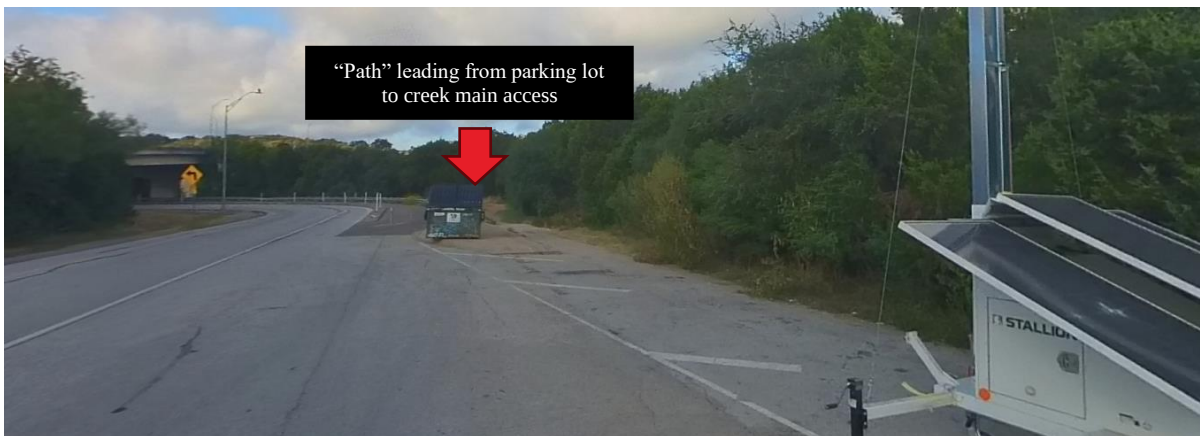
Barton Creek Wilderness Park scored poorly in the natural surveillance and natural access control CPTED categories. The main access points for the park were adjacent to a freeway off ramp, with little to no surveillance and wayfinding signage present at the creek access point as shown in Picture C-33.

**Picture C-33. Barton Creek Wilderness Park - Natural Access Control**

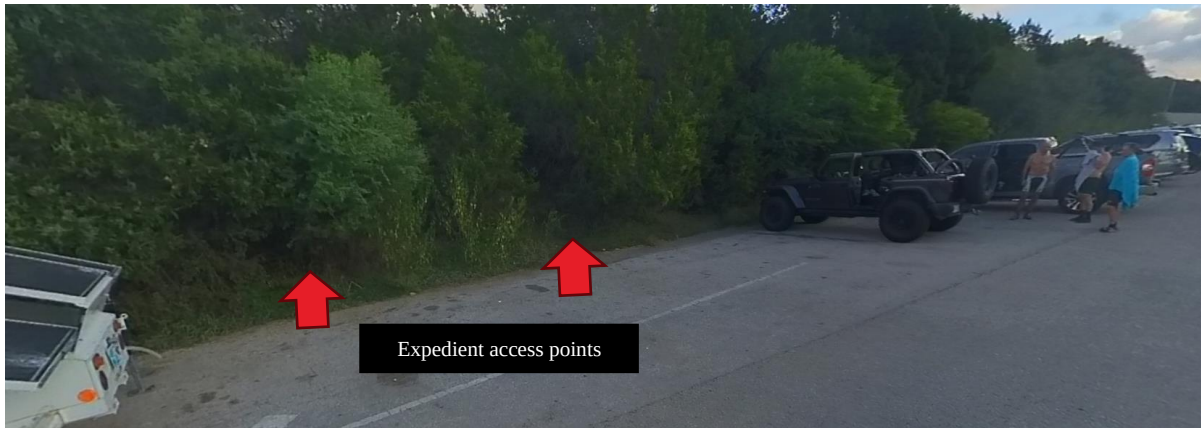
The main access point is located significantly away from the parking lot and has no signage directing visitors to the intended access point. Expedient access points or “desire paths” are shown in Picture C-34; they are undesigned, shortcuts into the park created by foot traffic overtime. Extensive trash was present all along the tree line in the parking area.

**Picture C-34. Barton Creek Wilderness Park - Natural Access Control**

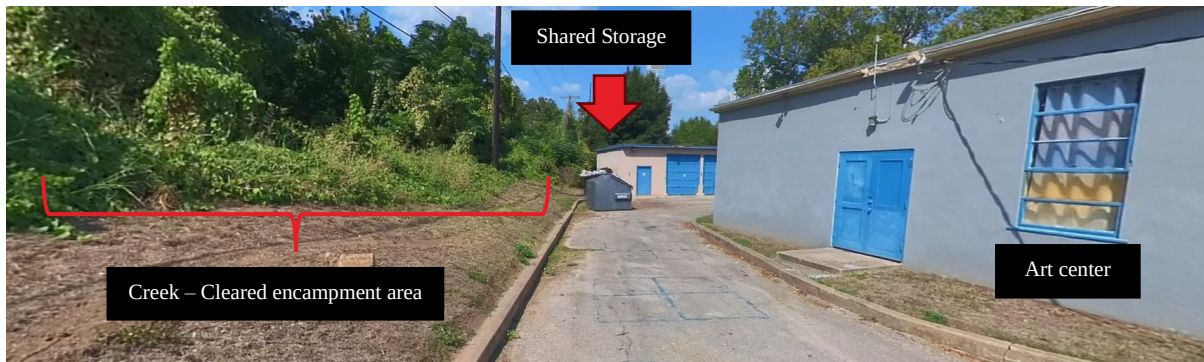
The western side of the arts center is accessible through a path with signage delineating employee access. Staff noted that the storage garages on the north side had been broken into before. This is shared storage between the arts center and park maintenance. Overgrown vegetation along the creek, where encampments have been cleared previously, forms the western perimeter of the facility. There are several blind spots, as the road leading to the back of the arts center forms a “U,” and the creek blocks visibility from the street or adjacent properties. Security cameras are present along this corridor, as shown in Picture C-45.

**Picture C-45. Dougherty Arts Center - Western side of facility**

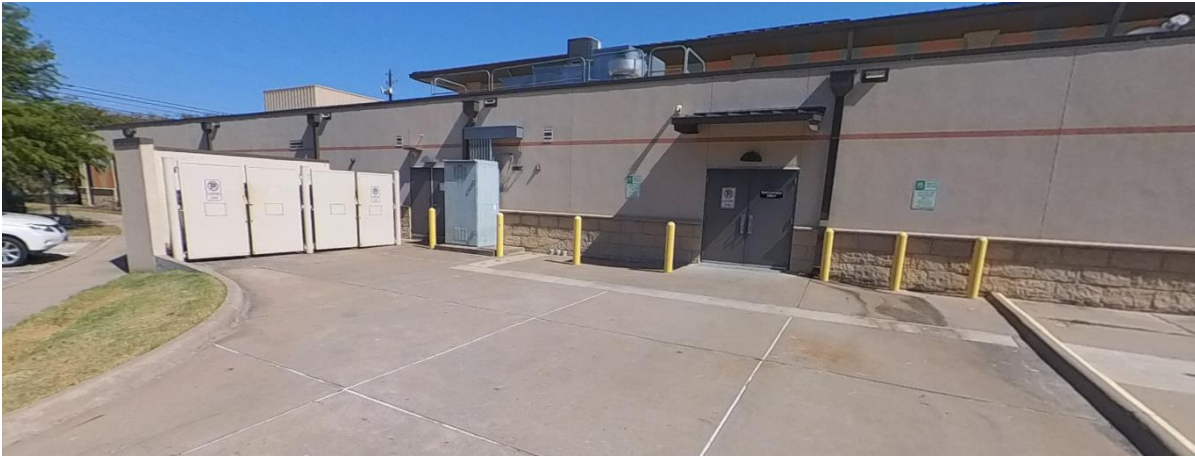
While enclosures keep the dumpsters out of sight and is more aesthetically pleasing, it provides a potential hiding spot, as shown in Picture C-47. PARD staff shared that there have been multiple instances of individuals defecating in the dumpster enclosure. An outdoor automatic light was installed near the enclosure to discourage the behavior.

**Picture C-47. Asian American Resource Center - Maintenance Area**

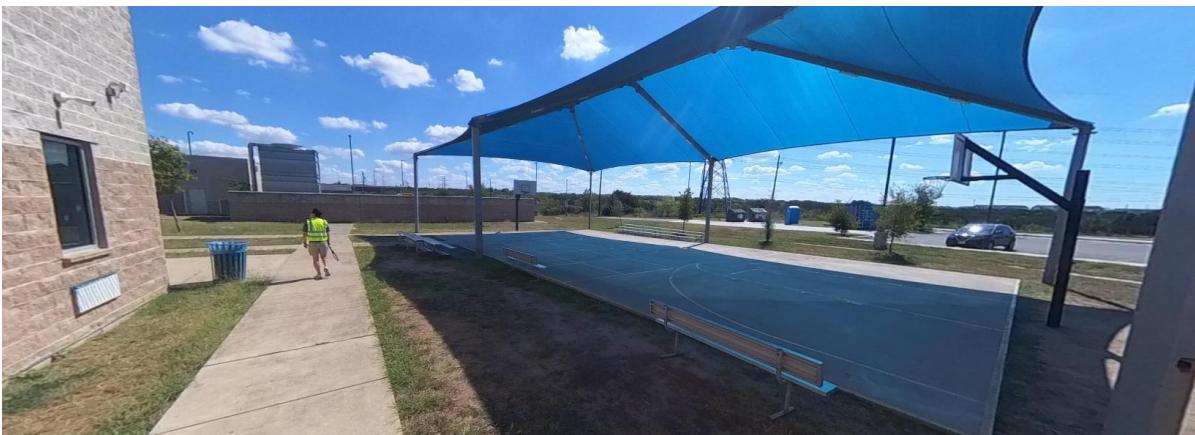
Turner Roberts Recreation Center scored highly among all CPTED categories, scoring highly in natural surveillance, natural access control, activity support, and site / target hardening. The facility is detached from the city center and is connected to the Overton Elementary school. The main facility and satellite gymnasium had an extensive amount of security cameras. Cameras were placed at blind spots, corners of buildings, maintenance areas, and park centers, such as the basketball court in the back of the facility, as shown in Picture C-48.

**Picture C-48. Turner Roberts Recreation Center - Natural Surveillance**

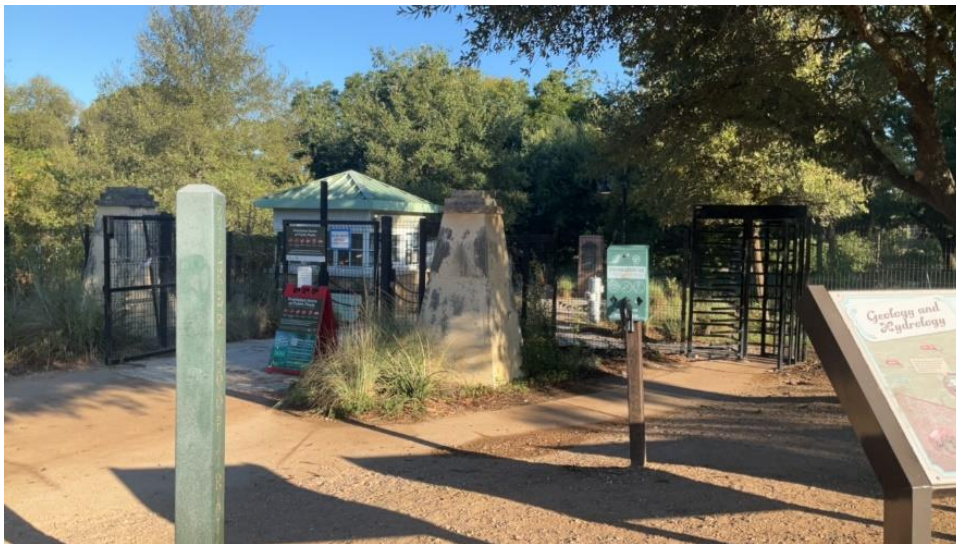
Barton Spring Municipal Pool scored highly in the territorial reinforcement and site / target hardening CPTED categories. The site was well maintained, enclosed by fencing, and access was controlled through ticketing for entry into the facility, as shown in Picture C-50.

**Picture C-50. Barton Springs Municipal Pool - Natural Access Control**

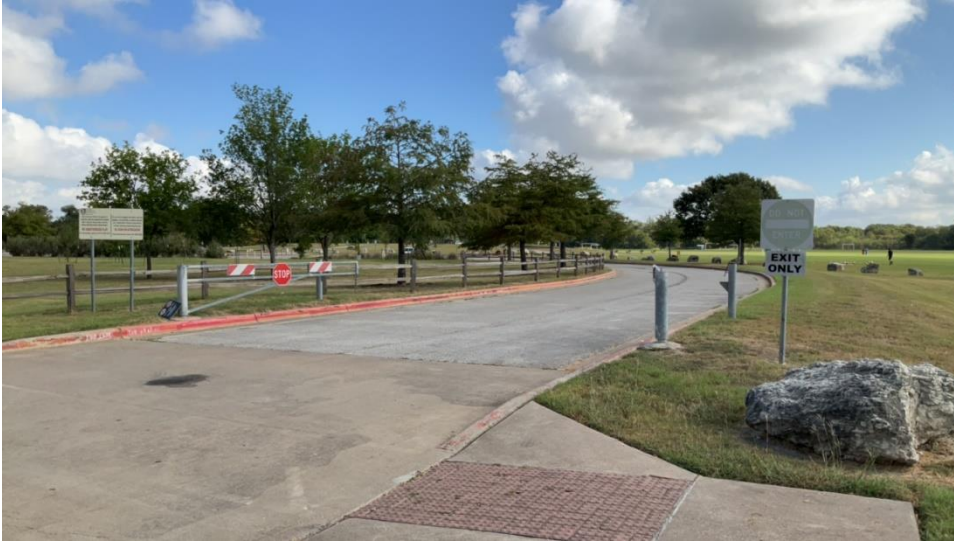
Onion Creek Soccer Complex scored highly among the natural access control, territorial reinforcement, and image management / maintenance CPTED categories. The complex had clear sight lines throughout, was well maintained, and was mostly free of trash. There are multiple vehicle access points to the park, all except one were closed, chained, and secured with a pad lock, as shown in Picture C-51. Boulders and vehicle barriers were placed throughout the complex, extending into the center of the facility as shown in Picture C-52. One gate was open at the time of the site visit, as individuals and small groups can freely access the fields without reservations.

**Picture C-51. Onion Creek Soccer Complex - Site / Target Hardening**

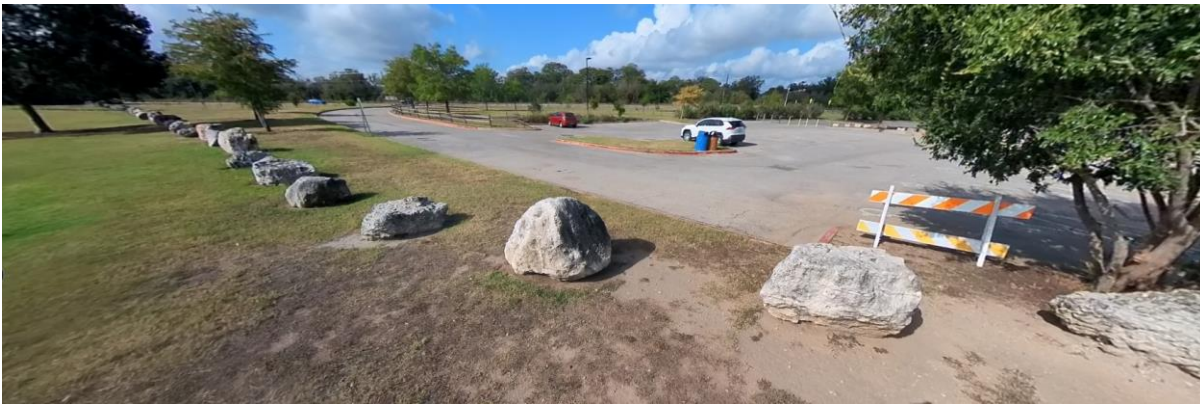
**Picture C-52. Onion Creek Soccer Complex - Site / Target Hardening**

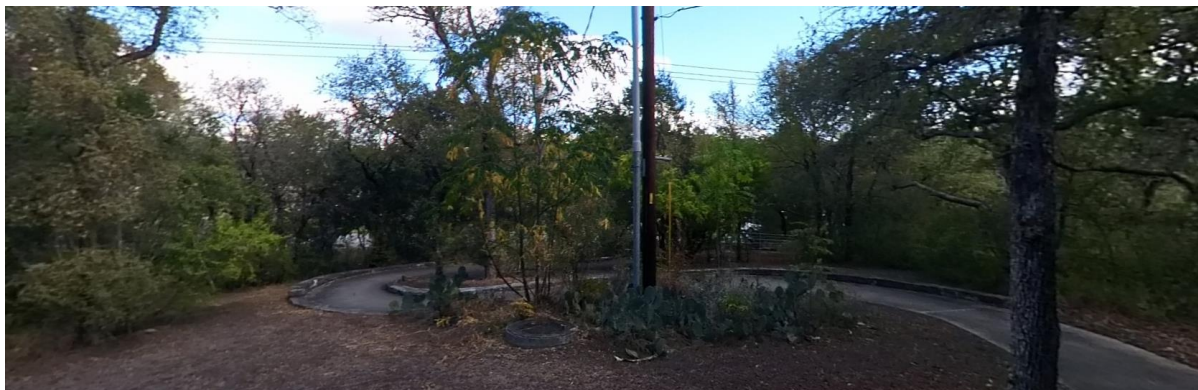
The northernmost annex building hosts programs after school for children, including programs for the special needs population. Staff mentioned that afternoon/evening programming at this location was impacted by the lack of lighting around the back of the facility. A paved pathway leads from the facility through a heavily forested area to the bus stop along a major roadway, as shown in Picture C-69.

**Picture C-69. Danny G. McBeth Recreation Center - Natural Surveillance**

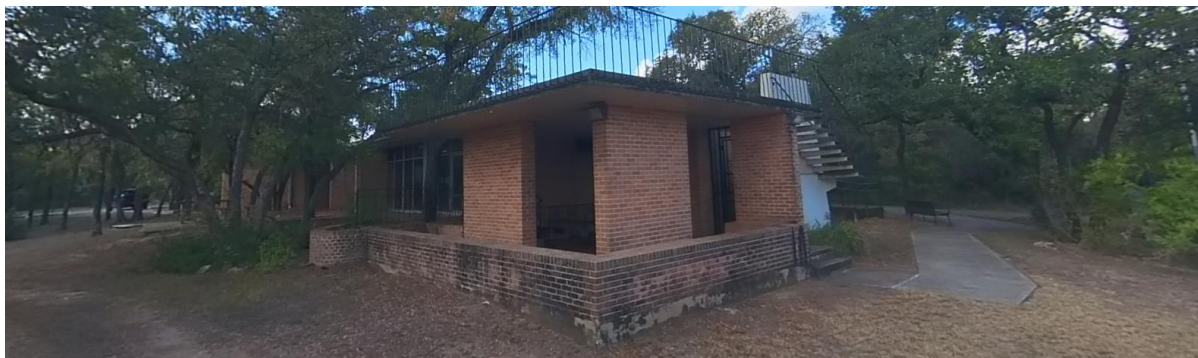
Program participants have expressed safety concerns with walking to the bus stop after dark because of the lack of visibility, and staff have had to escort them to the bus stop. The area is poorly lit and have multiple blind spots and areas that unknown individuals can / have occupied. Specifically, sheltered areas around the building with outdoor access to power outlets are often occupied by unknown individuals. These outdoor power outlets have since been covered up.

**Picture C-70. Danny G. McBeth Recreation Center - The back of the annex building experiences a high number of unknown individuals seeking shelter, using the outdoor power outlet, or consuming alcohol or using drugs**

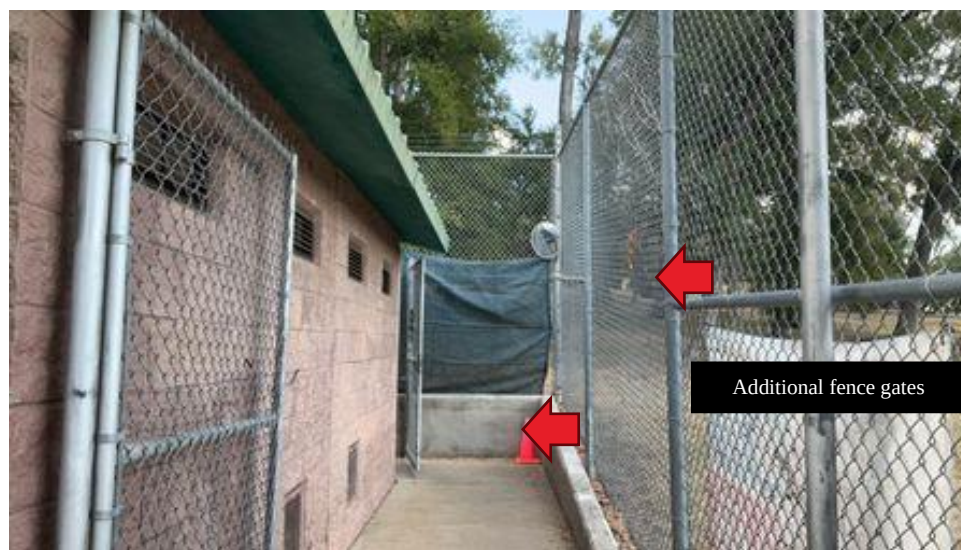
Multiple fence gates at each corner of the restroom and shower facility are installed to reinforce it against unauthorized access during non-operating hours. Safety convex mirrors are also installed to provide staff and pool users the ability to see around the building corner, as shown in Picture C-73.

**Picture C-73. Big Stacy Pool - Site / Target Hardening**

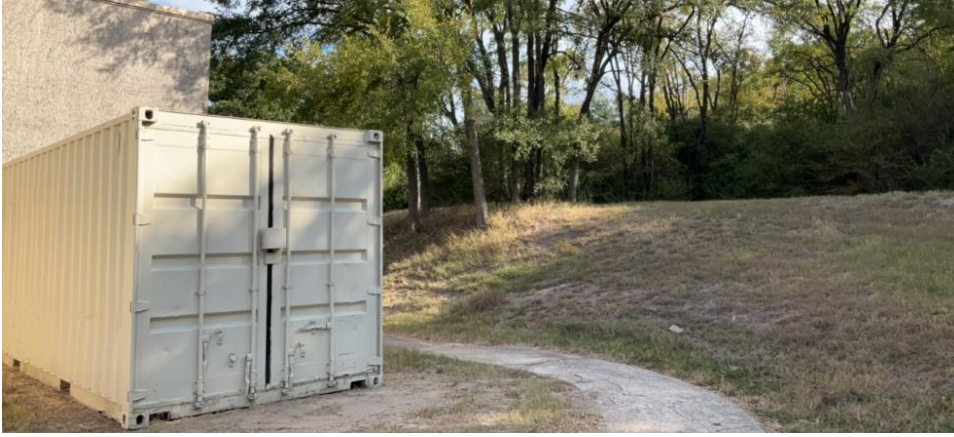
Multiple encampments have existed on the site and in the surrounding area, mainly to the east side of the facility and on the western side in the forested area, as shown in Picture C-80. Staff reported that APD has cleared out nearby encampments in the past but is unsure if they monitor and keep the area clear of encampments.

**Picture C-80. Givens Recreation Center Western side – previous site of encampment**

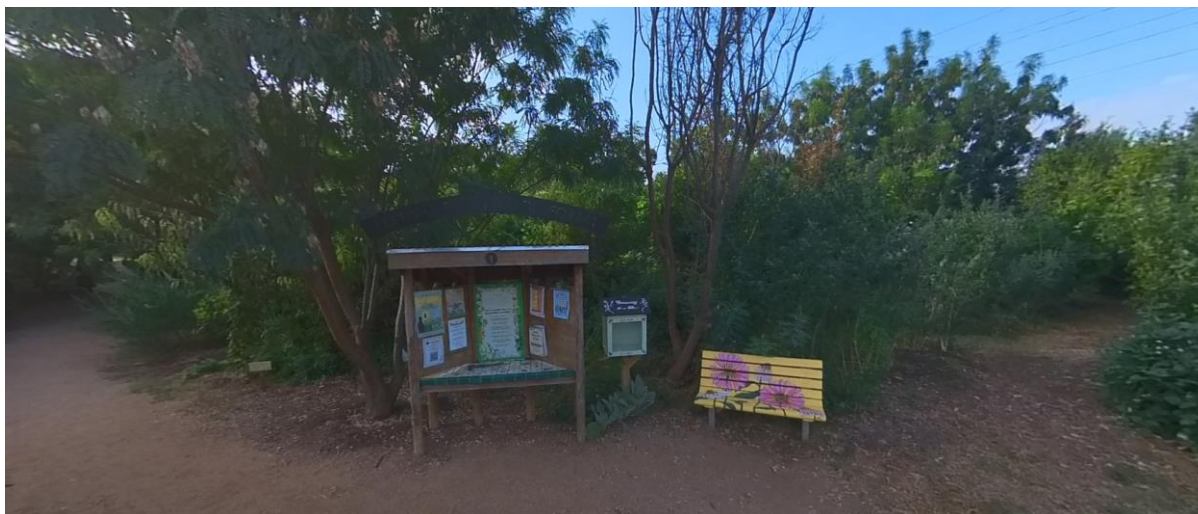
Volunteers were present throughout both the food forest and community garden. The food forest mission is to use regenerative practices in order to “provide food, shade, and ecosystem services to its neighbors.” As a result, there is poor natural surveillance throughout, as visibility is limited by the abundance of trees, plants, and bushes.

**Picture C-87. Festival Beach Food Forest – Information booth which contains site and program information, along with a painted bench, at a food forest access point**

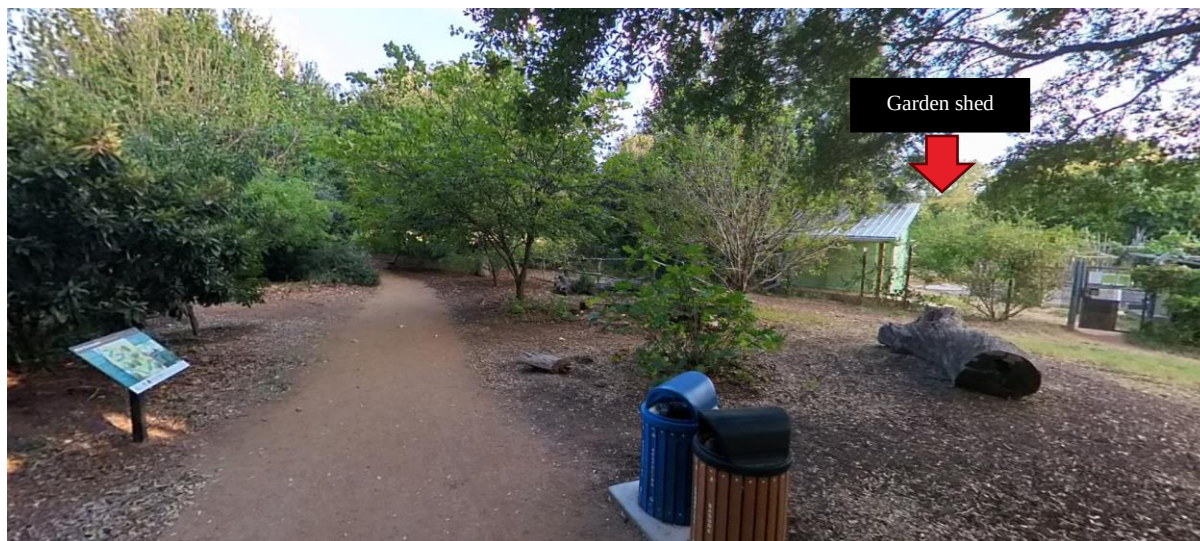
Staff noted that a garden shed, which sits within the community garden perimeter, had recently been broken into, and gardening tools and other equipment were stolen. There was an abundance of trash throughout (specifically alcohol containers) and vandalism (spray paint on wooden benches) throughout the food forest.

**Picture C-97. Festival Beach Food Forest – The dirt pathway leads through the food forest; pictured right is a pedestrian gate leading into the community garden where the garden shed is located**

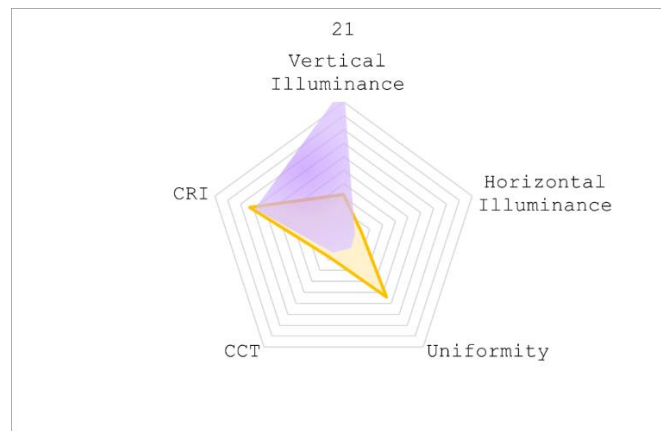
Picture C-89. 360 image of pathway to park

## 21- Park Access (Safety Score 44)

The path to get to the pavilion from the parking lot has bollards that create pockets of light. On the street, there are light poles with varying color temperatures. Across the pavilion, bright lights can be seen coming from the baseball fields at Lorraine Camacho Activity Center. There were no lights provided at the parking lot.

Vertical Illuminance: High  
Horizontal Illuminance: Low  
Uniformity: Low  
CRI: Standard  
CCT: Standard

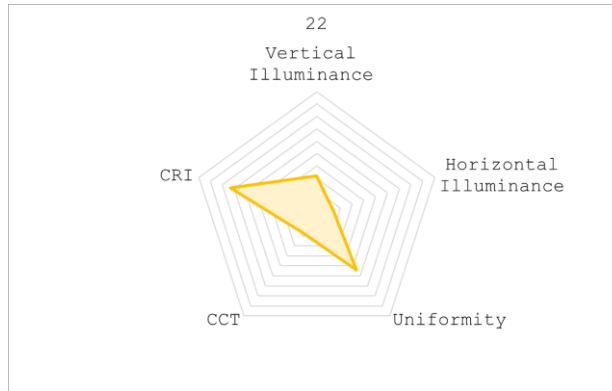
Picture C-90. 360 Image of park pathway to lake

22- Park Center (Safety  
Score 64)

The path is very dark with no lighting, except for lights visible from across the lake. Occasionally, people can be seen biking on the Ann and Roy Butler Hike and Bike Trail with headband lights. The boat dock area, where a few cars were camped out, is lit by a warm pole-mounted light fixture. According to PARD, a lighting plan is in place for the Lady Bird Lake Trail.

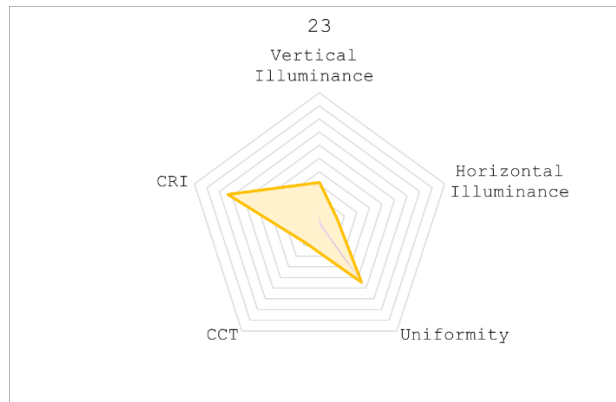
Picture C-91. 360 image of secondary parking lot

### 23- Parking Lot (Safety Score 70)

The small parking lots along the park paths lacked lighting, and the only lights came from adjacent streets and the city skyline. During the survey, there were no cars or pedestrians since the park was closed for the Trail of Lights. Typically, there would be occasional visitors and cars. This parking lot had blue lights on the security camera structures, but despite this deterrent, car break-ins still occur at night.

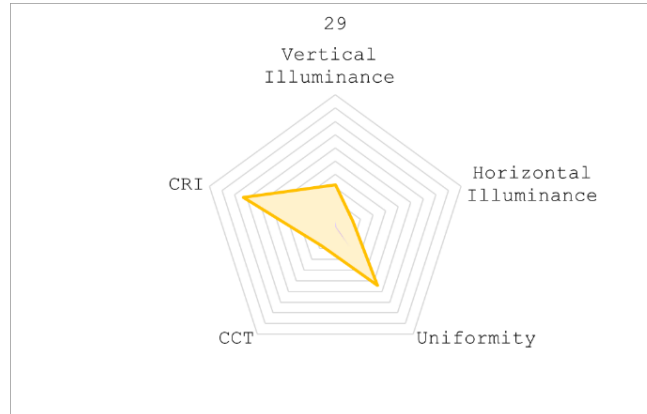
Picture C-97. 360 Image of large gravel parking lot

## 29- Parking Lot (Safety Score 51)

The main parking lot tows cars after closing hours. During the visit, a couple of cars were camping out. The parking lot is very dark due to the lack of lighting. Bright light comes from the Botanical Gates of Paradise, and the city skyline and light poles on Mopac Expressway are also visible. Bollards are present across the street to illuminate the pathway and make pedestrians visible to oncoming vehicles.

Vertical Illuminance: Low  
Horizontal Illuminance: Low  
Uniformity: Standard  
CRI: N/A  
CCT: N/A

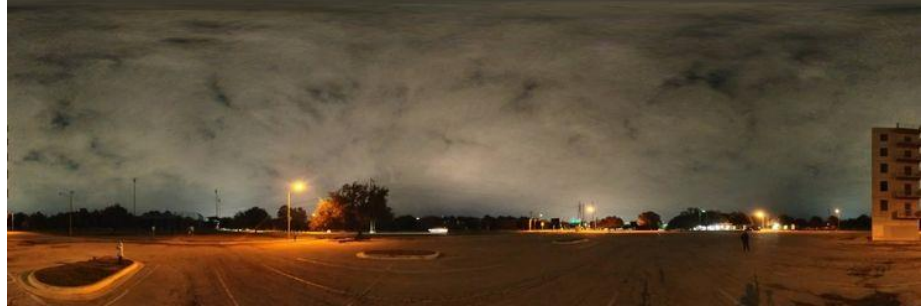
Picture C-100. 360 Image of parking lot next to fire tower

The light poles in the parking lot had different color temperatures. The neighboring baseball field lights were off. A police car was parked in the lot, and two cars, likely drifters, pulled up. There was also a large fire tower, blocking visibility, standing in the parking lot.

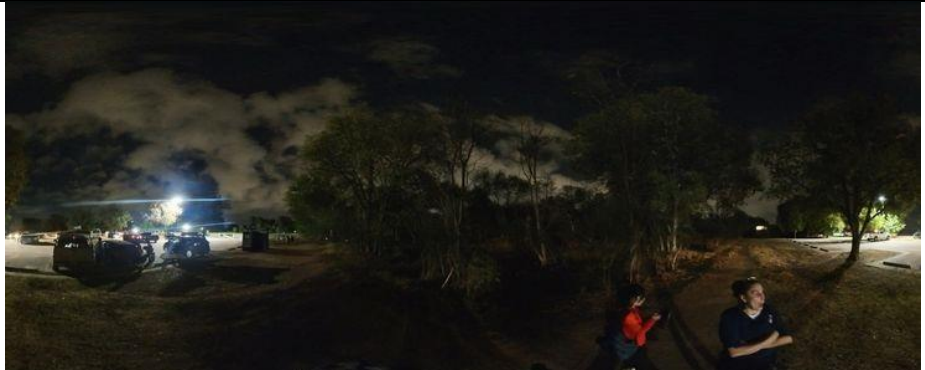
Picture C-103. 360 Image next to parking lot and trail access

The trailhead was quite dark with no designated lights. Light from the parking lot spilled light onto the pathway. A soccer match was happening, and the field lights turned off immediately after the game, manually. Many cars and parents were waiting in the parking lot to pick up kids, but they quickly vacated at the game end.

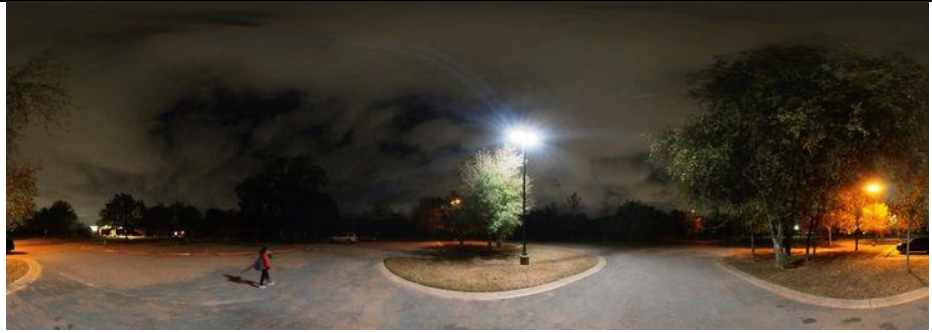
Picture C-104. 360 Image in parking lot

Gunshots were heard at this site coming approximately 50ft into the park. The park was very dark, making it difficult to see anything. The pavilion nearby was bright and inviting with tables, and the bathroom wall packs lit the area well. The light poles in the parking were varying color temperatures.

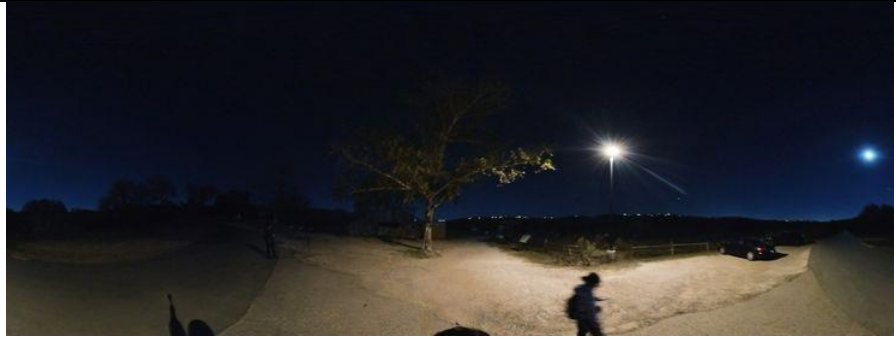
Picture C-110. 360 Image of parking lot next to the main entry

There is one light pole for the parking area. The neighboring storage unit is not maintained and rundown. You can't see much past the porta potties, and you need a flashlight to see the trail if you walk further. There are no cars, and while lights are coming from the Bee Cave area, you can't see into the field or spot any animals or people in the vegetation.

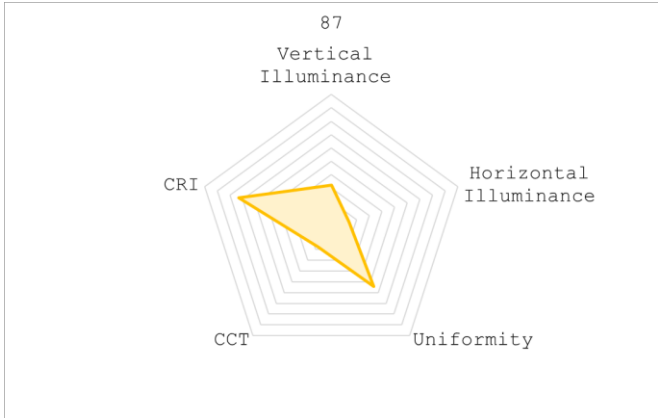
| <p><u>87- Park Center (Safety Score 63)</u></p> <p>There is a low level of light coming from the moon. There are trees on the side, but they are not hovering over the pathway which allows the light from the moon to hit the path.</p> <p><i>Safety Score Rationale:</i><br/> Perception of safety: Average/Low<br/> Reflectance: Dark<br/> Specularity: Matte<br/> Visual Transparency: Low<br/> Physical Transparency: Average<br/> Scale: Average</p> <p><i>Spider Diagram Analysis:</i><br/> Vertical Illuminance: Low<br/> Horizontal Illuminance: Low<br/> Uniformity: Standard<br/> CRI: N/A<br/> CCT: N/A</p> | <p><b>Picture C-117. 360 Image of Pathway</b></p> <p><b>63</b>/100</p> |

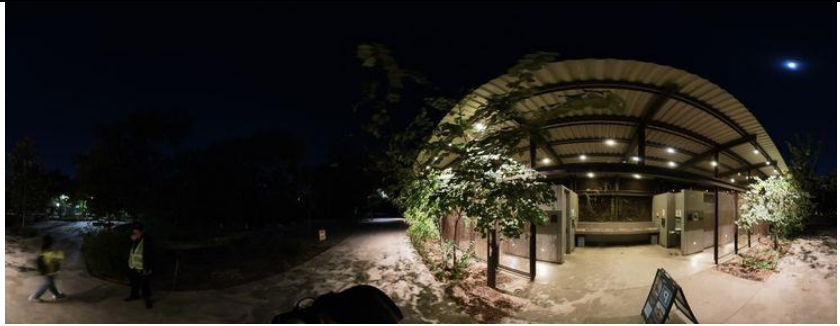
Picture C-119. 360 Image of restroom

### 85- Park Facility (Safety Score 51)

The bathroom is equipped with track lights and step lights, creating an even level of light. The bathroom implements different layers of light that make it visible and not too glary. Some people are walking around the area and sitting at the tables, although there are no lights above the tables, making it hard to see.

Vertical Illuminance: Low  
Horizontal Illuminance: Low  
Uniformity: Low  
CRI: High  
CCT: Low

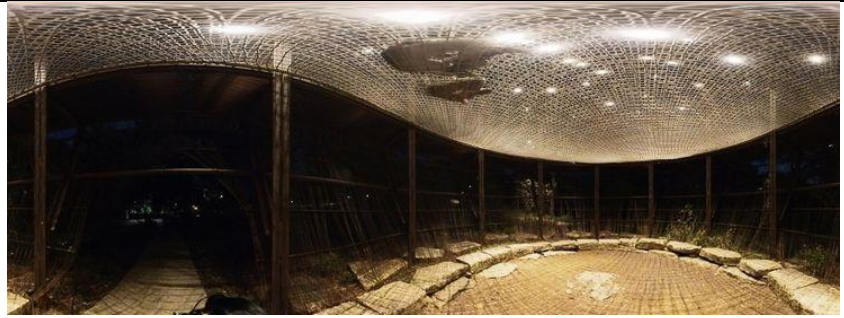
Picture C-121. 360 Image of Tree House

### 86- Art and Culture (Safety Score 52)

The area features intentional lighting, with pendant lights that resemble stars in the treehouse, and handrail lighting and lights hanging from trees to illuminate the paths. Couples could be seen hanging out on the trampoline structure, enjoying the ambiance.

Vertical Illuminance: Low  
Horizontal Illuminance: Low  
Uniformity: High  
CRI: Standard  
CCT: Low

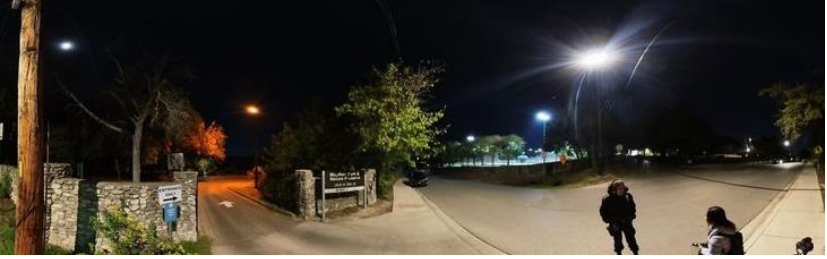
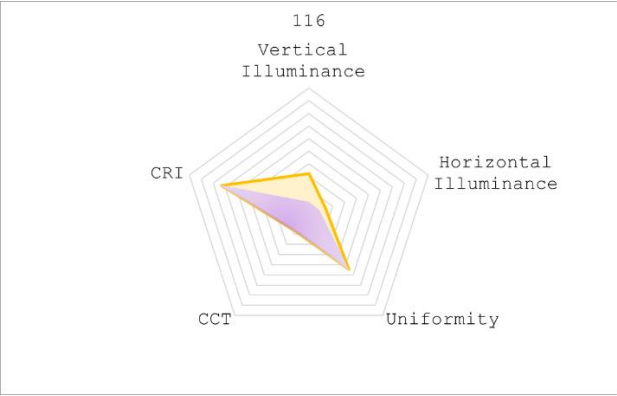
| <p><u>116- Park Access (Safety Score 48)</u></p> <p>Street lights make the area feel well-lit, and flood lights from the tennis court across the street add to the brightness. The pathway closest to the entryway is fairly dark, but there is some light spill from the road and lots of lights from passing cars.</p> <p><i>Safety Score Rationale:</i><br/> Perception of safety: Average/High<br/> Reflectance: Neutral<br/> Specularity: Neutral<br/> Visual Transparency: High<br/> Physical Transparency: Average<br/> Scale: Average</p> <p><i>Spider Diagram Analysis:</i><br/> Vertical Illuminance: Low<br/> Horizontal Illuminance: Standard<br/> Uniformity: Standard<br/> CRI: Standard<br/> CCT: Standard</p> | <p><b>Picture C-122. 360 Image of park entryway</b></p> <p><b>48/100</b></p> |

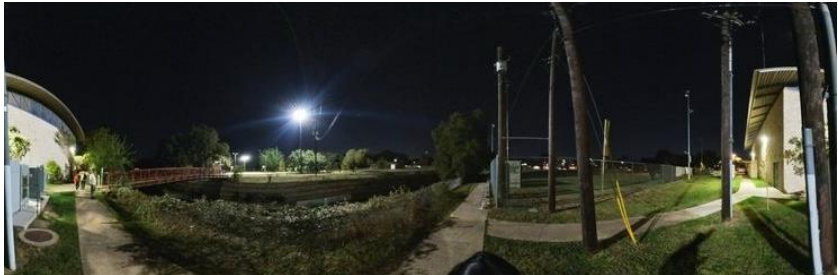
| <p><u>73- Park Access (Safety Score 49)</u></p> <p>Tall flood lights are seen illuminating the area on the opposite side of the bridge. Some parts on the path remains dark due to trees and vegetation. Wall packs are installed along the back of the facility. The entire park is surrounded by houses.</p> <p><i>Safety Score Rationale:</i><br/> Perception of safety: Average/High<br/> Reflectance: Neutral<br/> Specularity: Neutral<br/> Visual Transparency: Average<br/> Physical Transparency: Average<br/> Scale: Average</p> <p><i>Spider Diagram Analysis:</i><br/> Vertical Illuminance: Low<br/> Horizontal Illuminance: Low<br/> Uniformity: High<br/> CRI: Standard<br/> CCT: Standard</p> | <p><b>Picture C-125. 360 Image bridge to the park</b></p> <p><b>49</b> /100</p> |

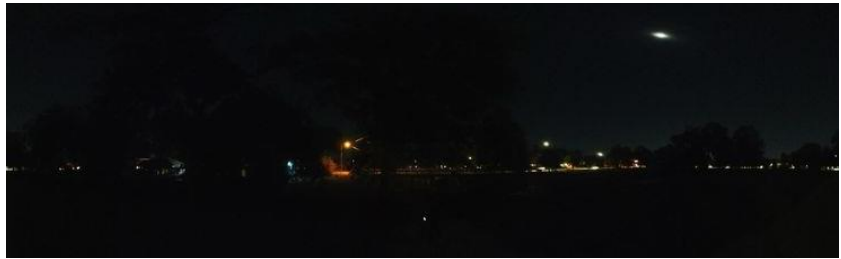
Picture C-126. 360 Image of entry to the park

### 118- Park Access (Safety Score 57)

A warm light from a pole provides some illumination, but the area is still quite dark. Walking to this point from inside the park required a flashlight. Light is seen from nearby houses, and streetlights with different color temperatures line the road.

Vertical Illuminance: Low  
Horizontal Illuminance: Low  
Uniformity: Standard  
CRI: Low  
CCT: Low
