**City of Austin**

# Parks and Recreation Department Security Audit

## Findings and Recommendations Report

Version 2 | July 18, 2025

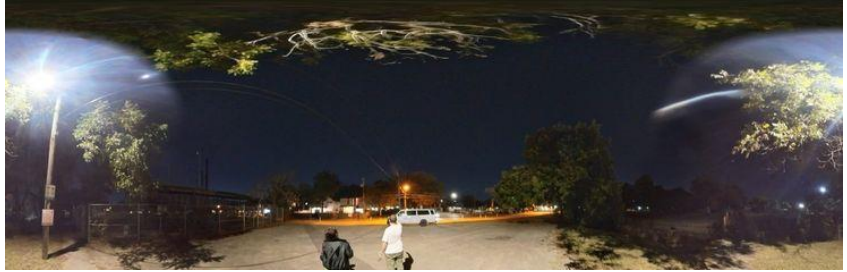
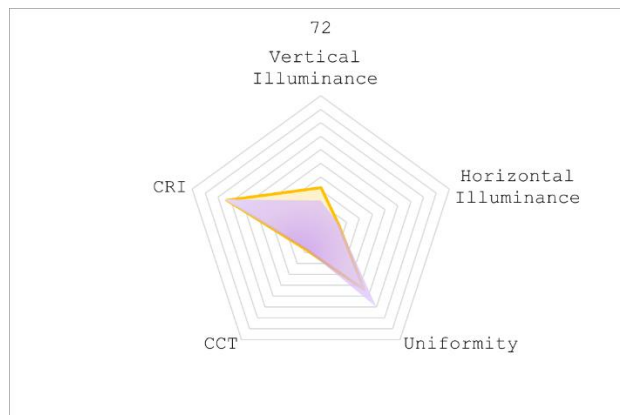
Picture C-128. 360 Image of parking lot

### 72- Parking Lot (Safety Score 52)

It is very dark across the bridge and path, due to dense vegetation. Warm streetlights provide some illumination across the street. There is one white light poles that illuminates the area. In the parking lot a tree creates a dark hiding place, and a few cars are parked.

Vertical Illuminance: Low  
Horizontal Illuminance: Standard  
Uniformity: High  
CRI: Standard  
CCT: Standard

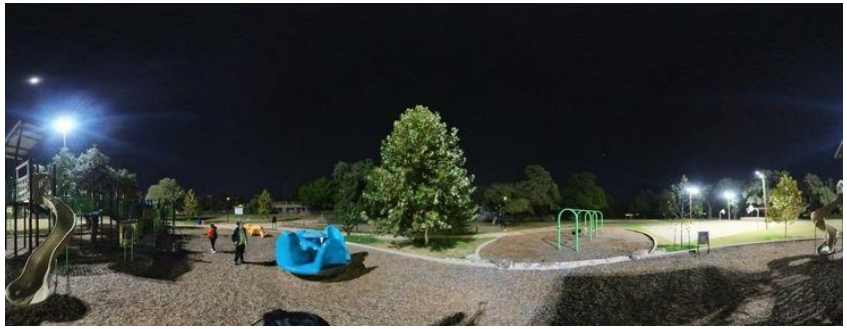
**Picture C-129. 360 Image of playground**

**75- Passive Recreation (Safety Score 42)**

At the time of survey, someone was sleeping in the playground facility. Along the path motion-sensor lights are installed. The area next to the basketball court is quite bright, thanks to tall flood lights.

Vertical Illuminance: Low  
Horizontal Illuminance: Low  
Uniformity: Low  
CRI: Standard  
CCT: Standard

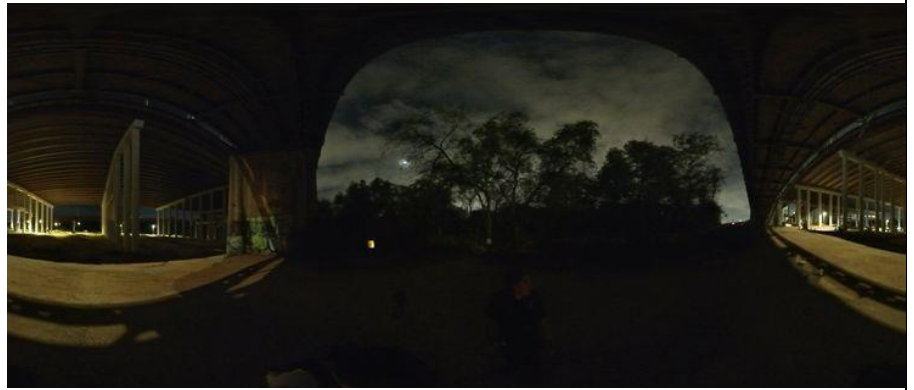
Picture C-133. 360 Image at trail entry

### 51- Park Access (Safety Score 73)

At the time of survey, a couple ventured onto the trail flashlight. Inside the trail, lights were seen indicating the presence of people possibly camping out in the trail at night. Another man could be heard yelling on the bridge. At first, the survey team did not know where the yelling was coming from until they looked up. At this underpass, there was a lot of graffiti on the columns. There were many cars parked at night, and a lot of the vehicles had strong headlights which are very bright to those walking through the area.

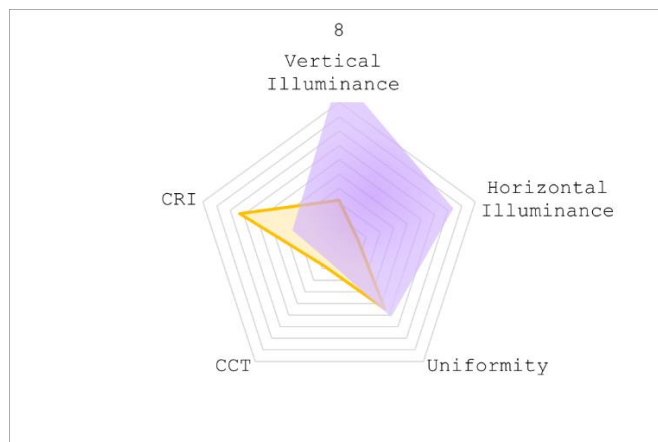
Picture C-141. 360 Image of east entry

The entryway features a bright, overhead linear fixture that illuminates both the door and the path. Light spills from the windows, revealing children inside the building. The garden remains dimly lit due to the absence of designated lighting.

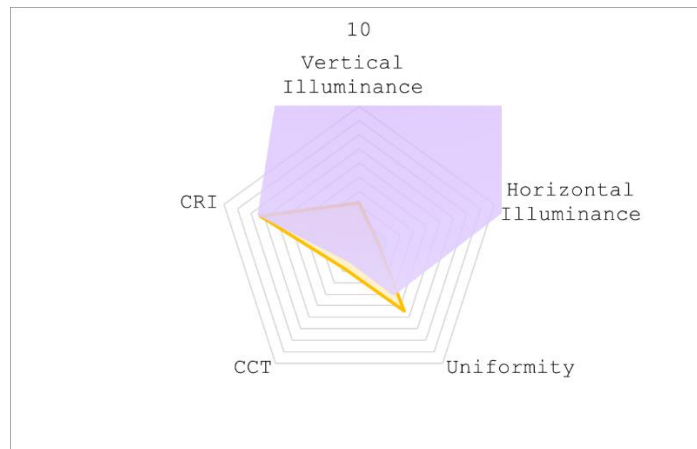
Picture C-143. 360 Image of the back of the facility

The back of the facility is equipped with wall packs on the walls and linear fixtures at the entrances. There are play features for kids, like four square and hopscotch, but they are faded, unlit, and no one was seen using them.

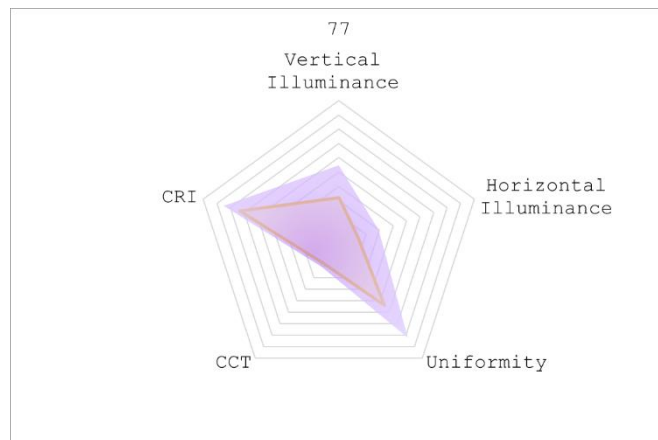
Picture C-145. 360 Image of facility entry

The entry is illuminated by down lights and wall-mounted fixtures on the columns. A person is staying in a single tent outside the building. The light poles all around this museum have different color temperatures. Nonetheless, the entry walkway is well-lit by these poles, and the lights are not glaring.

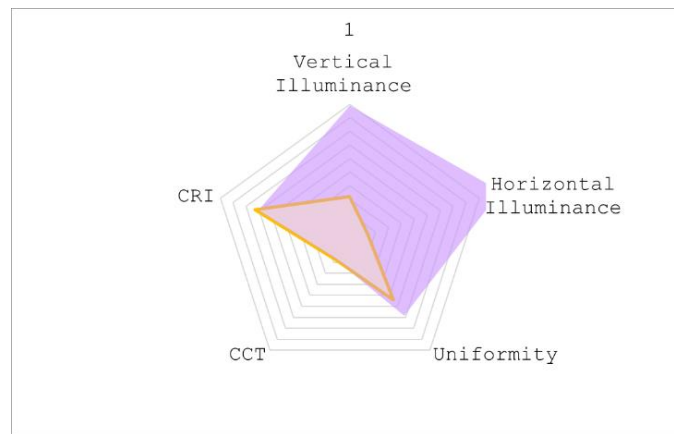
Picture C-149. 360 Image of parking lot entry

The recreation center parking entrance leads to a fully utilized parking lot when there are games. The entry way is lit by a warm street light pole, and there is light spill from bright, neighboring flood lights on the field.

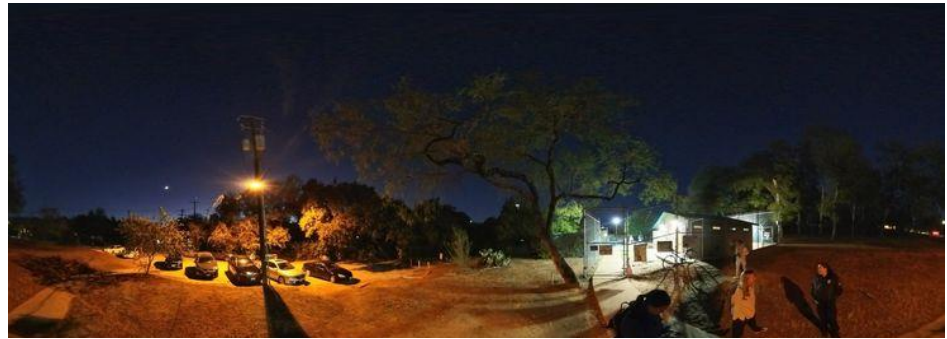
Picture C-153. 360 Image of pool entry

The parking lot at this entry is illuminated by warm lights from a light pole, contrasting with the bright light spilling from inside the facility. The path from the parking lot to the pool is adequately lit, but the path beyond the parking lot into Blunn Greenbelt Trail has low visibility due to a lack of lighting.

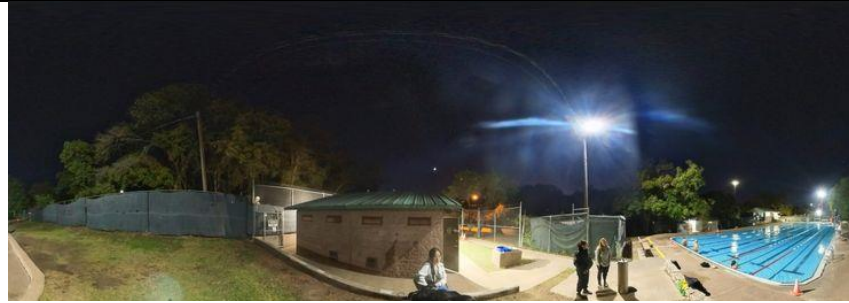
Picture C-154. 360 Image inside the pool

During the visit, several people were using the pool facility, which is brightly lit by pool lights that flood the entire area. Additional lighting comes from wall packs on the buildings and the moonlight tower on Leland & Eastside Drive.

Vertical Illuminance: High  
Horizontal Illuminance: High  
Uniformity: Low  
CRI: Low  
CCT: Standard

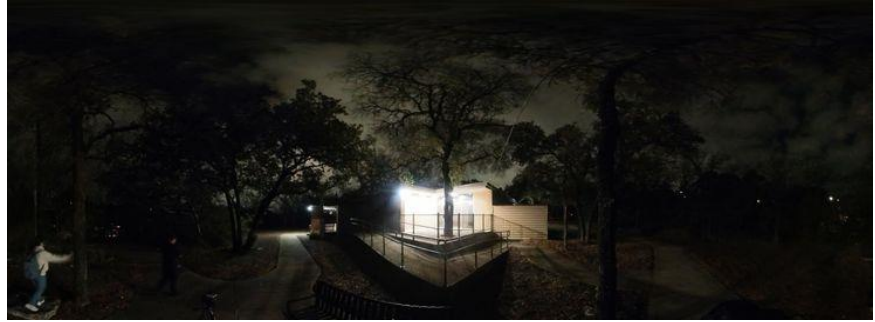
**Picture C-156. 360 Image of the annex facility back entryway**

The exterior of the building is equipped with wall packs and troffers, which are very bright. There is a spotlight effect from the lights on the building making it difficult to see past the woods, affecting the perception of safety. The pathway next to the building is well illuminated, but there is no pedestrian pathway lighting for the pathway as it goes further away.

Vertical Illuminance: High  
Horizontal Illuminance: Standard  
Uniformity: Low  
CRI: High  
CCT: Standard

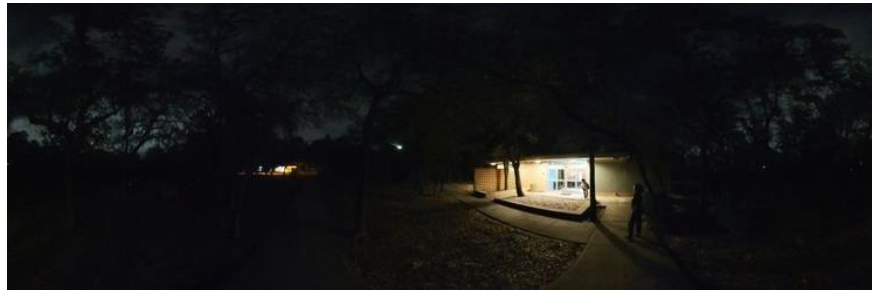
Picture C-157. 360 Image of annex building front entryway

The ceiling features large 2x2 troffers, creating a spotlight effect from the building's bright lights. This makes it difficult to see people on the pathway and road leading to the building. While the area next to the building feels safe, walking up to it does not.

Vertical Illuminance: High  
Horizontal Illuminance: High  
Uniformity: Low  
CRI: Standard  
CCT: Standard

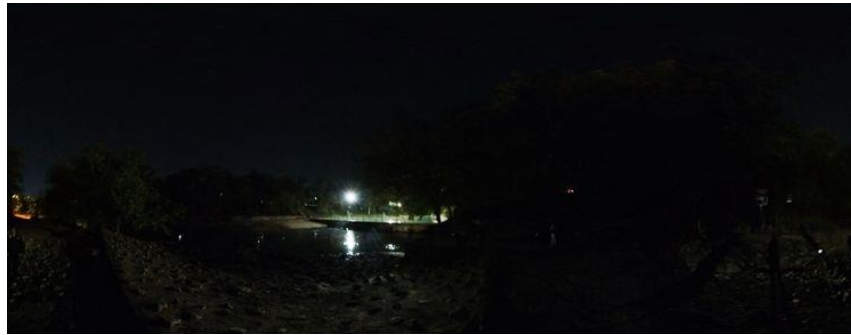
Picture C-159. 360 Image of waterside platform

Light from the pool spills onto the path, but otherwise, it is very dark with no lights at this point. The stairs leading to this area are very rocky and dark, making it easy to trip. Activity seen in this area includes fishing, drug use, and busking.

Vertical Illuminance: Low  
Horizontal Illuminance: Low  
Uniformity: Standard  
CRI: N/A  
CCT: N/A

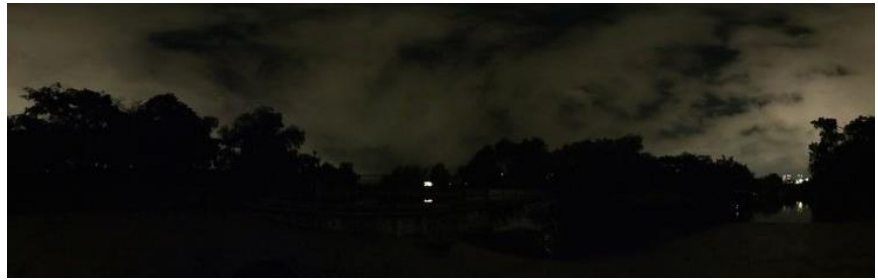
Picture C-160. 360 Image of waterside platform

The light from the pool turned off at 10 PM, leaving this area dark. Someone's belongings were on the platform, and the path to the ledge was difficult to navigate due to the lack of lighting. The only sources of lights were the from the pool facility and the city skyline.

Vertical Illuminance: Low  
Horizontal Illuminance: Low  
Uniformity: Standard  
CRI: N/A  
CCT: N/A

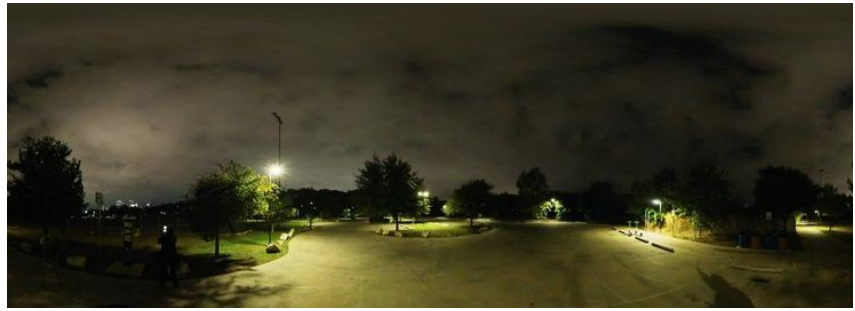
Picture C-164. 360 Image of parking lot

This parking lot is illuminated by light poles that provide patches of light throughout the entirety of the lot.

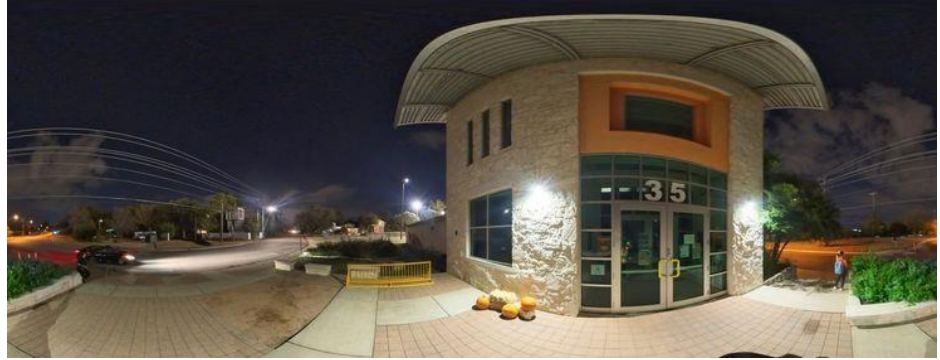
Picture C-166. 360 Image of facility entryway

Wall packs illuminate the entrance, with light spilling from the floodlights on the fields. The area is next to a street and adjacent to apartments, with warm street lights providing additional illumination. There was not much activity at the facility due to the building being closed, but there are a lot of people on the fields when there are recreational activities.

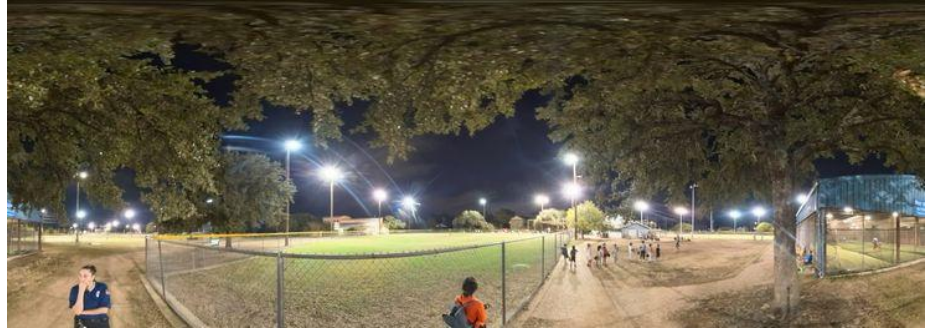
Picture C-168. 360 Image near athletic fields

Kids are playing in the fields and grass areas. At the time of survey, kids were running around the batting cage (where the storage container is), which is mostly see-through except for one wall which could impede visibility. Floodlights from the fields provide ample illumination, though some light poles and light on the batting cage are out.

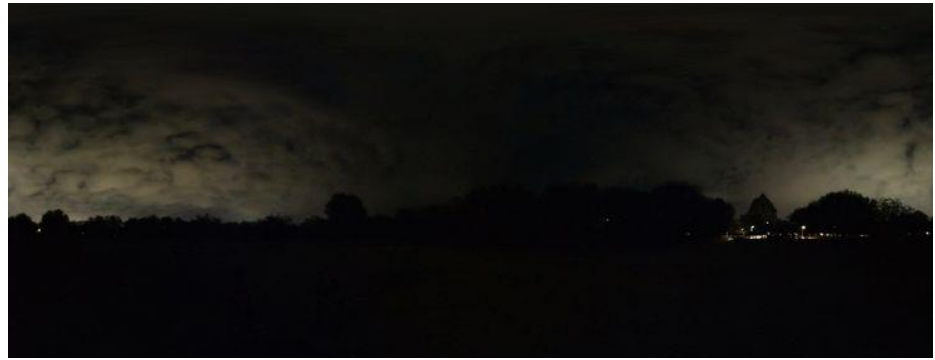
Picture C-171. 360 Image near trail

60 - Passive Recreation  
(Safety Score 62)

This area is an open field with a zipline and a neighboring trail. Some light spilled from the opposite side of the playground. It was very quiet with no one around, and the trees divided this area from other areas of the park.

62/100

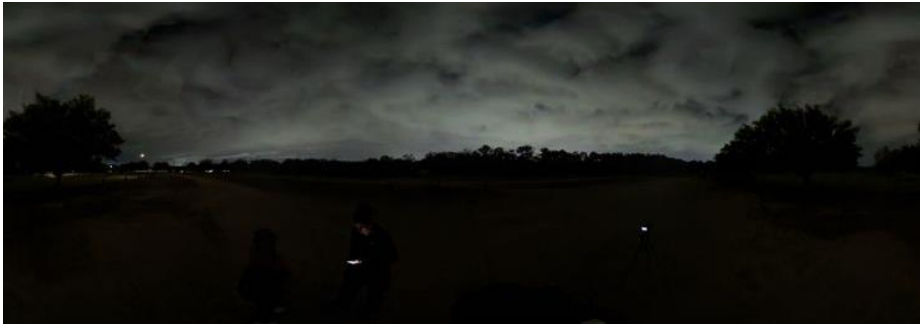
| <p><u>61 – Parking Lot (Safety Score 56)</u></p> <p>There was no light except for some light poles in the parking lot. Trees and vegetation surrounded the area. Facial recognition was not good for those further away, but overall there were few hiding spots since it was an open field and everything was flat.</p> | <p><b>Picture C-172. 360 Image at the edge of the parking lot</b></p> |

**Safety Score Rationale:**  
Perception of safety:  
Average  
Reflectance: Neutral  
Specularity: Neutral  
Visual Transparency: Low  
Physical Transparency:  
Average  
Scale: Average

**Spider Diagram Analysis:**  
Vertical Illuminance: Low  
Horizontal Illuminance:  
Low  
Uniformity: Standard  
CRI: N/A  
CCT: N/A

56/100

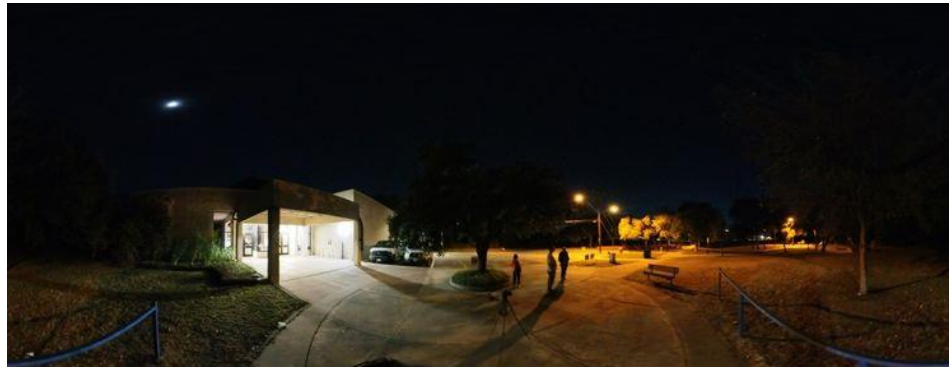
Picture C-175. 360 Image of facility front entryway

## 64 - Facility Entry (Safety Score 49)

The entryway has wall packs and light flooding from the interior. There are light poles in the area with two different color temperatures. At the playground park, there is a warm light pole. Despite hearing people, visibility was poor. There are facility vehicles parked in the parking lot overnight. The bench area had some dark patches because of the trees, and the garden pots on the side of the building were not visible.

49/100

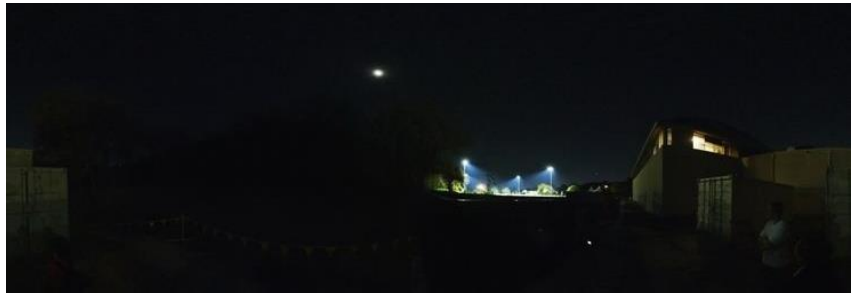
Picture C-177. 360 Image at the facility back entryway

66 - Facility Back Entry (Safety  
Score 54)

The field lights are quite bright, but storage containers create dark shadows and hiding spots. There is light spill coming from the windows of the facility.

Vertical Illuminance: Low  
Horizontal Illuminance: Low  
Uniformity: Standard  
CRI: N/A  
CCT: N/A

54/100

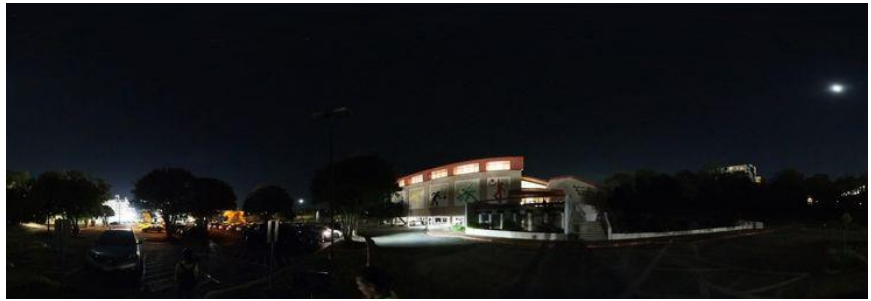
Picture C-183. 360 Image of the facility entryway

### 81 - Facility Entry (Safety Score 49)

There are some encampments in the area. The lights were not set correctly for daylight savings at the time of survey. The light poles in the parking lot, wall pack above the garage, downlights at the entry, and steps lights on the stairs turned on at 8pm, two hours after sun set.

Vertical Illuminance: Low  
Horizontal Illuminance: Standard  
Uniformity: Standard  
CRI: Standard  
CCT: Standard

49/100

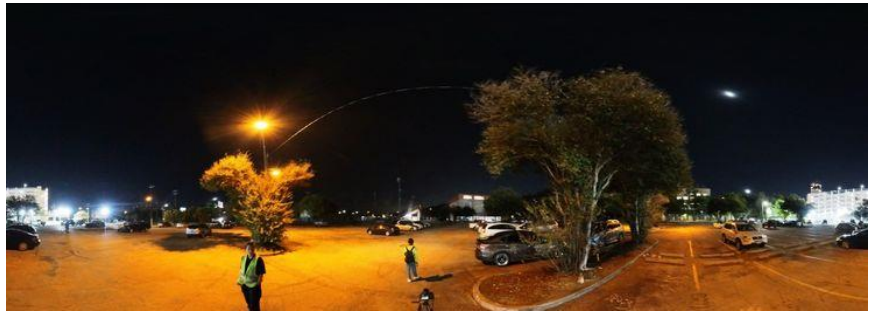
Picture C-184. 360 Image of the parking lot

## 82 - Parking Lot (Safety Score 52)

The lights are orange compared to the bright white lighting in the neighboring parking garage and the skate park. Some unhoused people are roaming around the side of the parking lot. The neighboring lights for the football field were turned off.

Vertical Illuminance: Low  
Horizontal Illuminance: Standard  
Uniformity: Standard  
CRI: Low  
CCT: Low

52/100

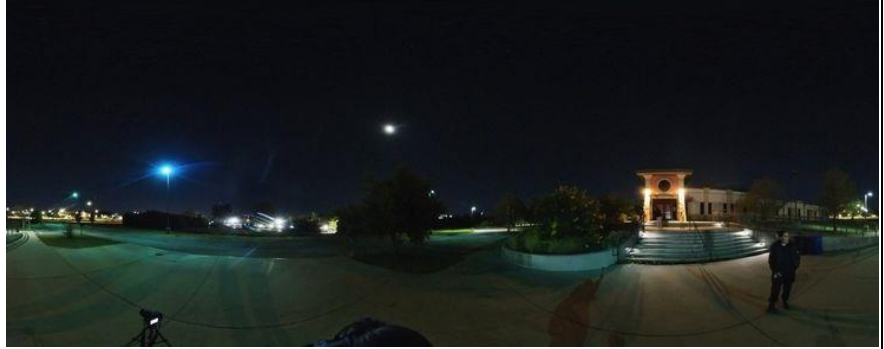
Picture C-186. 360 Image of main facility entry

Wall sconces are installed next to the entry. There are step lights and light poles on the ramp, although one is broken. Bright lights come from poles in the parking lot of the church across the street, as well as from light poles and wall packs on the houses across the street. The parking lot areas have white light poles. At the time of survey, there was an unhoused man throwing items around.

Vertical Illuminance: Low  
Horizontal Illuminance: Low  
Uniformity: Standard  
CRI: Standard  
CCT: Low

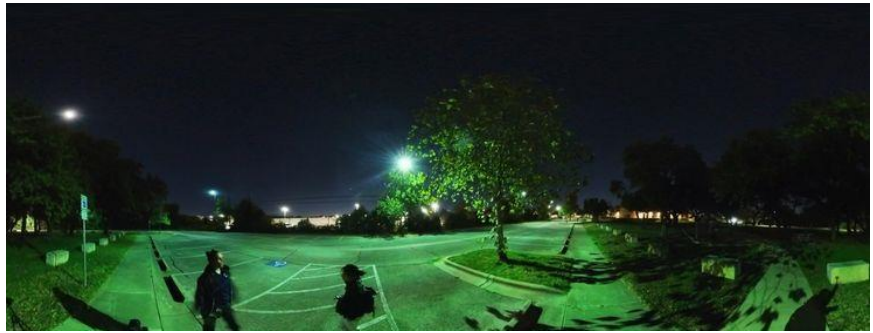
Picture C-189. 360 Image of gym area

### 95 - Active Recreation (Safety Score 54)

The outdoor gym area is quite dark with no lighting. The only light comes from the poles in the parking lot and the wall packs on the building. It is hard to see into the trees beyond the parking lot, creating a visual and physical barrier.

Vertical Illuminance: Low  
Horizontal Illuminance: Low  
Uniformity: Standard  
CRI: Low  
CCT: High

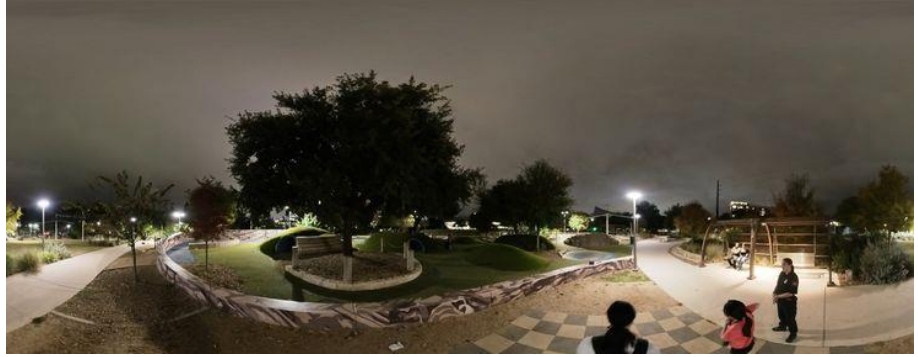
Picture C-197. 360 Image of play area

### 13- Passive Recreation (Safety Score 49)

The pathway in a central location of the park had multiple people enjoying the park and a family selling ice cream. The path is lit by indirect pole mounted luminaires which spills into the hilly play facility. The hilly play facility was lit, but it was dim in some areas, especially near the trees. The bench has soft downlights illuminating the structure.

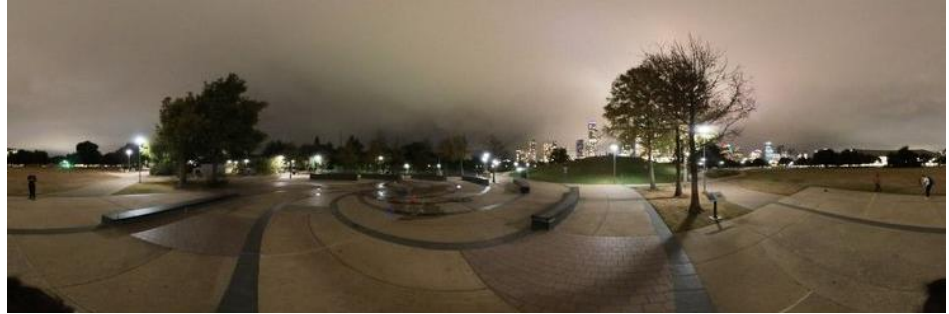
Picture C-198. 360 Image of splashpad and field

12- Passive Recreation  
(Safety Score 40)

The splashpad and field area is a wide, open space with high physical transparency. There are indirect pole top luminaires along the pathway. Near the splashpad that was not in operation, two light poles were broken. The city skyline provided a vertical plane of illumination.

*Safety Score Rationale:*  
Perception of safety: High  
Reflectance: Neutral  
Specularity: Neutral  
Visual Transparency: Average  
Physical Transparency: High  
Scale: Average

*Spider Diagram Analysis:*  
Vertical Illuminance: Standard  
Horizontal Illuminance: Standard  
Uniformity: High  
CRI: Low  
CCT: Standard

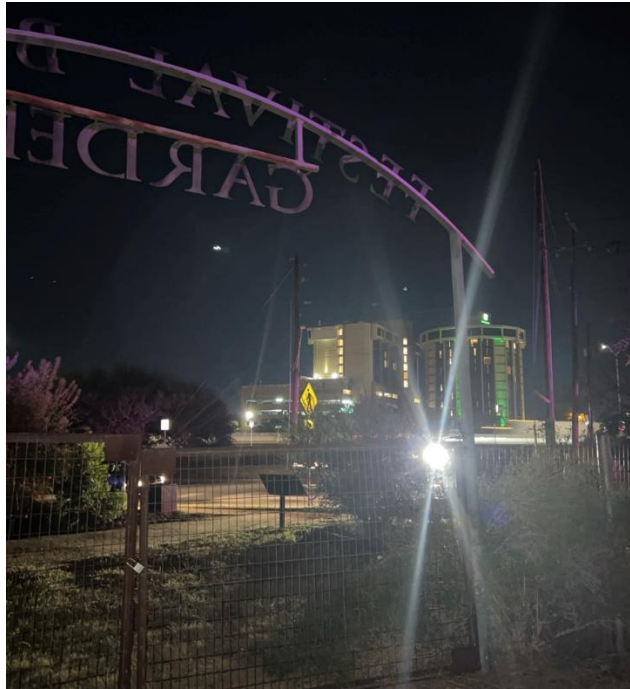
Picture C-201. Gated-park access, taken with long exposure

19- Park Access (Safety Score 66)

The fenced off gate entrance was locked at the time of visit. The only source of light came from cars on neighboring roads and buildings across the highway.

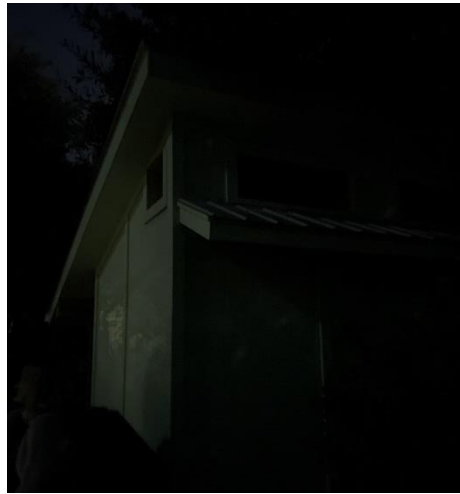
Picture C-202. Image of storage shed, taken with long exposure

Staff noted that a garden shed, which sits within the community garden perimeter, had recently been broken into, and gardening tools and other equipment were stolen. There was an abundance of trash throughout (specifically alcohol containers) and vandalism (spray paint on wooden benches) throughout the food forest.

18- Park Facility (Safety  
Score 73)

The interior next to the garden shed had extremely low levels of light due to lack of lighting. The survey team had to carry flashlights to navigate around, as it is easy to get disoriented if you are unfamiliar with the area. During the visit, a volunteer came through the back gate to use the shed, and the individual had to use a flashlight.

Vertical Illuminance: Low  
Horizontal Illuminance: Low  
Uniformity: Standard  
CRI: N/A  
CCT: N/A
