**City of Austin**

# Parks and Recreation Department Security Audit

## Findings and Recommendations Report

Version 2 | July 18, 2025

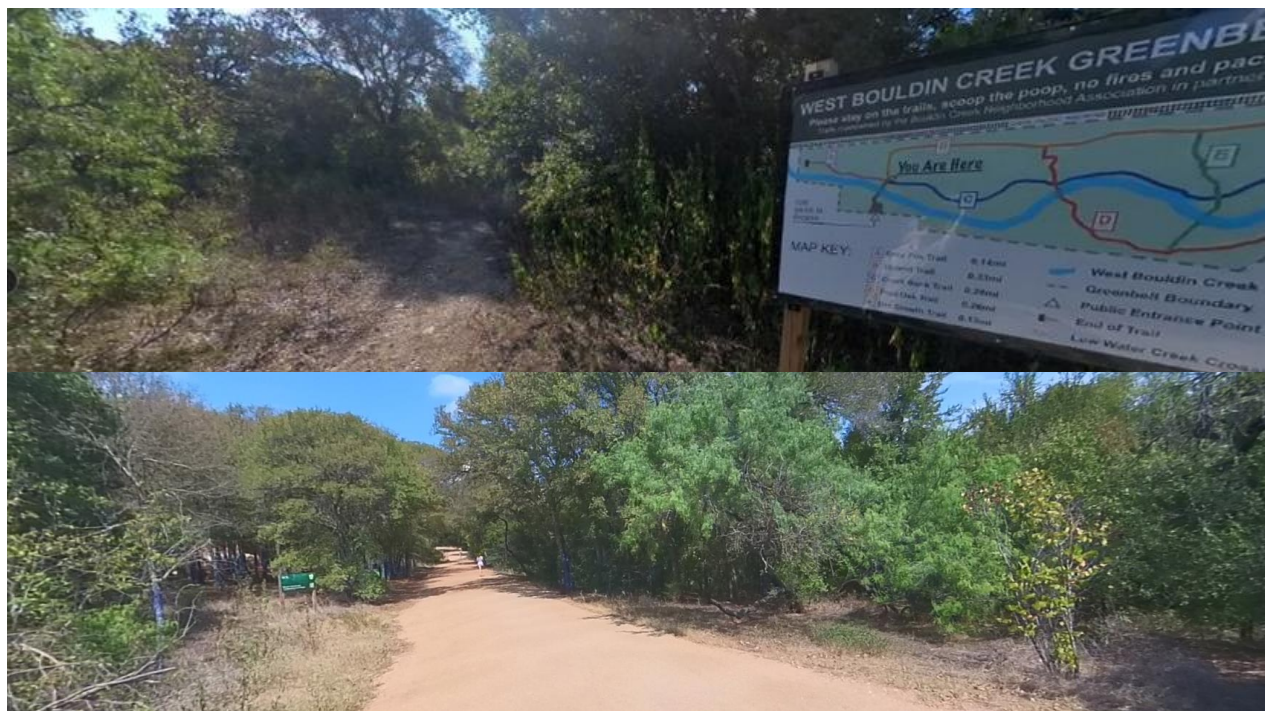
The width of trails or walking paths also contributes to the level of visibility at the park. For example, the trail leading through the West Bouldin Creek Greenbelt is narrow and curves frequently around large, tall bushes and trees with low hanging canopies. In contrast, the wide, straight trails at Pease Park provided higher levels of visibility even while dense trees line both sides of the trail.

**Picture 2. Narrow, winding trail at West Bouldin Creek Greenbelt (top) and wide trail at Pease Park (bottom)**

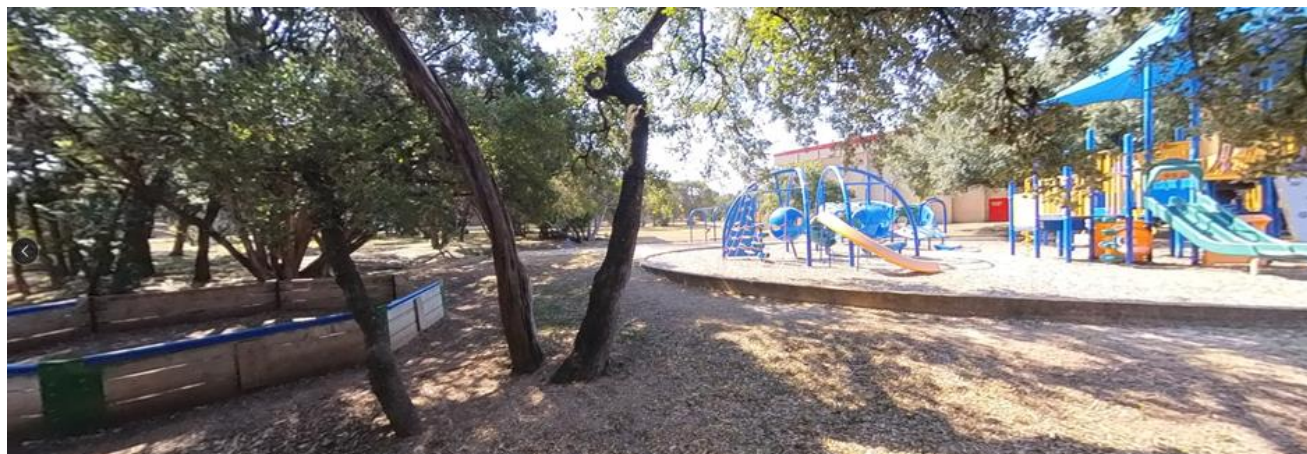
**Picture 3. Play structures and trails behind the South Austin Recreation Center activate the area behind the building which is largely out of view from street traffic and houses on adjacent properties**

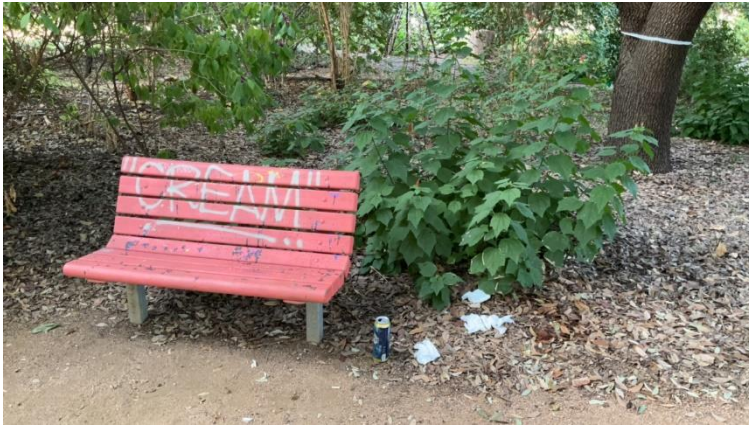
**Picture 4. Vandalized park bench, nearby empty alcohol container and trash, and poor visibility due to dense vegetation all negatively impacts perception of safety**

There is an abundance of passive recreational facilities at each of the sites visited. Often, they are located along tree lines, because shade is provided by the tree canopies or tall grass. However, in areas where there are issues with encampments, trash, or public drug and alcohol use, park users are discouraged from remaining in the area and using these amenities, because they are unable to see whether individuals are just on the other side of dense vegetation (see Picture 4). In some areas, tall and dense vegetation along trails and walking paths isolate users at various areas of the park. New amenities like trails, playgrounds, and sports fields are beneficial but can remain unused in areas where people feel unsafe.

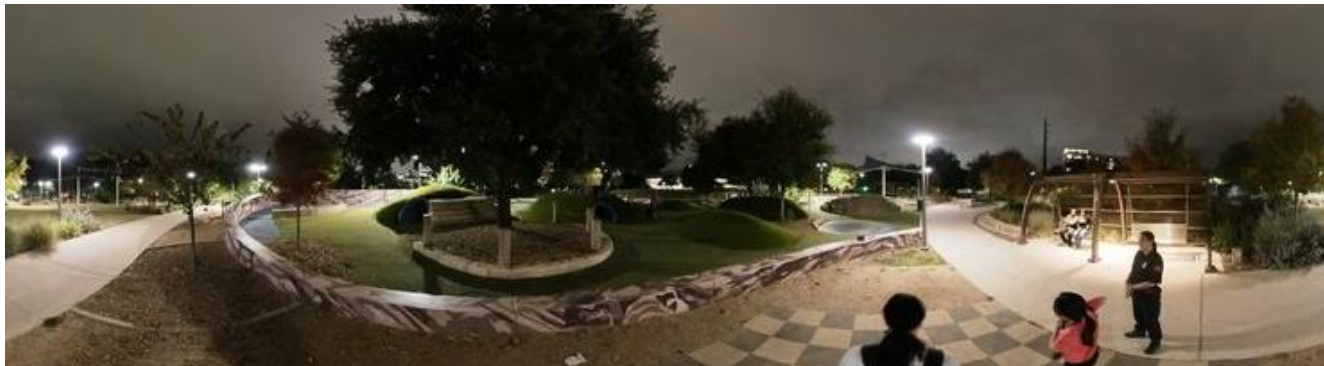
**Picture 6: Alliance Children's Garden featuring pathway lighting and bench lighting**

An example of an area with lighting infrastructure that encourages nighttime activity is Alliance Children's Garden. It is one of the few parks with passive recreation structures that are highly utilized and lit up. There were lights for the play areas, pathways, and benches that fostered nighttime activity of families. In addition, the park has a splashpad illuminated with different colors that people can interact with.

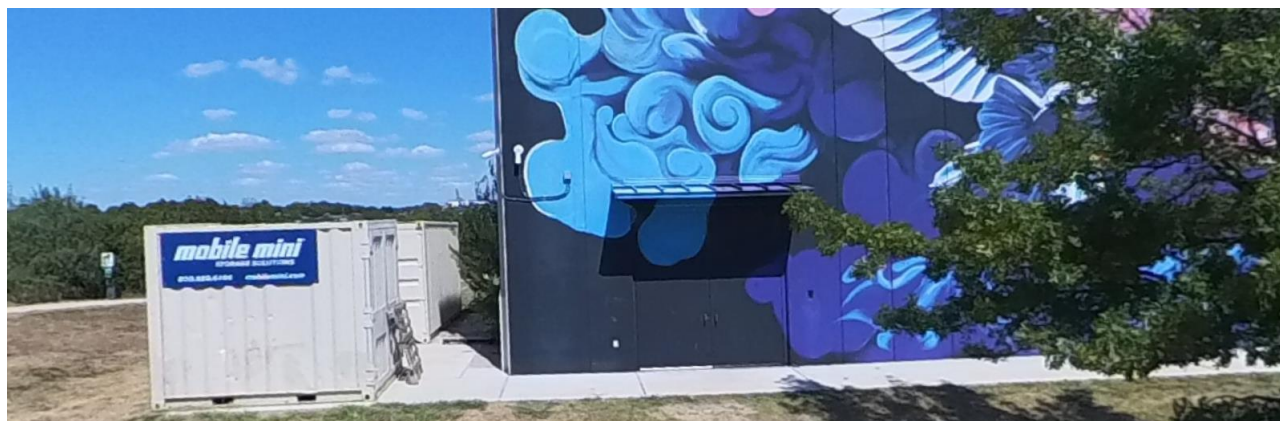
Shipping containers have become a long-term solution for storage needs, as some facilities have used the containers for several years. Not only are all the containers rented, which costs about \$200-300 a month per container, they are also obvious targets for burglary and theft and do not require a high skill level to break into.

At Turner-Roberts Recreation Center, multiple surveillance cameras installed at the same building corner are aimed between and around two shipping containers because of the blind spots they create. This creates the need for an increased number of cameras and additional cost to PARD.

**Picture 8. Multiple surveillance cameras are installed at the same building corner and are pointed between and around two shipping containers because of the blind spots they create**

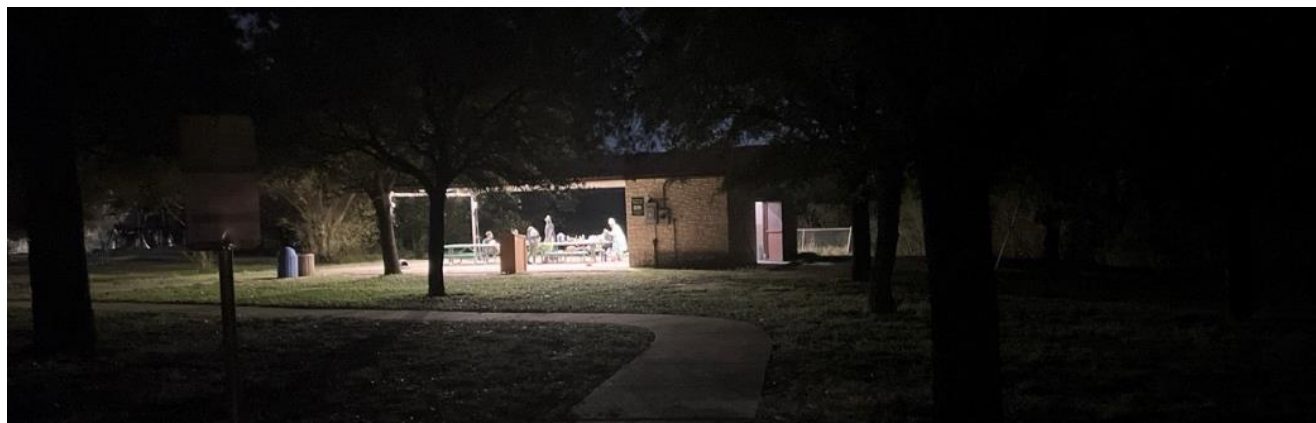
**Picture 10. A gathering of individuals at the restrooms in Bartholomew District Park after park curfew (taken with phone camera, no flash)**

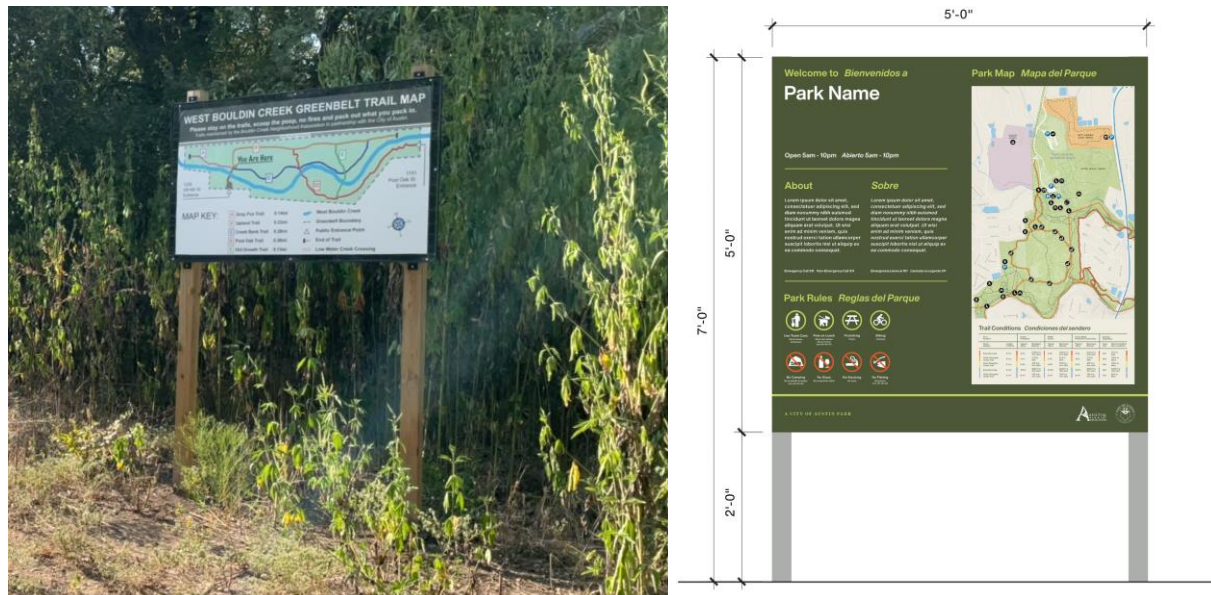
Examples of existing clear and robust signage within PARD assets are captured in Figure 15. As shown, West Bouldin Creek Greenbelt displays a comprehensive trail map with rigid wooden materials to better resist vandalism. Similarly, the 125 Large Welcome Sign design included as part of PARD's 2023 *Signage and*

*Wayfinding Guidelines* provides a suitable template for future park entrances. Other smaller signage design templates (such as the 165 Single Rule Panel and 170 Small Regulatory designs), while comprehensive and aesthetically pleasing, may give way to vandalism given their slender dimensions. It is recommended that robust, vandal resistant materials be used for *all* signage to deter futural vandalism and other damage.

**Figure 15. Examples of existing park entry signage in West Bouldin Creek Greenbelt (left) and 125 Large Welcome Sign design template from the PARD 2023 Signage and Wayfinding Guidelines (right)**

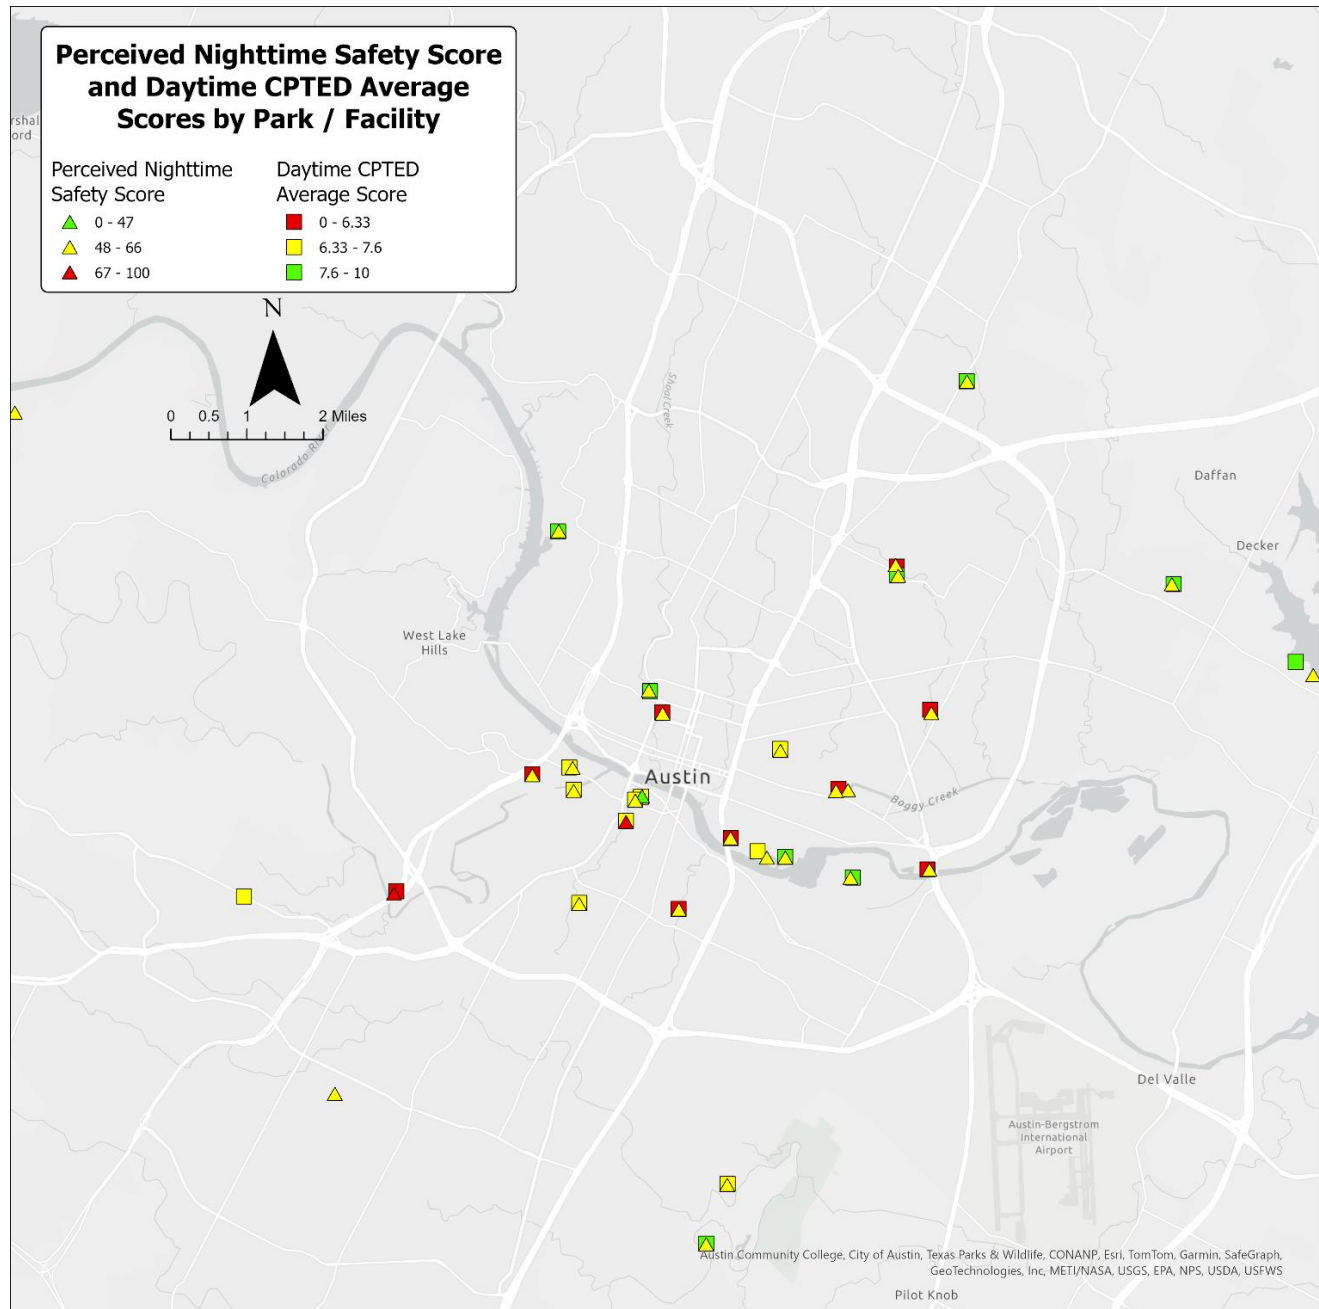
A summary of the daytime and nighttime assessment ratings is provided in Figure C-1. Site visit findings are used to develop security and lighting recommendations.

**Figure C-1. Perceived nighttime safety score and daytime CPTED average scores by park and facility**

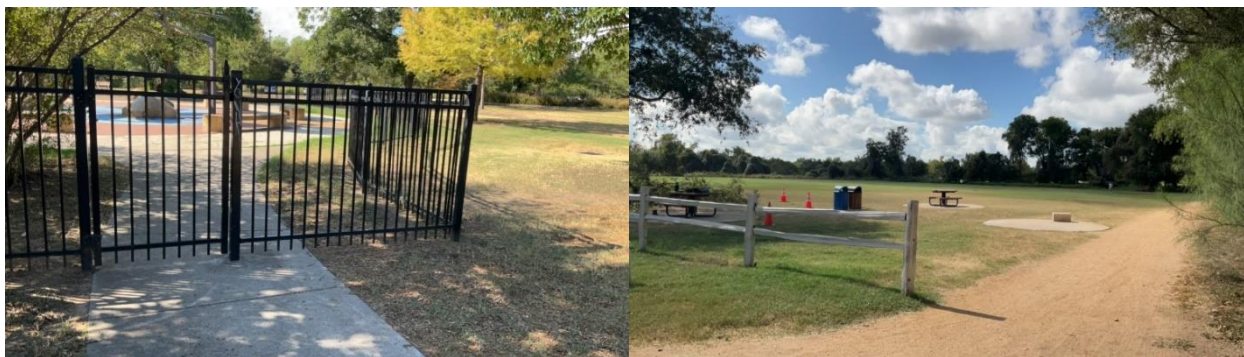
**Picture C-1. Roy G. Gurrero Metropolitan Park - Site / Target Hardening**

Roy G. Gurrero Metropolitan Park scored highly across all CPTED categories, most notably in image management / maintenance, activity support, and territorial reinforcement. The eastern side of the park had little observable trash, monitoring from PARD facility workers, extensive signage, and activity generators such as playgrounds and a disc golf course. The disc golf course was the site of a cleared encampment of over 200 individuals; therefore, it received more consistent monitoring and maintenance from APD and PARD staff. Vehicle barriers and fencing were present throughout the playground area and disc golf course as shown in Picture C-1.

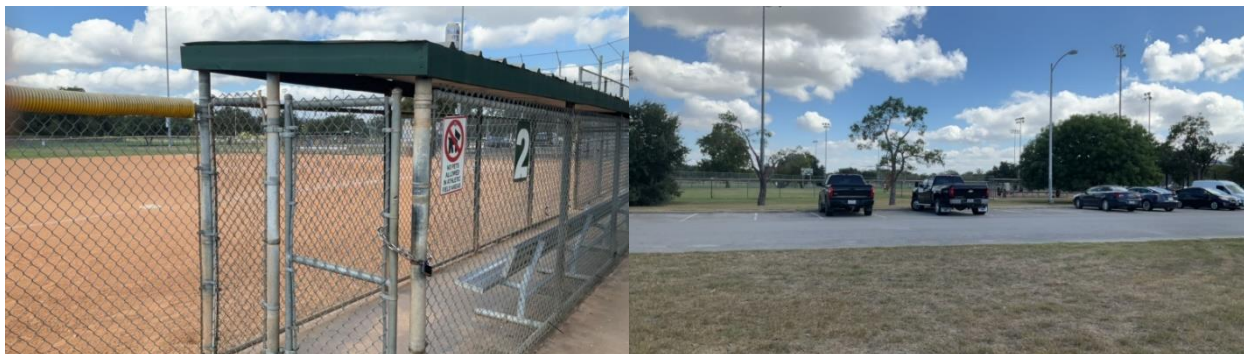
**Picture C-2. Roy G. Gurrero Metropolitan Park - Western Side**

The western side of Roy G. Gurrero Metropolitan Park contains recreation fields and administrative offices. The fields and parking lots are well lit, locked and fenced, have extensive signage, and are monitored by PARD maintenance staff and by the neighboring fire station as shown in Picture C-2.

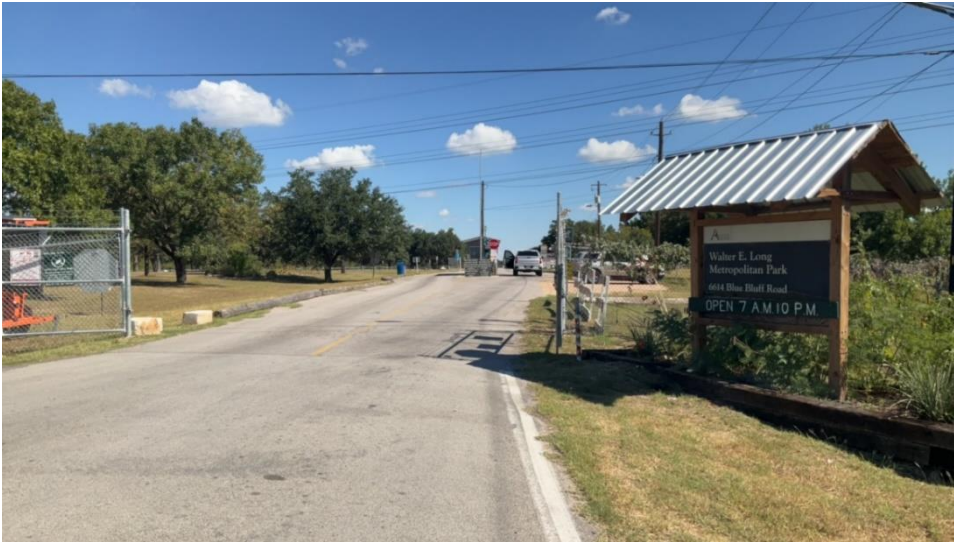
**Picture C-3. Walter E. Long Metropolitan Park – Natural Access Control, Territorial Reinforcement, and Site / Target Hardening**

Walter E. Long Metropolitan Park scored highly among the natural access control, territorial reinforcement, image management / maintenance, and site / target hardening categories. Signage, wayfinding, fencing, and vehicle barriers were present throughout publicly accessible areas of the park. The main point of entry is fenced as shown in Picture C-3, and a staffed ticketing booth manages entry into the park. The park is enclosed with fencing enhancements (barbed wire), locked vehicle gates designated for PARD staff, and fencing with signage designating private areas on the eastern side of the vehicle path. There is extensive park rules signage, maintained landscaping and vegetation, and activity generators such as picnic tables and pavilions throughout as shown in Picture C-4.

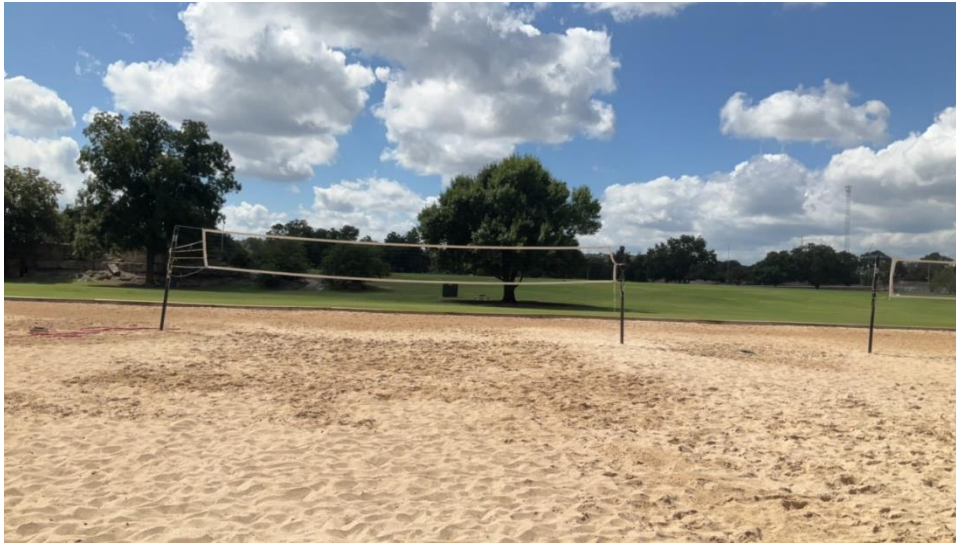
**Picture C-11. Zilker Metropolitan Park (Park Center, North) - Activity Support**

The eastern area of Zilker Park was being actively used at the time of the site visit by Austin City Limits workers for event storage and setup. This area was well maintained, had clear demarcation of space, and had activity generators such as volleyball courts and picnic benches, as shown in Picture C-11.

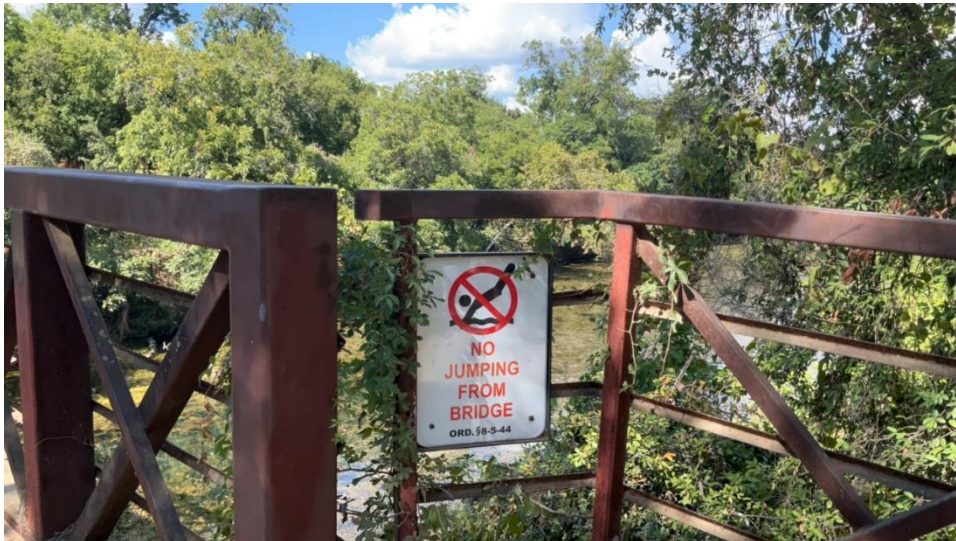
**Picture C-12. Zilker Metropolitan Park (Park Center, North) - Image Management / Maintenance**

PARD staff had reported multiple incidents of bridge jumping on the eastern side of the park into Barton Creek. At the time of the site visit, this area was frequently travelled with extensive signage indicating the illegality of swimming and jumping, as shown in Picture C-12.

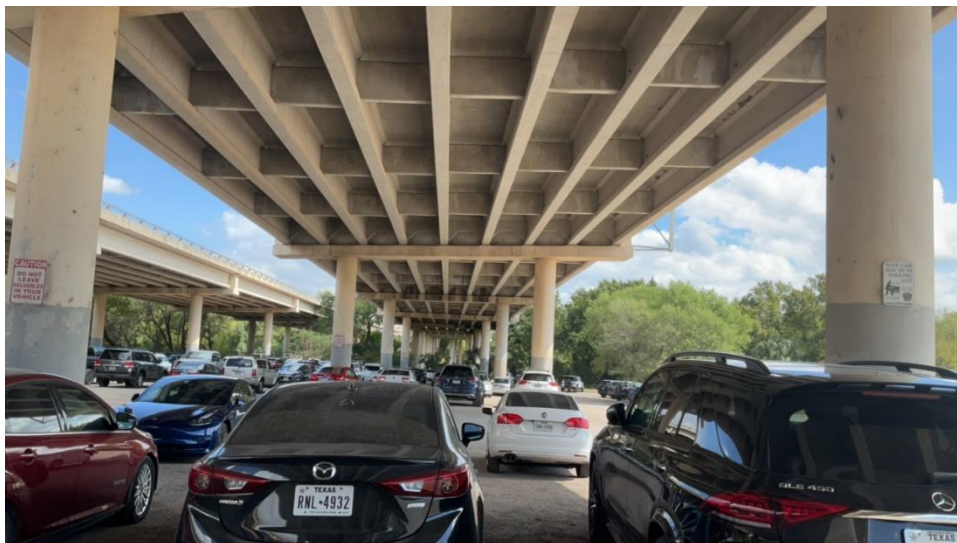
**Picture C-13. Zilker Metropolitan Park (Park Center, North) - Image Management / Maintenance**

The northwest area of Zilker Park was surveyed at the MoPac Expressway underpass parking lot. The area adjacent to this site was not accessible due to Austin City Limits setup activities. This area was accessible by Strafford Drive by car, and the greenway running adjacent by foot. This area lacked clear demarcation and signage, access control features such as bollards or vehicle gates, and was poorly maintained (unpaved, gravel parking lot). PARD staff had reported multiple vehicle break-ins at this site, with signage throughout to warn park users, as shown in Picture C-13. There were no security camera trailers or other deterrents to vehicle break ins at the time of the site visit.

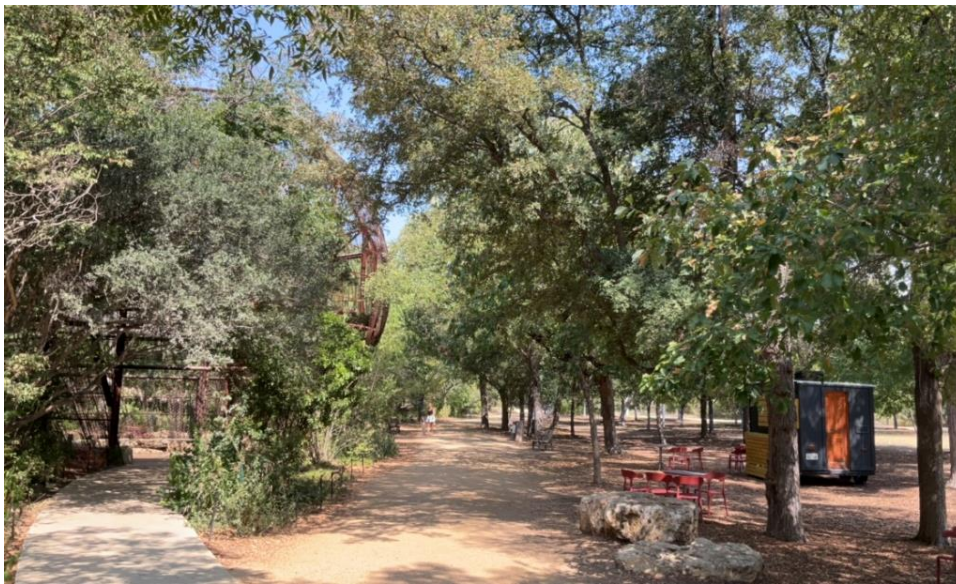
**Picture C-17. Pease Park Conservancy – Natural Surveillance, Image Management / Maintenance, Activity Support**

Pease Park Conservancy scores highly across all categories, with clear sightlines, maintained landscaping and pathways, extensive wayfinding and rules signage, and activity generators. Sightlines were supported by clearly defined pathways free of trash, a lack of shipping containers and blind spots, and maintained vegetation and trees along pathways as shown Picture C-17. Activity generators such as interactive art installation, seating and tables, and beverage / food trucks lead to a high activity support category rating (see Picture C-17).

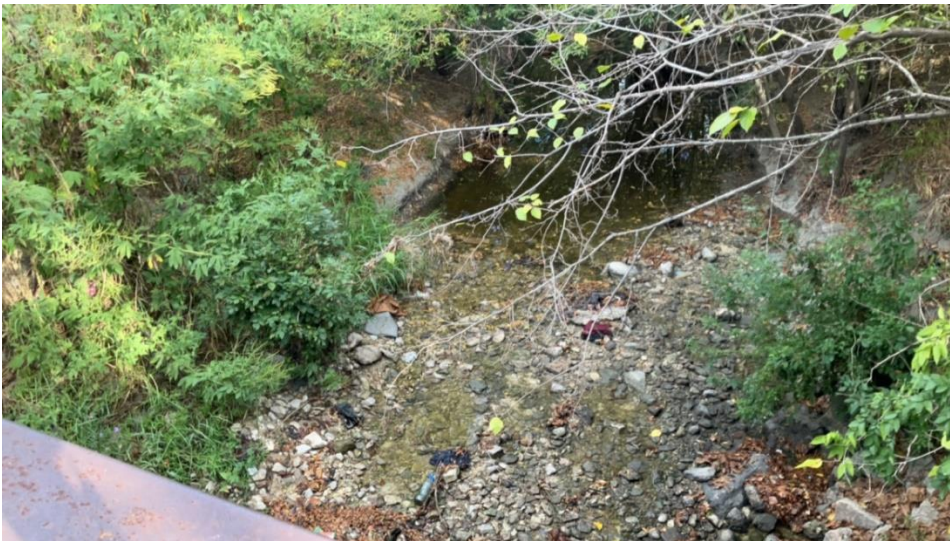
**Picture C-19. Bartholomew District Park – Image Management / Maintenance**

Similar observations continued into Tannehill Creek, as shown in Picture C-19.

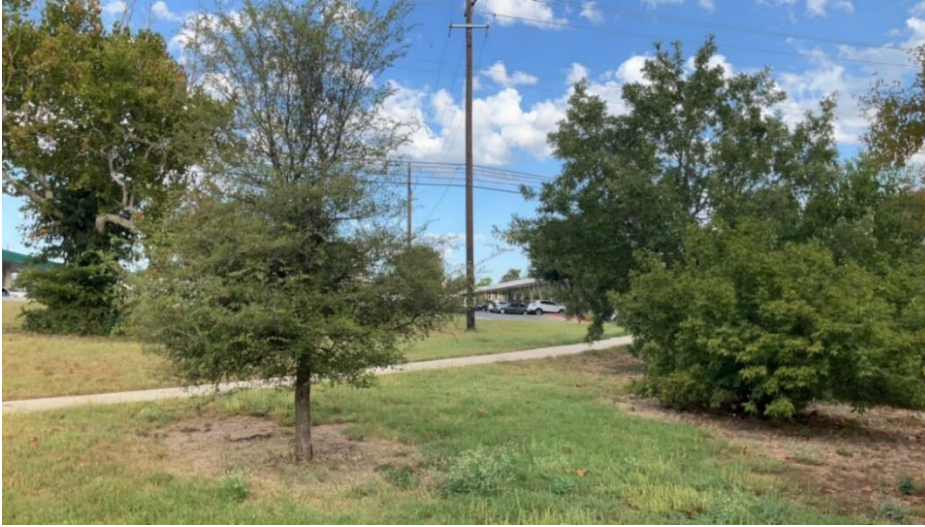
**Picture C-20. Bartholomew District Park - Territorial Reinforcement**

The western side of the park along Berman Drive is adjacent to a shopping center, with no delineation of PARD property, and overgrown vegetation, contributing to a lower territorial reinforcement rating as shown in Picture C-20.

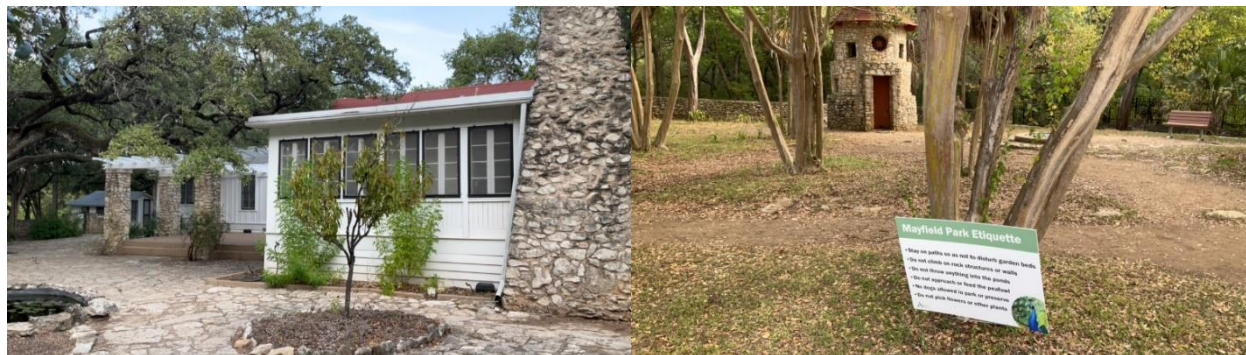
Picture C-23. Mayfield Park – Natural Access Control / Image Management / Maintenance

Mayfield Park offers a facility for event rentals, located next to the parking lot on the eastern side of the park. This area is surrounded by stone walls and can be accessed through multiple pedestrian gates and one vehicle access point as shown in Picture C-23. This area is well fenced, has clear wayfinding signs and park rules, free of vegetation and trash, and maintains clear sightlines from the parking lot and from the windows of the facility, as shown in Picture C-24.

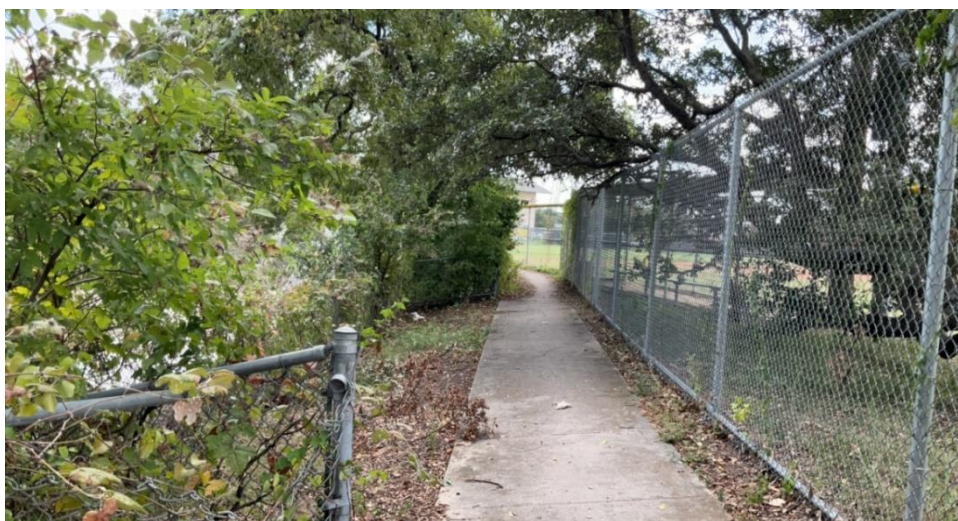
**Picture C-26. Parque Zaragoza Neighborhood Park - Natural Surveillance**

The westernmost entry point of Parque Zaragoza is concealed from passive surveillance from nearby traffic and has extensive overgrown vegetation in and around the fencing of the baseball field and creek as shown in Picture C-26. This area had blind spots from the vegetation and curved pathway and is detached from any potential passive surveillance from pedestrians or the roadway.

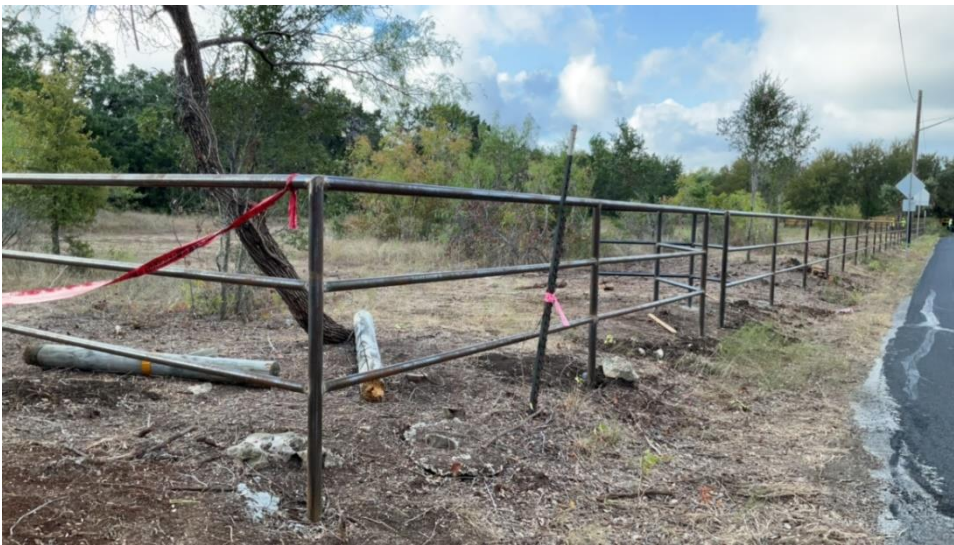
**Picture C-31. Stephenson Nature Preserve - Site / Target Hardening**

At the time of the site visit, workers were in the process of installing fencing at the northernmost entry point of the park. This fence type specifically deters motorized bikes, as shown in Picture C-31.

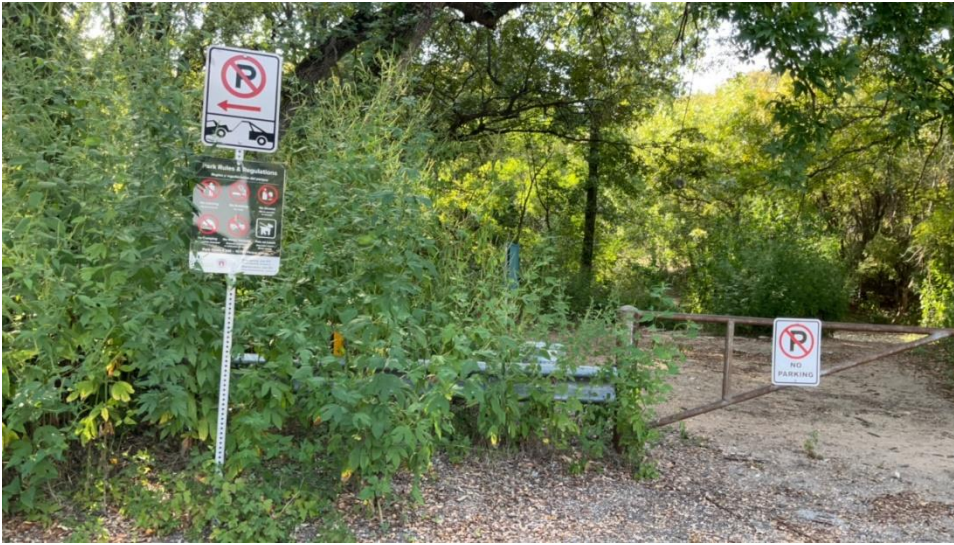
**Picture C-32. West Bouldin Creek Greenbelt - Natural Surveillance, Natural Access Control**

West Bouldin Creek Greenbelt scored highly among the natural access control, territorial reinforcement, and image management / maintenance CPTED categories. The southernmost access point on South 6<sup>th</sup> Street was partly concealed from pedestrian and vehicle pathways and has some overgrown vegetation concealing the access point and greenway as shown in Picture C-32. The lack of vehicle barriers and signage contribute to lower CPTED ratings along the southern access point.

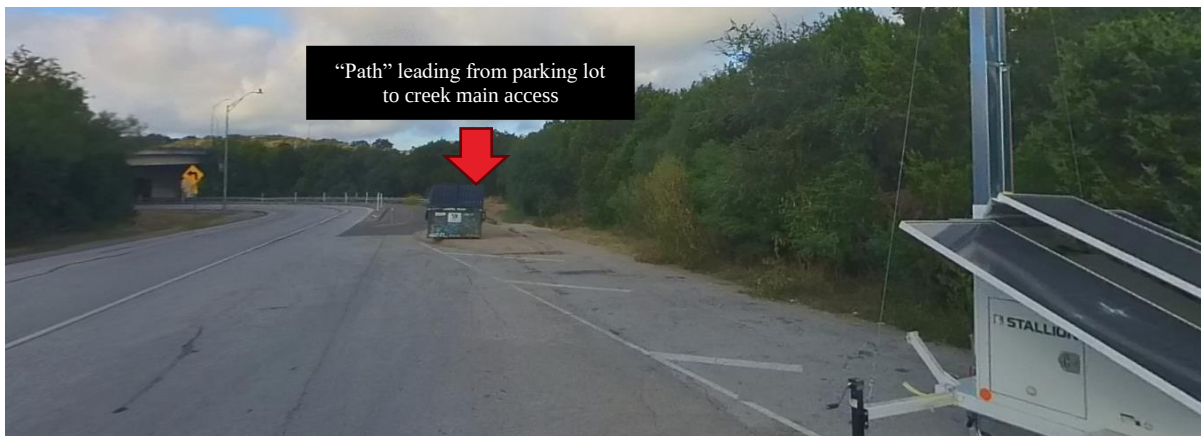
**Picture C-33. Barton Creek Wilderness Park - Natural Access Control**

Barton Creek Wilderness Park scored poorly in the natural surveillance and natural access control CPTED categories. The main access points for the park were adjacent to a freeway off ramp, with little to no surveillance and wayfinding signage present at the creek access point as shown in Picture C-33.

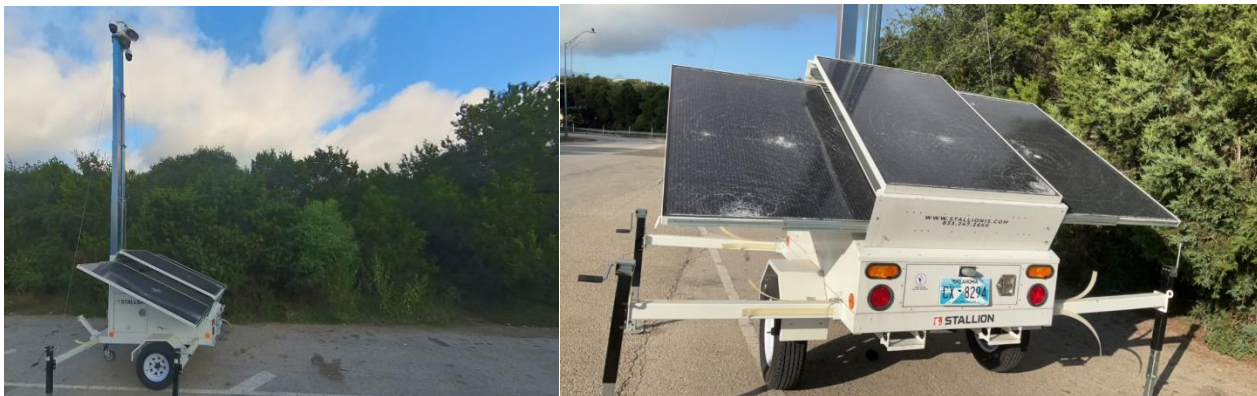
This park experiences a high level of vehicle break-in's. Because of this, there is a security camera trailer present in the middle of the parking lot. This trailer was vandalized at the time of the site visit (smashed solar panels) as shown in Picture C-35.

**Picture C-35. Barton Creek Wilderness Park - security camera trailer monitoring the creek parking area**

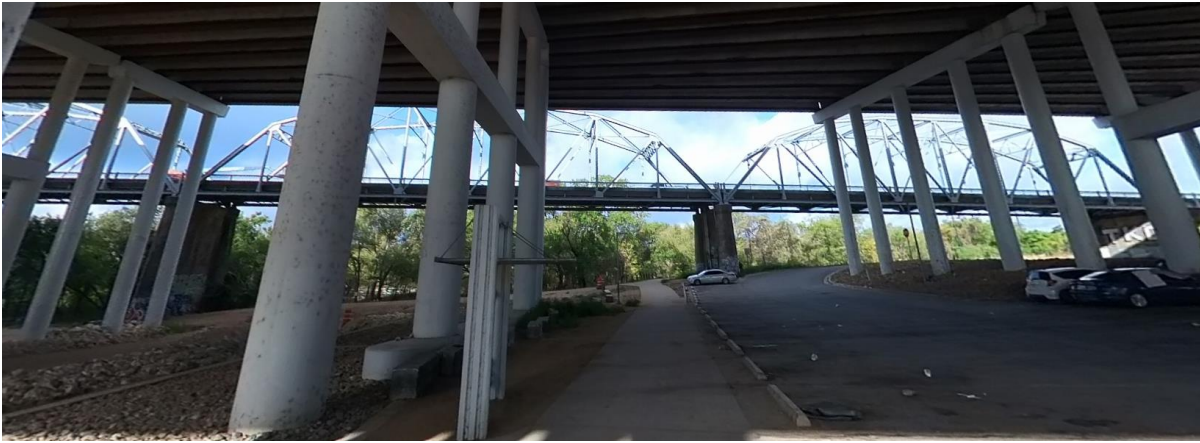
The Colorado River Wildlife Sanctuary scored poorly across all CPTED categories, most notably in natural surveillance and image management / maintenance. Similar to the Barton Creek Wilderness Park, this area is accessible through a highway off ramp; however, the main parking area is located under the highway and is surrounded by dense vegetation. This leads to little surveillance from passing vehicles and foot traffic. The only natural surveillance would come from individuals working (maintenance crew was present during the survey) or walking along the adjacent pedestrian bridge, as shown in Picture C-36.

**Picture C-36. Colorado River Wildlife Sanctuary - pedestrian bridge adjacent to the greenbelt parking lot which is underneath a major highway**

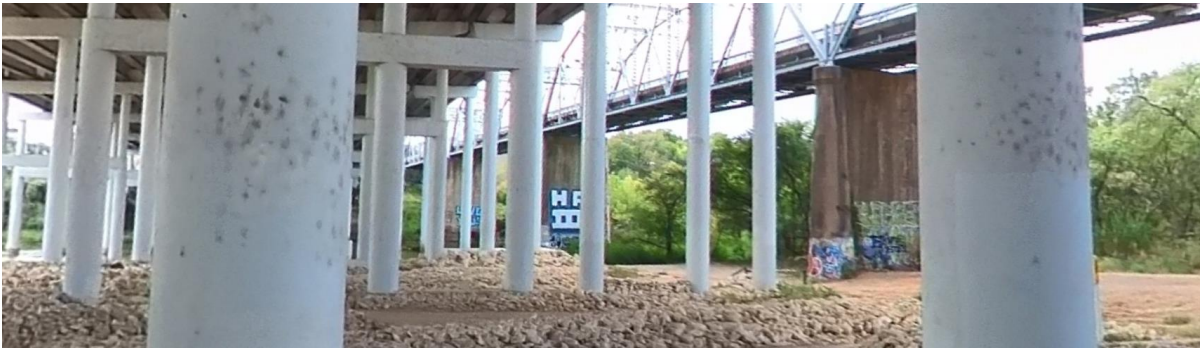
There is evidence of alcohol consumption in the parking lot and hiking trail; there were alcohol packaging and containers all throughout. While there were waste baskets at the parking lot, there were a lot of trash throughout the parking lot, picnic area, and hiking trail as shown in Picture C-38. There were also extensive graffiti observed on multiple pillars as shown in Picture C-39.

**Picture C-39. Colorado River Wildlife Sanctuary - extensive graffiti covers the pedestrian bridge pillars**

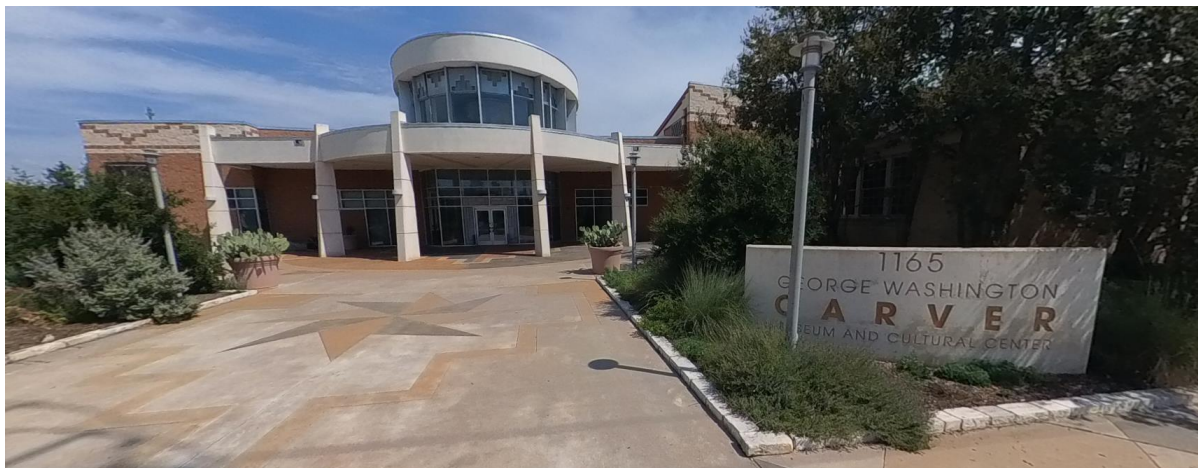
**Picture C-40. George Washington Carver Museum and Cultural Center - Natural Surveillance**

George Washington Carver Museum and Cultural Center scored well in the natural access control, image management / maintenance, and site / target hardening CPTED categories, and scored poorly in natural surveillance. The museum is adjacent to a middle school, public library, and church, a mixed retail and residential neighborhood. While thick bushes and trees obstruct views from the street towards the museum, there are large windows at the museum main entrance and several benches to help with natural surveillance from staff and museum visitors inside the building as shown in Picture C-40.

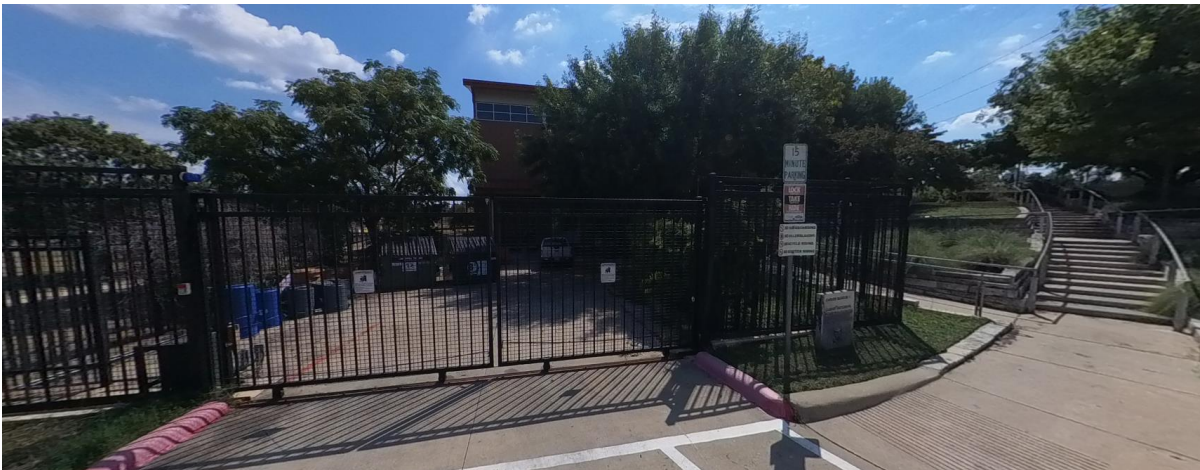
Two loading docks on the north side were gated with keypad for entry, with security cameras facing the entry point to the facility, as shown in Picture C-43.

**Picture C-43. George Washington Carver Museum and Cultural Center - Loading dock at the back of the museum**

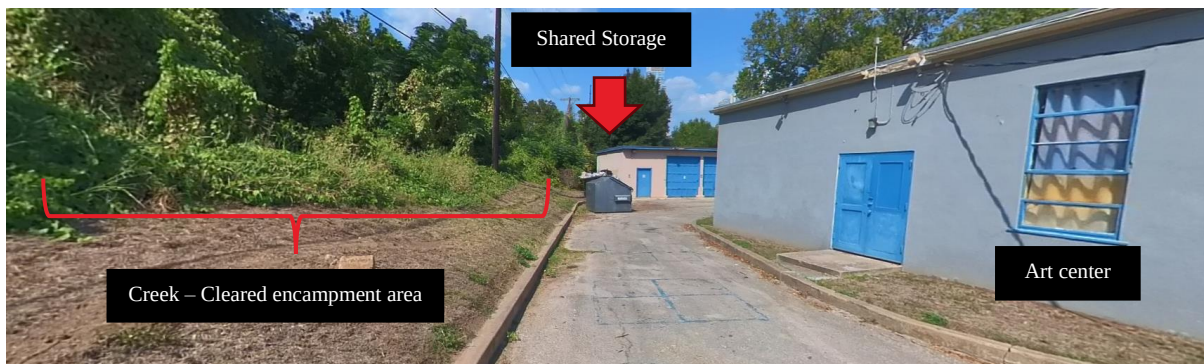
**Picture C-45. Dougherty Arts Center - Western side of facility**

The western side of the arts center is accessible through a path with signage delineating employee access. Staff noted that the storage garages on the north side had been broken into before. This is shared storage between the arts center and park maintenance. Overgrown vegetation along the creek, where encampments have been cleared previously, forms the western perimeter of the facility. There are several blind spots, as the road leading to the back of the arts center forms a “U,” and the creek blocks visibility from the street or adjacent properties. Security cameras are present along this corridor, as shown in Picture C-45.

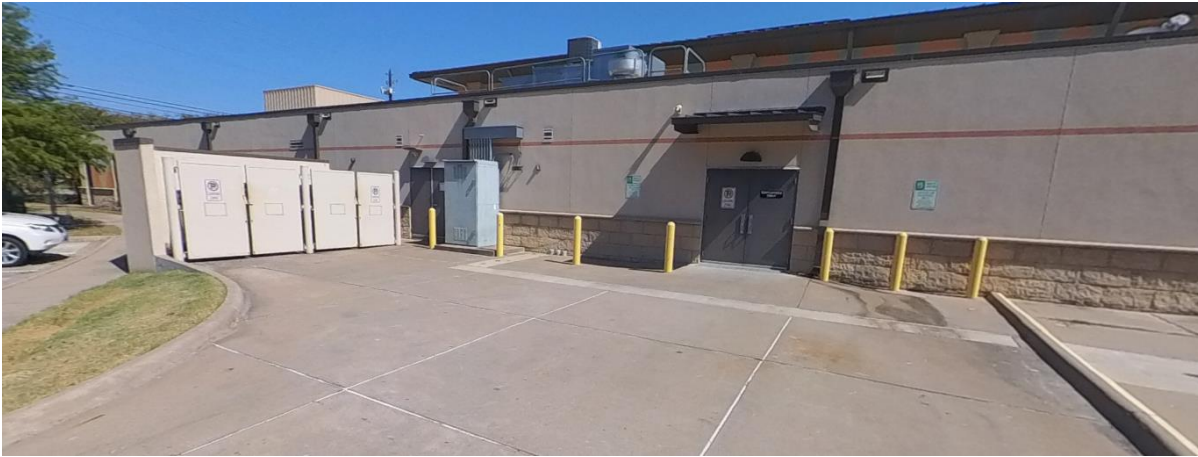
**Picture C-47. Asian American Resource Center - Maintenance Area**

While enclosures keep the dumpsters out of sight and is more aesthetically pleasing, it provides a potential hiding spot, as shown in Picture C-47. PARD staff shared that there have been multiple instances of individuals defecating in the dumpster enclosure. An outdoor automatic light was installed near the enclosure to discourage the behavior.

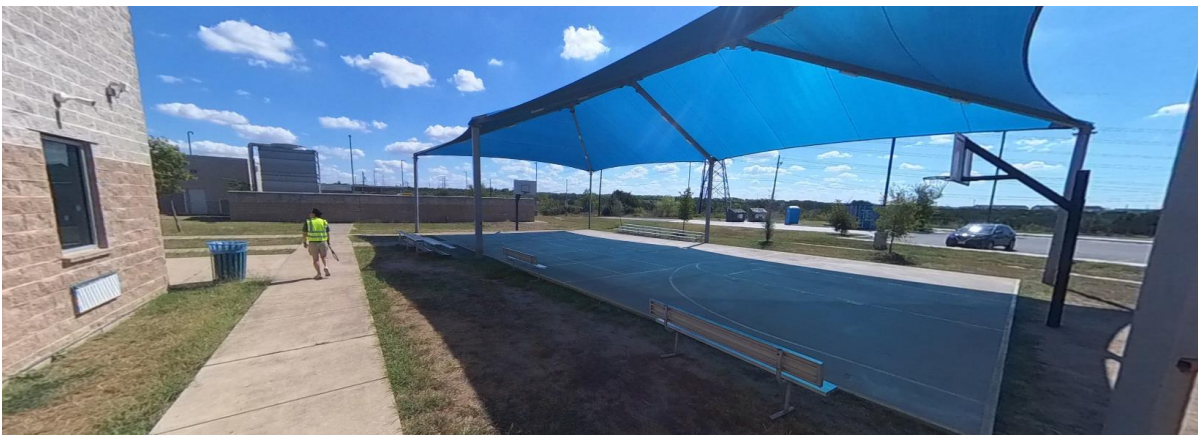
**Picture C-48. Turner Roberts Recreation Center - Natural Surveillance**

Turner Roberts Recreation Center scored highly among all CPTED categories, scoring highly in natural surveillance, natural access control, activity support, and site / target hardening. The facility is detached from the city center and is connected to the Overton Elementary school. The main facility and satellite gymnasium had an extensive amount of security cameras. Cameras were placed at blind spots, corners of buildings, maintenance areas, and park centers, such as the basketball court in the back of the facility, as shown in Picture C-48.

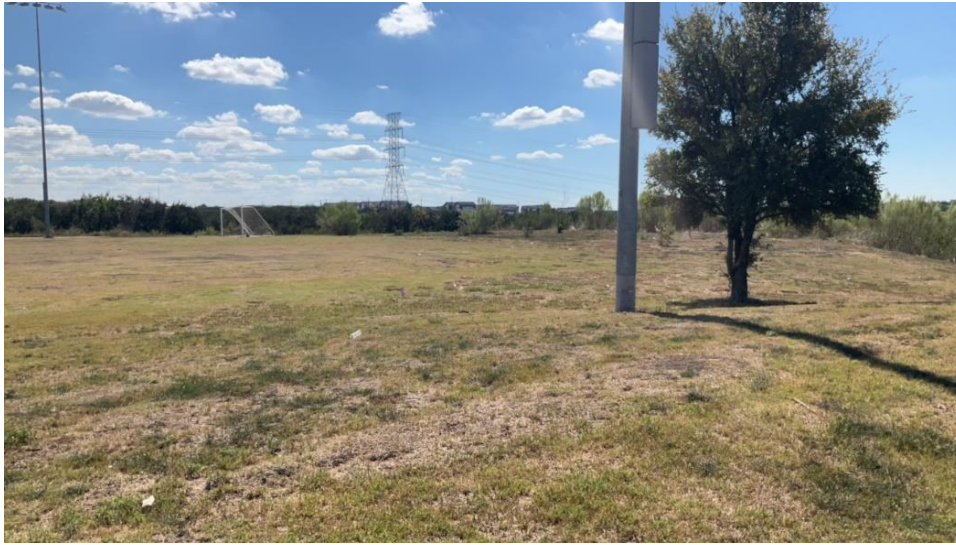
**Picture C-49. Turner Roberts Recreation Center - Image Management / Maintenance**

Some trash was present throughout the park area on the back side of the facility adjacent to the baseball fields and playgrounds, as shown in Picture C-49.

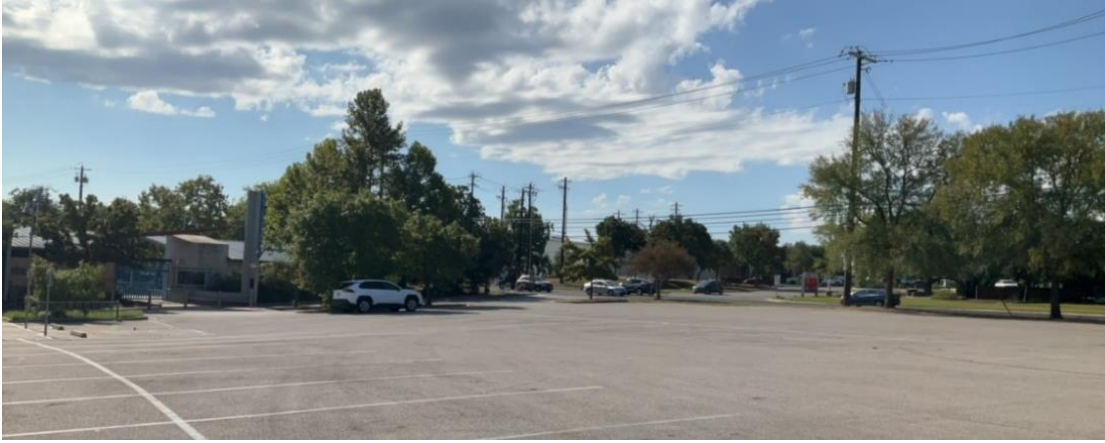
**Picture C-53. Bartholomew Pool - Natural Surveillance**

Bartholomew Pool scored highly in the natural surveillance, activity support, and site / target hardening CPTED categories. The front side of the pool faces dedicated parking for the facility, a road well-travelled by cars and pedestrians, and a shopping center, as shown in Picture C-53. The back side of the facility connects to the Bartholomew District Park across Tannehill Creek.
