**City of Austin**

# Parks and Recreation Department Security Audit

## Findings and Recommendations Report

Version 2 | July 18, 2025

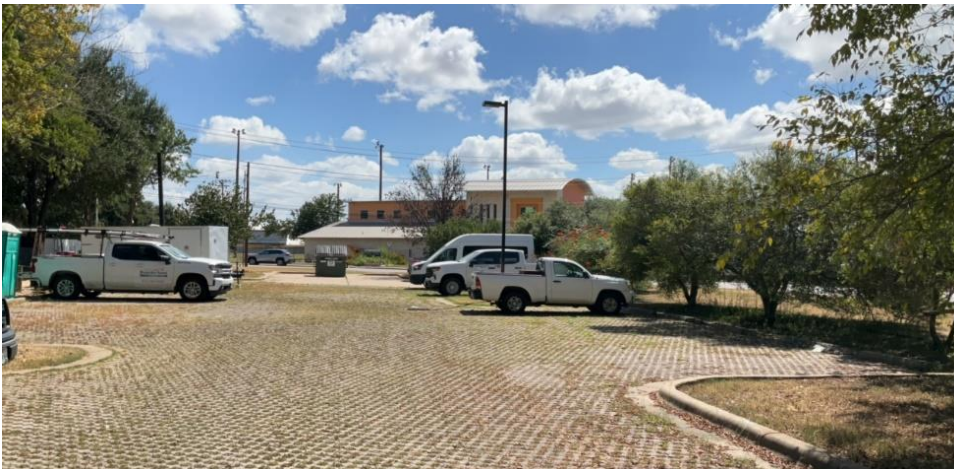
**Picture C-56. Lorraine “Grandma” Camacho Recreation Center - Natural Surveillance**

Lorraine “Grandma” Camacho Recreation Center scored highly across the natural access control, territorial reinforcement, image management / maintenance, and activity support CPTED categories. The recreation center is located in a neighborhood along Festival Beach, with the main entrance facing these residences and a shared parking lot. The parking lot is shared between PARD storage trailers, parking for the facility, and maintenance equipment from the residences, as shown in Picture C-56. Staff reported a recent break-in in this location, with items from a trailer being stolen the week prior to the site visit.

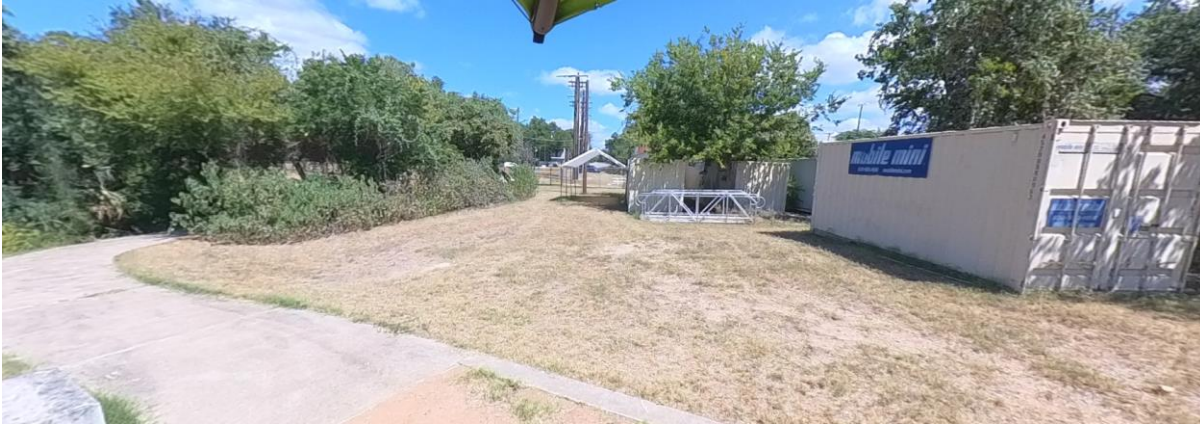
**Picture C-59. Lorraine “Grandma” Camacho Recreation Center - Fenced facility area**

The western side of the facility contains a fenced kayak launch point which is used for programming, as shown in Picture C-59. Staff shared that there are approved plans to build a new facility on the dock which will provide public access to the kayak launch system, while keeping one side reserved for recreation center programs. Nearby the dock within the fence enclosure are six storage containers, which contain water sport and other equipment. Staff shared that they’ve had the containers for at least a decade or more.

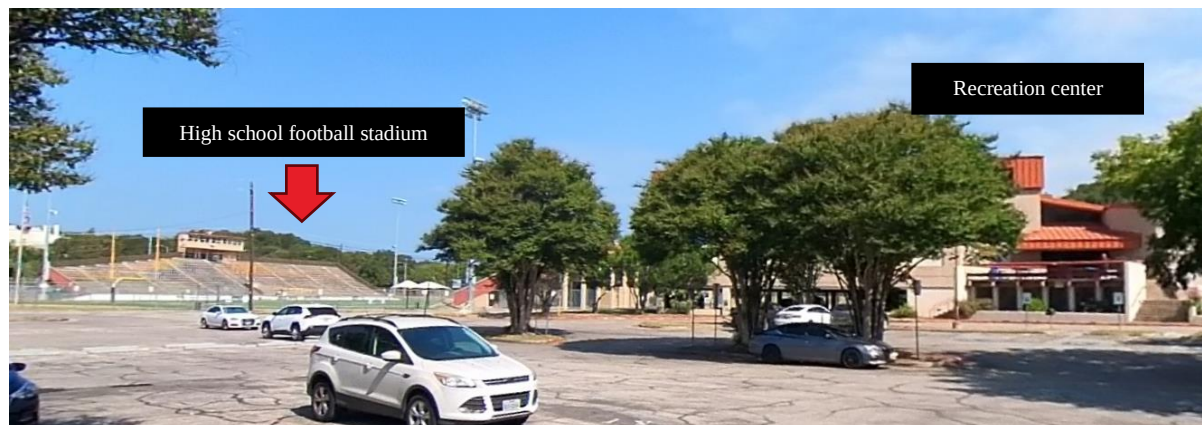
**Picture C-65. Austin Recreation Center and Skate Park - Natural Surveillance**

Austin Recreation Center and Skate Park scored consistently lower across all CPTED categories, with lower ratings across the natural access control and image management / maintenance categories. The recreation center

parking lot shares property with the skate park and a high school football stadium operated by the Austin Independent School District (ISD), as shown in Picture C-65.

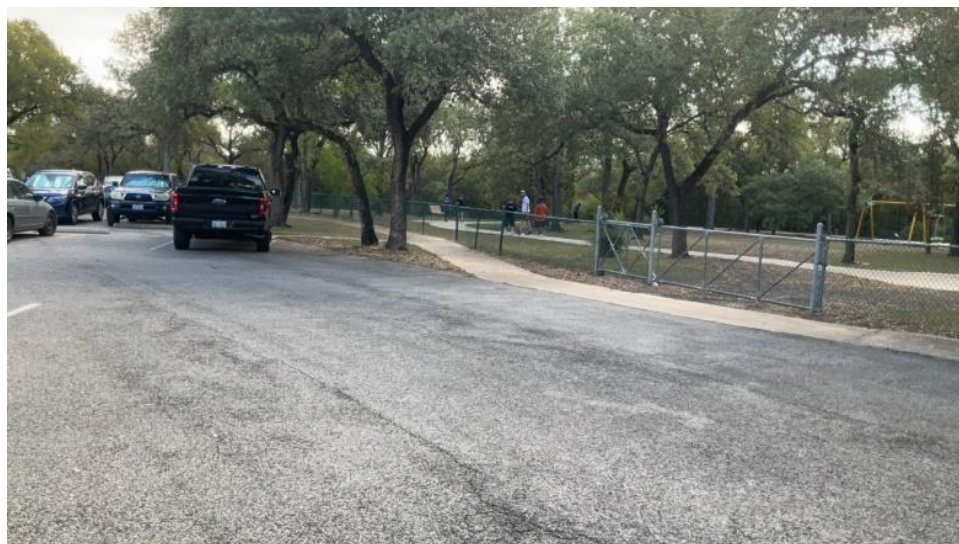
**Picture C-68. Danny G. McBeth Recreation Center - Site / Target Hardening**

The southernmost recreation center was actively used by children and staff during the time of the site visit. Although the playground and back area of the facility were hidden and surrounded by bushes, vegetation, and trees, there was extensive fencing around the facility which is designed to keep children on facility property, as shown in Picture C-68.

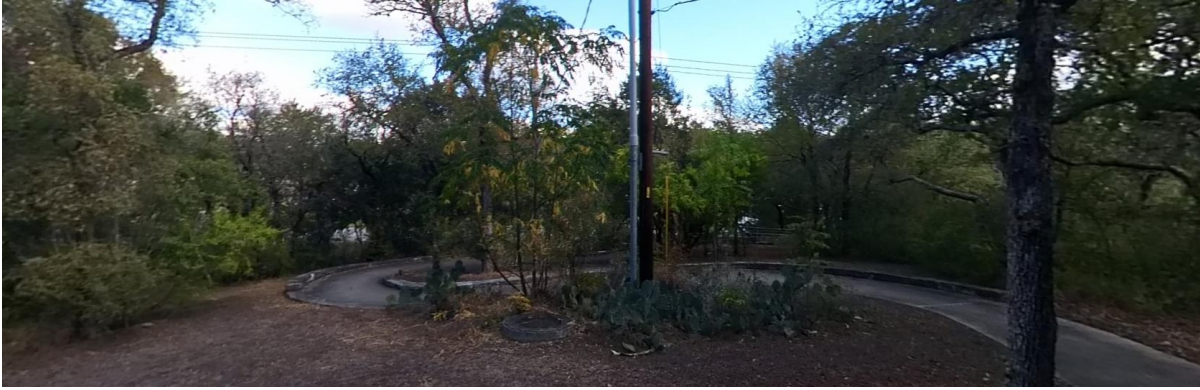
**Picture C-69. Danny G. McBeth Recreation Center - Natural Surveillance**

The northernmost annex building hosts programs after school for children, including programs for the special needs population. Staff mentioned that afternoon/evening programming at this location was impacted by the lack of lighting around the back of the facility. A paved pathway leads from the facility through a heavily forested area to the bus stop along a major roadway, as shown in Picture C-69.

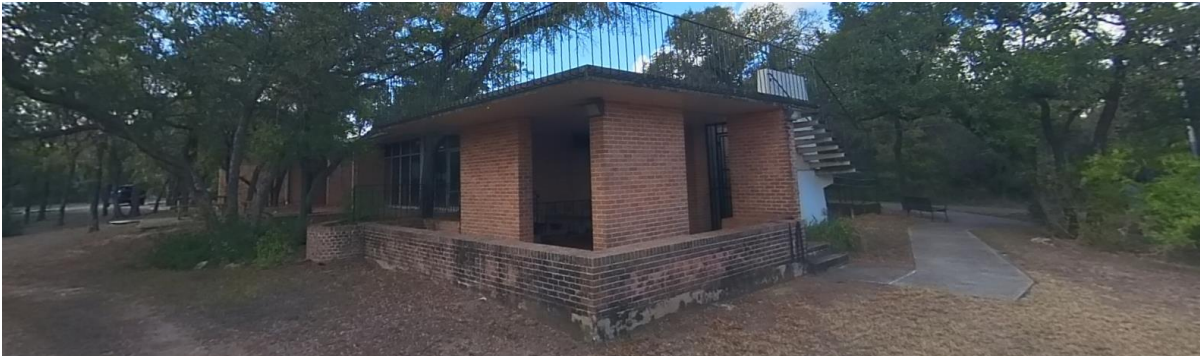
Program participants have expressed safety concerns with walking to the bus stop after dark because of the lack of visibility, and staff have had to escort them to the bus stop. The area is poorly lit and have multiple blind spots and areas that unknown individuals can / have occupied. Specifically, sheltered areas around the building with outdoor access to power outlets are often occupied by unknown individuals. These outdoor power outlets have since been covered up.

**Picture C-70. Danny G. McBeth Recreation Center - The back of the annex building experiences a high number of unknown individuals seeking shelter, using the outdoor power outlet, or consuming alcohol or using drugs**

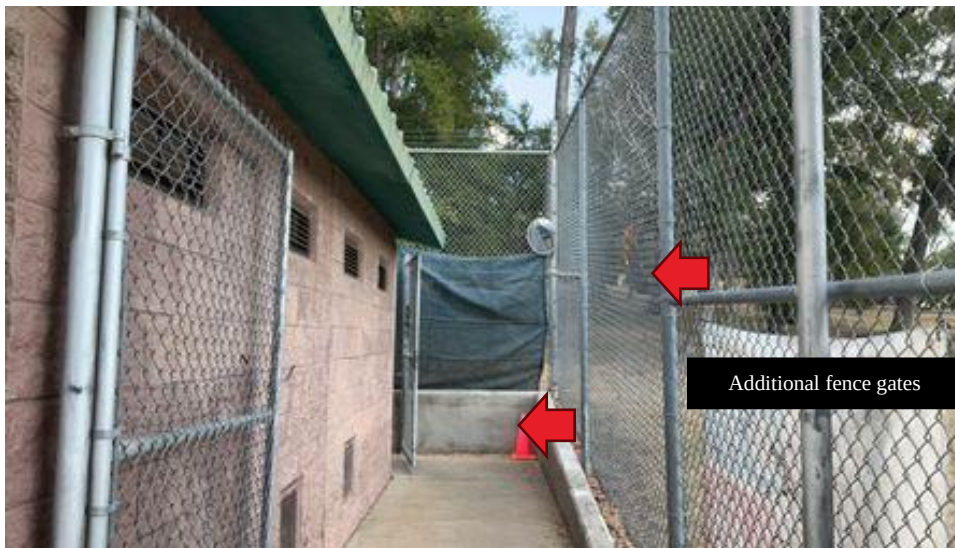
**Picture C-73. Big Stacy Pool - Site / Target Hardening**

Multiple fence gates at each corner of the restroom and shower facility are installed to reinforce it against unauthorized access during non-operating hours. Safety convex mirrors are also installed to provide staff and pool users the ability to see around the building corner, as shown in Picture C-73.

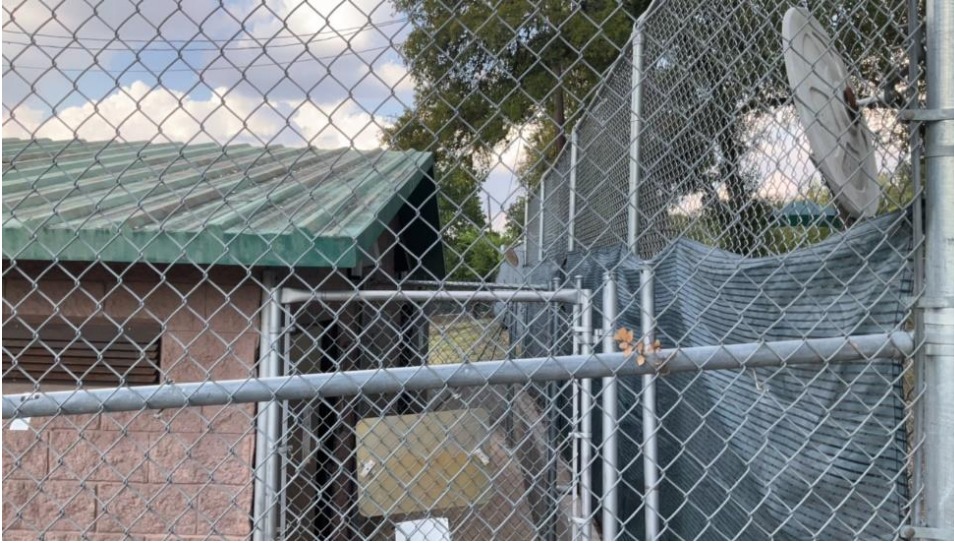
**Picture C-74. Big Stacy Pool - Site / Target Hardening**

There is 6-10 ft chain link fencing around the entire pool facility. Some sections of the fencing also have a three-strand barbed wire topper and green privacy screens. Fencing on the western side of the pool has been bypassed by individuals swimming overnight, although it has been reinforced on the eastern side with the addition of barbed wire and an additional, taller fence, as shown in Picture C-74.

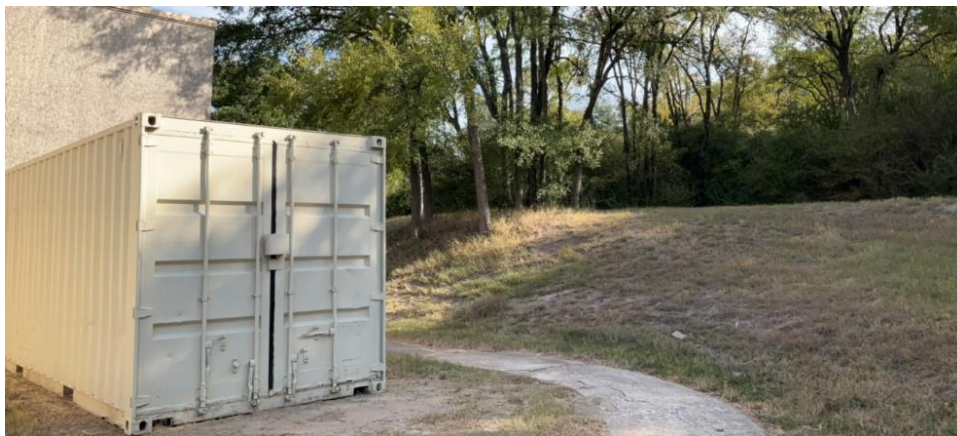
Multiple encampments have existed on the site and in the surrounding area, mainly to the east side of the facility and on the western side in the forested area, as shown in Picture C-80. Staff reported that APD has cleared out nearby encampments in the past but is unsure if they monitor and keep the area clear of encampments.

**Picture C-80. Givens Recreation Center Western side – previous site of encampment**

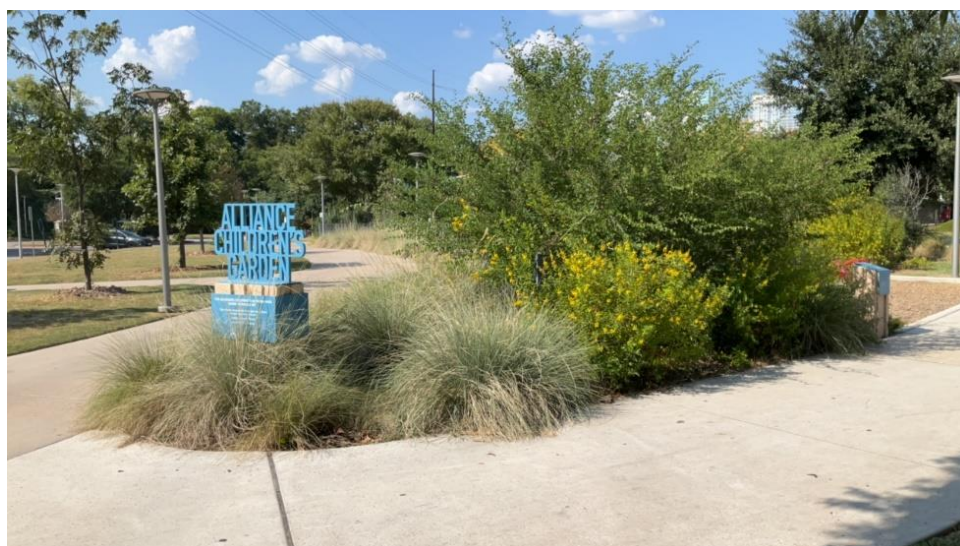
Dense vegetation surrounds the entrance of the park, which impacts visibility when accessing the facility, as shown in Picture C-83. This type of vegetation is present throughout the entire park, surrounding the main playground area.

**Picture C-83. Alliance Children's Garden entrance – Thick, tall bushes and vegetation forms the garden perimeter, obstructing views from outside and throughout the garden**

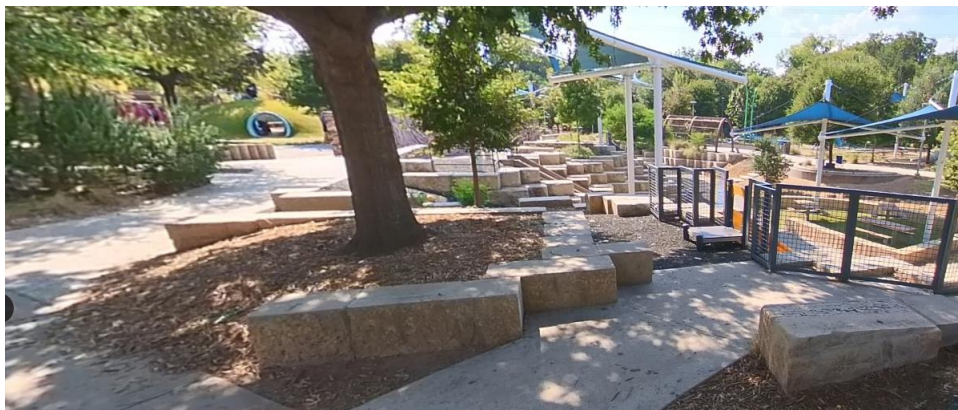
**Picture C-84. Alliance Children's Garden - Natural Surveillance**

The below grade play area requires users to climb down to the play area, as shown in Picture C-84. This is ideal if the adult supervision remains above, because they have increased visibility from the higher vantage point;

however, it would be difficult to observe approaching individuals if the adult supervision is down in play area where there also are picnic tables and shade structures.

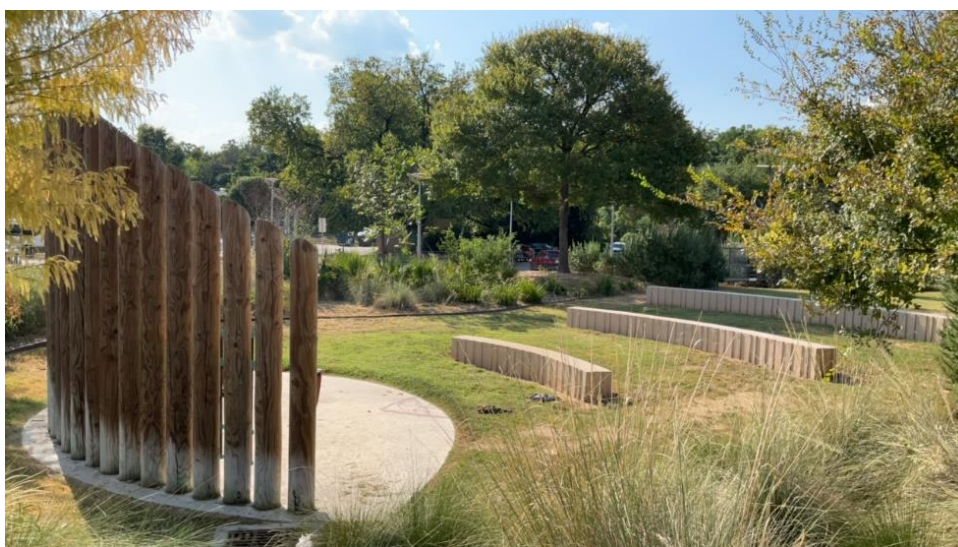
There were two individuals experiencing homelessness at the adjacent park at the time of the site visit, along with scattered trash and discarded clothes in and around the below grade play structure, as shown in Picture C-85.

**Picture C-85. Alliance Children's Garden - Evidence of Vagrancy**

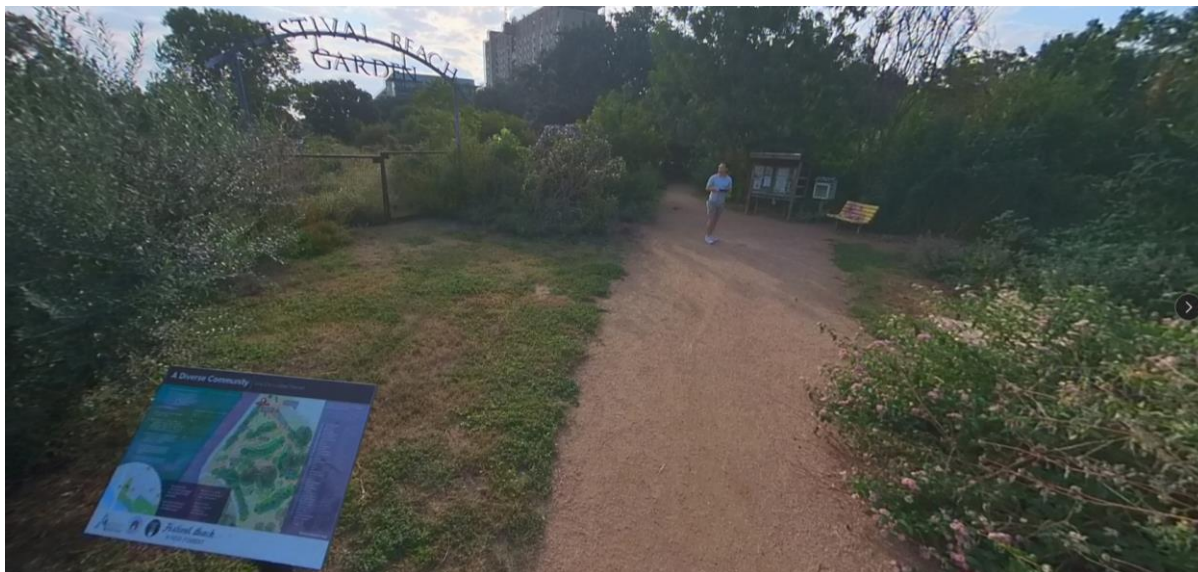
The food forest is open to the public with no perimeter fence or barriers, while the community garden has a perimeter fence, and access is controlled. Community garden pedestrian gates have push padlock, and vehicle gates are secured with chains and padlock, as shown in Picture C-86.

**Picture C-86. Festival Beach Food Forest – The community garden is to the left, while the dirt pathway leads through the food forest which is openly accessible to the public**

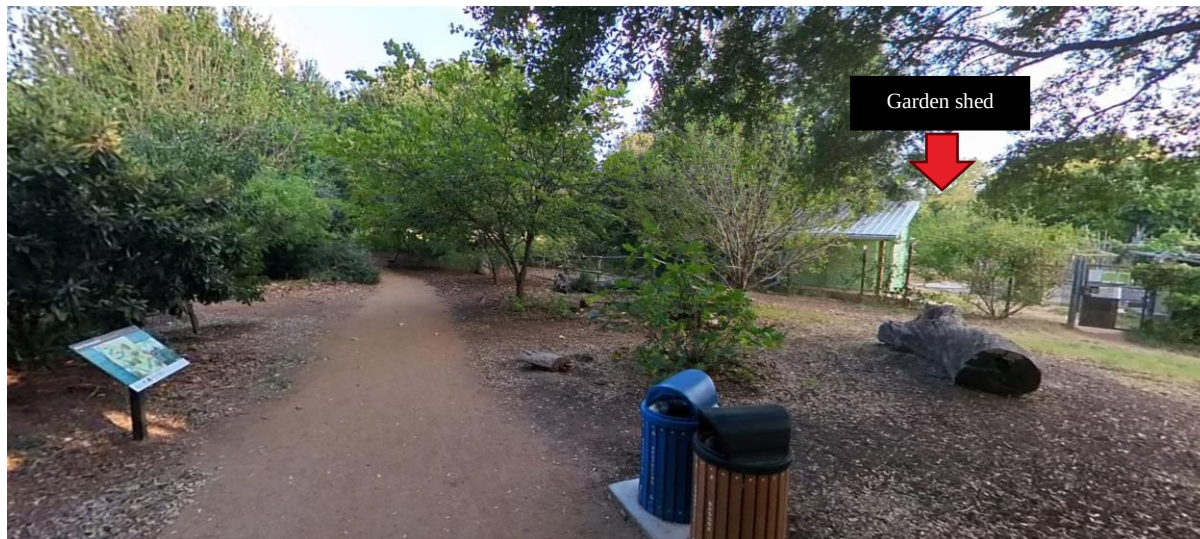
Staff noted that a garden shed, which sits within the community garden perimeter, had recently been broken into, and gardening tools and other equipment were stolen. There was an abundance of trash throughout (specifically alcohol containers) and vandalism (spray paint on wooden benches) throughout the food forest.

**Picture C-97. Festival Beach Food Forest – The dirt pathway leads through the food forest; pictured right is a pedestrian gate leading into the community garden where the garden shed is located**

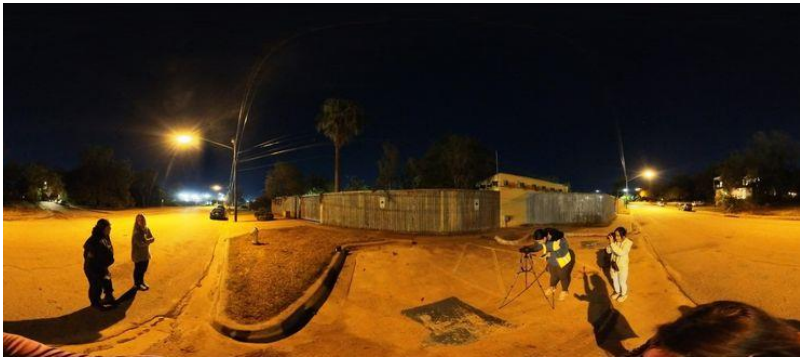
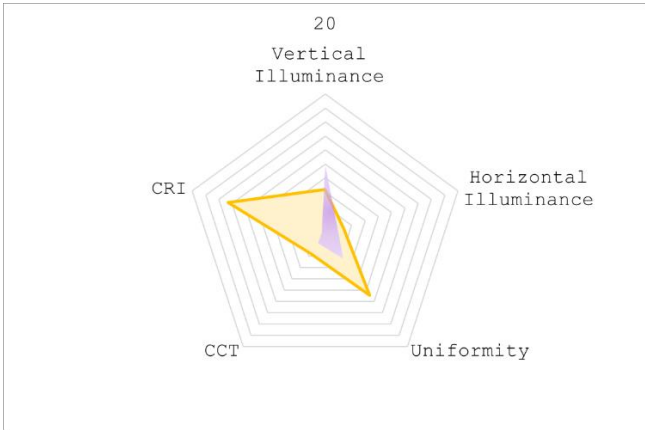
| <p><u>20- Park Facility (Safety Score 57)</u></p> <p>The parking area next to the entrance of the facility is lit by warm, streetlights. Bright white lights can be seen from the fields at Lorraine Camacho Activity Center. Lights can also be seen spilling from the residential buildings across the street. There was one white pole mounted light coming from inside the facility.</p> <p><i>Safety Score Rationale:</i><br/> Perception of safety: Average<br/> Reflectance: Neutral<br/> Specularity: Neutral<br/> Visual Transparency: Average<br/> Physical Transparency: Average<br/> Scale: Average</p> <p><i>Spider Diagram Analysis:</i><br/> Vertical Illuminance: High<br/> Horizontal Illuminance: Low<br/> Uniformity: Low<br/> CRI: Low<br/> CCT: Low</p> | <p><b>Picture C-88. 360 image of parking area</b></p> <p><b>57</b> /100</p> |

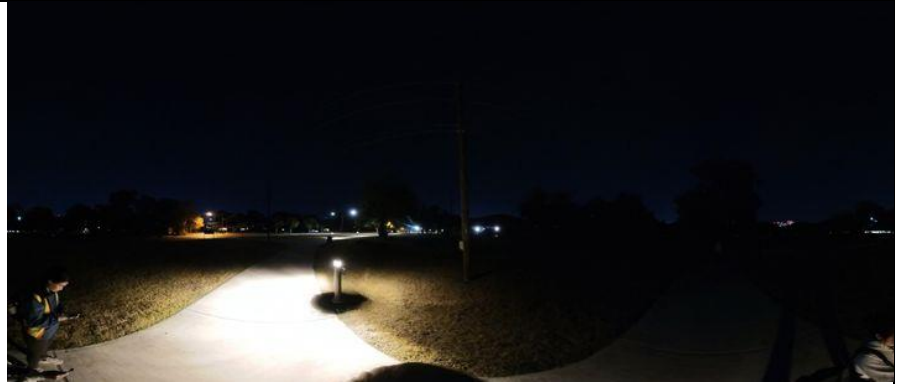
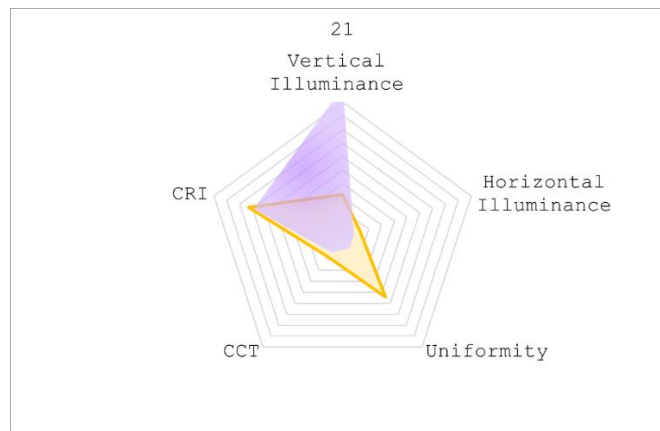
Picture C-89. 360 image of pathway to park

The path to get to the pavilion from the parking lot has bollards that create pockets of light. On the street, there are light poles with varying color temperatures. Across the pavilion, bright lights can be seen coming from the baseball fields at Lorraine Camacho Activity Center. There were no lights provided at the parking lot.

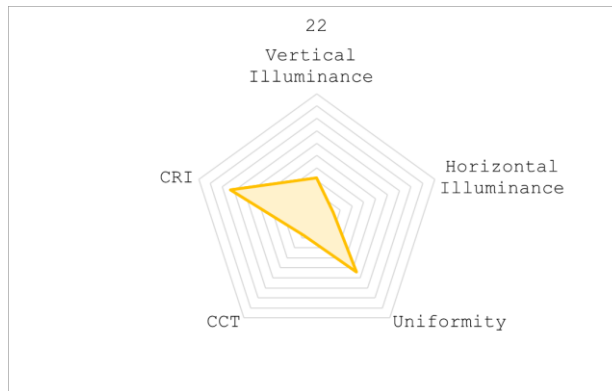
Picture C-90. 360 Image of park pathway to lake

The path is very dark with no lighting, except for lights visible from across the lake. Occasionally, people can be seen biking on the Ann and Roy Butler Hike and Bike Trail with headband lights. The boat dock area, where a few cars were camped out, is lit by a warm pole-mounted light fixture. According to PARD, a lighting plan is in place for the Lady Bird Lake Trail.

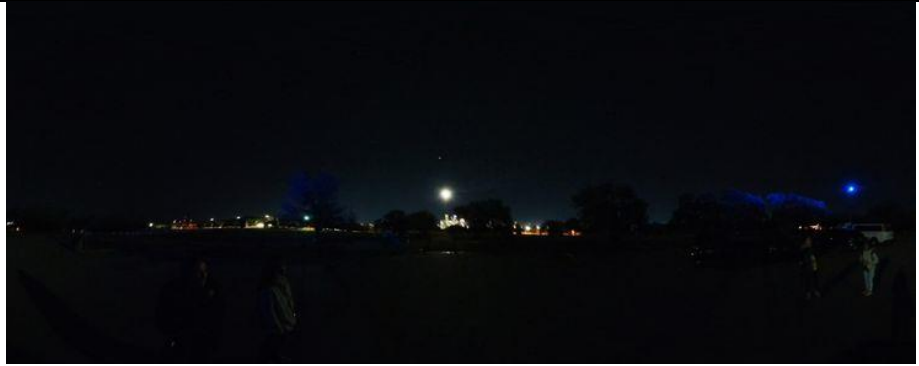
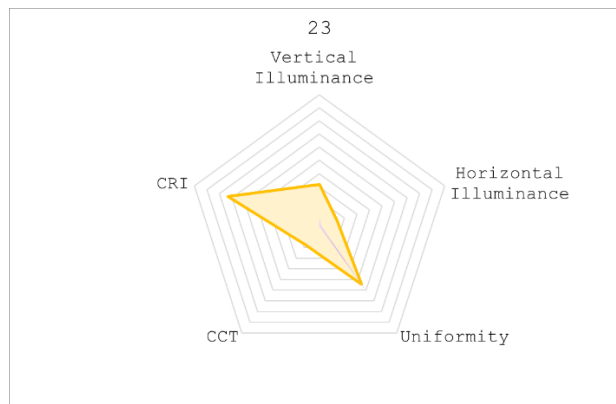
Picture C-91. 360 image of secondary parking lot

The small parking lots along the park paths lacked lighting, and the only lights came from adjacent streets and the city skyline. During the survey, there were no cars or pedestrians since the park was closed for the Trail of Lights. Typically, there would be occasional visitors and cars. This parking lot had blue lights on the security camera structures, but despite this deterrent, car break-ins still occur at night.

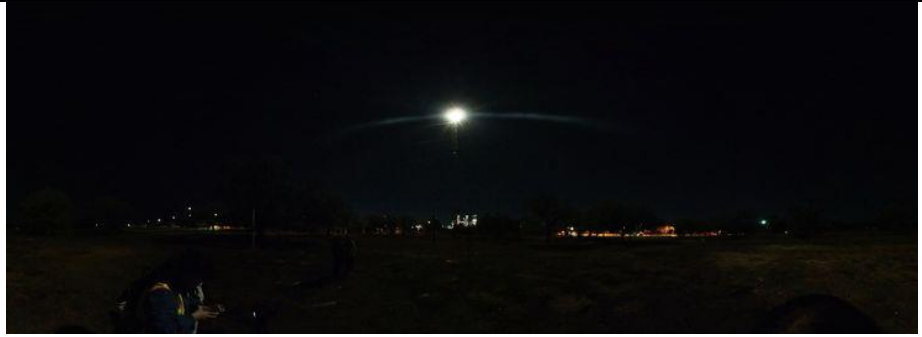
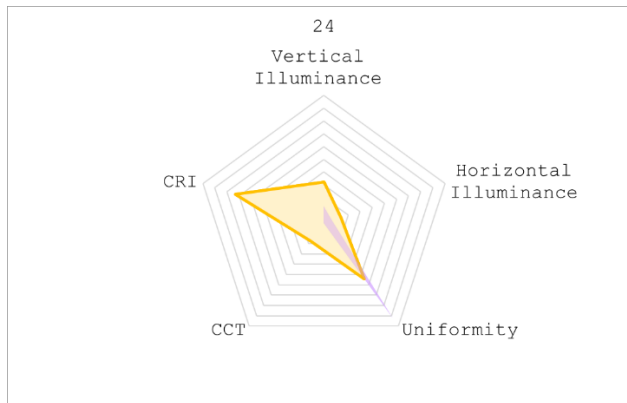
Picture C-92. 360 image of central park area next to moonlight tower

The moonlight tower illuminates a wide area around it. Close to the tower, visibility is high due to the open field with scattered trees. Besides the tower's light, warm lights from the nearby parking lot and the city skyline are also visible. During the visit, preparations were underway for the Trail of Lights, an annual light show in December.

Vertical Illuminance: Low  
Horizontal Illuminance: Low  
Uniformity: High  
CRI: N/A  
CCT: N/A

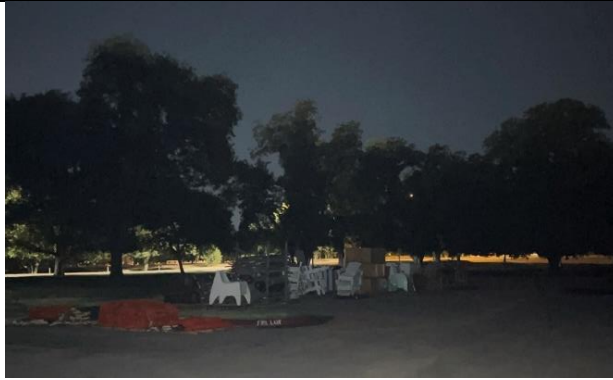
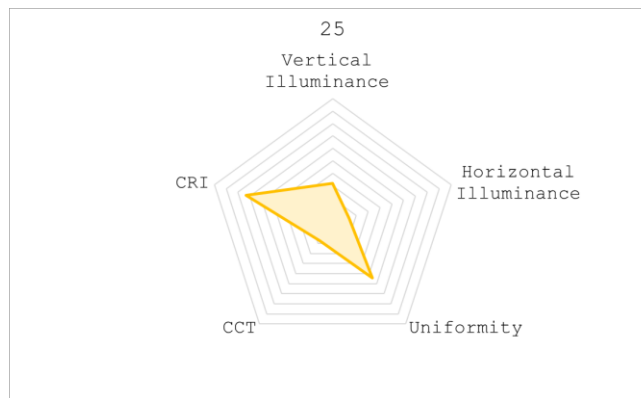
Picture C-93. Phone Image with flash of parking lot around the main lawn

The small parking lots along the park paths lacked lighting, and the only lights came from adjacent streets and the city skyline. During the survey, there were no cars or pedestrians since the park was closed for the Trail of Lights. Typically, there would be occasional visitors and cars.

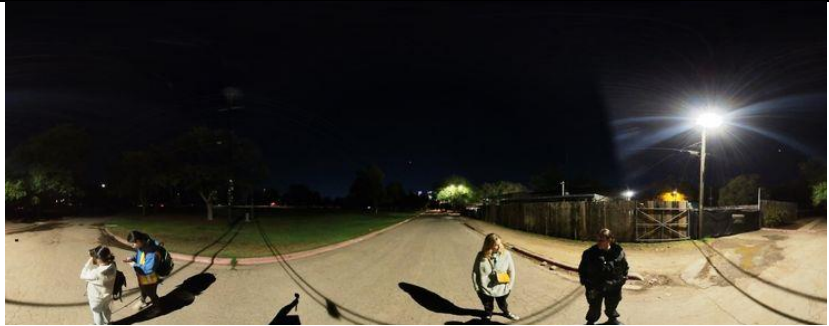
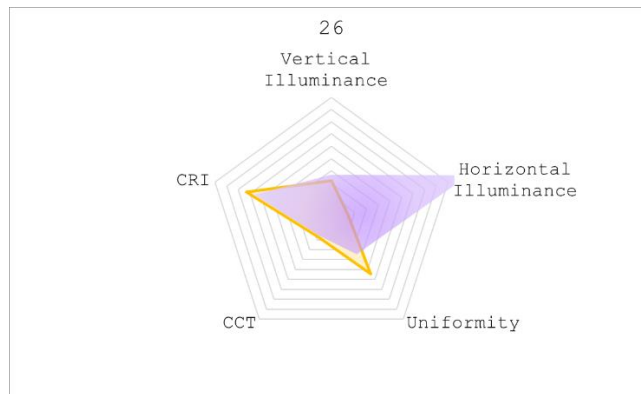
Picture C-94. 360 Image near the maintenance complex

The maintenance complex is lit by light poles and wall packs on the building, all with a white color temperature except for one warm light pole inside the gate. The surrounding area remains dark due to the lack of additional lighting.

Vertical Illuminance: High  
Horizontal Illuminance: High  
Uniformity: Low  
CRI: Standard  
CCT: Standard

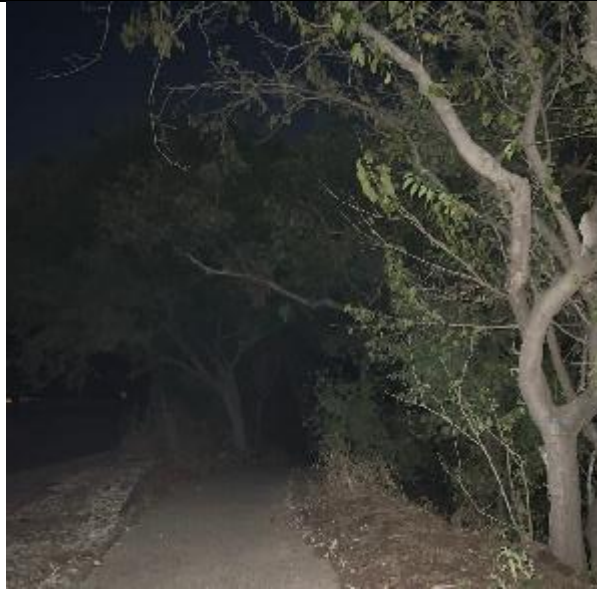
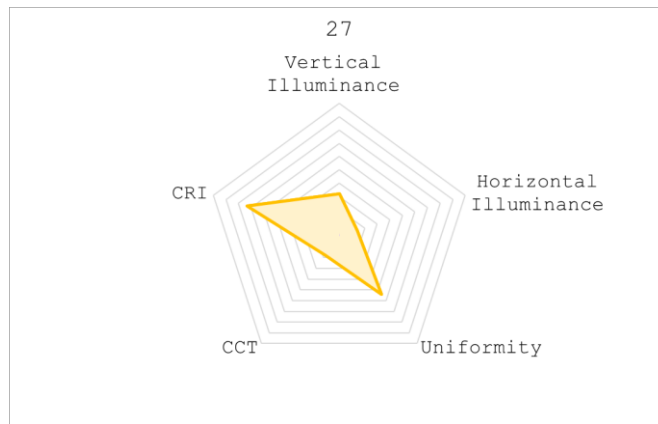
Picture C-95. Phone image of pathway to Ladybird Lake with flash on

This path connects to the Ann and Roy Butler Hike and Bike Trail along Lady Bird Lake. The area had almost no lighting, making the survey team feel unsafe beyond the entryway. During the survey, the security guard noticed someone possibly walking or biking on the trail through the trees, but it was hard to tell if there was someone there due to the low physical and visual transparency.

Vertical Illuminance: Low  
Horizontal Illuminance: Low  
Uniformity: Standard  
CRI: N/A  
CCT: N/A

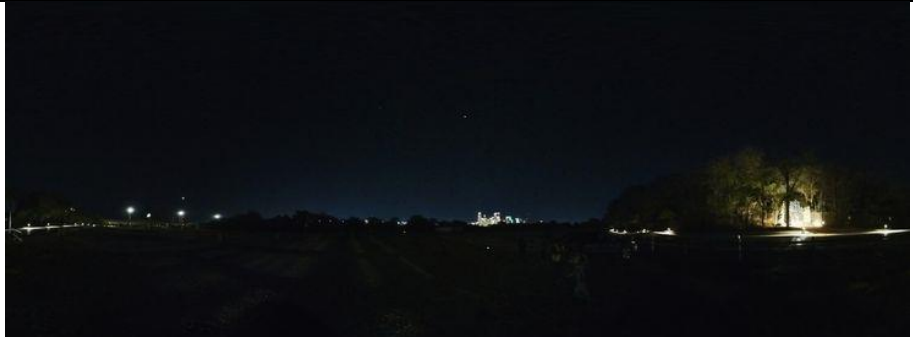
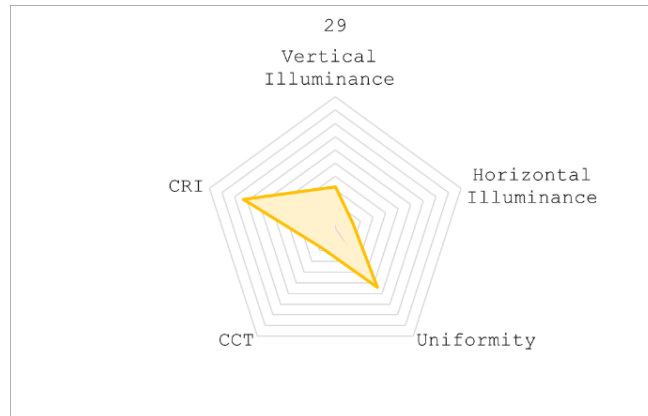
Picture C-97. 360 Image of large gravel parking lot

The main parking lot tows cars after closing hours. During the visit, a couple of cars were camping out. The parking lot is very dark due to the lack of lighting. Bright light comes from the Botanical Gates of Paradise, and the city skyline and light poles on Mopac Expressway are also visible. Bollards are present across the street to illuminate the pathway and make pedestrians visible to oncoming vehicles.

Vertical Illuminance: Low  
Horizontal Illuminance: Low  
Uniformity: Standard  
CRI: N/A  
CCT: N/A

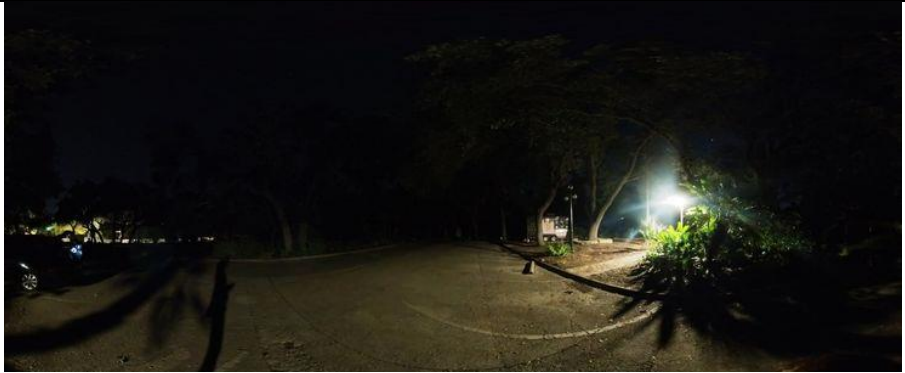
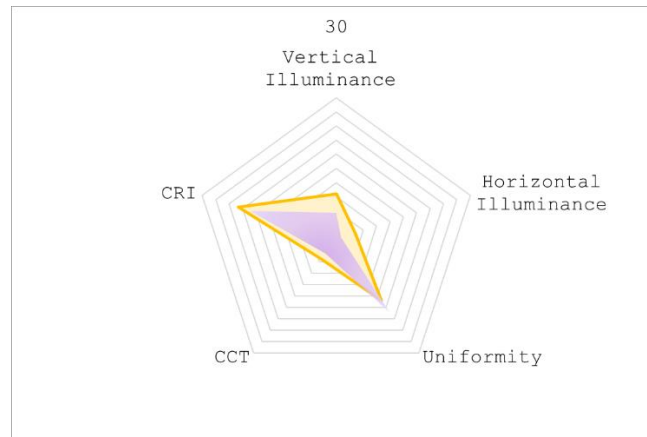
Picture C-98. 360 Image of Zilker Botanical Gardens parking lot

The sign at the entrance of the Botanical Gardens is lit by ground-staked flood lights, providing an even illumination that makes the sign easy to read. A password is required for after-hours entry. In the parking area, only one light pole was on, as the others are never used due to the facility's hours.

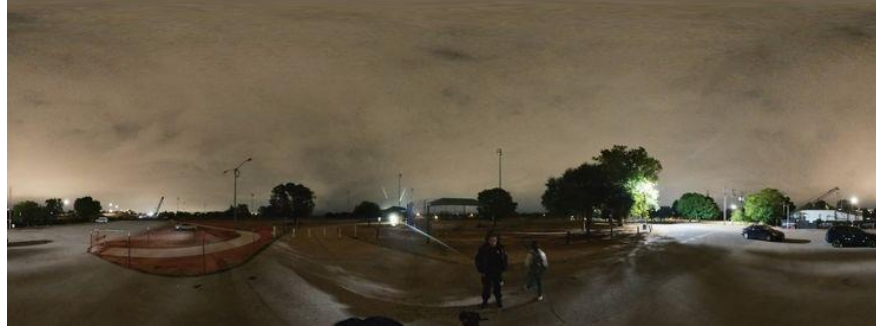
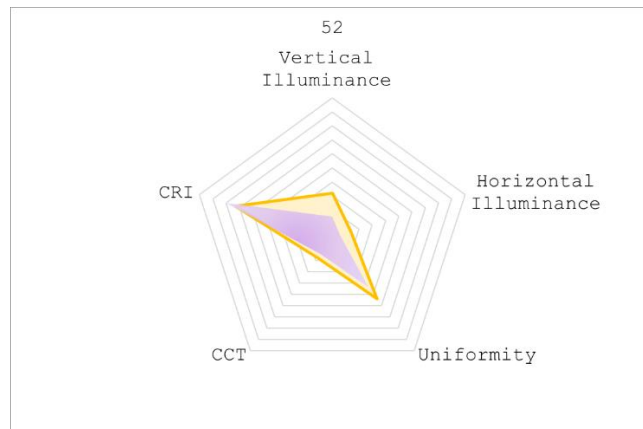
Picture C-99. 360 Image of parking lot

There was nearby construction. The fields had no lights. The restroom facility had a bright wall pack. Unhoused individuals were seen hanging under the tree and the bleachers. A bright light pole was nearby, with light spilling from the streetlights. The baseball area was roped off, and bollards blocked the road.

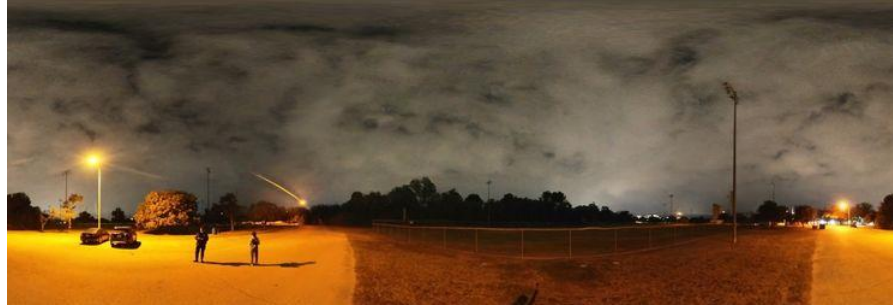
**Picture C-101. 360 Image next to baseball field**

**54- Active Recreation**  
**(Safety Score 53)**

The only form of lighting comes from the warm, light poles for the parking lots and light spill from the facility nearby. The lights for the field were not lit. A person could be seen further away, but their face was not recognizable. The pavilion next to the lot was very dark, and it was surrounded by a lot of vegetation.

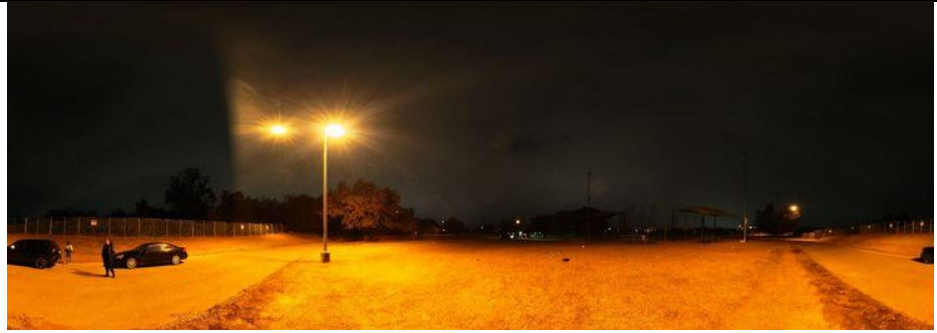
Picture C-102. 360 Image next to baseball field

55- Active Recreation  
(Safety Score 56)

People were hanging out in the bleachers of the baseball field, but they could not be identified due to the baseball field area being extremely dark. There was a lot of trash around the floor despite the presence of trash bins. Only warm streetlights provided some illumination, but visibility was limited beyond the light pole due to limited reach.

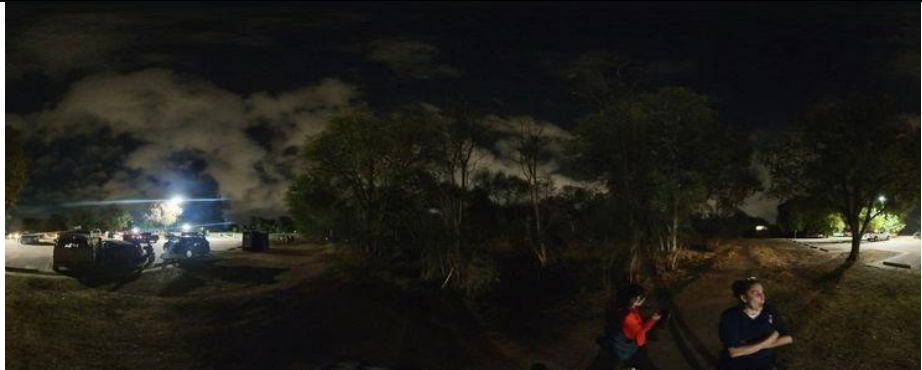
Picture C-103. 360 Image next to parking lot and trail access

### 56- Parking Lot (Safety Score 58)

The trailhead was quite dark with no designated lights. Light from the parking lot spilled light onto the pathway. A soccer match was happening, and the field lights turned off immediately after the game, manually. Many cars and parents were waiting in the parking lot to pick up kids, but they quickly vacated at the game end.

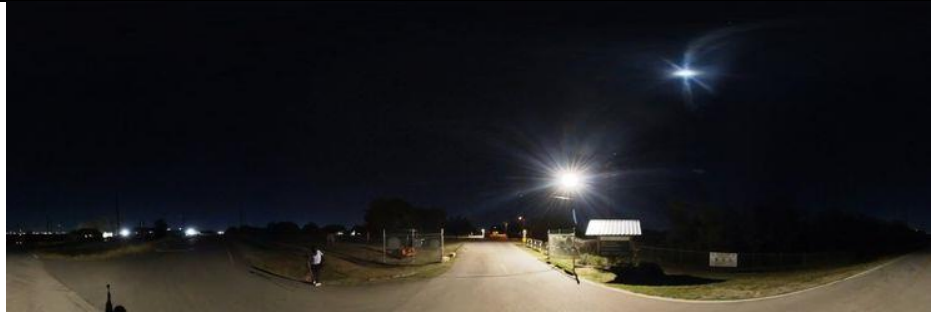
Picture C-105. 360 Image of park vehicle access

102- Park Access (Safety  
Score 49)

A bright white light pole is at the entry sign and there are warm light poles at the parking areas. Some building facilities across the road have wall packs. The admission booth has bright white linear fixtures on the exit side of the booth.

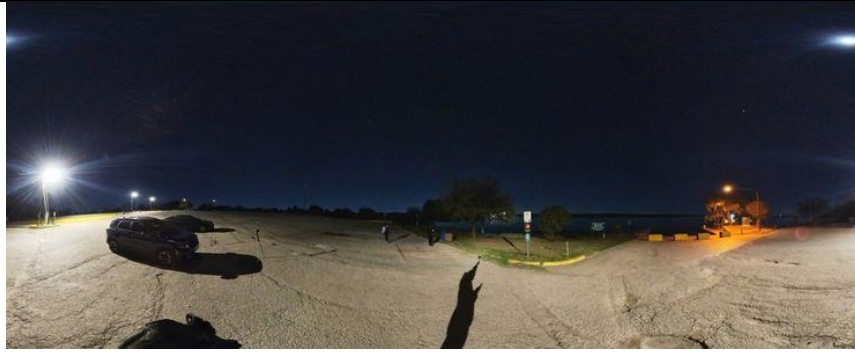
Picture C-106. 360 Image of parking lot next to pier

103- Parking Lot (Safety  
Score 45)

There is one warm light near the dock, and the parking area has white pole lighting. The lights at the entry are solar, while those aligned with the side are not.

Vertical Illuminance: Low  
Horizontal Illuminance: Low  
Uniformity: Low  
CRI: Standard  
CCT: Standard

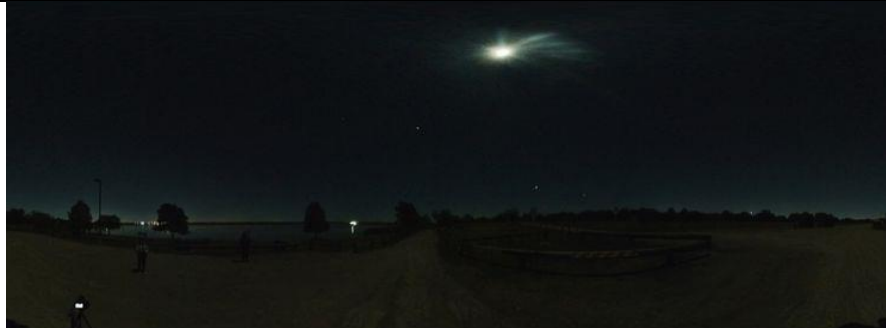
Picture C-108. 360 Image of benches along the lake

105- Active Recreation  
(Safety Score 58)

The light pole for this area was off, but lights across the water from a dam and the city can be seen. There is no other lighting, and no people are seen here. There was a mix of light poles being on and off. The solar powered fixtures seemed to be the ones being on.

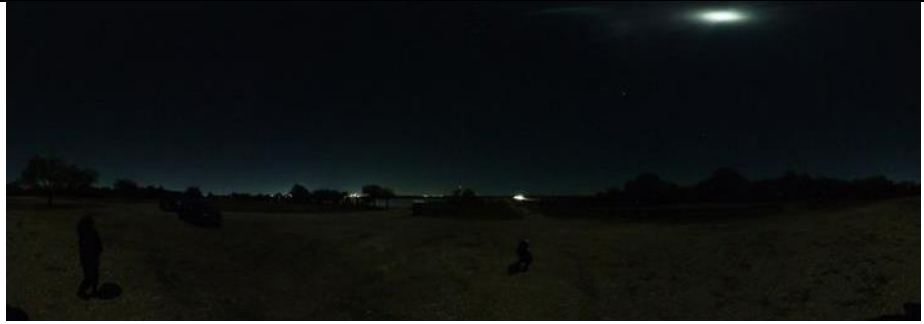
Picture C-109. 360 Image of roadway access from the park to the dam

106- Park Access (Safety  
Score 59)

There are no lights except for those coming from the dam across the water. The pavilion nearby is very dark, with no additional lighting.

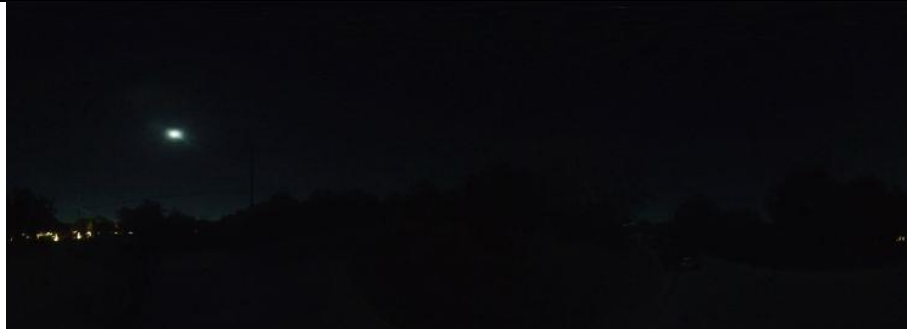
Picture C-111. 360 Image of vehicle park entry

112- Park Access (Safety  
Score 55)

This entry is near a road with large residences. Lights can be seen coming from the houses, but there is no light coming from the park itself.

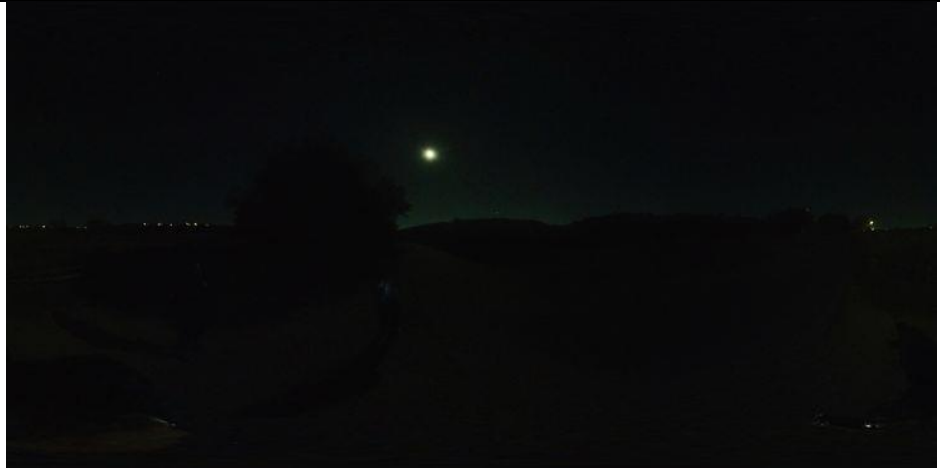
Picture C-113. 360 Image next to a secondary park entry

114- Park Access (Safety  
Score 64)

There were two cars are parked out here, suggesting there are people who hike here at night. There is no lighting in this area. At the time of survey, movement could be heard in the vegetation, but nothing could be seen.

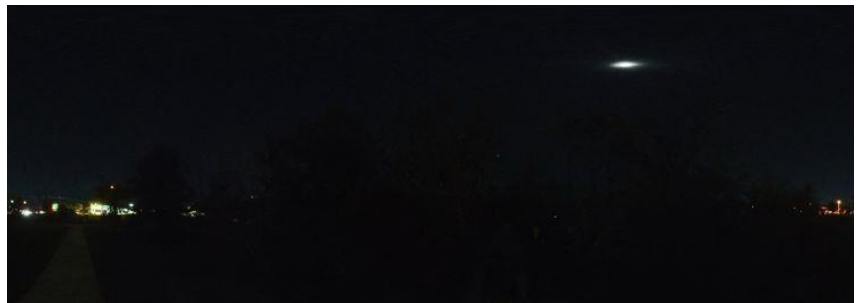
Picture C-114. 360 Image of park access bridge

99- Park Access (Safety Score 56)

The area is very dark, with the only light coming from across the street from the gas station and the streetlights.

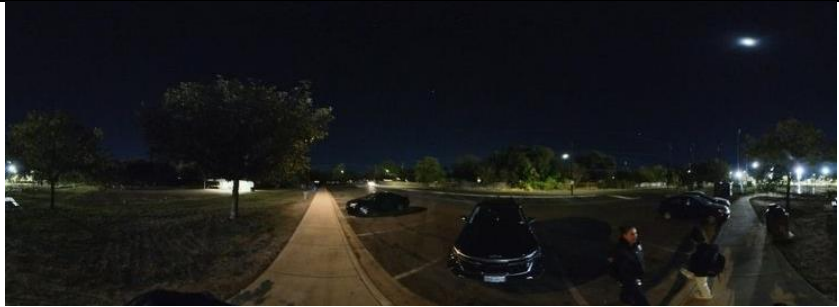
Picture C-115. 360 Image of parking lot

### 101- Parking Lot (Safety Score 51)

There light poles for the parking area with motion sensors. There are a lot of lights coming from the neighboring fields when they are on, but when they are off, it gets dark.

Vertical Illuminance: Low  
Horizontal Illuminance: Low  
Uniformity: Standard  
CRI: Standard  
CCT: Standard

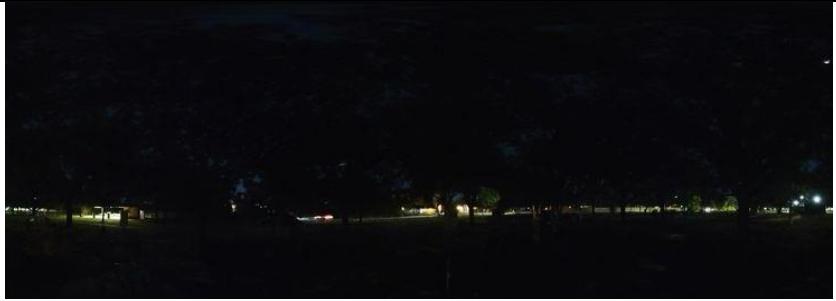
Picture C-116. 360 Image of children's play area

100- Passive Recreation (Safety  
Score 67)

Many individuals experiencing homelessness are camped out at the restroom and the dark pavilion near the play area. The kids' area has no lighting except for what comes from the neighboring houses and the restroom.

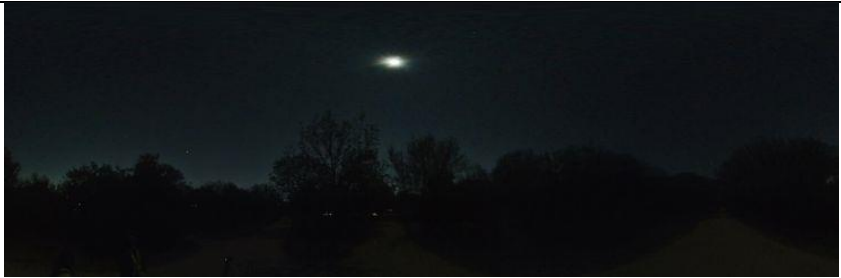
| <p><u>87- Park Center (Safety Score 63)</u></p> <p>There is a low level of light coming from the moon. There are trees on the side, but they are not hovering over the pathway which allows the light from the moon to hit the path.</p> <p><i>Safety Score Rationale:</i><br/> Perception of safety: Average/Low<br/> Reflectance: Dark<br/> Specularity: Matte<br/> Visual Transparency: Low<br/> Physical Transparency: Average<br/> Scale: Average</p> <p><i>Spider Diagram Analysis:</i><br/> Vertical Illuminance: Low<br/> Horizontal Illuminance: Low<br/> Uniformity: Standard<br/> CRI: N/A<br/> CCT: N/A</p> | <p><b>Picture C-117. 360 Image of Pathway</b></p> <p><b>63</b> /100</p> |

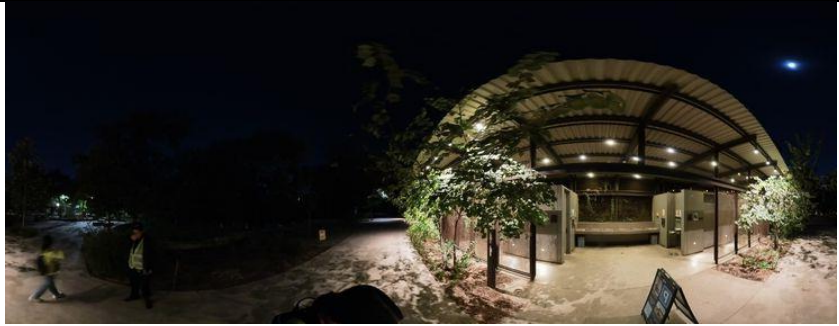
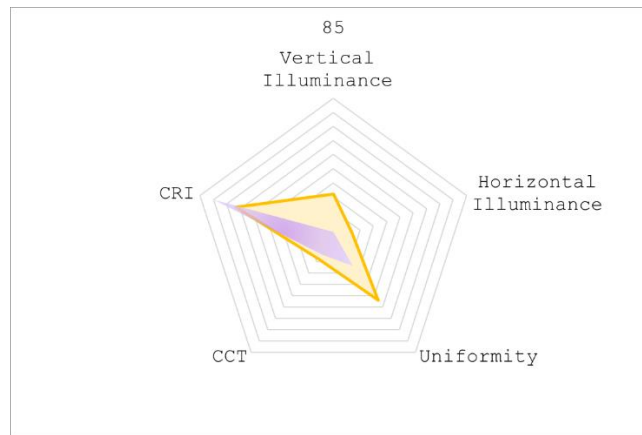
Picture C-119. 360 Image of restroom

The bathroom is equipped with track lights and step lights, creating an even level of light. The bathroom implements different layers of light that make it visible and not too glary. Some people are walking around the area and sitting at the tables, although there are no lights above the tables, making it hard to see.

Vertical Illuminance: Low  
Horizontal Illuminance: Low  
Uniformity: Low  
CRI: High  
CCT: Low
