**City of Austin**

# Parks and Recreation Department Security Audit

## Findings and Recommendations Report

Version 2 | July 18, 2025

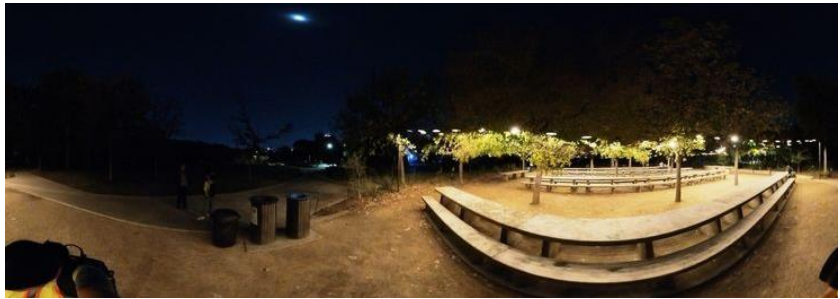
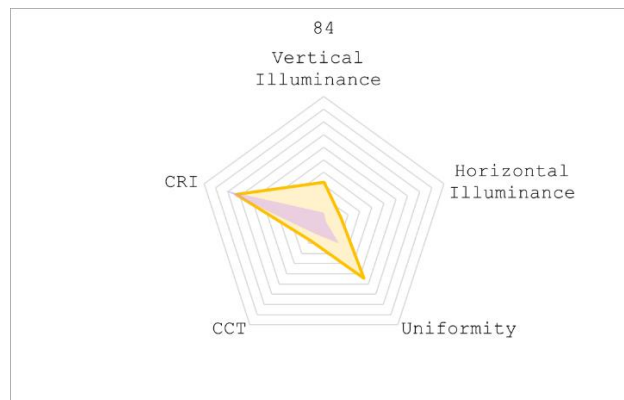
Picture C-120. 360 Image of benches

Warm catenary lights provide a pleasant glow without being too bright or glaring due to the fixture's conical shape. Two people are camping out here, with one using a power outlet. The field next to the park is very dark, but light poles in the parking lot offer some illumination.

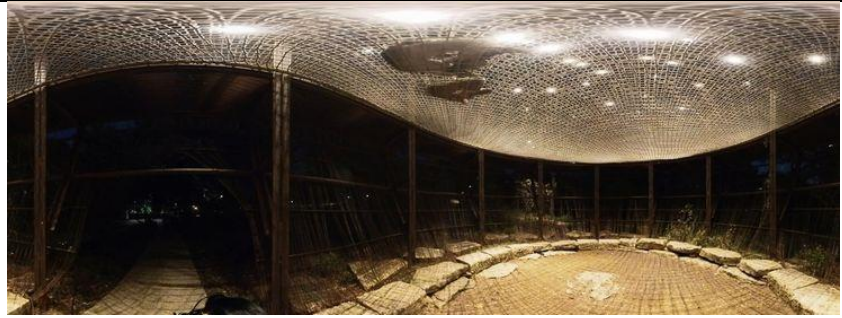
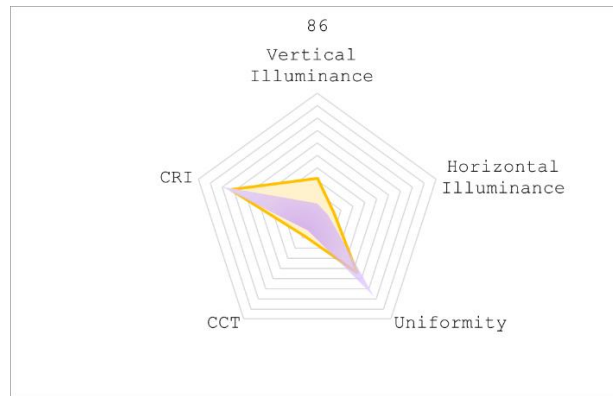
Picture C-121. 360 Image of Tree House

The area features intentional lighting, with pendant lights that resemble stars in the treehouse, and handrail lighting and lights hanging from trees to illuminate the paths. Couples could be seen hanging out on the trampoline structure, enjoying the ambiance.

Vertical Illuminance: Low  
Horizontal Illuminance: Low  
Uniformity: High  
CRI: Standard  
CCT: Low

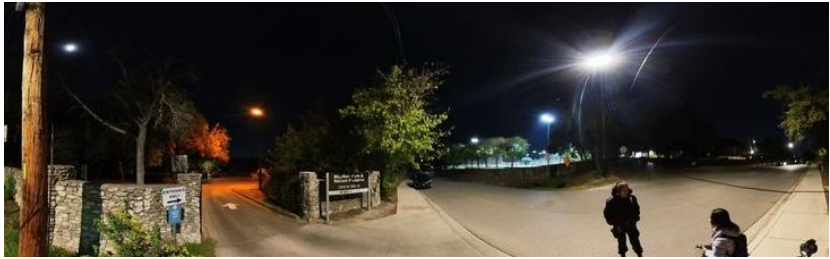
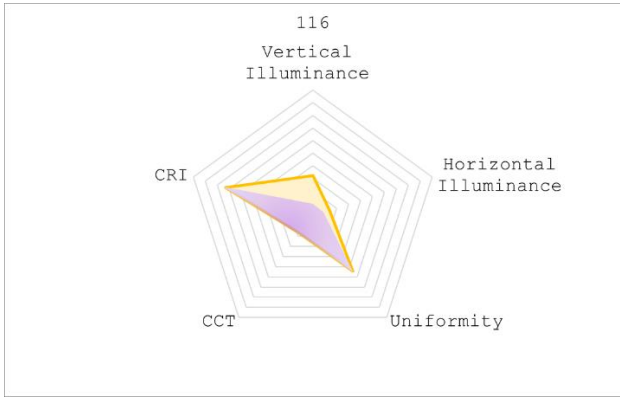
| <p><u>116- Park Access (Safety Score 48)</u></p> <p>Street lights make the area feel well-lit, and flood lights from the tennis court across the street add to the brightness. The pathway closest to the entryway is fairly dark, but there is some light spill from the road and lots of lights from passing cars.</p> <p><i>Safety Score Rationale:</i><br/> Perception of safety: Average/High<br/> Reflectance: Neutral<br/> Specularity: Neutral<br/> Visual Transparency: High<br/> Physical Transparency: Average<br/> Scale: Average</p> <p><i>Spider Diagram Analysis:</i><br/> Vertical Illuminance: Low<br/> Horizontal Illuminance: Standard<br/> Uniformity: Standard<br/> CRI: Standard<br/> CCT: Standard</p> | <p><b>Picture C-122. 360 Image of park entryway</b></p> <p><b>48/100</b></p> |

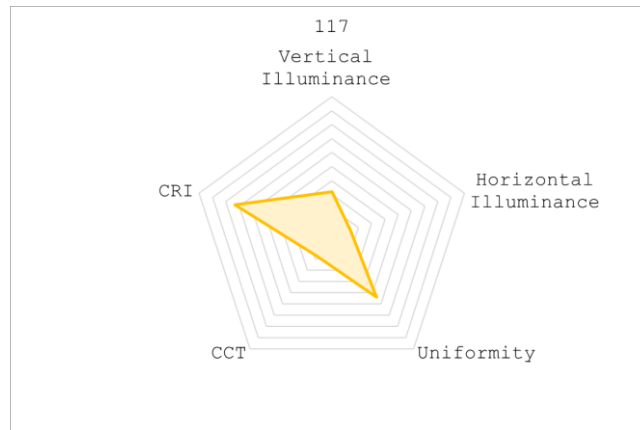
Picture C-123. 360 Image inside the park

The area is very dark, with only the moon and one street light peering through the trees providing illumination. Inside the building, someone left their decorative crystal figure on. It felt very scary walking into the garden area due to the dark pathway needed to get there.

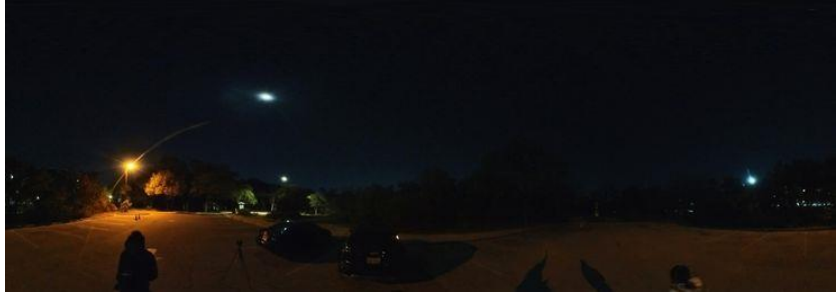
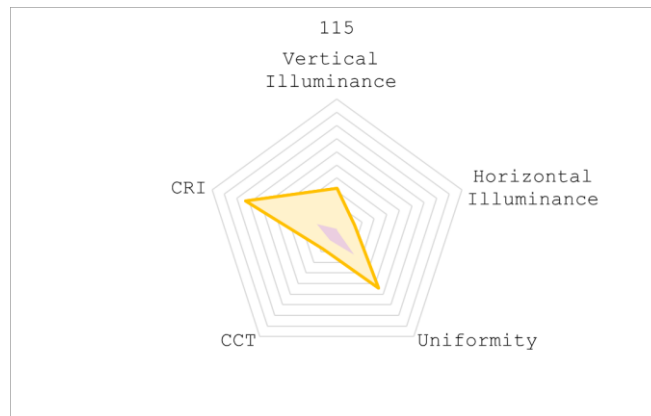
Picture C-124. 360 Image in the parking lot

There is an inconsistent color temperature with one warm light for the parking and one white light at the entry of the park. There is no one in the parking lot, but cars are coming through on the neighboring streets. Across the street, one can see lights from the tennis court.

Vertical Illuminance: Low  
Horizontal Illuminance: Low  
Uniformity: Low  
CRI: Low  
CCT: Low

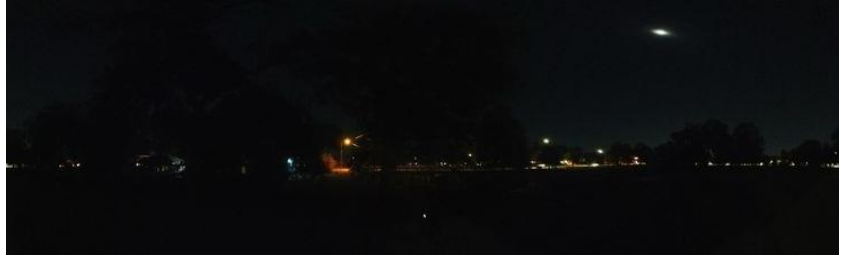
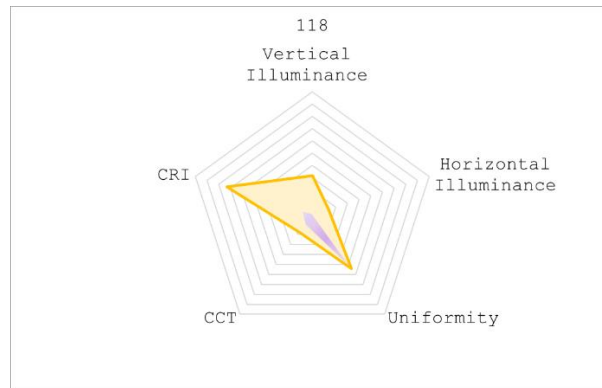
Picture C-126. 360 Image of entry to the park

Vertical Illuminance: Low  
Horizontal Illuminance: Low  
Uniformity: Standard  
CRI: Low  
CCT: Low

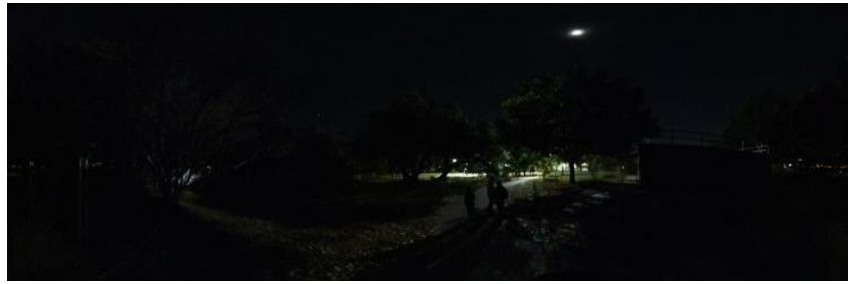
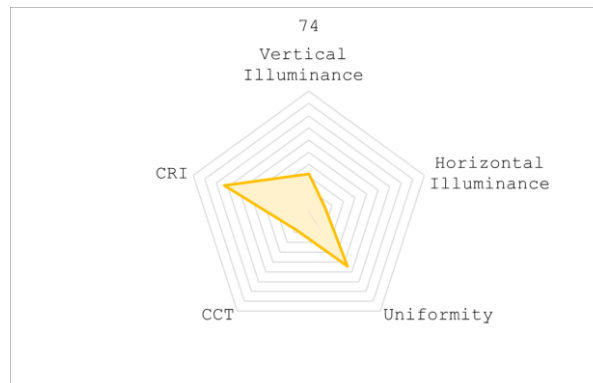
Picture C-127. 360 Image of park center

The area behind the sketchy, gated-off pool facility is quite dark. Some barriers were present to protect vegetation during construction. The playground from afar is well-lit, and the main building with wall packs is visible from here. This path is situated behind people's backyards, and their voices can be heard from their yards.

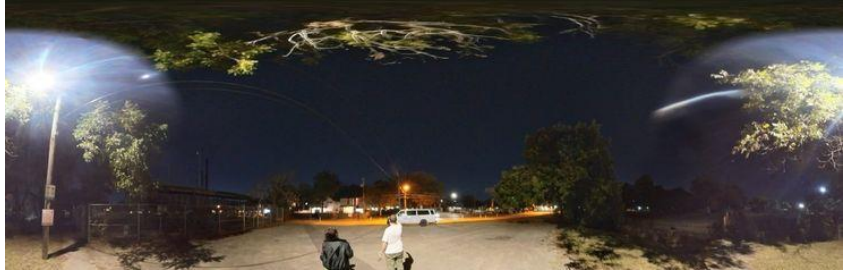
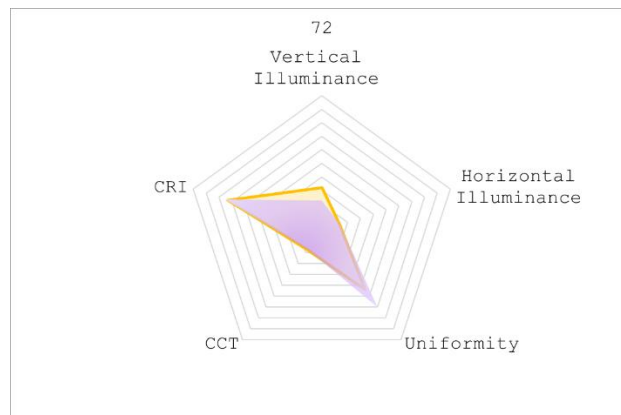
Picture C-128. 360 Image of parking lot

It is very dark across the bridge and path, due to dense vegetation. Warm streetlights provide some illumination across the street. There is one white light poles that illuminates the area. In the parking lot a tree creates a dark hiding place, and a few cars are parked.

Vertical Illuminance: Low  
Horizontal Illuminance: Standard  
Uniformity: High  
CRI: Standard  
CCT: Standard

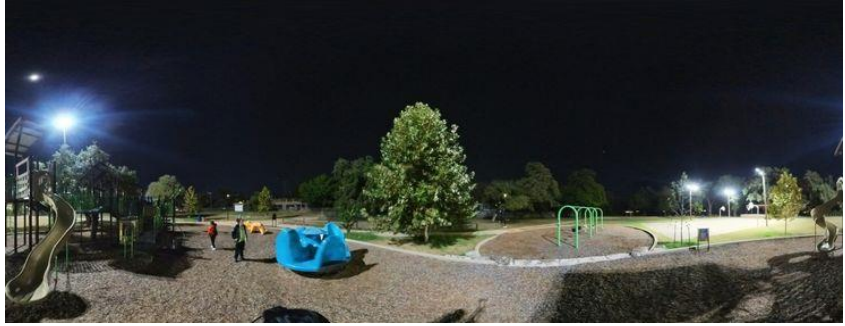
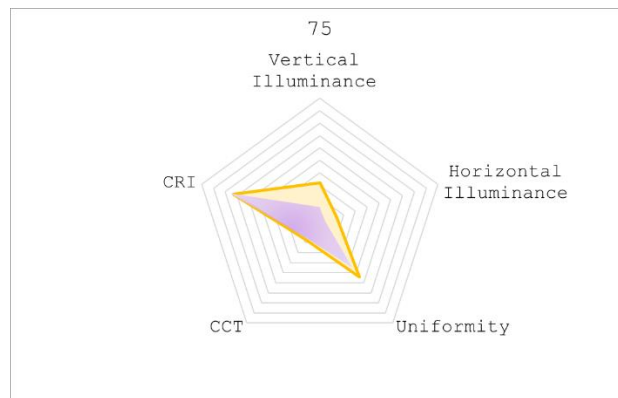
Picture C-129. 360 Image of playground

At the time of survey, someone was sleeping in the playground facility. Along the path motion-sensor lights are installed. The area next to the basketball court is quite bright, thanks to tall flood lights.

Vertical Illuminance: Low  
Horizontal Illuminance: Low  
Uniformity: Low  
CRI: Standard  
CCT: Standard

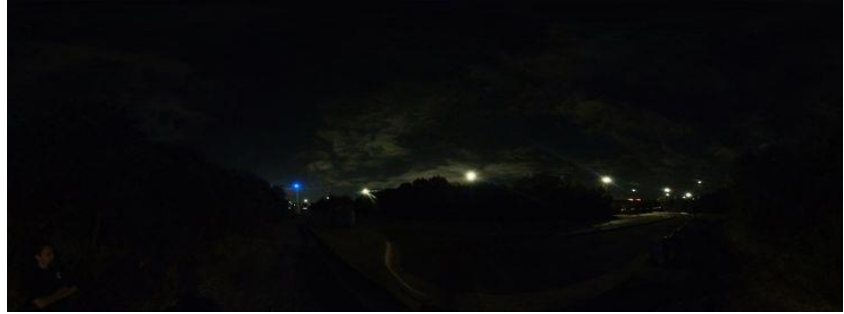
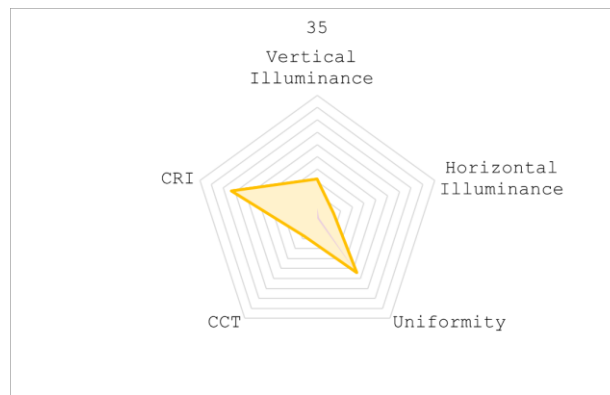
Picture C-130. 360 Image of park access

A blue security lamp monitors the area, and there is a large dumpster next to the road. Visibility under the bridge adjacent to the site is poor. Streetlights from the highway illuminate the area, but the designated streetlight for this spot is broken/off. There are very few cars in the area, and the shrubbery is quite dark. Near the trailhead, after driving around the curve of the road, Barton Creek Mopac Mobility Bridge can be seen.

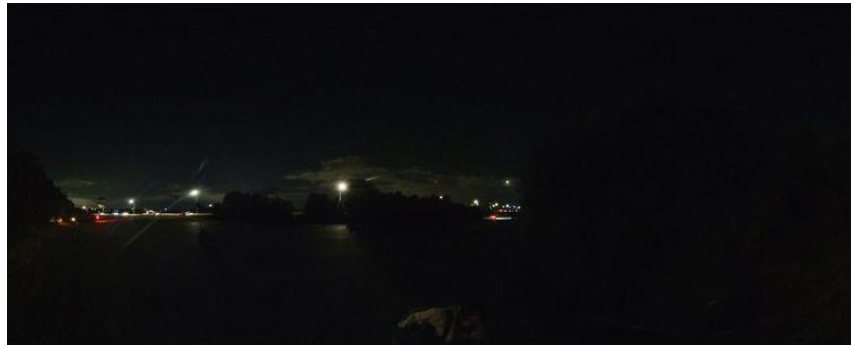
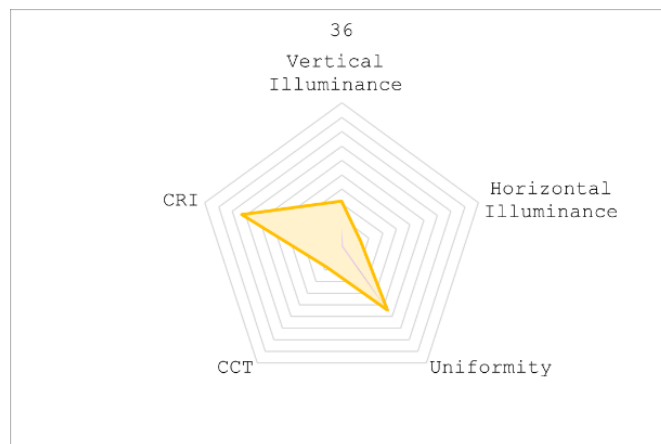
Picture C-131. 360 Image of parking lot

There is a street lamp right in front of the parking lot, which is an offshoot of the main road. Streetlight spillage from the highway provides additional light. Some cars are parked at night, but there is little activity. A security blue light is located at the end of the road near the trailhead.

Vertical Illuminance: Low  
Horizontal Illuminance: Low  
Uniformity: Standard  
CRI: N/A  
CCT: N/A

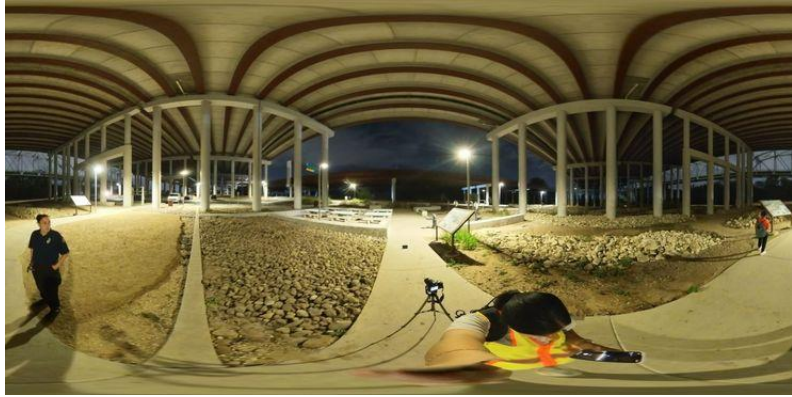
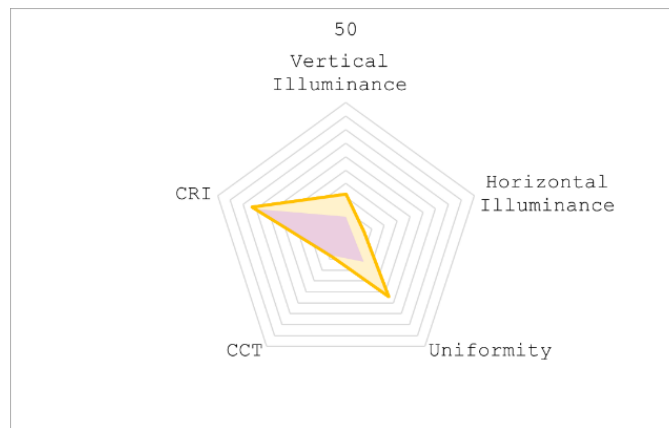
Picture C-132. 360 Image of bench area

The bench area was well-lit with very bright light poles along the paths; however, the surrounding areas were very dark. One person was seen camping out at the benches. At the time of survey, the security guard was confronted by a person who had stolen from them in the past. There was a light pole that was out near the parking lot, and people were seen talking under that light pole. There was very low facial recognition in the dark patches. More people were seen walking in the dark patches than the brightly lit area.

Vertical Illuminance: Low  
Horizontal Illuminance: Low  
Uniformity: Low  
CRI: Standard  
CCT: Standard

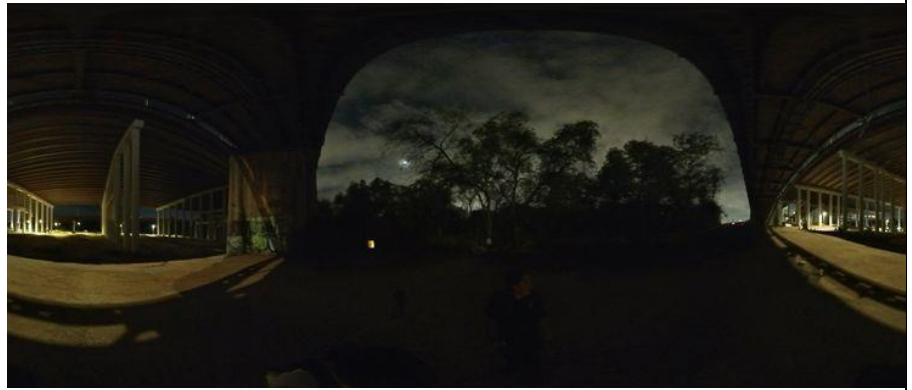
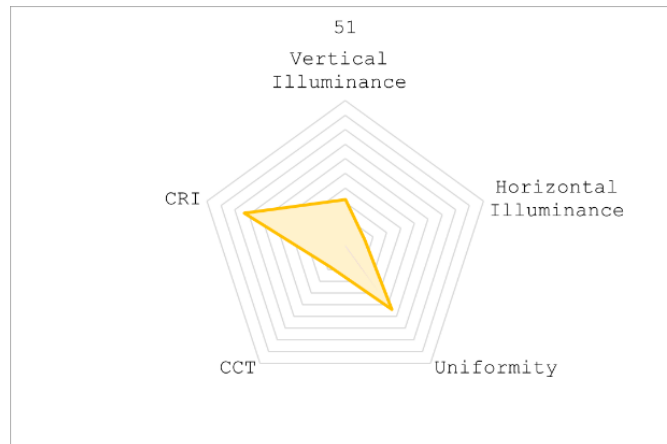
Picture C-133. 360 Image at trail entry

At the time of survey, a couple ventured onto the trail flashlight. Inside the trail, lights were seen indicating the presence of people possibly camping out in the trail at night. Another man could be heard yelling on the bridge. At first, the survey team did not know where the yelling was coming from until they looked up. At this underpass, there was a lot of graffiti on the columns. There were many cars parked at night, and a lot of the vehicles had strong headlights which are very bright to those walking through the area.

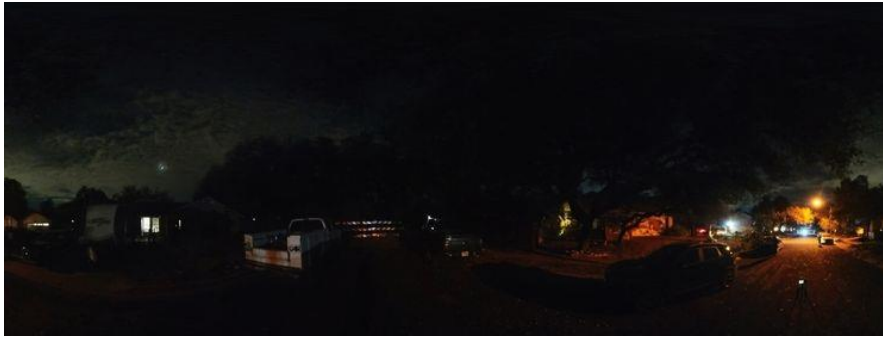
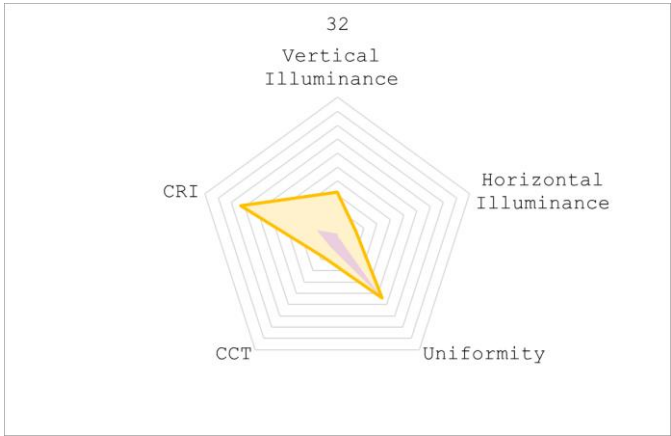
| <p><u>32- Park Access (Safety Score 59)</u></p> <p>The park is adjacent to a neighborhood, with the only light coming from a streetlight. Someone entered the park by carrying their bike above their head. The neighboring houses are heavily decorated due to the survey being around Halloween. The entrance was obscured by parked cars, so we initially could not see that it is connected to the sidewalk path. Occasionally, cars pass through the area.</p> <p><i>Safety Score Rationale:</i><br/> Perception of safety: Average<br/> Reflectance: Dark<br/> Specularity: Matte<br/> Visual Transparency: Average<br/> Physical Transparency: Low<br/> Scale: Average</p> <p><i>Spider Diagram Analysis:</i><br/> Vertical Illuminance: Low<br/> Horizontal Illuminance: Low<br/> Uniformity: Standard<br/> CRI: Low<br/> CCT: Low</p> | <p><b>Picture C-134. 360 Image of park access point</b></p> <p><b>59</b> /100</p> |

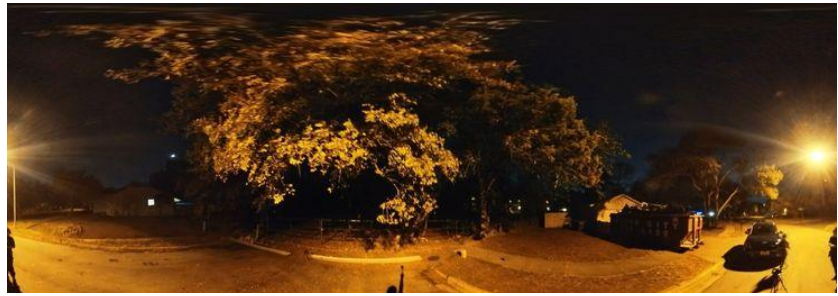
Picture C-135. 360 Image of park entry

This access point is nestled within a neighborhood. Next door, a large trash bin sits outside a house undergoing renovations. A single warm light pole illuminates the entrance. Inside the park, two people were riding bikes equipped with headlamps. The sidewalk extends all the way to the entrance.

Vertical Illuminance: High  
Horizontal Illuminance: High  
Uniformity: Low  
CRI: Low  
CCT: Low

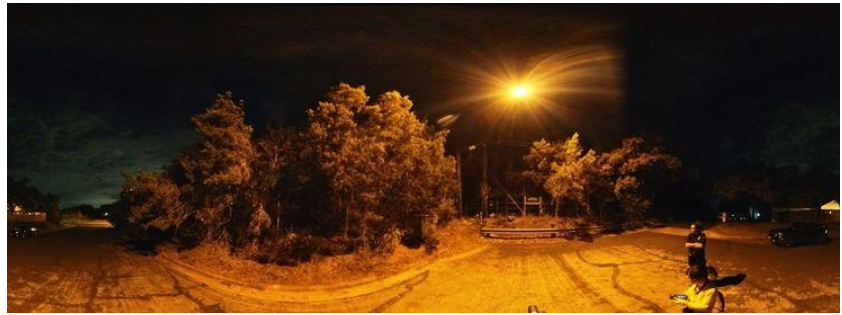
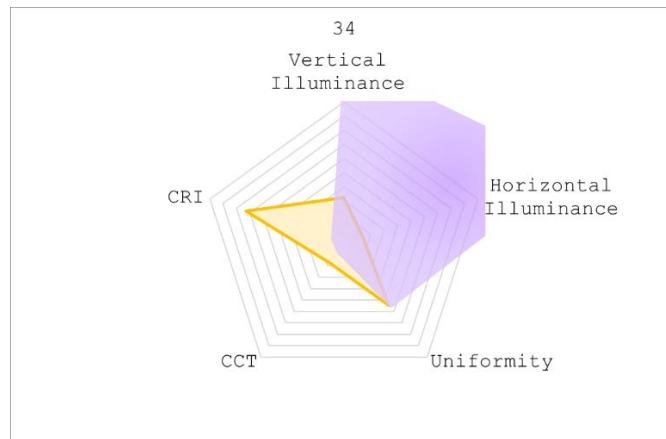
Picture C-136. 360 Image of park access

### 34- Park Access (Safety Score 60)

The main access point to the park is in a neighborhood. To enter, visitors must navigate rocky steps. Clear signage indicates the presence of the park to people. A single warm streetlamp illuminates the entryway, but beyond its light, visibility is limited, making it difficult to see others.

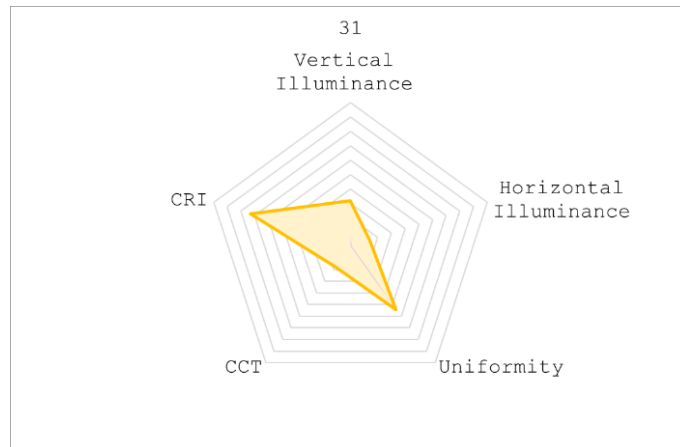
Picture C-137. 360 Image of park access

### 31- Park Access (Safety Score 62)

This access point is situated right next to a street. The entryway lacks dedicated lighting, relying instead on the light from nearby houses and streetlights. The streetlights have varying color temperatures, and one nearby is broken. There is no sidewalk leading to the entrance, making it difficult for pedestrians to be seen by vehicles due to poor visibility.

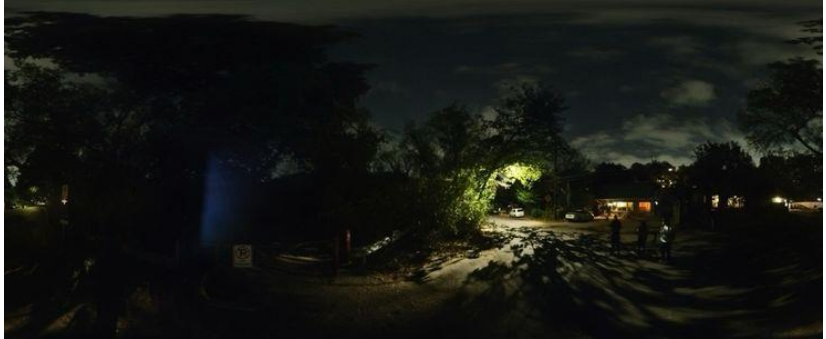
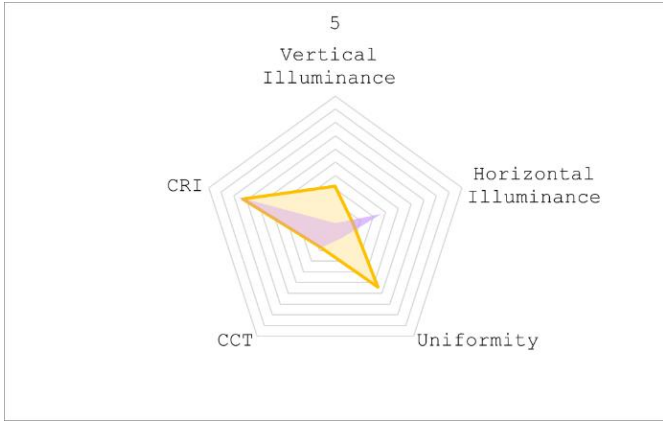
| <p><u>5- Park Access (Safety Score 75)</u></p> <p>The trail access point lacks dedicated lighting and is lit by the streetlight nearby and spillage from the inside of the houses facing it. Prior to data collection, the survey team drove by the access point due to low visibility and low light levels.</p> <p><i>Safety Score Rationale:</i><br/> Perception of safety: Low<br/> Reflectance: Dark<br/> Specularity: Matte<br/> Visual Transparency: Low<br/> Physical Transparency: Low<br/> Scale: Average</p> <p><i>Spider Diagram Analysis:</i><br/> Vertical Illuminance: Low<br/> Horizontal Illuminance: High<br/> Uniformity: Low<br/> CRI: Standard<br/> CCT: Standard</p> | <p><b>Picture C-138. 360 Image of neighborhood access point</b></p> <p><b>75</b>/100</p> |

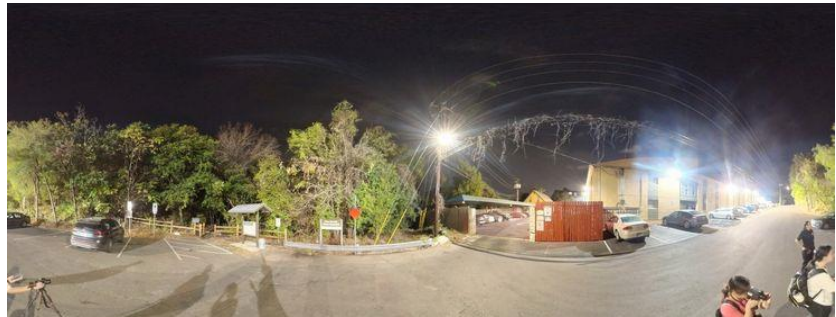
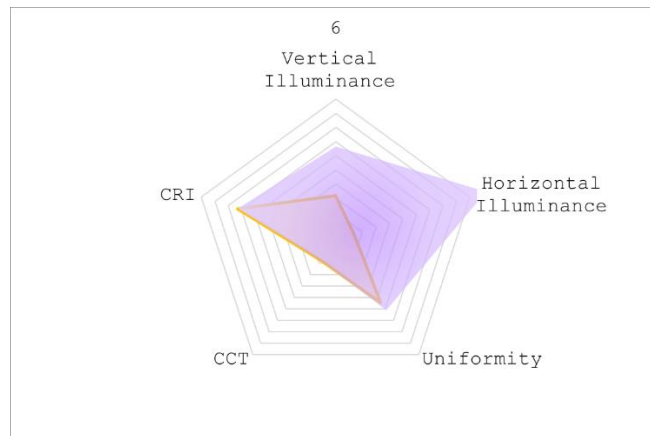
Picture C-139. 360 Image of main access point

### 6- Park Access (Safety Score 63)

The trail main access point lacks dedicated lighting, relying only on the lights from the wall packs on the neighboring apartment and the light pole for the parking lot. Looking into the trail, nothing can be seen due to the darkness.

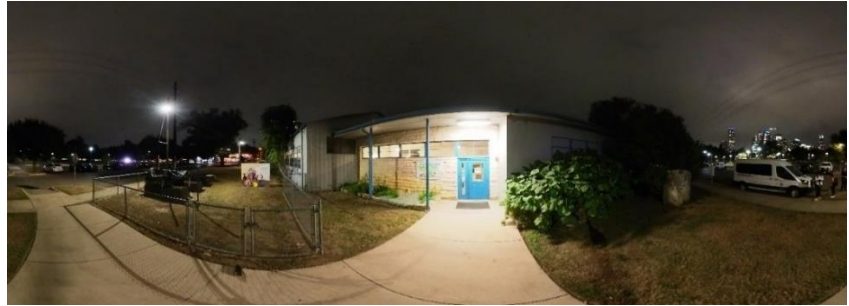
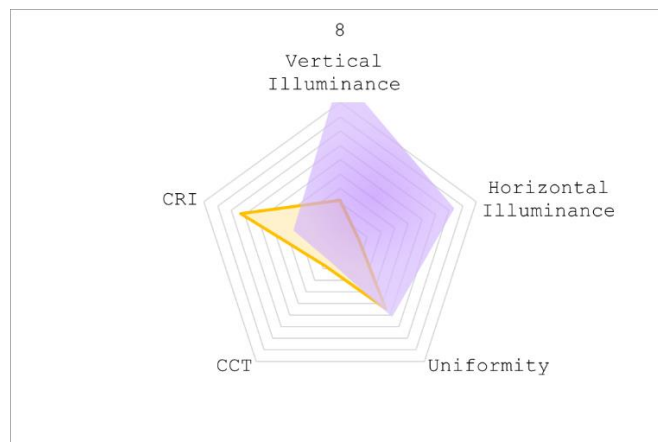
Picture C-141. 360 Image of east entry

### 8- Facility Entry (Safety Score 41)

The entryway features a bright, overhead linear fixture that illuminates both the door and the path. Light spills from the windows, revealing children inside the building. The garden remains dimly lit due to the absence of designated lighting.

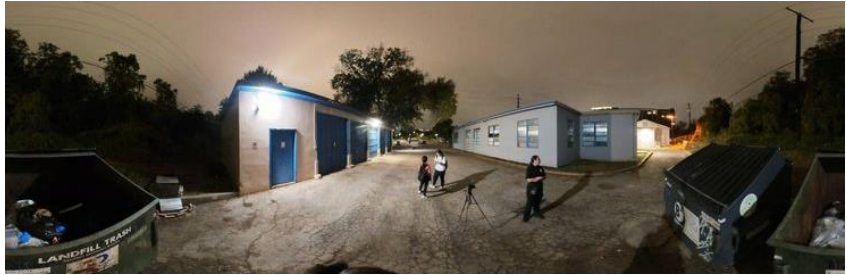
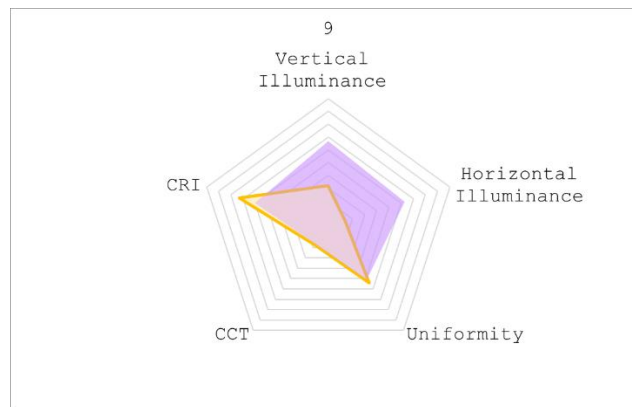
Picture C-142. 360 Image of loading dock

### 9- Facility Back Entry (Safety Score 61)

The loading dock has bright wall packs, in which some were not operational. There were some areas of low visibility around the corners of the building and through the vegetation near the creek side.

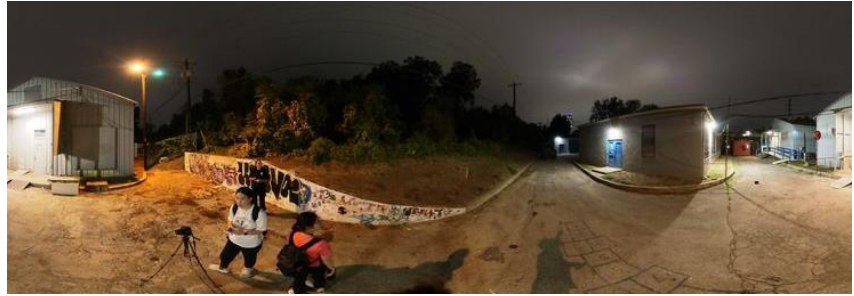
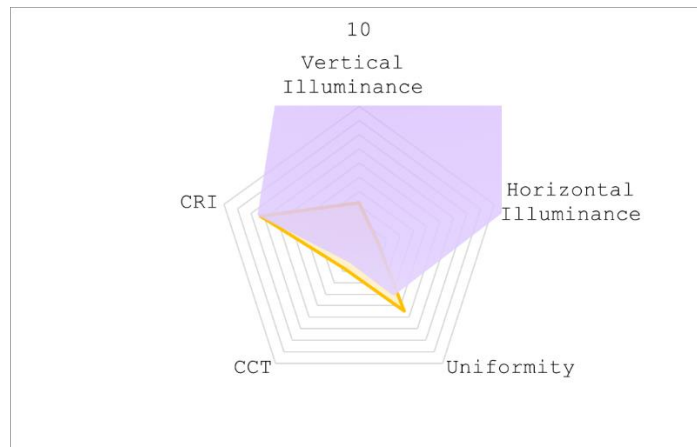
Picture C-143. 360 Image of the back of the facility

### 10- Facility Back Entry (Safety Score 51)

The back of the facility is equipped with wall packs on the walls and linear fixtures at the entrances. There are play features for kids, like four square and hopscotch, but they are faded, unlit, and no one was seen using them.

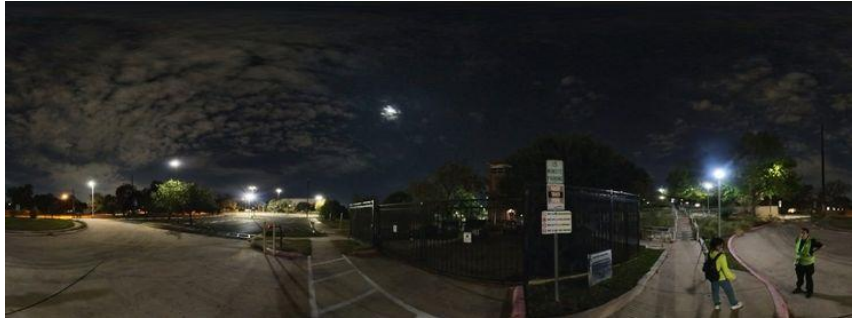
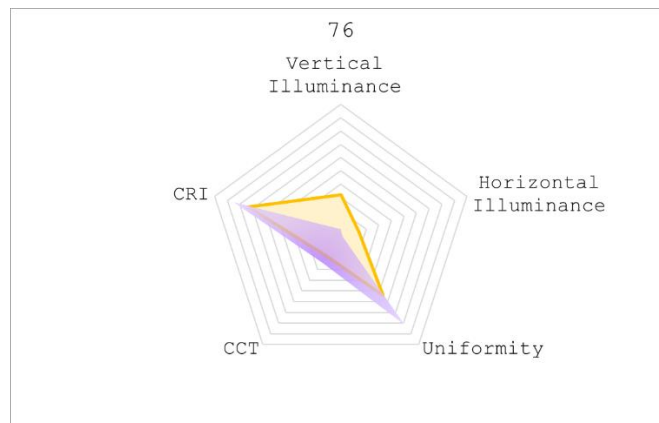
Picture C-144. 360 Image of parking lot

### 76- Parking Lot (Safety Score 52)

In the parking lot, light poles provide illumination, and a moonlight tower is visible. Short, indirect light poles line the stairway, though one is broken in a dark corner. Some people walk through this path, but vegetation blocks some of the light from the poles. Wall packs are present on the loading dock side.

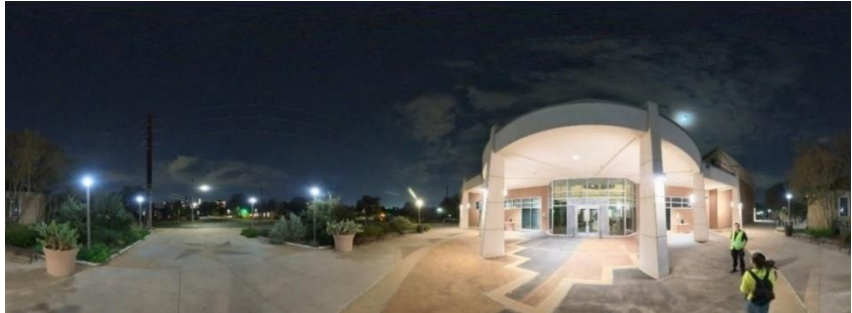
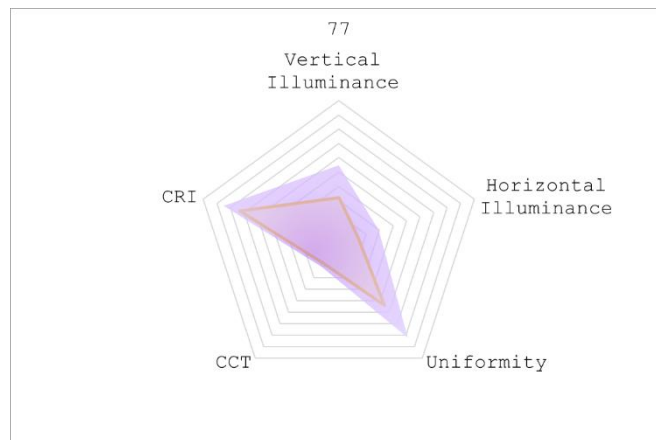
Picture C-145. 360 Image of facility entry

### 77- Facility Entry (Safety Score 47)

The entry is illuminated by down lights and wall-mounted fixtures on the columns. A person is staying in a single tent outside the building. The light poles all around this museum have different color temperatures. Nonetheless, the entry walkway is well-lit by these poles, and the lights are not glaring.

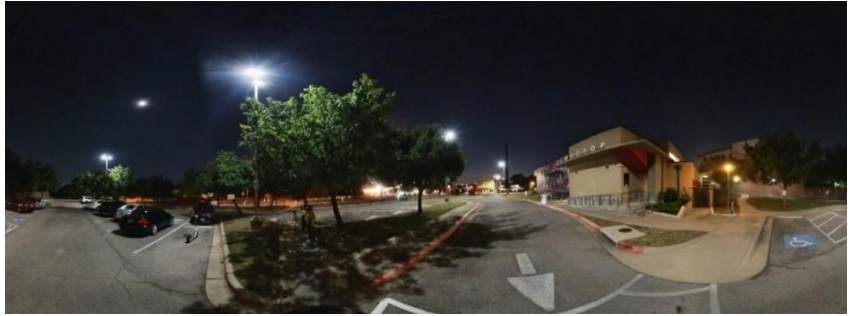
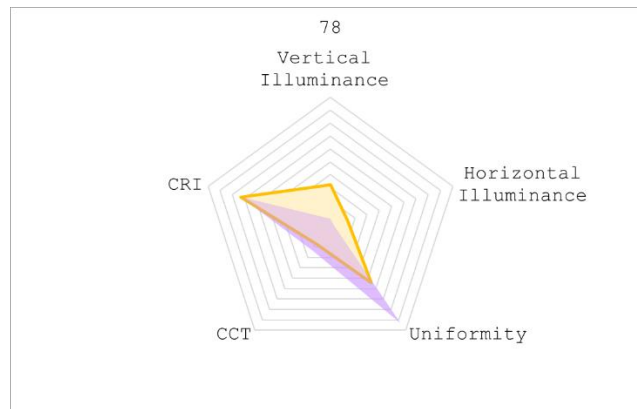
Picture C-146. 360 Image of parking lot

### 78- Parking Lot (Safety Score 47)

There are white LED light poles in the parking lot and shorter light poles near the building have different color temperatures. The area is next to some restaurants and houses. The mural on the library has no lighting. The wall packs on the library were not on.

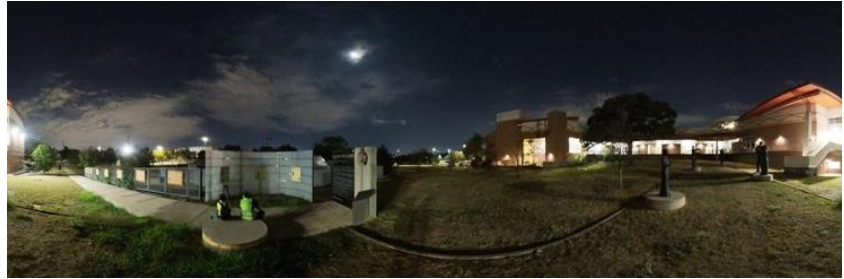
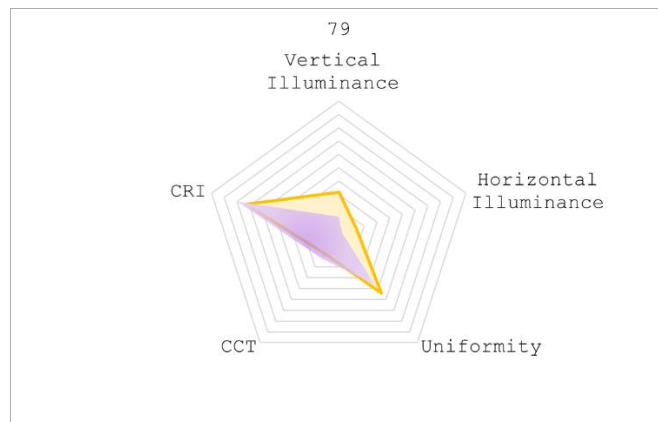
Picture C-147. 360 Image of facility back entry and exhibit

79- Arts and Culture (Safety Score 53)

Wall packs on the wall illuminate the space quite well. Higher output wall packs are above the stairs and another above the exit doors. Statues and historical information signs are not lit with their own lighting. There is major light spill coming from inside the building.

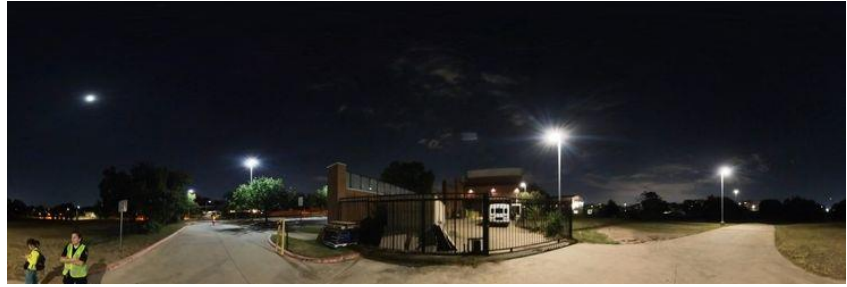
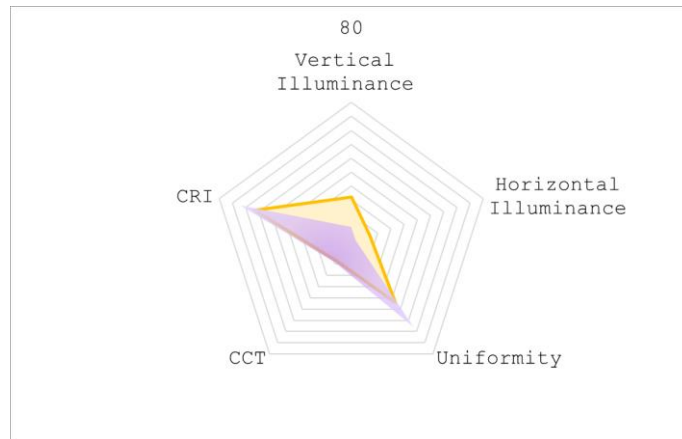
Picture C-148. 360 Image at the loading dock

### 80- Facility Back Entry (Safety Score 50)

There are LED light poles lining the pathway and wall packs are installed on the building. Trash storage bins and a bus are inside the gate. The trees on the side are very dark and unlit, making it difficult to see anything at all.

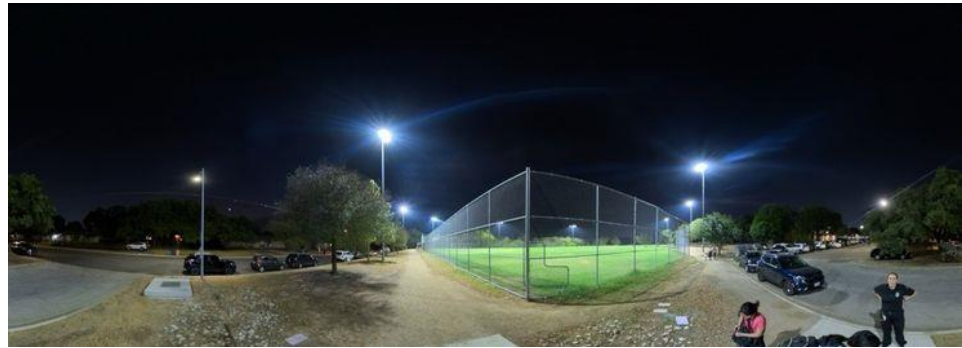
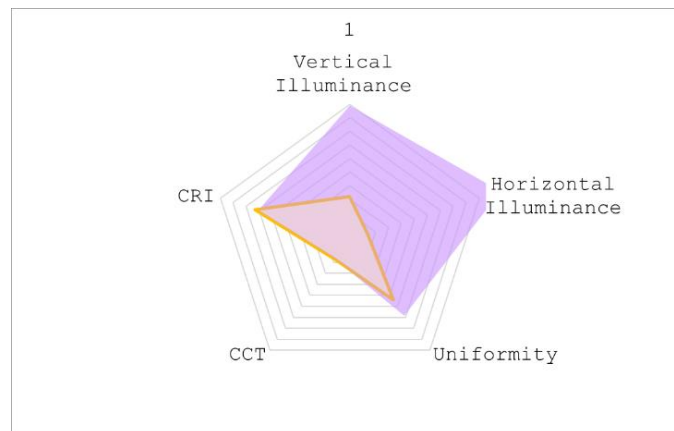
Picture C-149. 360 Image of parking lot entry

1 - Parking Lot (Safety  
Score 42)

The recreation center parking entrance leads to a fully utilized parking lot when there are games. The entry way is lit by a warm street light pole, and there is light spill from bright, neighboring flood lights on the field.

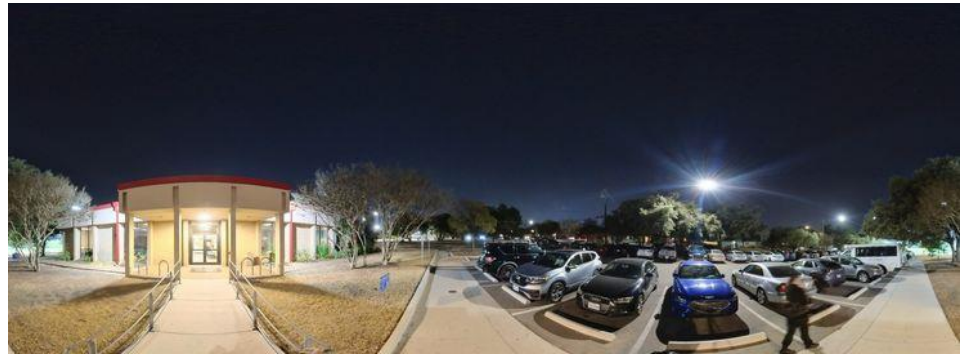
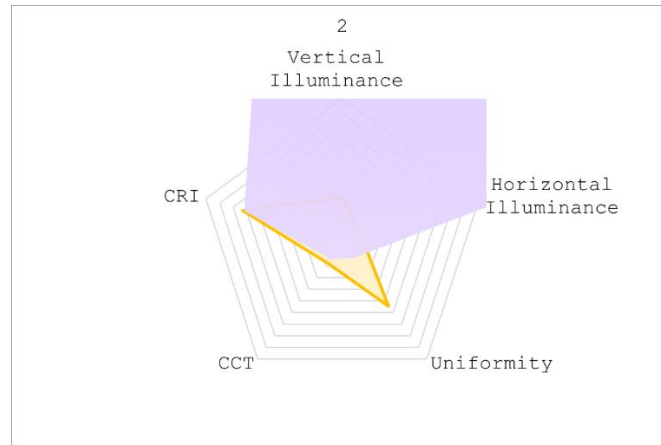
Picture C-150. 360 Image of facility entryway

## 2 - Facility Entry (Safety Score 42)

The entrance of the facility is lit by a warm, bright ceiling mounted fixture. Light spills from the interior of the building through the glass doors. There are people frequently walking in and out to use the facility.

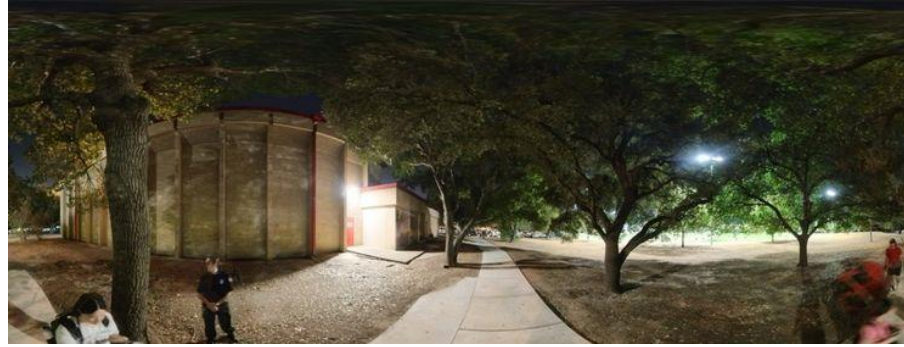
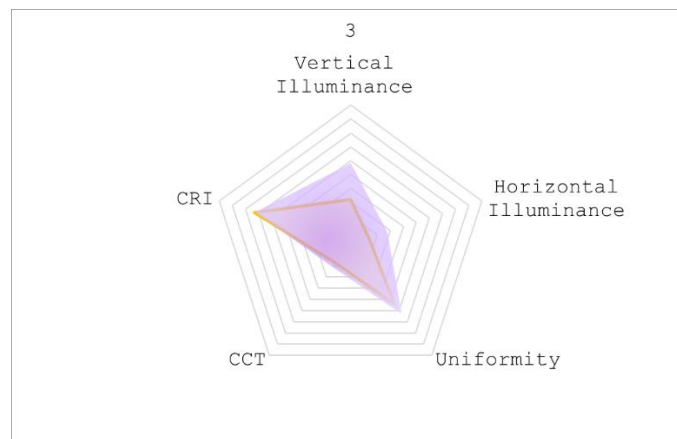
Picture C-151. 360 Image of park pathway

### 3 – Park Center (Safety Score 55)

The side entry of the building had a bright, glary wall pack above the door which causes a spotlight effect at the door. The side of the facility was very dark in comparison to the entry way, and a figure was seen hiding in the dark patch. The pathway had little foot traffic.

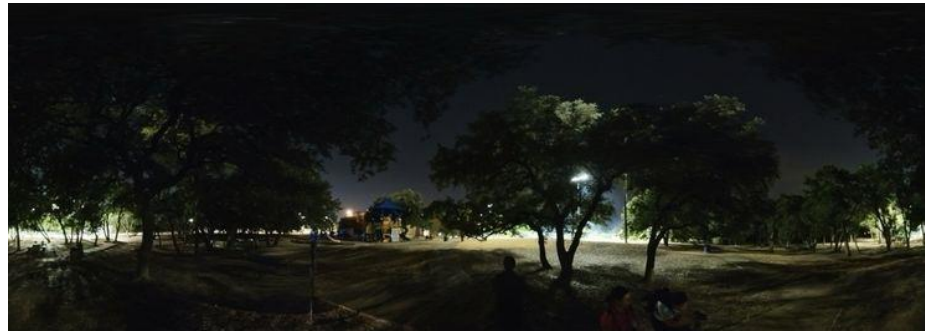
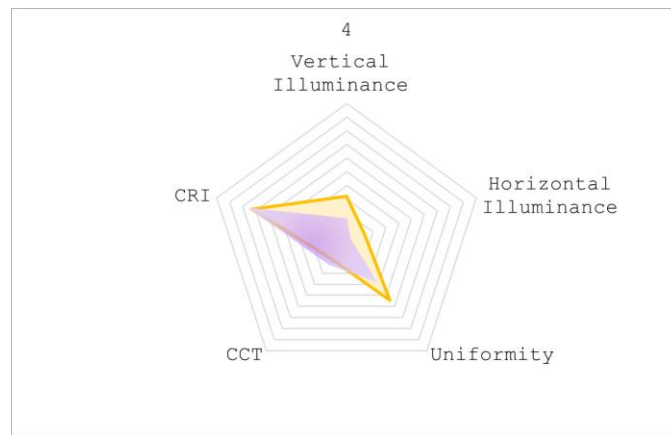
Picture C-152. 360 Image between courts and playground

4 - Active Recreation  
(Safety Score 57)

The pathway has many trees, and while the courts are crowded, the pathways are not. The only light on the pathway comes from the floodlights on the field, causing some pedestrians to carry flashlights to see. The playground has no dedicated lighting, but it was in use by families.

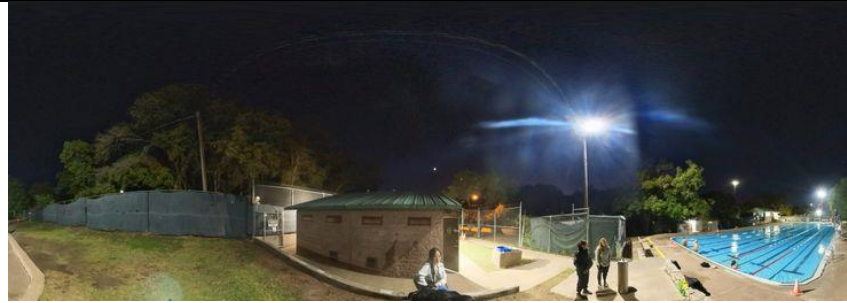
Picture C-154. 360 Image inside the pool

During the visit, several people were using the pool facility, which is brightly lit by pool lights that flood the entire area. Additional lighting comes from wall packs on the buildings and the moonlight tower on Leland & Eastside Drive.

Vertical Illuminance: High  
Horizontal Illuminance: High  
Uniformity: Low  
CRI: Low  
CCT: Standard

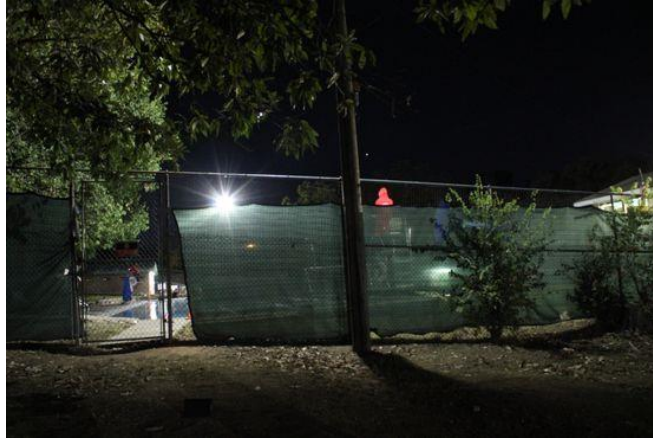
Picture C-155. Phone image towards the back entryway

This entry was closed at the time of survey and there were no cars in parking lot. Around this entrance, one can see Travis Heights Elementary School and its playground facility. Although the school itself is brightly lit by wall packs, the park itself does not have any designated lighting. There is light flooding from the inside of the pool facility itself and the moonlight tower on Leland & Eastside Drive as well.

Vertical Illuminance: High  
Horizontal Illuminance: Low  
Uniformity: Low  
CRI: Low  
CCT: Low

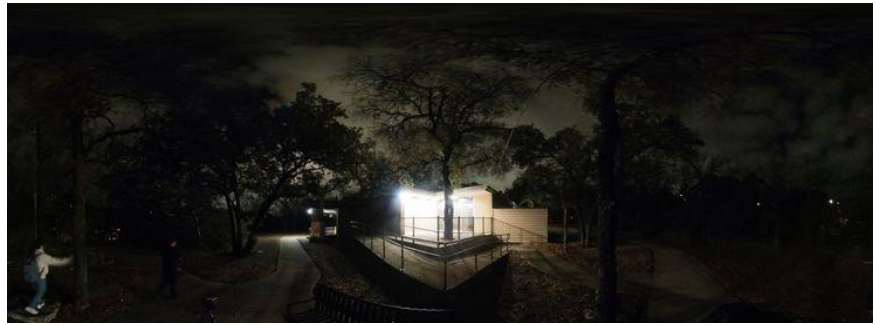
**Picture C-156. 360 Image of the annex facility back entryway**

The exterior of the building is equipped with wall packs and troffers, which are very bright. There is a spotlight effect from the lights on the building making it difficult to see past the woods, affecting the perception of safety. The pathway next to the building is well illuminated, but there is no pedestrian pathway lighting for the pathway as it goes further away.

Vertical Illuminance: High  
Horizontal Illuminance: Standard  
Uniformity: Low  
CRI: High  
CCT: Standard

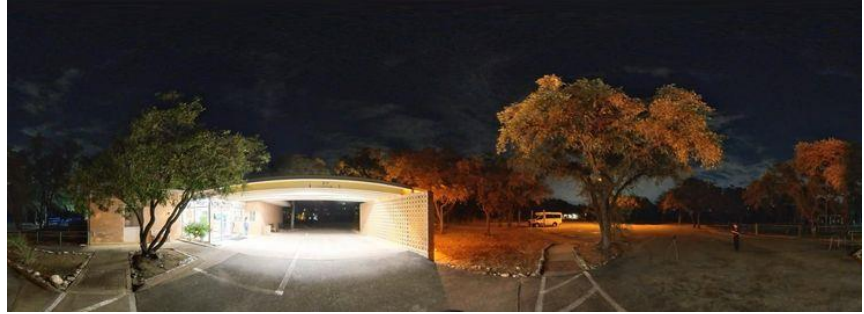
Picture C-158. 360 Image of facility front entryway

The entryway is very bright, with light spill from inside the building. The color temperature is inconsistent, with white light coming from inside the canopy, and warm light illuminating the facility sign. The neighboring park itself is not illuminated. There is one streetlight for the parking.

Vertical Illuminance: High  
Horizontal Illuminance: High  
Uniformity: Low  
CRI: High  
CCT: Standard

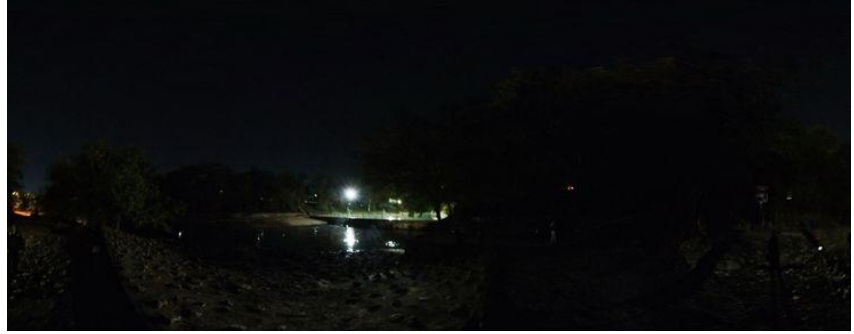
Picture C-159. 360 Image of waterside platform

Light from the pool spills onto the path, but otherwise, it is very dark with no lights at this point. The stairs leading to this area are very rocky and dark, making it easy to trip. Activity seen in this area includes fishing, drug use, and busking.

Vertical Illuminance: Low  
Horizontal Illuminance: Low  
Uniformity: Standard  
CRI: N/A  
CCT: N/A

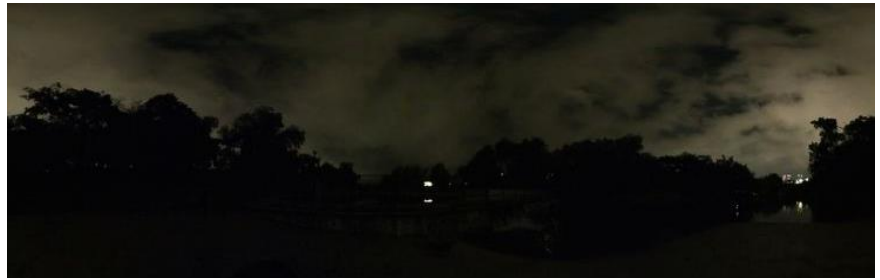
Picture C-160. 360 Image of waterside platform

The light from the pool turned off at 10 PM, leaving this area dark. Someone's belongings were on the platform, and the path to the ledge was difficult to navigate due to the lack of lighting. The only sources of lights were the from the pool facility and the city skyline.

Vertical Illuminance: Low  
Horizontal Illuminance: Low  
Uniformity: Standard  
CRI: N/A  
CCT: N/A

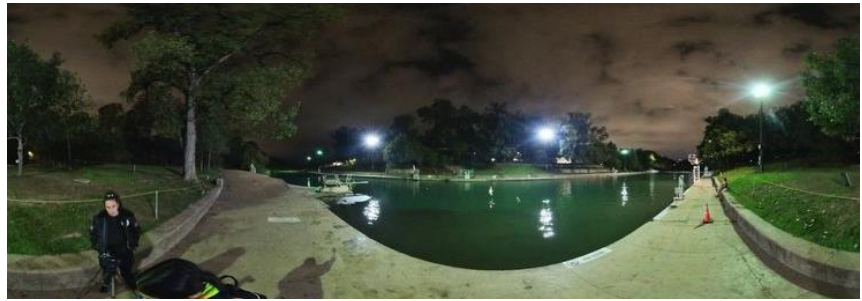
Picture C-161. 360 Image inside the pool

There are a handful of swimmers in the pool. Flood lights on poles provide ample lighting to the pool and parkway. However, the walkway to the pool is not well illuminated and can be a tripping hazard if not careful. There is light coming from the pool facility. Trees surround the lawn and pool.

Vertical Illuminance: High  
Horizontal Illuminance: High  
Uniformity: High  
CRI: Low  
CCT: Standard
