**City of Austin**

# Parks and Recreation Department Security Audit

## Findings and Recommendations Report

Version 2 | July 18, 2025

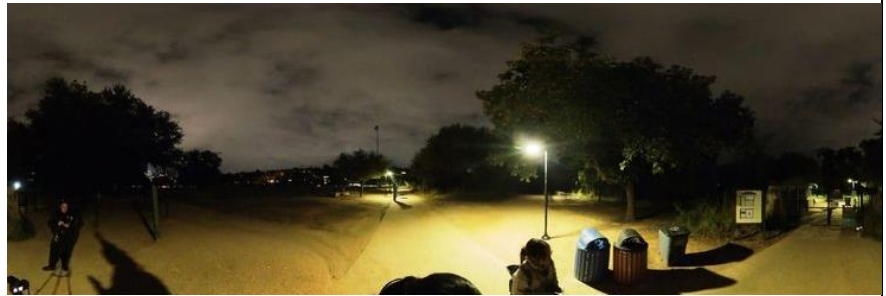
Picture C-162. 360 Image of park admission entry

There is a lot of pedestrian lighting on the path toward the entry point, with many low-level light poles. The field lights next to this area were not on. The admission booth was lit by the neighboring light poles along the pathway.

Vertical Illuminance: Low  
Horizontal Illuminance: High  
Uniformity: Low  
CRI: Low  
CCT: Standard

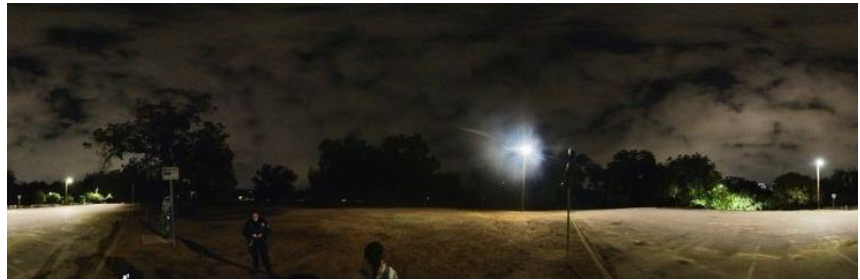
Picture C-163. 360 Image of parking lot

There are light poles for the parking lot, but it was hard to see beyond into the field and the pool due to the lack of other light sources. Although people could be heard from the field, they were not visible. A path next to the parking lot led to a dead end where an unhoused person was sleeping.

Vertical Illuminance: High  
Horizontal Illuminance: Standard  
Uniformity: Low  
CRI: Standard  
CCT: Standard

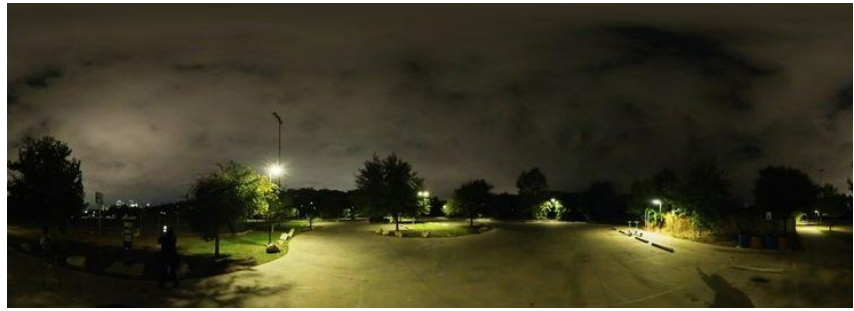
Picture C-164. 360 Image of parking lot

This parking lot is illuminated by light poles that provide patches of light throughout the entirety of the lot.

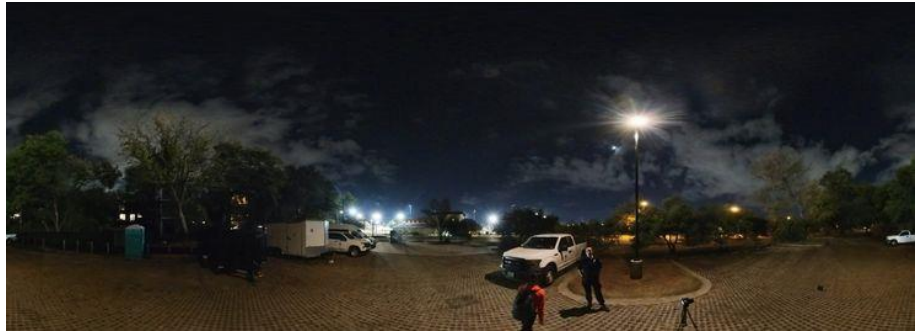
| <p><b><u>46 - Parking Lot (Safety Score 63)</u></b></p> <p>The parking lot has light poles, with additional light spilling over from nearby residential areas and field lights. COA cars and trailers are parked here. Some trees partially block the view to the neighboring residences, but not significantly. There is a large dumpster in the area.</p> <p><i>Safety Score Rationale:</i><br/> Perception of safety: Average<br/> Reflectance: Neutral<br/> Specularity: Neutral<br/> Visual Transparency: Average<br/> Physical Transparency: Average<br/> Scale: Average</p> <p><i>Spider Diagram Analysis:</i><br/> Vertical Illuminance: Low<br/> Horizontal Illuminance: Low<br/> Uniformity: Standard<br/> CRI: Standard<br/> CCT: Low</p> | <p><b>Picture C-165. 360 Image of parking lot</b></p> <p><b>63 /100</b></p> |

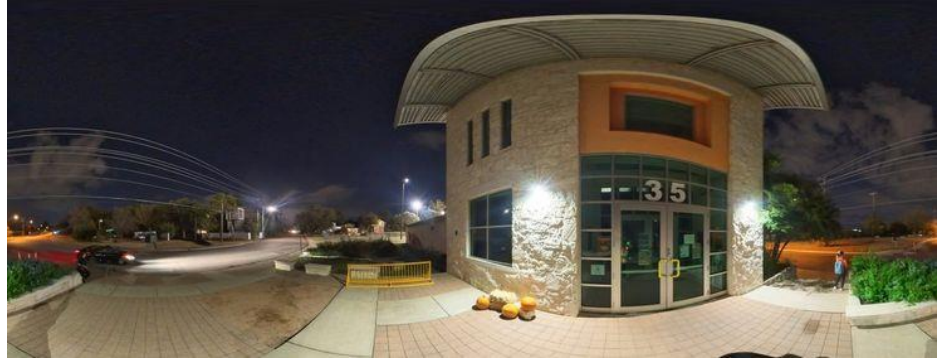
Picture C-166. 360 Image of facility entryway

Wall packs illuminate the entrance, with light spilling from the floodlights on the fields. The area is next to a street and adjacent to apartments, with warm street lights providing additional illumination. There was not much activity at the facility due to the building being closed, but there are a lot of people on the fields when there are recreational activities.

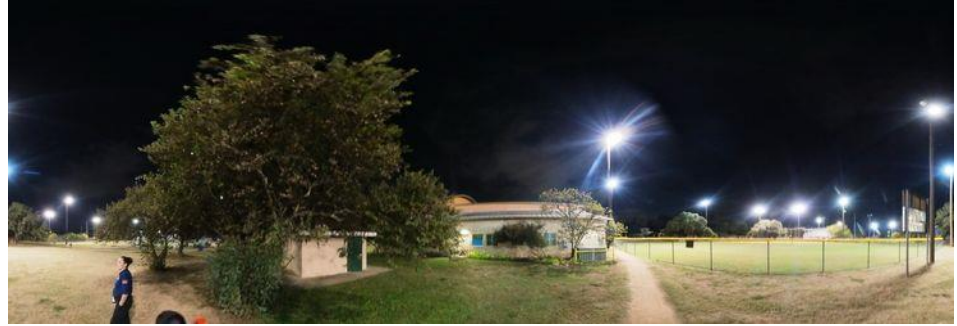
**Picture C-167. 360 Image near athletic fields**

On the paths the area is well lit by the neighboring field lights and wall pack on the facility. However, the bathroom lights on the bathroom between all the fields are broken, including the interior. The site is busy with kids, parents, and people walking their dogs. Recreational activities and leagues are common here.

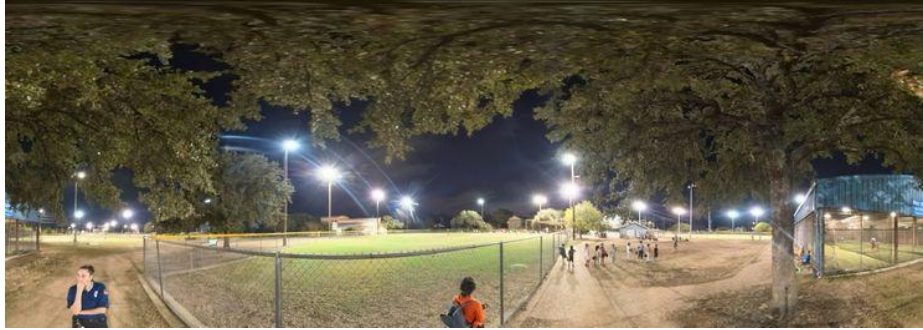
Picture C-168. 360 Image near athletic fields

Kids are playing in the fields and grass areas. At the time of survey, kids were running around the batting cage (where the storage container is), which is mostly see-through except for one wall which could impede visibility. Floodlights from the fields provide ample illumination, though some light poles and light on the batting cage are out.

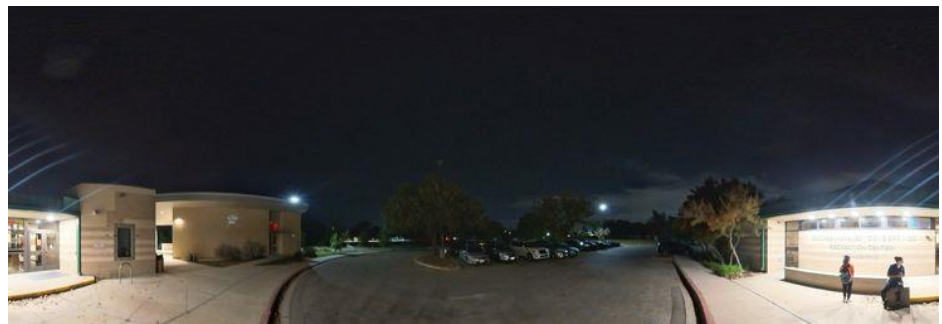
**Picture C-169. 360 Image near facility entryway**

At the entry of the facility, there are downlights that light the sign and there is also light shining through the window from the inside of the facility. Some fixtures were broken including the wall pack above a window and a light pole in the parking lot.

**Safety Score Rationale:**  
Perception of safety: Average/High  
Reflectance: Neutral  
Specularity: Neutral  
Visual Transparency: Average  
Physical Transparency: Average  
Scale: Average

**Spider Diagram Analysis:**  
Vertical Illuminance: Low  
Horizontal Illuminance: Low  
Uniformity: Low  
CRI: High  
CCT: Standard

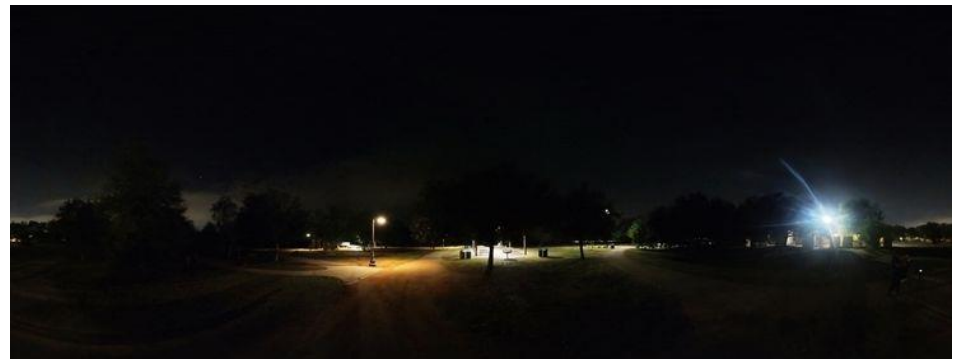
Picture C-170. 360 Image near pavilion and playground

The pavilion was well-lit and seemed like a good hangout spot, with one unhoused person present. The playground had some lighting from the pathway around it. There was a wall pack on the facility that shines on the storage containers around the facility.

**Safety Score Rationale:**  
Perception of safety: Average  
Reflectance: Dark  
Specularity: Neutral  
Visual Transparency: Average  
Physical Transparency: High  
Scale: Average

**Spider Diagram Analysis:**  
Vertical Illuminance: Low  
Horizontal Illuminance: Low  
Uniformity: Low  
CRI: Standard  
CCT: Standard

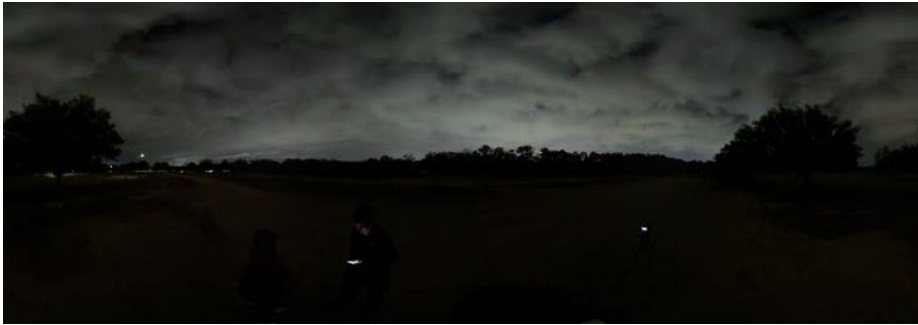
| <p><u>61 – Parking Lot (Safety Score 56)</u></p> <p>There was no light except for some light poles in the parking lot. Trees and vegetation surrounded the area. Facial recognition was not good for those further away, but overall there were few hiding spots since it was an open field and everything was flat.</p> | <p><b>Picture C-172. 360 Image at the edge of the parking lot</b></p> |

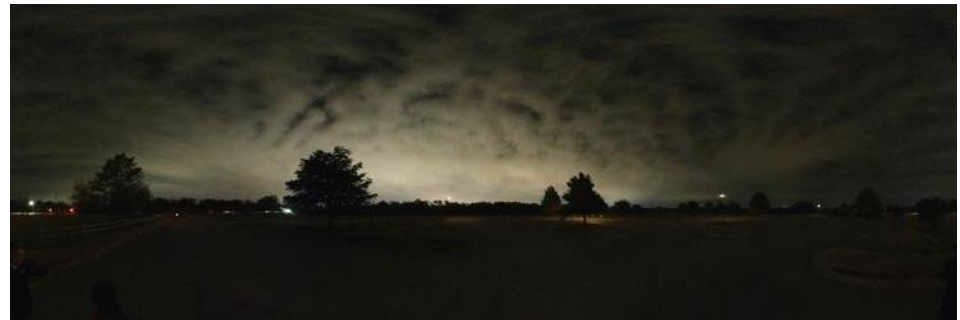
Picture C-173. 360 Image of the parking lot

**62 - Parking Lot (Safety Score 51)**

There was no lighting at the entrance of the parking lot. The light poles had a relatively low output. The gate was blocked off for cars due to reseeding the grass and maintenance. Although it was dark, it felt safe because there was no one around and it was an open space.

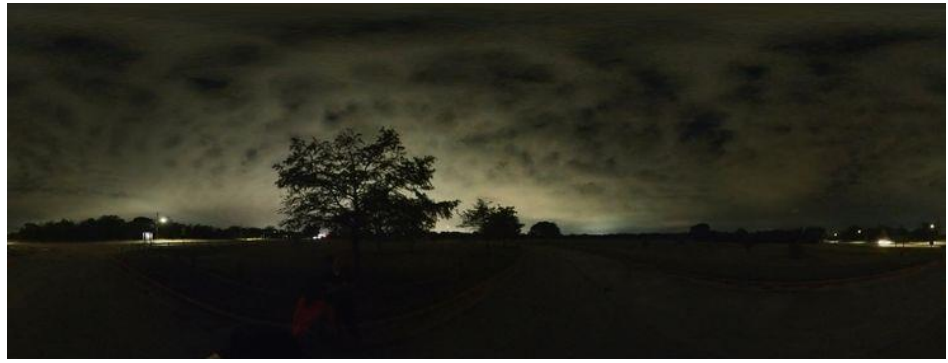
**Picture C-174. 360 Image of the vehicle entryway**

**63 – Park Access (Safety  
Score 52)**

There was no designated lighting for the entryway, and there were no light poles or structures on the field. Streetlights were the only source of light for this entryway. The gate was put up for cars.

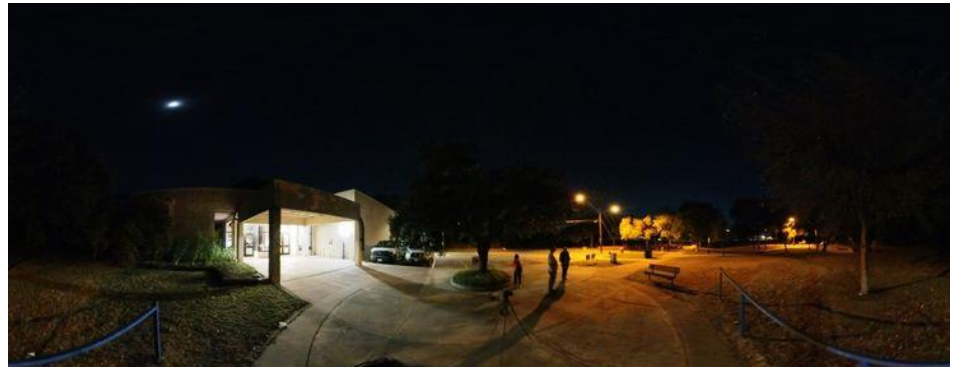
**Picture C-175. 360 Image of facility front entryway**

### 64 - Facility Entry (Safety Score 49)

The entryway has wall packs and light flooding from the interior. There are light poles in the area with two different color temperatures. At the playground park, there is a warm light pole. Despite hearing people, visibility was poor. There are facility vehicles parked in the parking lot overnight. The bench area had some dark patches because of the trees, and the garden pots on the side of the building were not visible.

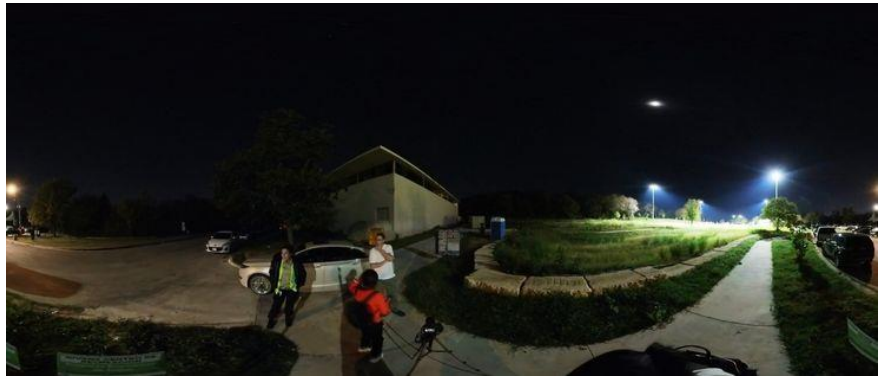
Picture C-176. 360 Image near the athletic fields

### 65 - Active Recreation (Safety Score 50)

There is a big juxtaposition between the lighting for the facility and the field. There is hardly any lighting for the facility, but getting closer to the field, there is a lot of light due to the field flood lights. People can be seen sitting outside and smoking weed near the parking lot.

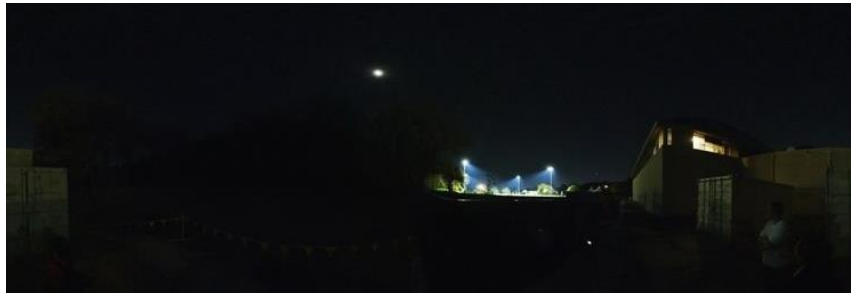
Picture C-177. 360 Image at the facility back entryway

66 - Facility Back Entry (Safety  
Score 54)

The field lights are quite bright, but storage containers create dark shadows and hiding spots. There is light spill coming from the windows of the facility.

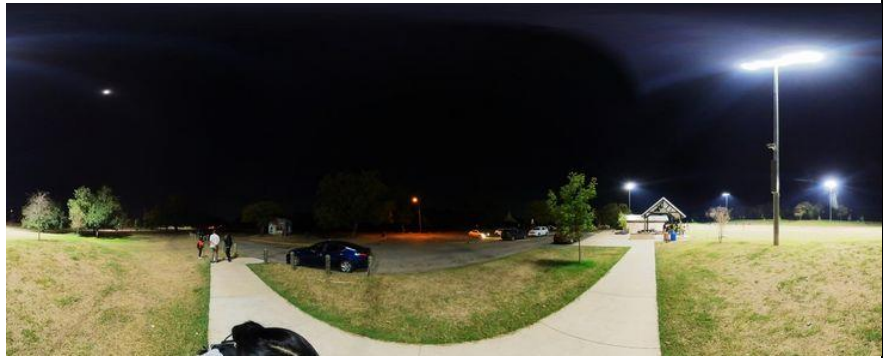
Picture C-178. 360 Image next to the athletic fields

### 67 - Active Recreation (Safety Score 51)

The field lights are very bright, where a lot of kids and parents are seen. However, people are seen loitering and on drugs in the pavilion parking lot. The parking lots are not well lit, with only a few solar powered light poles. There is some trash left in the pavilion near the field.

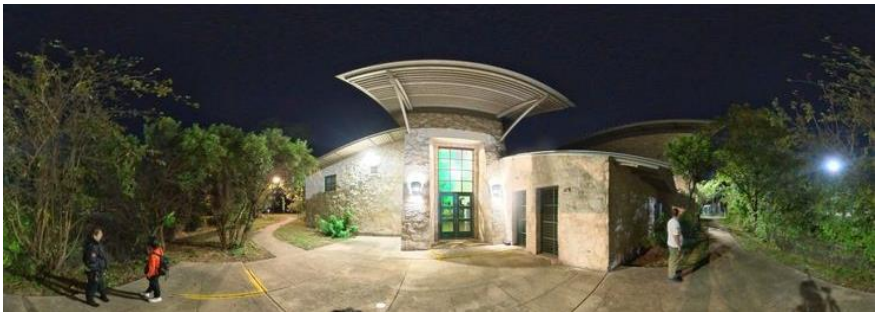
| <p><b><u>68 - Facility Back Entry (Safety Score 59)</u></b></p> <p>On the side of the building, there are wall-mounted fixtures and wall packs. Light poles line the pathway, and a floodlight shines through the vegetation on the other side. This section is well illuminated, but further along the pathway where there is tree coverage, it can get dark.</p> <p><i>Safety Score Rationale:</i><br/> Perception of safety: Average<br/> Reflectance: Neutral<br/> Specularity: Neutral<br/> Visual Transparency: Average<br/> Physical Transparency: Average<br/> Scale: Average</p> <p><i>Spider Diagram Analysis:</i><br/> Vertical Illuminance: Standard<br/> Horizontal Illuminance: Standard<br/> Uniformity: Standard<br/> CRI: Standard<br/> CCT: Standard</p> | <p><b>Picture C-179. 360 Image at the facility back entryway</b></p> <p><b>59/100</b></p> |

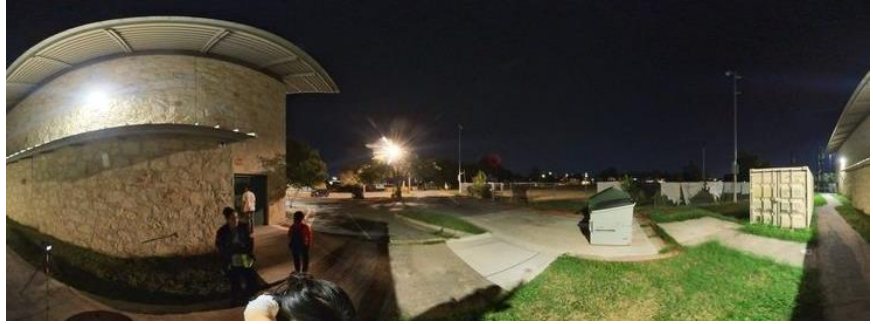
Picture C-180. 360 Image on the pathway on the side of the building

### 69 - Park Access (Safety Score 57)

There are wall packs on the wall providing light for the pathway. The neighboring field on the side of this building had their lights off. There are also light poles on the pathway in the back that led to the park.

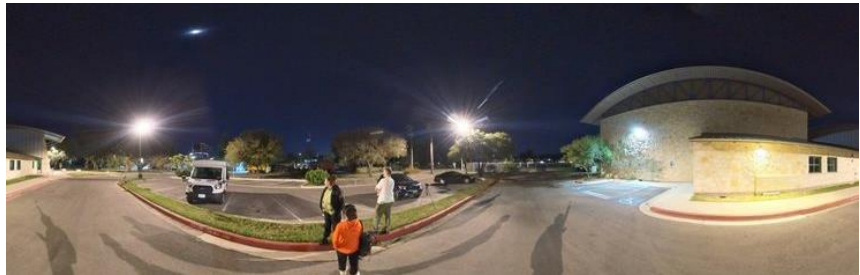
Picture C-181. 360 Image of the parking lot

### 70 - Parking Lot (Safety Score 47)

The parking lot is well illuminated by light poles and wall packs on the facility. The wall packs have two different color temperatures. The back of the facilities across the street is also visible.

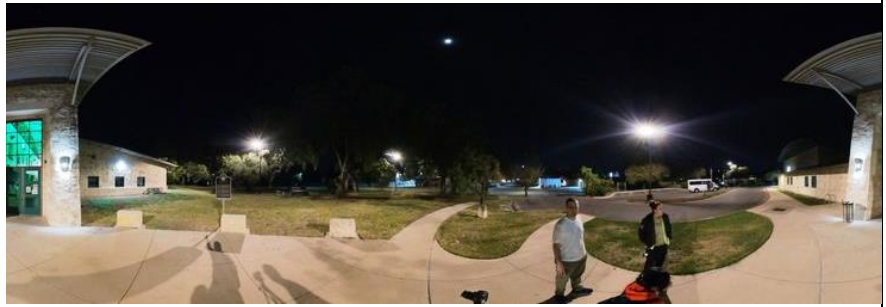
Picture C-182. 360 Image of the facility entryway

### 71 - Facility Entry (Safety Score 54)

At the facility door, there are two sconces on either side, and there is also colored light seeping from the inside of the building. Around the entryway, there are light poles placed around. There is also additional light coming off the buildings across the street. Some people are seen walking along the perimeter of the building.

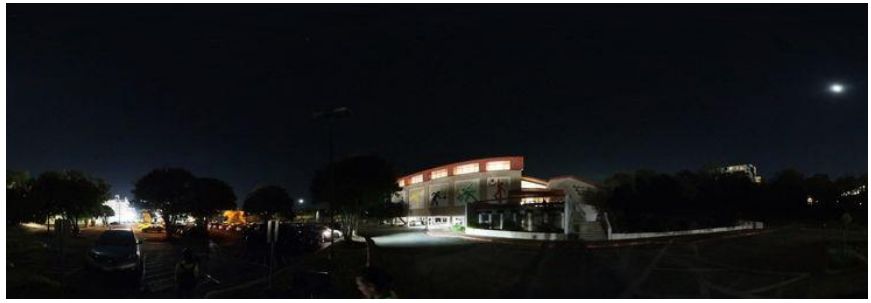
Picture C-183. 360 Image of the facility entryway

## 81 - Facility Entry (Safety Score 49)

There are some encampments in the area. The lights were not set correctly for daylight savings at the time of survey. The light poles in the parking lot, wall pack above the garage, downlights at the entry, and steps lights on the stairs turned on at 8pm, two hours after sun set.

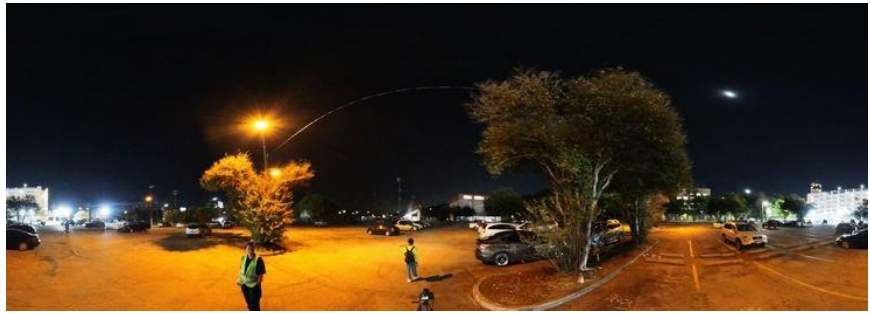
Picture C-184. 360 Image of the parking lot

## 82 - Parking Lot (Safety Score 52)

The lights are orange compared to the bright white lighting in the neighboring parking garage and the skate park. Some unhoused people are roaming around the side of the parking lot. The neighboring lights for the football field were turned off.

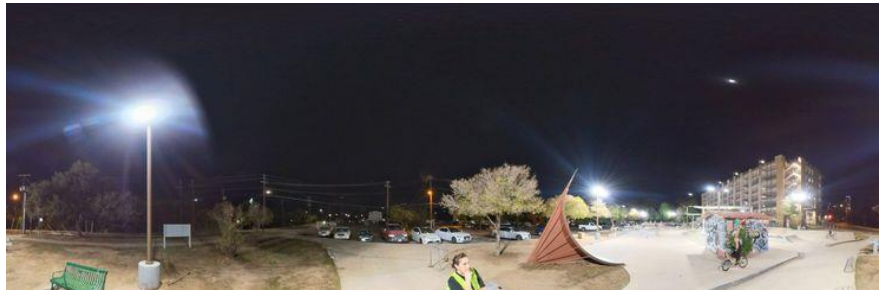
Picture C-185. 360 Image of the skatepark

### 83 - Active Recreation (Safety Score 44)

The area is very bright, with some lights being brighter than others. Many people are skating, and light is coming from the parking garage next door. A moonlight tower is visible in the back. The streetlights next to the skate park are orange.

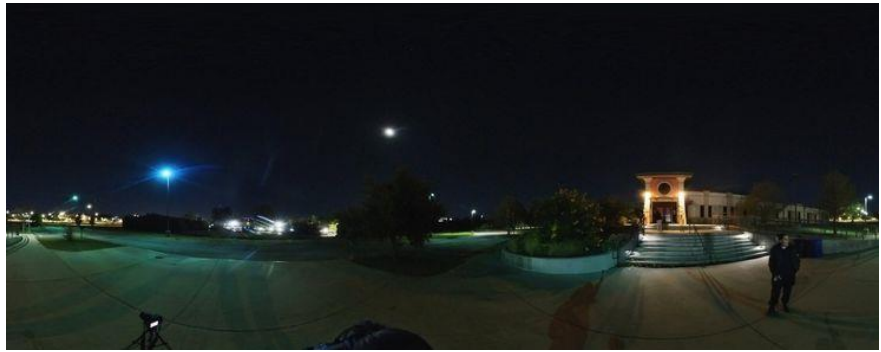
Picture C-186. 360 Image of main facility entry

## 92 - Facility Entry (Safety Score 51)

Wall sconces are installed next to the entry. There are step lights and light poles on the ramp, although one is broken. Bright lights come from poles in the parking lot of the church across the street, as well as from light poles and wall packs on the houses across the street. The parking lot areas have white light poles. At the time of survey, there was an unhouseed man throwing items around.

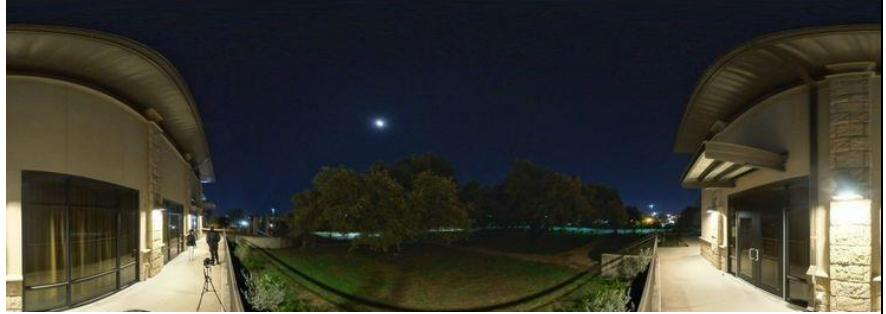
Picture C-187. 360 Image of side facility entry

93 - Facility Entry (Safety Score 56)

There are bright wall packs lining the wall. The outdoor gym area behind the center is not lit at all, making it hard to see. The only other light comes from the poles in the parking lot.

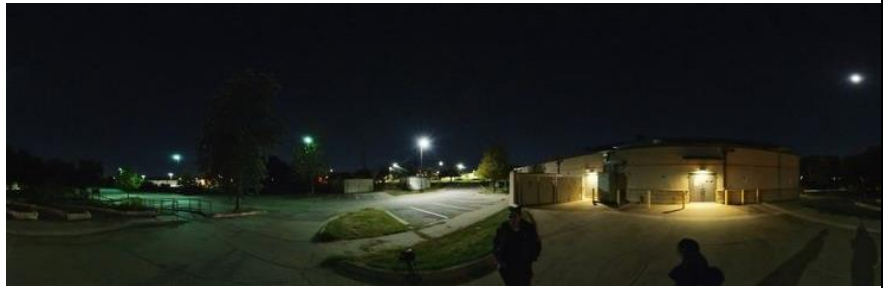
**Picture C-188. 360 Image of back facility entry**

**94 - Facility Back Entry (Safety  
Score 54)**

Wall packs are above the door leading to the back parking and trash bins. The garden is not lit at night. The parking lot in the back has light poles, and you can see the light poles in the neighboring parking lot.

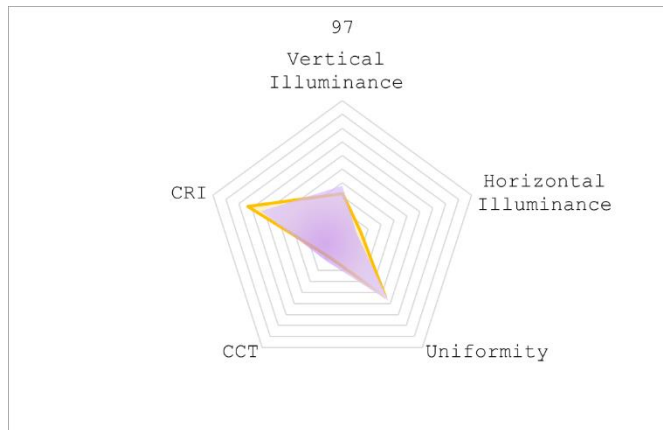
Picture C-191. 360 Image inside the pool

There are not many people who swim here at night due to the pool closing at 8pm and tarps being put up. In the pool, there are also lights installed, but they cannot be seen due to the tarps. Inside the pool area, there are light poles and wall packs on the facility at points of interest, making the area bright. Some light poles are broken outside the entry. People have been caught jumping over the fence at night and there are problems with people sneaking around the storage area where chemicals are kept.

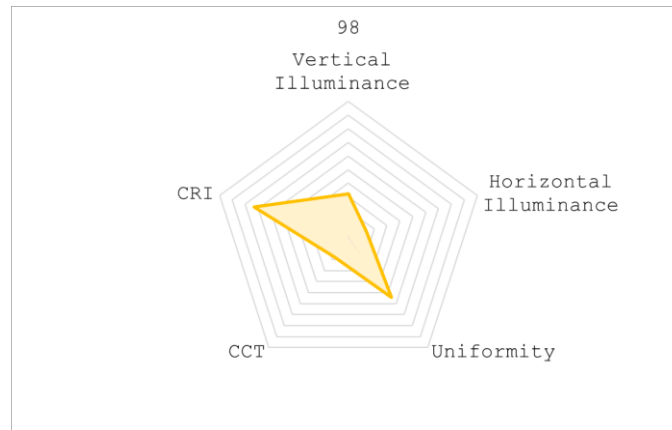
**Picture C-192. 360 Image near the frisbee golf course**

Flood lights from the fields in the park and pool can be seen. The picnic tables are not very well lit and are nestled in the vegetation.

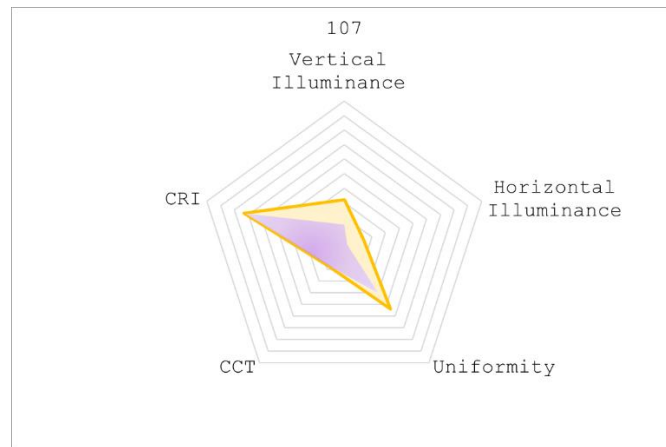
Picture C-193. 360 Image near the playground

The light poles in the nearby parking lot are completely off, and the wall packs for the mural are only half on. There are light poles on the pathways of the park, making the area feel well lit, although the actual playground is a bit dark.

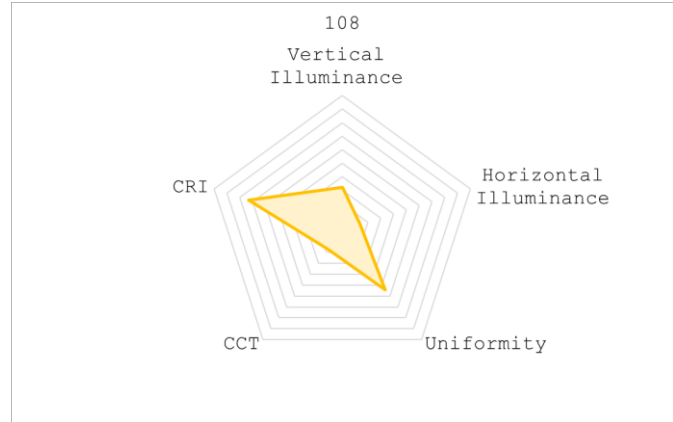
**Picture C-194. 360 Image on the basketball court**

In the basketball area, the lighting primarily comes from the light poles in the parking lot and the light streaming in from the inside of the building. The wall-packs on the building are not on, and some light poles were off.

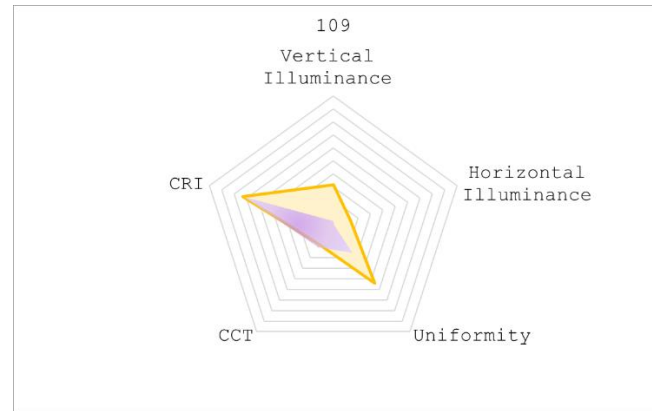
Picture C-195. 360 Image at the facility entry

The signage lighting is very spotty and broken. The bus comes to the facility at night, and there is a light pole next to the stop that illuminates the area. At the entryway, there are down lights on the overhang that are partially on, with every other one off.

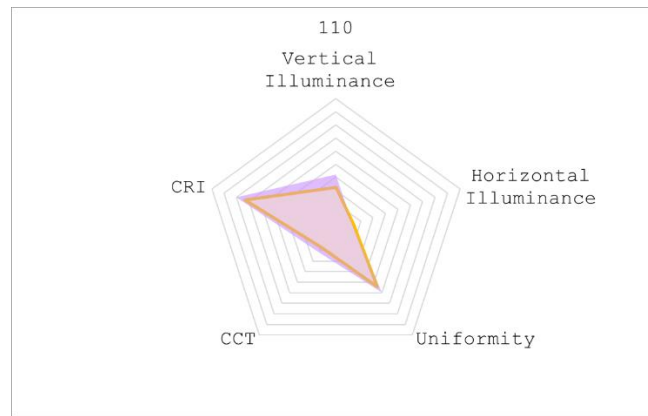
**Picture C-196. 360 Image near the facility entry**

The area is very well illuminated, with different layers of light. The light poles have a wide distribution, wall packs on the walls, troffers, and light shining in from the windows of the school. This facility has a lot of fixtures that are off (almost 1/3).

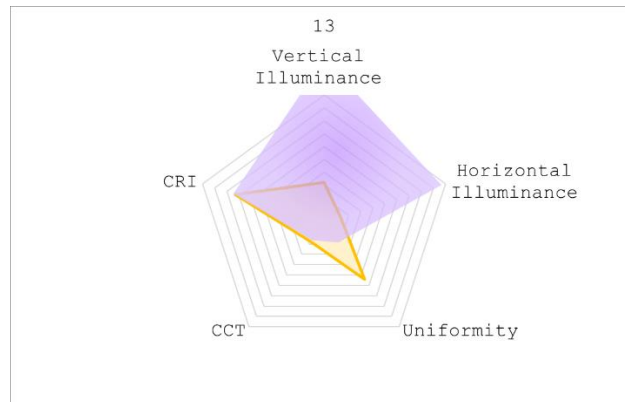
Picture C-197. 360 Image of play area

The pathway in a central location of the park had multiple people enjoying the park and a family selling ice cream. The path is lit by indirect pole mounted luminaires which spills into the hilly play facility. The hilly play facility was lit, but it was dim in some areas, especially near the trees. The bench has soft downlights illuminating the structure.

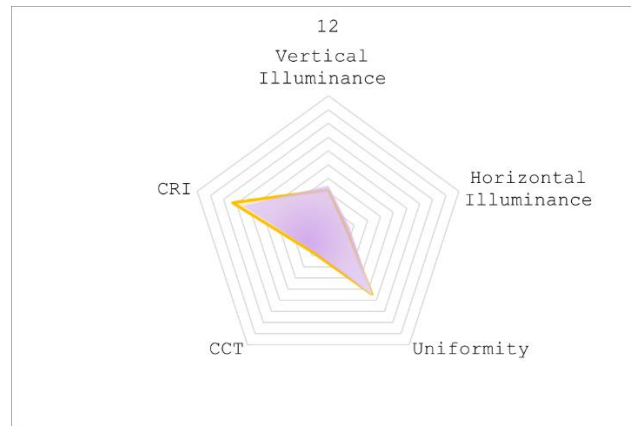
Picture C-198. 360 Image of splashpad and field

The splashpad and field area is a wide, open space with high physical transparency. There are indirect pole top luminaires along the pathway. Near the splashpad that was not in operation, two light poles were broken. The city skyline provided a vertical plane of illumination.

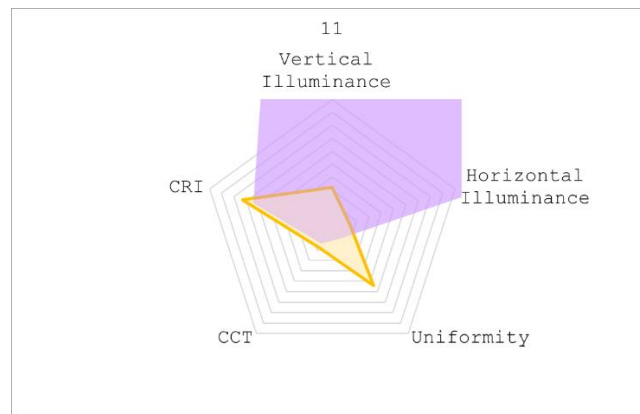
Picture C-199. 360 Image of playground and bench area

The playground area is mainly illuminated by a floodlight near the pathway, creating a spotlight effect with a bright patch around the light pole and stark shadows. The areas under the canopy structures have lower light levels. Families were observed using the play area and benches.

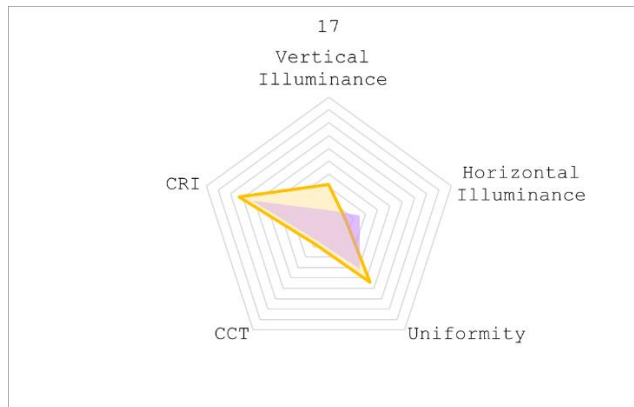
Picture C-200. 360 Image of park access

There is no lighting for the garden itself. From the entrance, street lights and city lights can be seen. Since the site is close in proximity to I35, there is a lot of light and noise pollution coming from cars. At the time of visit, a Metro bus moved up closer to this entrance when its actual stop is further down the road near Waller St & Flores St because there is lighter for passengers and the bus to be seen. There is no lit or seated waiting area for the bus stop.

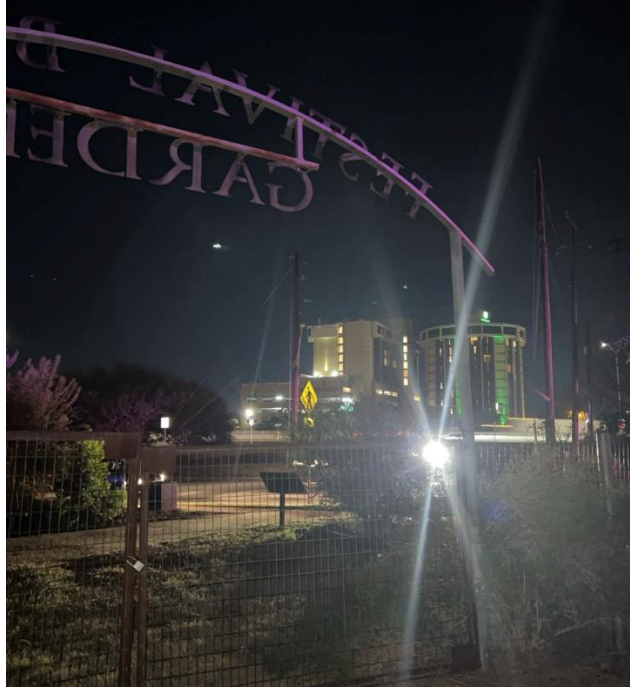
Picture C-201. Gated-park access, taken with long exposure

The fenced off gate entrance was locked at the time of visit. The only source of light came from cars on neighboring roads and buildings across the highway.

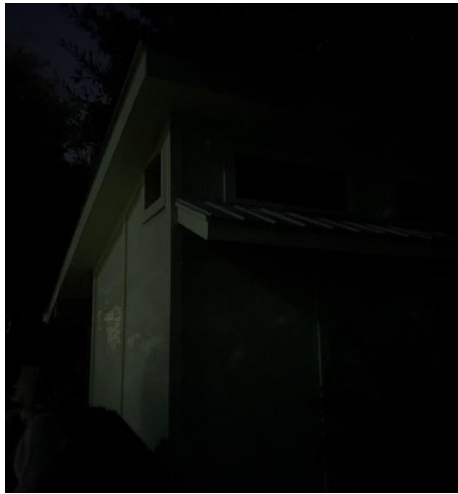
Picture C-202. Image of storage shed, taken with long exposure

Staff noted that a garden shed, which sits within the community garden perimeter, had recently been broken into, and gardening tools and other equipment were stolen. There was an abundance of trash throughout (specifically alcohol containers) and vandalism (spray paint on wooden benches) throughout the food forest.

The interior next to the garden shed had extremely low levels of light due to lack of lighting. The survey team had to carry flashlights to navigate around, as it is easy to get disoriented if you are unfamiliar with the area. During the visit, a volunteer came through the back gate to use the shed, and the individual had to use a flashlight.
