**City of Austin**

# Parks and Recreation Department Security Audit

## Findings and Recommendations Report

Version 2 | July 18, 2025

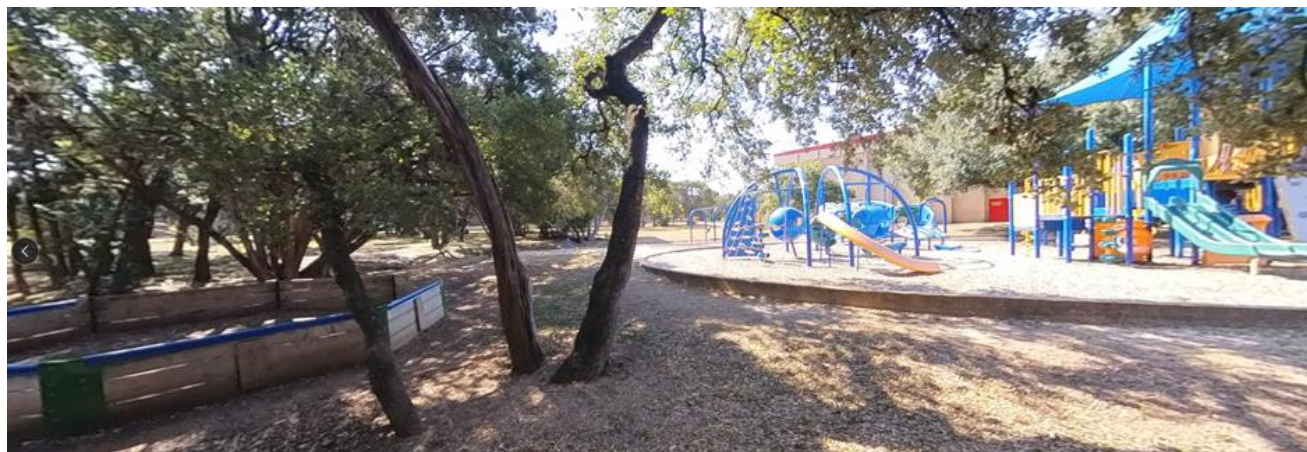
**Picture 3. Play structures and trails behind the South Austin Recreation Center activate the area behind the building which is largely out of view from street traffic and houses on adjacent properties**

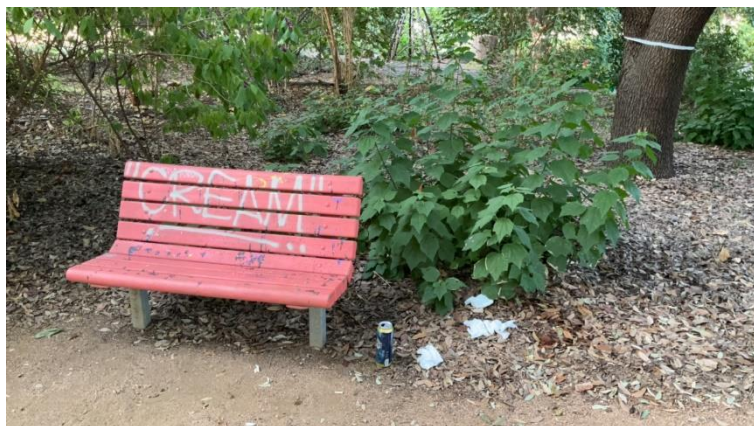
**Picture 4. Vandalized park bench, nearby empty alcohol container and trash, and poor visibility due to dense vegetation all negatively impacts perception of safety**

There is an abundance of passive recreational facilities at each of the sites visited. Often, they are located along tree lines, because shade is provided by the tree canopies or tall grass. However, in areas where there are issues with encampments, trash, or public drug and alcohol use, park users are discouraged from remaining in the area and using these amenities, because they are unable to see whether individuals are just on the other side of dense vegetation (see Picture 4). In some areas, tall and dense vegetation along trails and walking paths isolate users at various areas of the park. New amenities like trails, playgrounds, and sports fields are beneficial but can remain unused in areas where people feel unsafe.

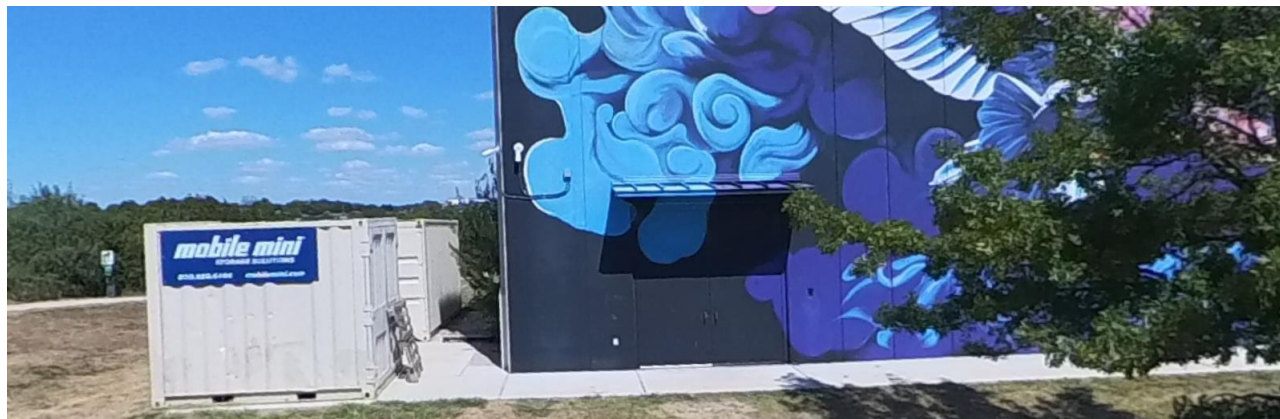
Shipping containers have become a long-term solution for storage needs, as some facilities have used the containers for several years. Not only are all the containers rented, which costs about \$200-300 a month per container, they are also obvious targets for burglary and theft and do not require a high skill level to break into.

At Turner-Roberts Recreation Center, multiple surveillance cameras installed at the same building corner are aimed between and around two shipping containers because of the blind spots they create. This creates the need for an increased number of cameras and additional cost to PARD.

**Picture 8. Multiple surveillance cameras are installed at the same building corner and are pointed between and around two shipping containers because of the blind spots they create**

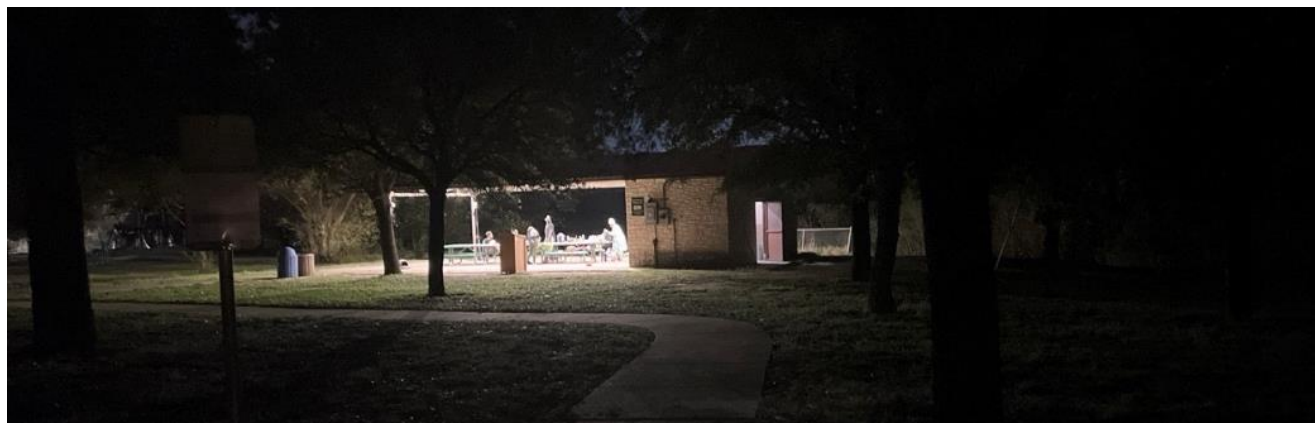
**Picture 10. A gathering of individuals at the restrooms in Bartholomew District Park after park curfew (taken with phone camera, no flash)**

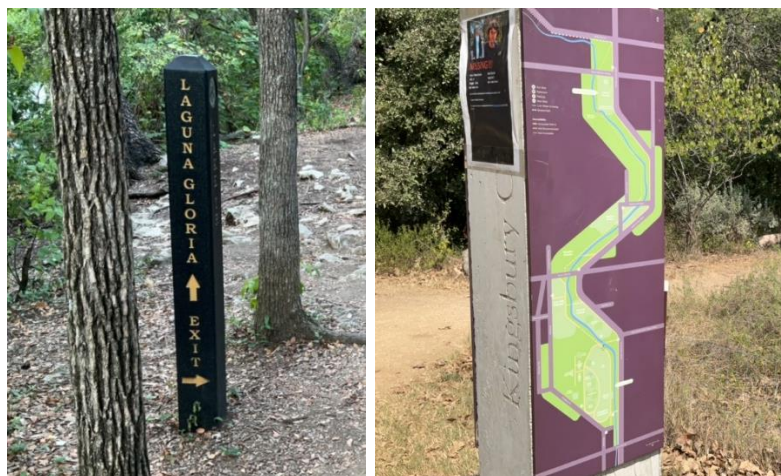
Examples of existing proactive location markers within PARD assets are showcased in Figure 21. As shown, both Mayfield Park and Pease Park Conservancy exhibit robust signage that serve as effective location indicators for public reference. These location markers also serve to deter vandalism when compared to traditional signage given their rigid materials and robust design. For additional reference, PARD's 2023 *Signage and Wayfinding Guidelines* provides legible and aesthetically pleasing mile marker templates in their 155 Trail Marker Post and 160 Trail Marker with Flag designs.

**Figure 21. Examples of existing location indicators in Mayfield Park (left) and Pease Park Conservancy (right)**

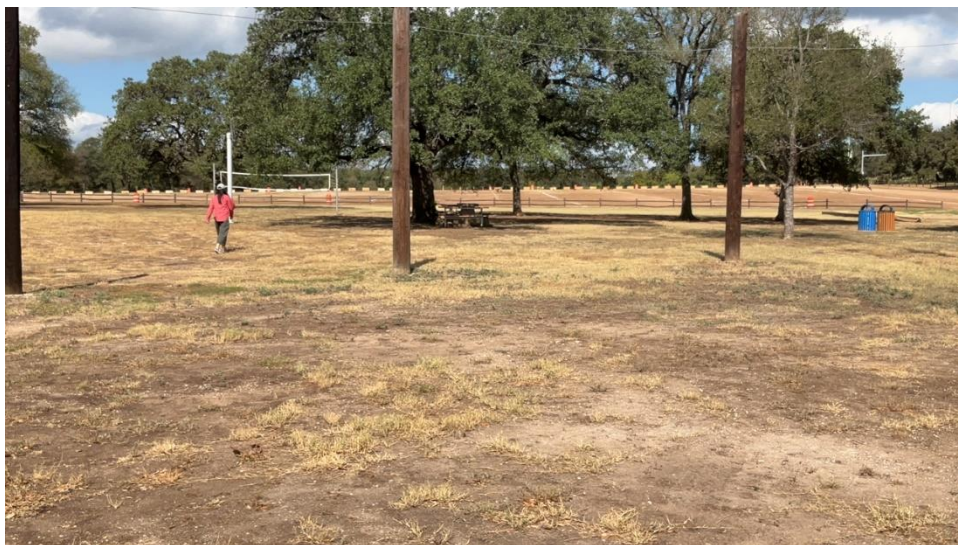
**Picture C-9. Zilker Metropolitan Park (Park Center, South) - Activity Support**

Zilker’s “park center” south of Barton Springs Road scored well across all CPTED categories. While this area had less usage than other parts of the park, the area was well maintained, had activity generators such as volleyball courts and park benches, and PARD staff traversing the area, as shown in Picture C-9. The parking lot along Andrew Zilker Road had a security camera trailer, with no evidence of vandalism or vehicle break ins at the time of the site visit.

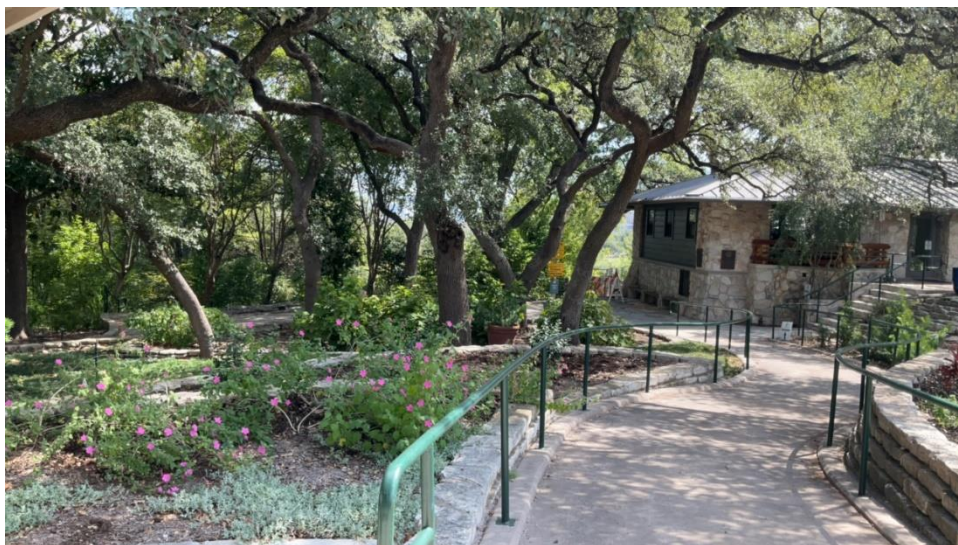
**Picture C-10. Zilker Metropolitan Park (Park Center, North) - Natural Access Control, Activity Support**

The Zilker Botanical Garden was well-secured, ticketed, and actively monitored by staff. The garden had activity generators such as a museum, benches, and food/beverage trucks as shown in Picture C-10.

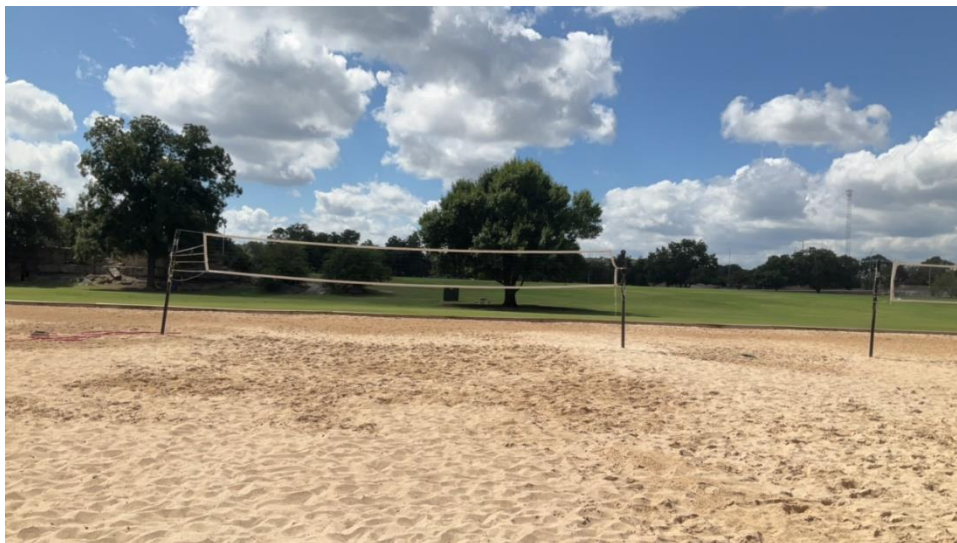
**Picture C-11. Zilker Metropolitan Park (Park Center, North) - Activity Support**

The eastern area of Zilker Park was being actively used at the time of the site visit by Austin City Limits workers for event storage and setup. This area was well maintained, had clear demarcation of space, and had activity generators such as volleyball courts and picnic benches, as shown in Picture C-11.

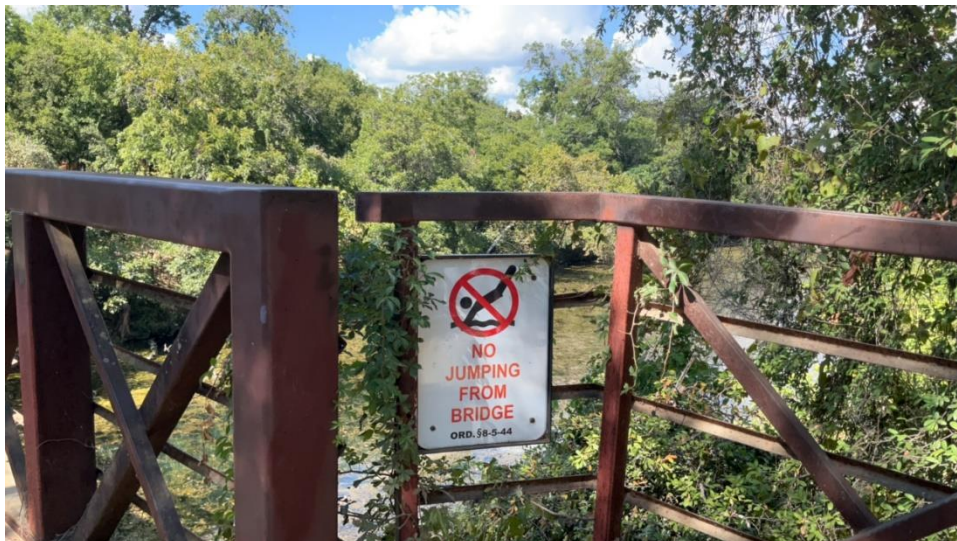
**Picture C-12. Zilker Metropolitan Park (Park Center, North) - Image Management / Maintenance**

PARD staff had reported multiple incidents of bridge jumping on the eastern side of the park into Barton Creek. At the time of the site visit, this area was frequently travelled with extensive signage indicating the illegality of swimming and jumping, as shown in Picture C-12.

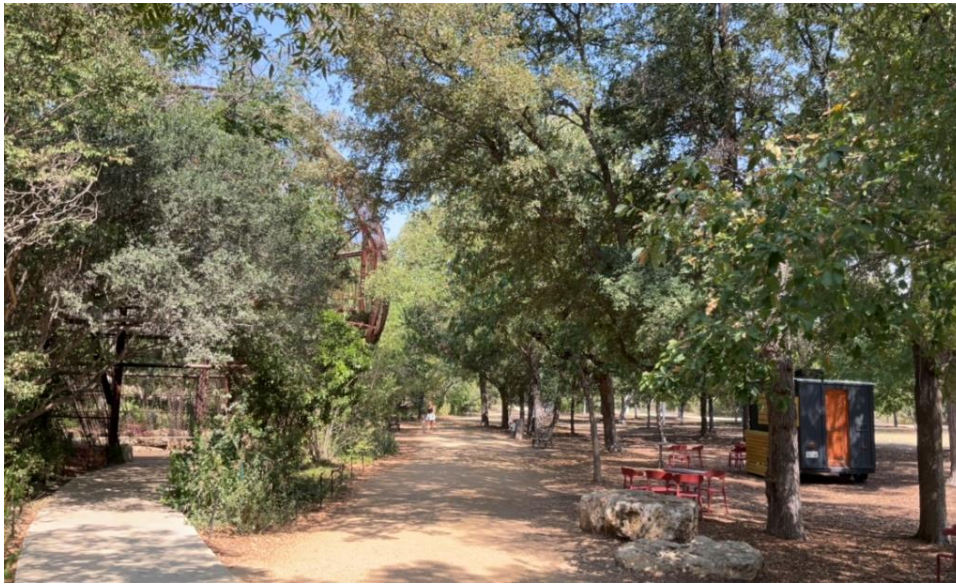
**Picture C-17. Pease Park Conservancy – Natural Surveillance, Image Management / Maintenance, Activity Support**

Pease Park Conservancy scores highly across all categories, with clear sightlines, maintained landscaping and pathways, extensive wayfinding and rules signage, and activity generators. Sightlines were supported by clearly defined pathways free of trash, a lack of shipping containers and blind spots, and maintained vegetation and trees along pathways as shown Picture C-17. Activity generators such as interactive art installation, seating and tables, and beverage / food trucks lead to a high activity support category rating (see Picture C-17).

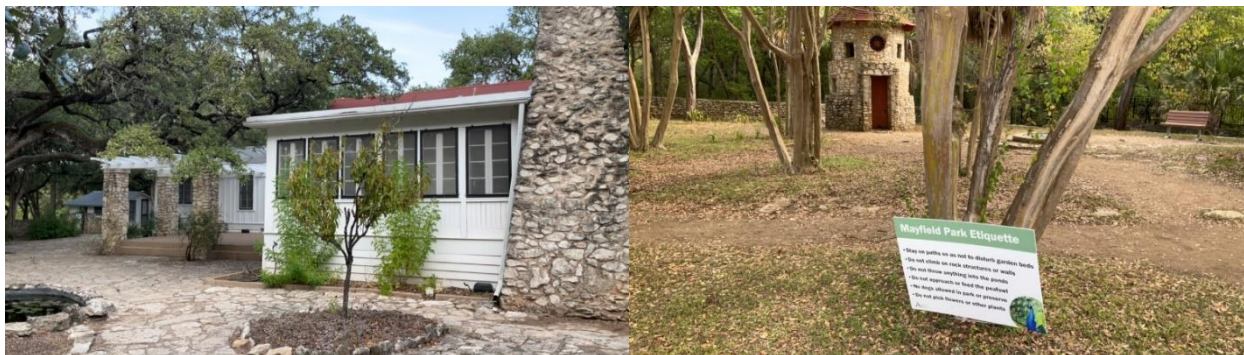
Picture C-23. Mayfield Park – Natural Access Control / Image Management / Maintenance

Mayfield Park offers a facility for event rentals, located next to the parking lot on the eastern side of the park. This area is surrounded by stone walls and can be accessed through multiple pedestrian gates and one vehicle access point as shown in Picture C-23. This area is well fenced, has clear wayfinding signs and park rules, free of vegetation and trash, and maintains clear sightlines from the parking lot and from the windows of the facility, as shown in Picture C-24.

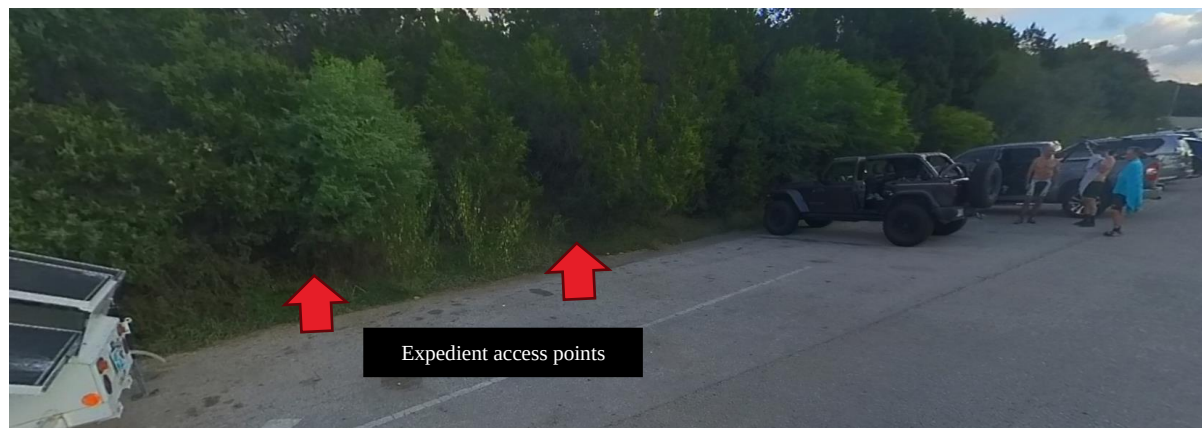
**Picture C-34. Barton Creek Wilderness Park - Natural Access Control**

The main access point is located significantly away from the parking lot and has no signage directing visitors to the intended access point. Expedient access points or “desire paths” are shown in Picture C-34; they are undesigned, shortcuts into the park created by foot traffic overtime. Extensive trash was present all along the tree line in the parking area.

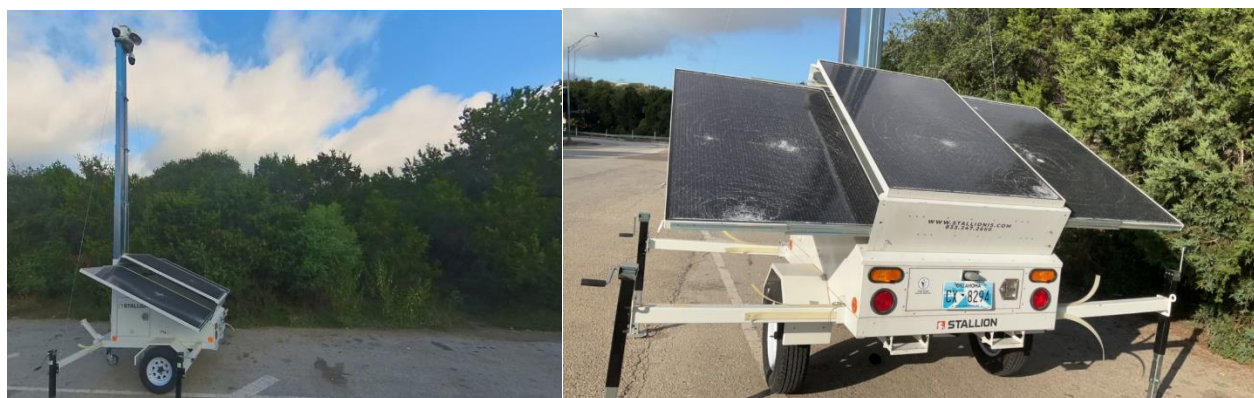
This park experiences a high level of vehicle break-in's. Because of this, there is a security camera trailer present in the middle of the parking lot. This trailer was vandalized at the time of the site visit (smashed solar panels) as shown in Picture C-35.

**Picture C-35. Barton Creek Wilderness Park - security camera trailer monitoring the creek parking area**

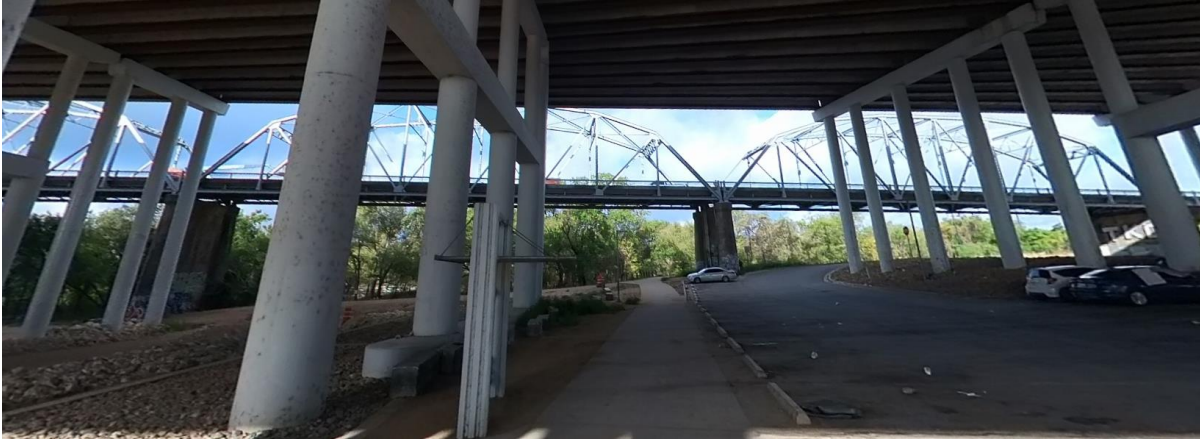
The Colorado River Wildlife Sanctuary scored poorly across all CPTED categories, most notably in natural surveillance and image management / maintenance. Similar to the Barton Creek Wilderness Park, this area is accessible through a highway off ramp; however, the main parking area is located under the highway and is surrounded by dense vegetation. This leads to little surveillance from passing vehicles and foot traffic. The only natural surveillance would come from individuals working (maintenance crew was present during the survey) or walking along the adjacent pedestrian bridge, as shown in Picture C-36.

**Picture C-36. Colorado River Wildlife Sanctuary - pedestrian bridge adjacent to the greenbelt parking lot which is underneath a major highway**

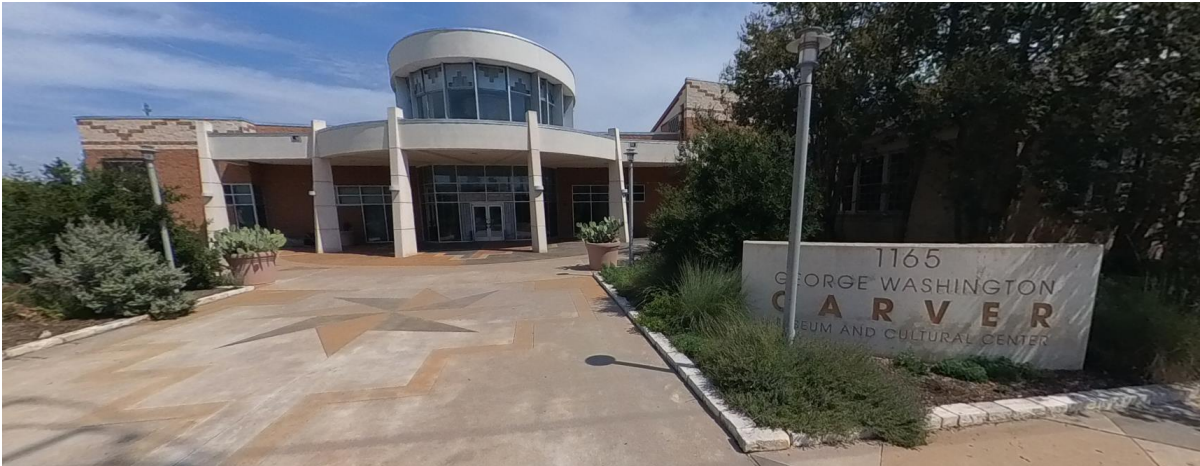
**Picture C-40. George Washington Carver Museum and Cultural Center - Natural Surveillance**

George Washington Carver Museum and Cultural Center scored well in the natural access control, image management / maintenance, and site / target hardening CPTED categories, and scored poorly in natural surveillance. The museum is adjacent to a middle school, public library, and church, a mixed retail and residential neighborhood. While thick bushes and trees obstruct views from the street towards the museum, there are large windows at the museum main entrance and several benches to help with natural surveillance from staff and museum visitors inside the building as shown in Picture C-40.

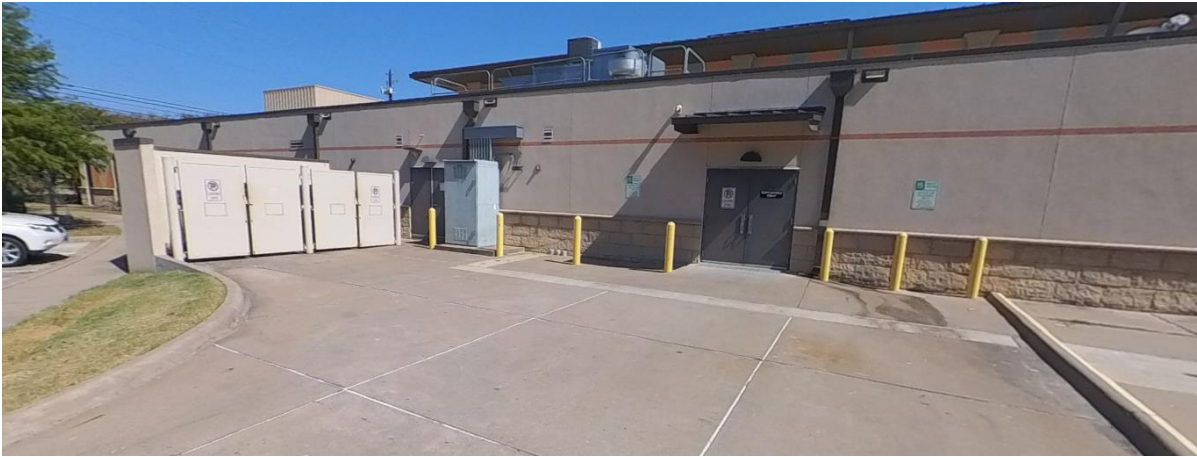
**Picture C-47. Asian American Resource Center - Maintenance Area**

While enclosures keep the dumpsters out of sight and is more aesthetically pleasing, it provides a potential hiding spot, as shown in Picture C-47. PARD staff shared that there have been multiple instances of individuals defecating in the dumpster enclosure. An outdoor automatic light was installed near the enclosure to discourage the behavior.

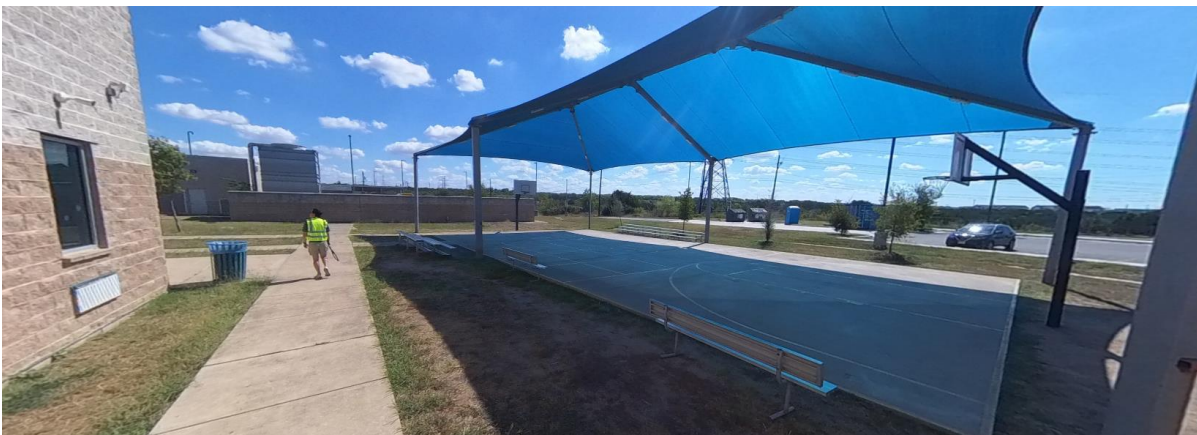
**Picture C-48. Turner Roberts Recreation Center - Natural Surveillance**

Turner Roberts Recreation Center scored highly among all CPTED categories, scoring highly in natural surveillance, natural access control, activity support, and site / target hardening. The facility is detached from the city center and is connected to the Overton Elementary school. The main facility and satellite gymnasium had an extensive amount of security cameras. Cameras were placed at blind spots, corners of buildings, maintenance areas, and park centers, such as the basketball court in the back of the facility, as shown in Picture C-48.

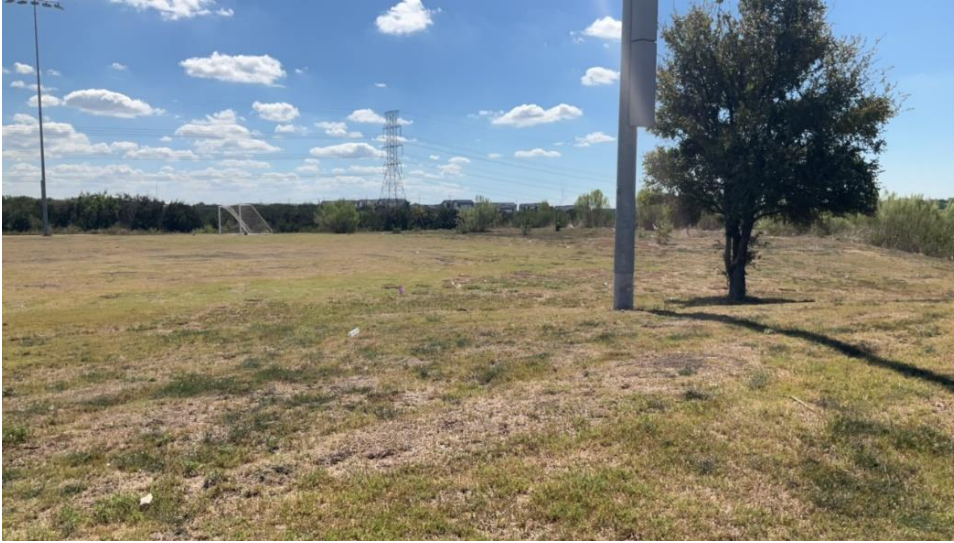
**Picture C-49. Turner Roberts Recreation Center - Image Management / Maintenance**

Some trash was present throughout the park area on the back side of the facility adjacent to the baseball fields and playgrounds, as shown in Picture C-49.

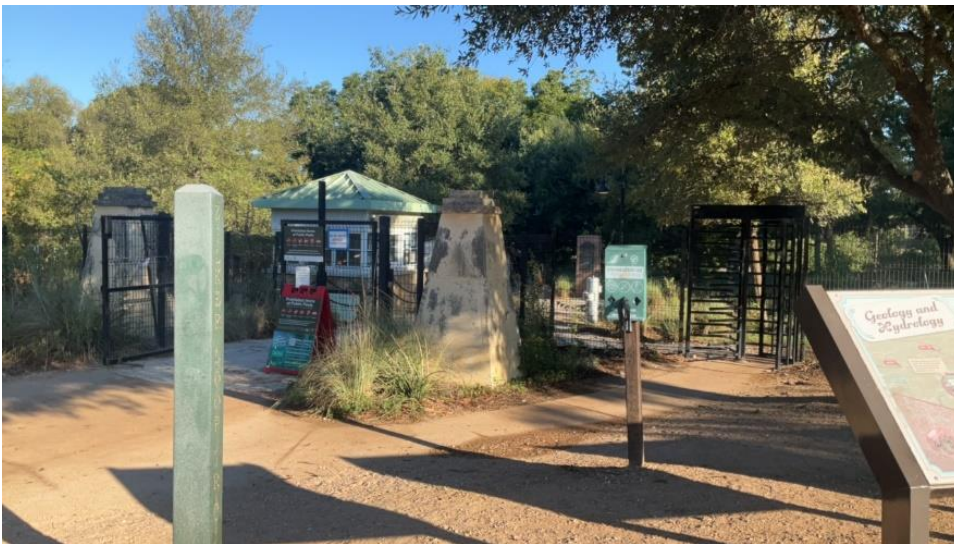
**Picture C-50. Barton Springs Municipal Pool - Natural Access Control**

Barton Spring Municipal Pool scored highly in the territorial reinforcement and site / target hardening CPTED categories. The site was well maintained, enclosed by fencing, and access was controlled through ticketing for entry into the facility, as shown in Picture C-50.

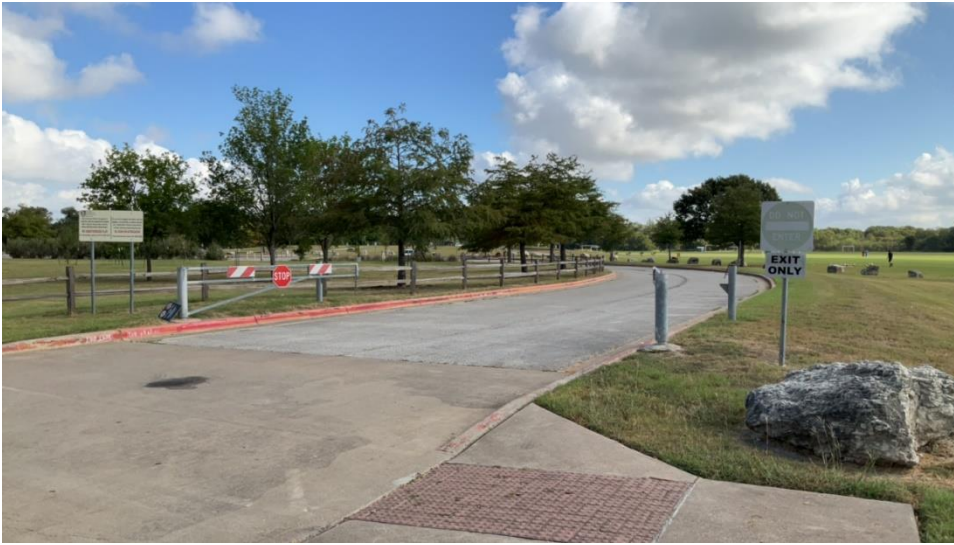
**Picture C-51. Onion Creek Soccer Complex - Site / Target Hardening**

Onion Creek Soccer Complex scored highly among the natural access control, territorial reinforcement, and image management / maintenance CPTED categories. The complex had clear sight lines throughout, was well maintained, and was mostly free of trash. There are multiple vehicle access points to the park, all except one were closed, chained, and secured with a pad lock, as shown in Picture C-51. Boulders and vehicle barriers were placed throughout the complex, extending into the center of the facility as shown in Picture C-52. One gate was open at the time of the site visit, as individuals and small groups can freely access the fields without reservations.

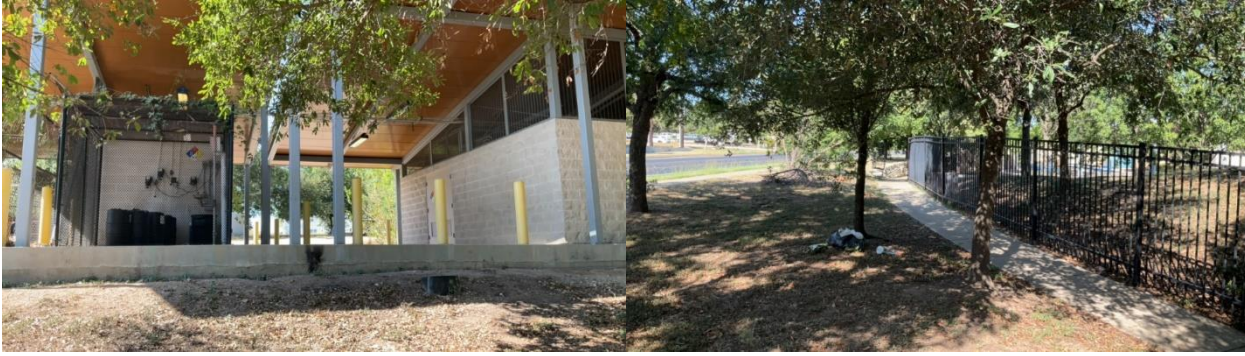
**Picture C-55. Bartholomew Pool - Image Management / Maintenance**

The pool storage area was secured by locked gates and anti-cut fencing, as shown in Picture C-55. Some trash was observed around the perimeter of the pool facility, including clothes, a shopping cart, and plastic wrappers, as shown in Picture C-55.

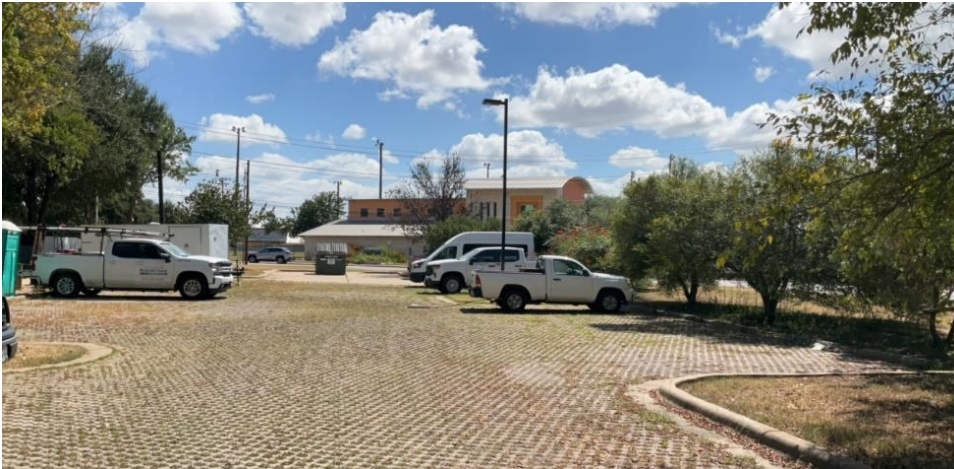
**Picture C-56. Lorraine “Grandma” Camacho Recreation Center - Natural Surveillance**

Lorraine “Grandma” Camacho Recreation Center scored highly across the natural access control, territorial reinforcement, image management / maintenance, and activity support CPTED categories. The recreation center is located in a neighborhood along Festival Beach, with the main entrance facing these residences and a shared parking lot. The parking lot is shared between PARD storage trailers, parking for the facility, and maintenance equipment from the residences, as shown in Picture C-56. Staff reported a recent break-in in this location, with items from a trailer being stolen the week prior to the site visit.

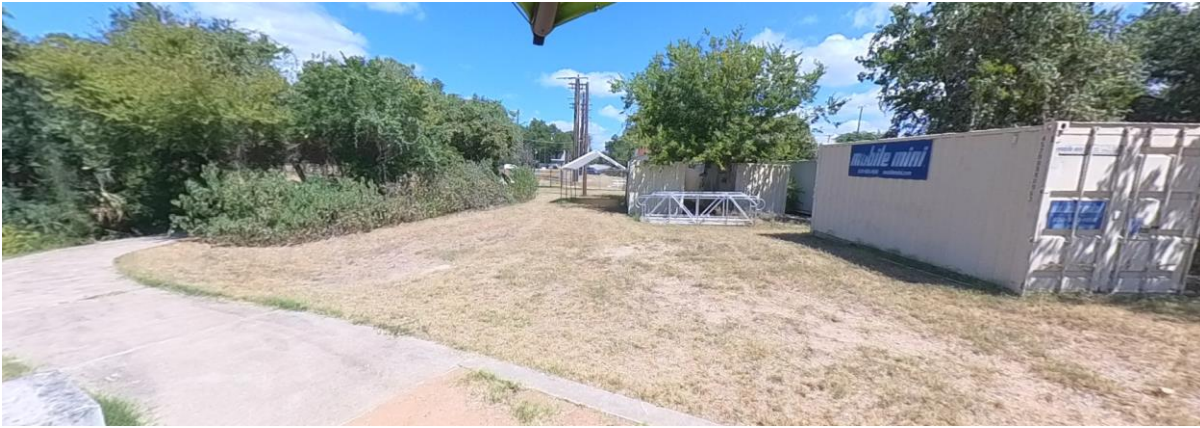
**Picture C-59. Lorraine “Grandma” Camacho Recreation Center - Fenced facility area**

The western side of the facility contains a fenced kayak launch point which is used for programming, as shown in Picture C-59. Staff shared that there are approved plans to build a new facility on the dock which will provide public access to the kayak launch system, while keeping one side reserved for recreation center programs. Nearby the dock within the fence enclosure are six storage containers, which contain water sport and other equipment. Staff shared that they’ve had the containers for at least a decade or more.

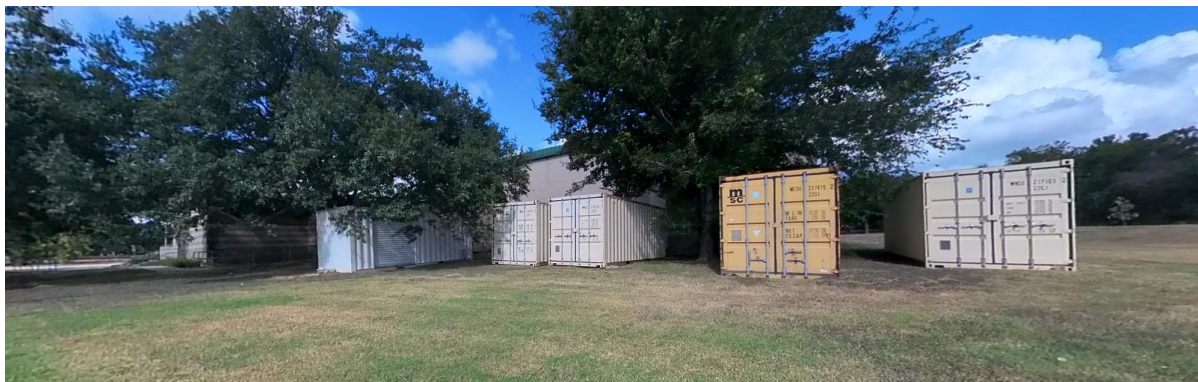
**Picture C-61. George Morales Dove Springs Recreation Center - Natural Surveillance**

The back side of the facility has five shipping containers placed adjacent to the facility, as shown in Picture C-61. PARD staff noted some instances of encounters with individuals experiencing homelessness in this area – it is poorly lit, has multiple blind spots, and has only one security camera.

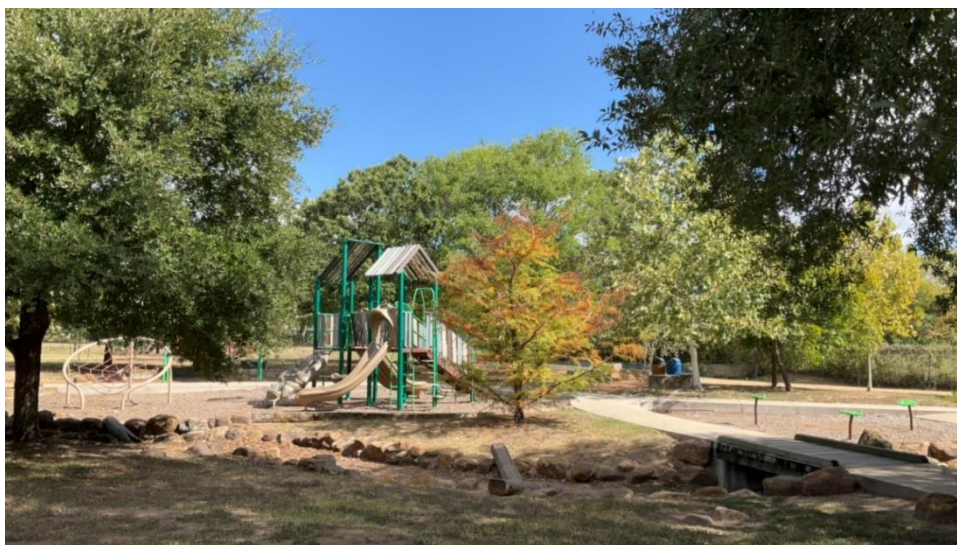
**Picture C-62. George Morales Dove Springs Recreation Center - Activity Support**

PARD staff noted previous incidents of drug use on the back side of the park that connects to the facility, as it is easily accessible through the greenway that runs adjacent to the property. This area has an abundance of passive recreation structures, including benches, outdoor calisthenics equipment, play structures, and picnic tables, as shown in Picture C-62.

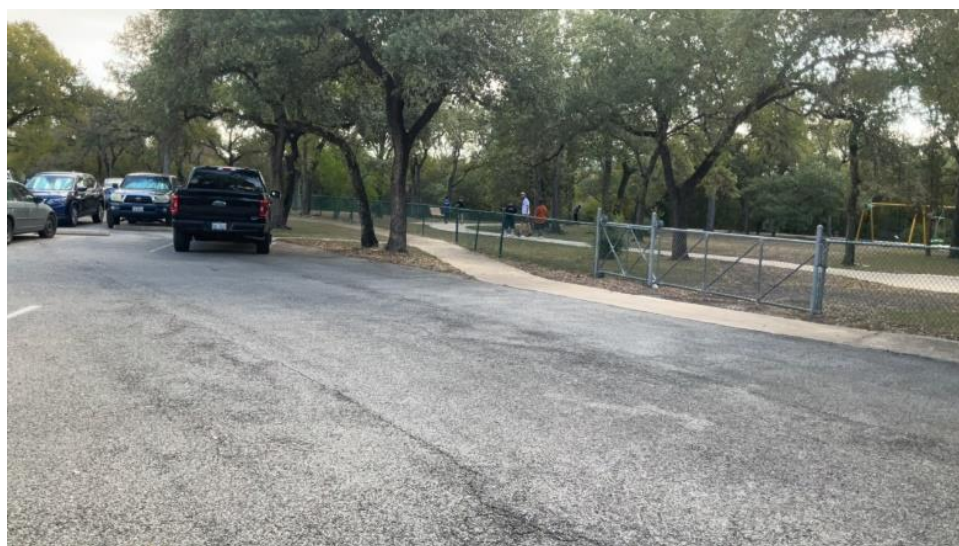
**Picture C-68. Danny G. McBeth Recreation Center - Site / Target Hardening**

The southernmost recreation center was actively used by children and staff during the time of the site visit. Although the playground and back area of the facility were hidden and surrounded by bushes, vegetation, and trees, there was extensive fencing around the facility which is designed to keep children on facility property, as shown in Picture C-68.

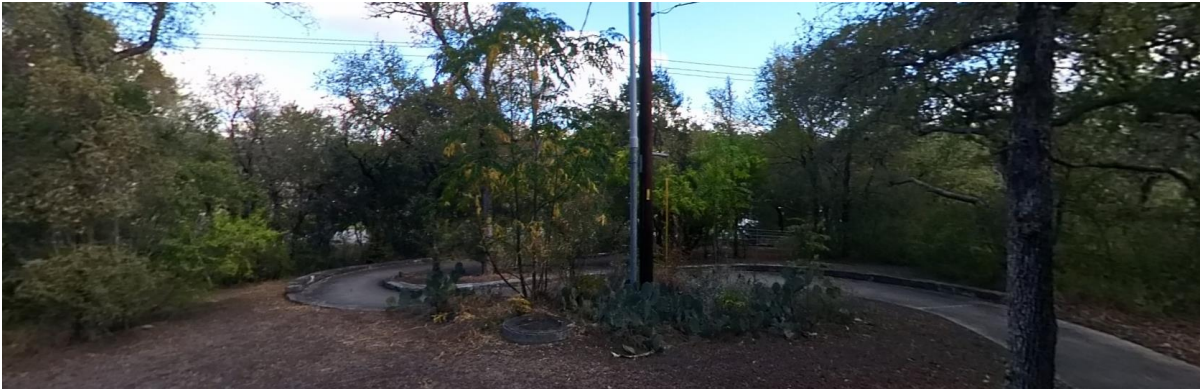
**Picture C-69. Danny G. McBeth Recreation Center - Natural Surveillance**

The northernmost annex building hosts programs after school for children, including programs for the special needs population. Staff mentioned that afternoon/evening programming at this location was impacted by the lack of lighting around the back of the facility. A paved pathway leads from the facility through a heavily forested area to the bus stop along a major roadway, as shown in Picture C-69.

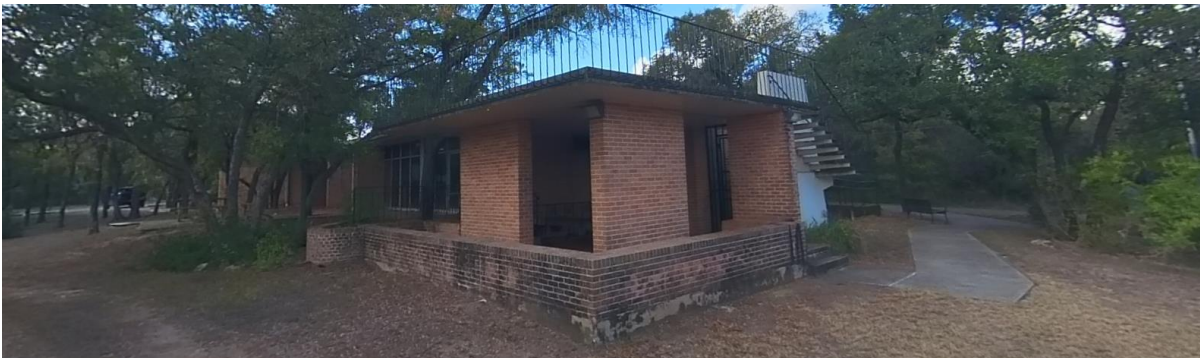
Program participants have expressed safety concerns with walking to the bus stop after dark because of the lack of visibility, and staff have had to escort them to the bus stop. The area is poorly lit and have multiple blind spots and areas that unknown individuals can / have occupied. Specifically, sheltered areas around the building with outdoor access to power outlets are often occupied by unknown individuals. These outdoor power outlets have since been covered up.

**Picture C-70. Danny G. McBeth Recreation Center - The back of the annex building experiences a high number of unknown individuals seeking shelter, using the outdoor power outlet, or consuming alcohol or using drugs**

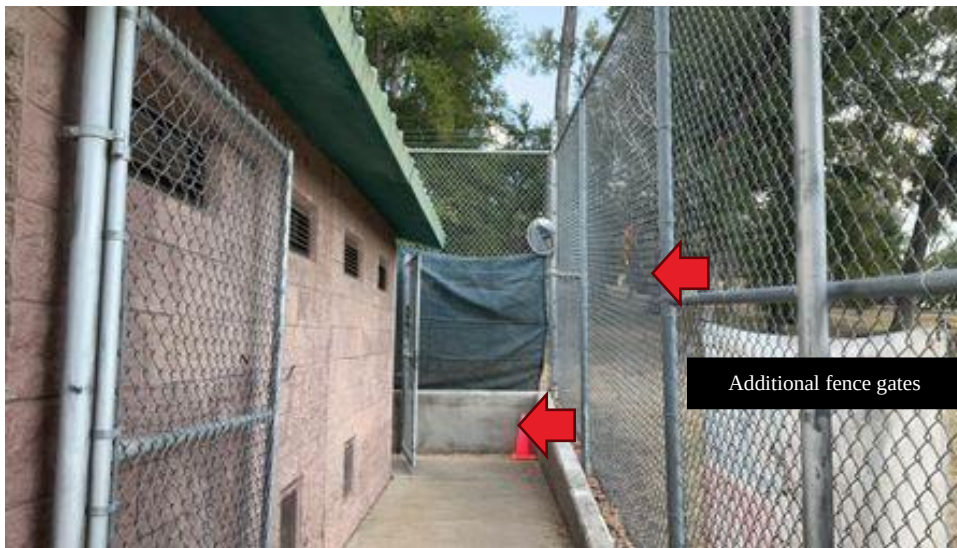
**Picture C-73. Big Stacy Pool - Site / Target Hardening**

Multiple fence gates at each corner of the restroom and shower facility are installed to reinforce it against unauthorized access during non-operating hours. Safety convex mirrors are also installed to provide staff and pool users the ability to see around the building corner, as shown in Picture C-73.

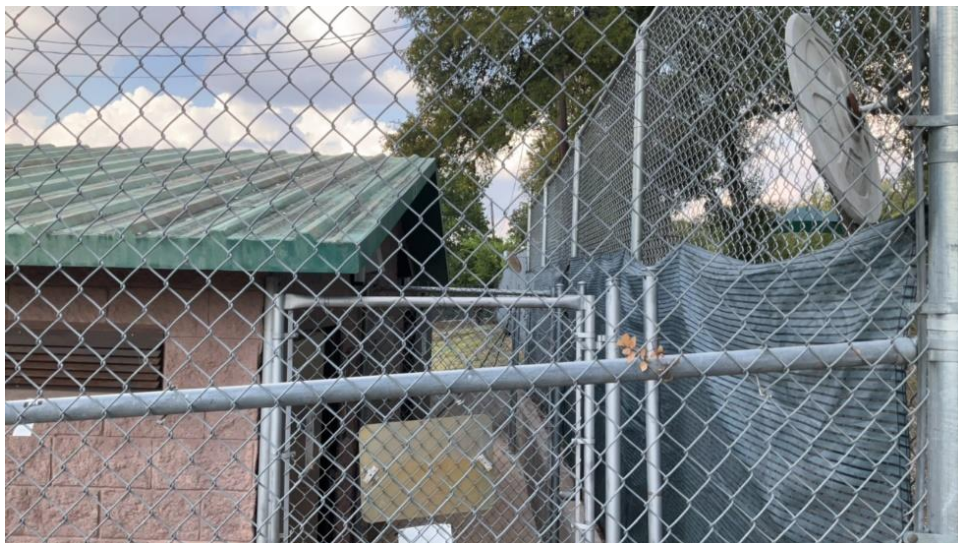
**Picture C-74. Big Stacy Pool - Site / Target Hardening**

There is 6-10 ft chain link fencing around the entire pool facility. Some sections of the fencing also have a three-strand barbed wire topper and green privacy screens. Fencing on the western side of the pool has been bypassed by individuals swimming overnight, although it has been reinforced on the eastern side with the addition of barbed wire and an additional, taller fence, as shown in Picture C-74.

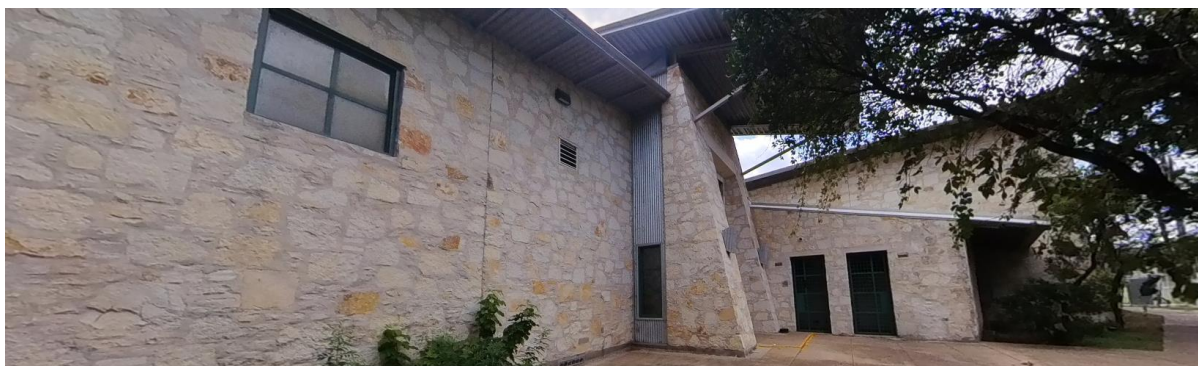
**Picture C-75. Parque Zaragoza Recreation Center - Natural Surveillance**

Parque Zaragoza Recreation Center scored very poorly across the natural surveillance, image management / maintenance, and activity support CPTED categories. The design of the building includes sharp corners, obtrusive walls, and hidden pockets of space, creating blind spots around the building, especially on the back side of the facility that faces dense vegetation, as shown in Picture C-75.

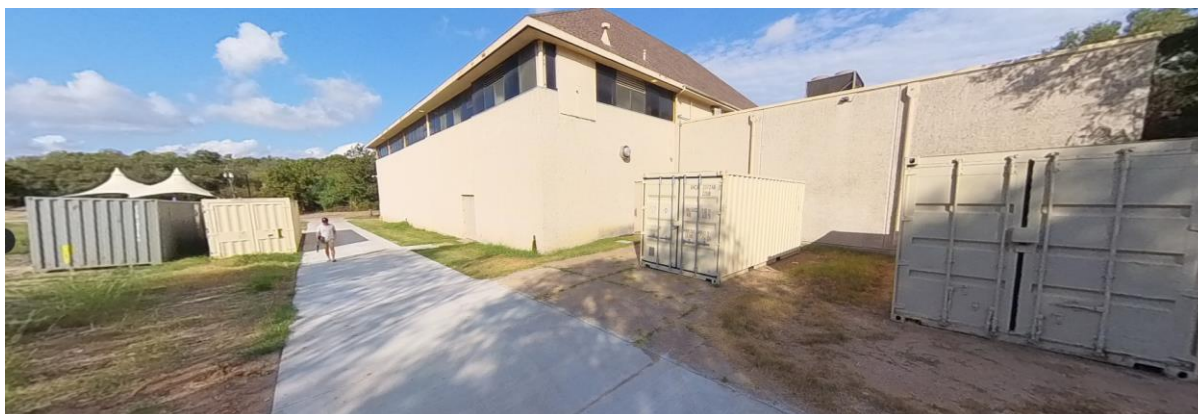
**Picture C-79. Givens Recreation Center - Natural Surveillance**

Trash and blind spots were observed throughout the back side of the building due to sharp corners, the lack of ground windows facing outwards, and multiple shipping containers, as shown in Picture C-79.

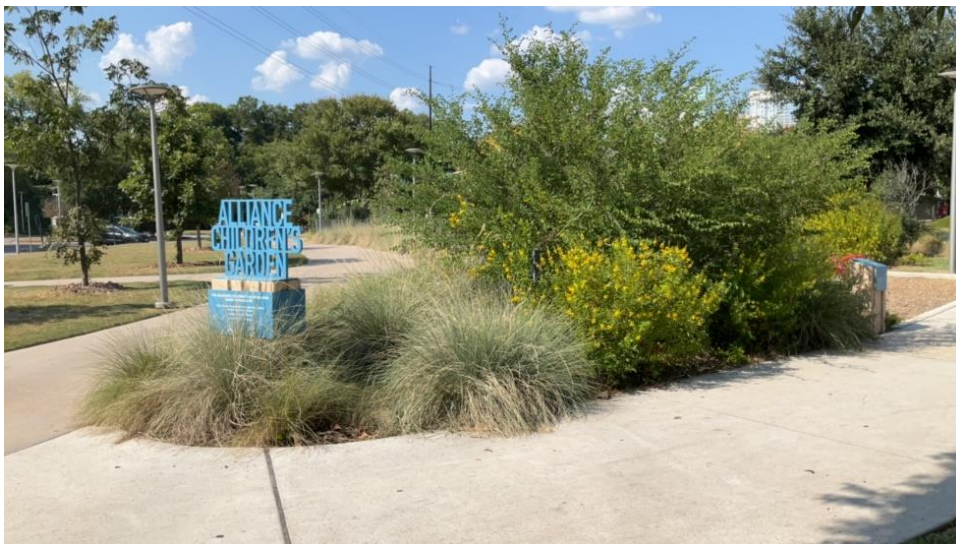
Dense vegetation surrounds the entrance of the park, which impacts visibility when accessing the facility, as shown in Picture C-83. This type of vegetation is present throughout the entire park, surrounding the main playground area.

**Picture C-83. Alliance Children's Garden entrance – Thick, tall bushes and vegetation forms the garden perimeter, obstructing views from outside and throughout the garden**

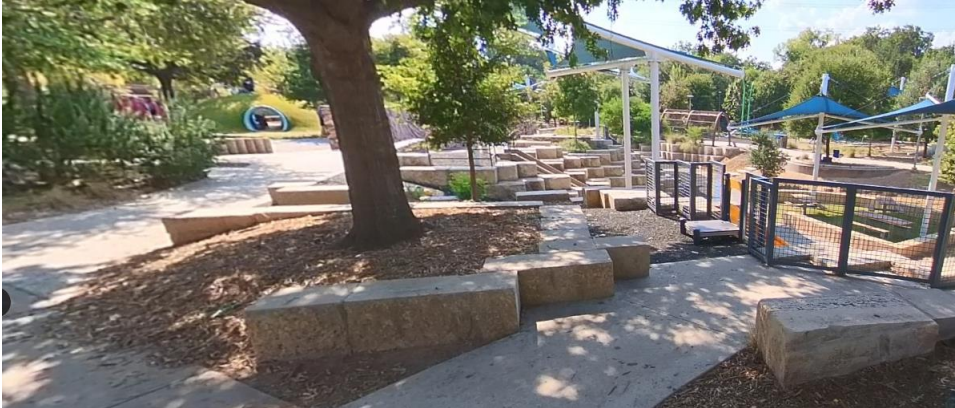
**Picture C-84. Alliance Children's Garden - Natural Surveillance**

The below grade play area requires users to climb down to the play area, as shown in Picture C-84. This is ideal if the adult supervision remains above, because they have increased visibility from the higher vantage point;

however, it would be difficult to observe approaching individuals if the adult supervision is down in play area where there also are picnic tables and shade structures.

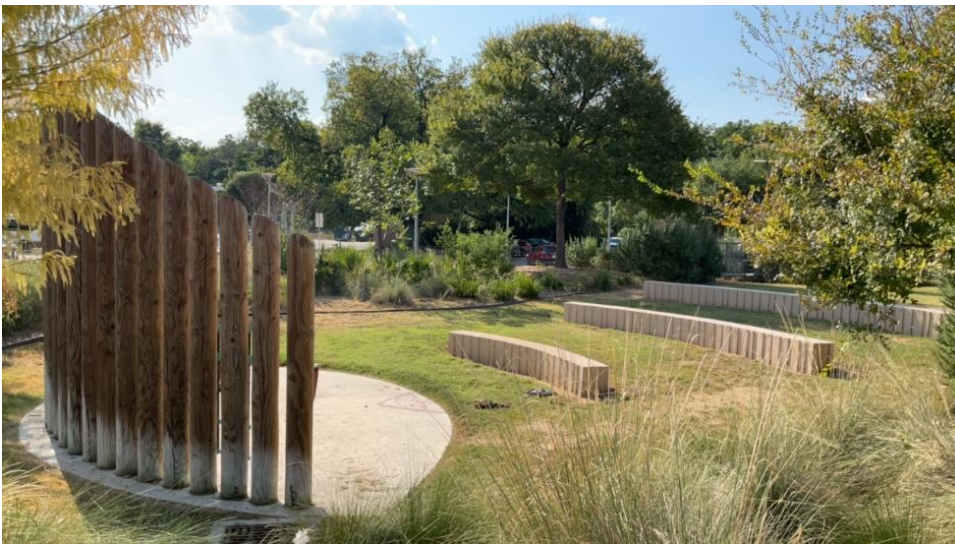
**Picture C-85. Alliance Children's Garden - Evidence of Vagrancy**

There were two individuals experiencing homelessness at the adjacent park at the time of the site visit, along with scattered trash and discarded clothes in and around the below grade play structure, as shown in Picture C-85.
