**City of Austin**

# Parks and Recreation Department Security Audit

## Findings and Recommendations Report

Version 2 | July 18, 2025

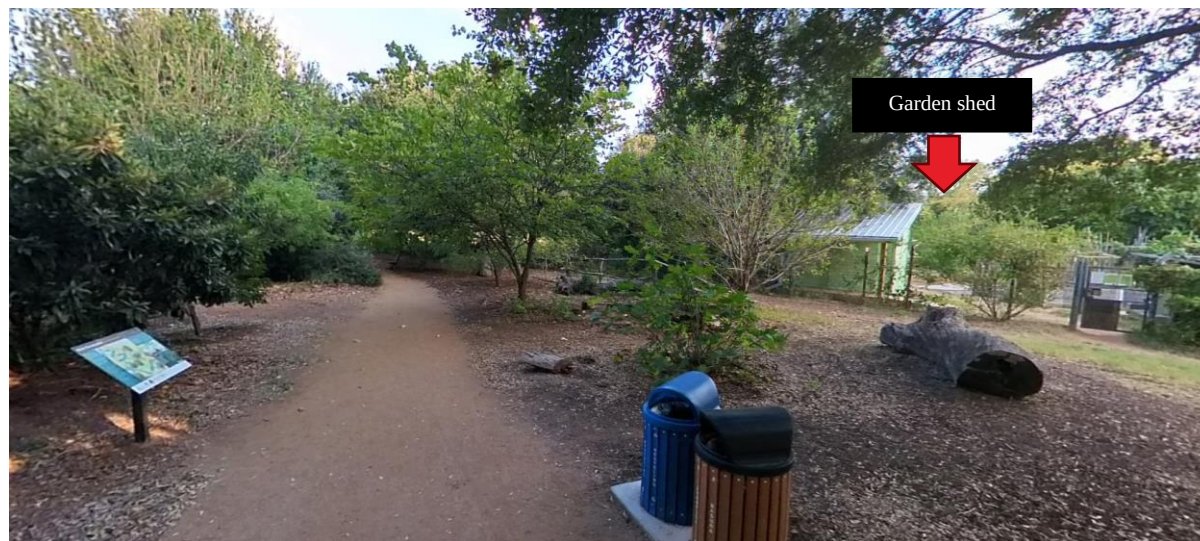
**Picture C-97. Festival Beach Food Forest – The dirt pathway leads through the food forest; pictured right is a pedestrian gate leading into the community garden where the garden shed is located**

Staff noted that a garden shed, which sits within the community garden perimeter, had recently been broken into, and gardening tools and other equipment were stolen. There was an abundance of trash throughout (specifically alcohol containers) and vandalism (spray paint on wooden benches) throughout the food forest.

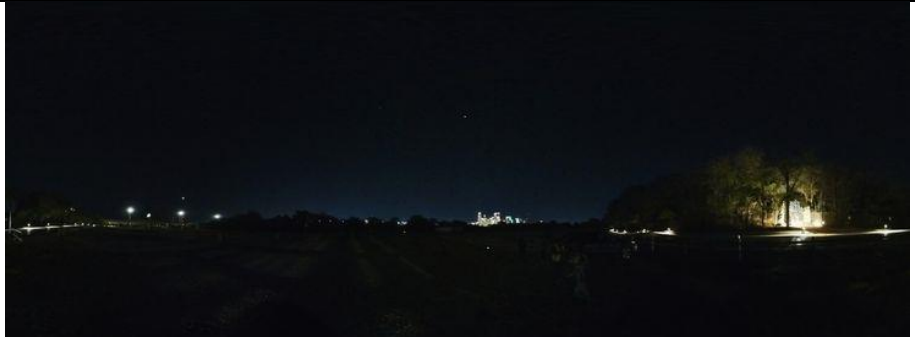
## 29- Parking Lot (Safety Score 51)

The main parking lot tows cars after closing hours. During the visit, a couple of cars were camping out. The parking lot is very dark due to the lack of lighting. Bright light comes from the Botanical Gates of Paradise, and the city skyline and light poles on Mopac Expressway are also visible. Bollards are present across the street to illuminate the pathway and make pedestrians visible to oncoming vehicles.

Picture C-97. 360 Image of large gravel parking lot

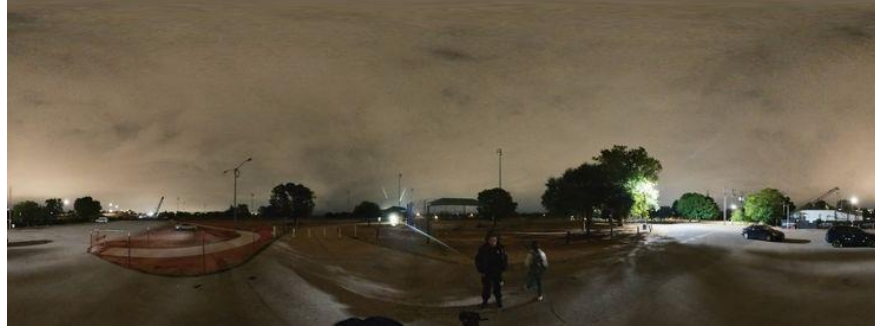
## 52- Parking Lot (Safety Score 57)

There was nearby construction. The fields had no lights. The restroom facility had a bright wall pack. Unhoused individuals were seen hanging under the tree and the bleachers. A bright light pole was nearby, with light spilling from the streetlights. The baseball area was roped off, and bollards blocked the road.

Picture C-99. 360 Image of parking lot

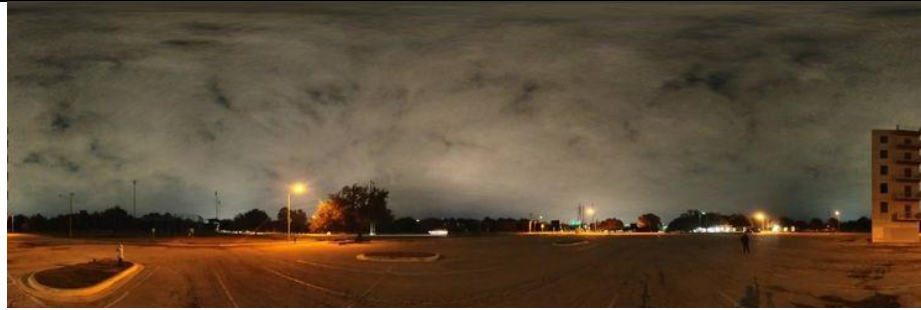
**53- Parking Lot (Safety  
Score 57)**

The light poles in the parking lot had different color temperatures. The neighboring baseball field lights were off. A police car was parked in the lot, and two cars, likely drifters, pulled up. There was also a large fire tower, blocking visibility, standing in the parking lot.

**Picture C-100. 360 Image of parking lot next to fire tower**

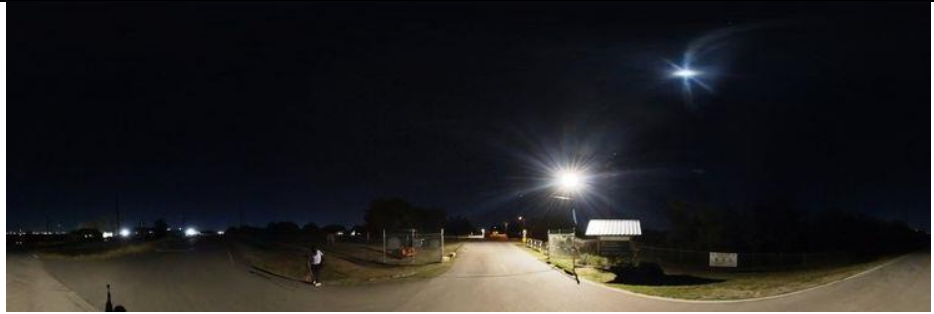
102- Park Access (Safety  
Score 49)

A bright white light pole is at the entry sign and there are warm light poles at the parking areas. Some building facilities across the road have wall packs. The admission booth has bright white linear fixtures on the exit side of the booth.

Picture C-105. 360 Image of park vehicle access

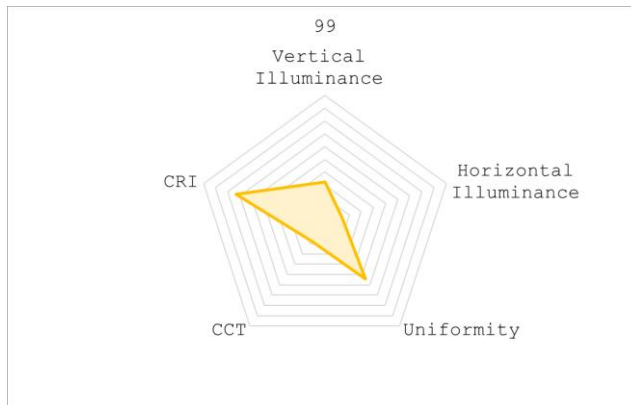
Picture C-114. 360 Image of park access bridge

### 99- Park Access (Safety Score 56)

The area is very dark, with the only light coming from across the street from the gas station and the streetlights.

Vertical Illuminance: Low  
Horizontal Illuminance: Low  
Uniformity: Standard  
CRI: N/A  
CCT: N/A

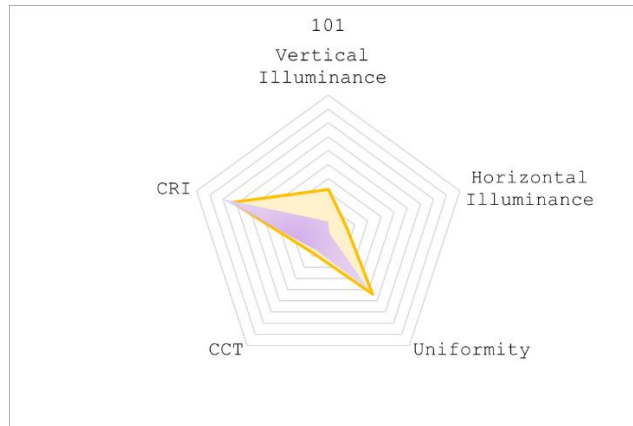
Picture C-115. 360 Image of parking lot

### 101- Parking Lot (Safety Score 51)

There light poles for the parking area with motion sensors. There are a lot of lights coming from the neighboring fields when they are on, but when they are off, it gets dark.

Vertical Illuminance: Low  
Horizontal Illuminance: Low  
Uniformity: Standard  
CRI: Standard  
CCT: Standard

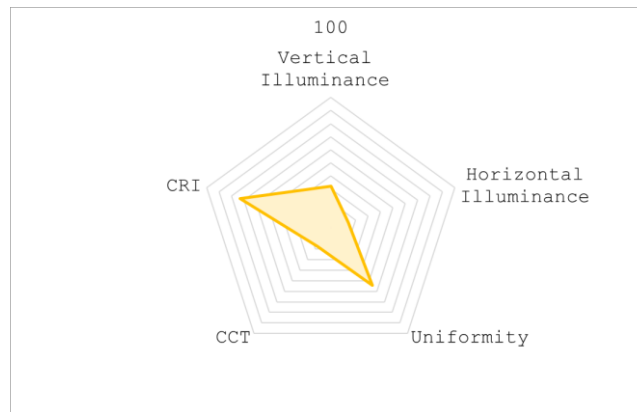
Picture C-116. 360 Image of children's play area

100- Passive Recreation (Safety  
Score 67)

Many individuals experiencing homelessness are camped out at the restroom and the dark pavilion near the play area. The kids' area has no lighting except for what comes from the neighboring houses and the restroom.

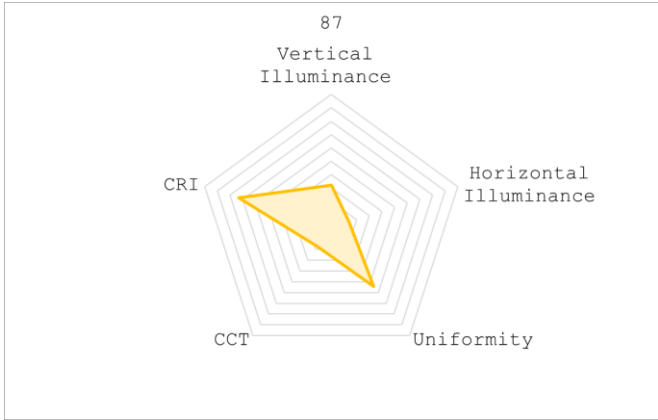
| <p><u>87- Park Center (Safety Score 63)</u></p> <p>There is a low level of light coming from the moon. There are trees on the side, but they are not hovering over the pathway which allows the light from the moon to hit the path.</p> <p><i>Safety Score Rationale:</i><br/> Perception of safety: Average/Low<br/> Reflectance: Dark<br/> Specularity: Matte<br/> Visual Transparency: Low<br/> Physical Transparency: Average<br/> Scale: Average</p> <p><i>Spider Diagram Analysis:</i><br/> Vertical Illuminance: Low<br/> Horizontal Illuminance: Low<br/> Uniformity: Standard<br/> CRI: N/A<br/> CCT: N/A</p> | <p><b>Picture C-117. 360 Image of Pathway</b></p> <p><b>63</b> /100</p> |

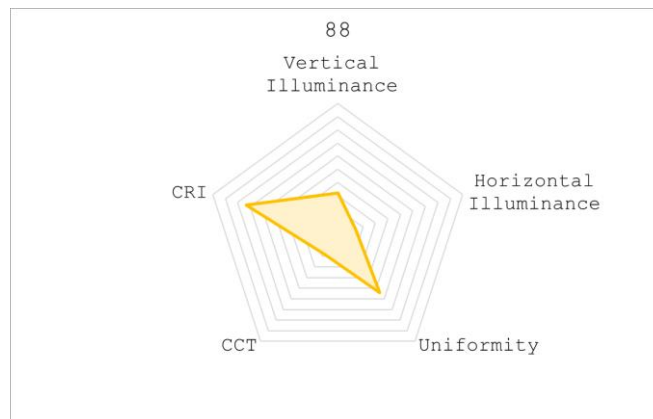
Picture C-118. 360 Image of Troll Malin

88- Art and Culture (Safety Score 72)

The area leading up to Malin the troll is very dark and lacks any lighting, making it easy to trip on surroundings. The abundance of trees adds to the darkness because it blocks the moonlight. To see the structure, a flashlight is needed.

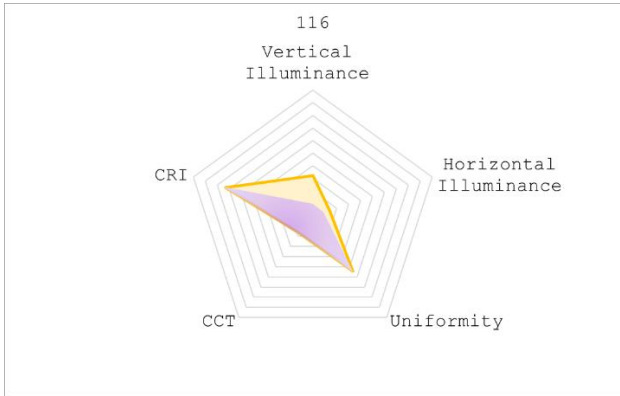
| <p><u>116- Park Access (Safety Score 48)</u></p> <p>Street lights make the area feel well-lit, and flood lights from the tennis court across the street add to the brightness. The pathway closest to the entryway is fairly dark, but there is some light spill from the road and lots of lights from passing cars.</p> <p><i>Safety Score Rationale:</i><br/> Perception of safety: Average/High<br/> Reflectance: Neutral<br/> Specularity: Neutral<br/> Visual Transparency: High<br/> Physical Transparency: Average<br/> Scale: Average</p> <p><i>Spider Diagram Analysis:</i><br/> Vertical Illuminance: Low<br/> Horizontal Illuminance: Standard<br/> Uniformity: Standard<br/> CRI: Standard<br/> CCT: Standard</p> | <p><b>Picture C-122. 360 Image of park entryway</b></p> <p><b>48/100</b></p> |

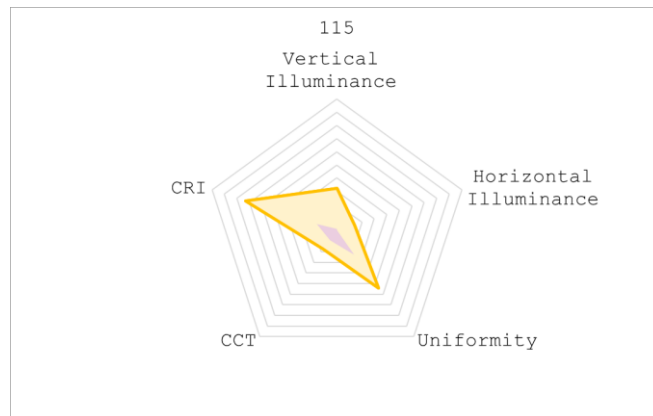
Picture C-124. 360 Image in the parking lot

### 115- Parking Lot (Safety Score 53)

There is an inconsistent color temperature with one warm light for the parking and one white light at the entry of the park. There is no one in the parking lot, but cars are coming through on the neighboring streets. Across the street, one can see lights from the tennis court.

Vertical Illuminance: Low  
Horizontal Illuminance: Low  
Uniformity: Low  
CRI: Low  
CCT: Low

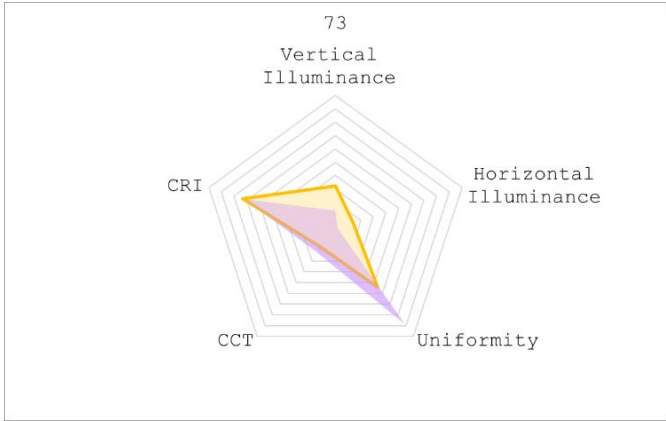
| <p><u>73- Park Access (Safety Score 49)</u></p> <p>Tall flood lights are seen illuminating the area on the opposite side of the bridge. Some parts on the path remains dark due to trees and vegetation. Wall packs are installed along the back of the facility. The entire park is surrounded by houses.</p> <p><i>Safety Score Rationale:</i><br/> Perception of safety: Average/High<br/> Reflectance: Neutral<br/> Specularity: Neutral<br/> Visual Transparency: Average<br/> Physical Transparency: Average<br/> Scale: Average</p> <p><i>Spider Diagram Analysis:</i><br/> Vertical Illuminance: Low<br/> Horizontal Illuminance: Low<br/> Uniformity: High<br/> CRI: Standard<br/> CCT: Standard</p> | <p><b>Picture C-125. 360 Image bridge to the park</b></p> <p><b>49</b> /100</p> |

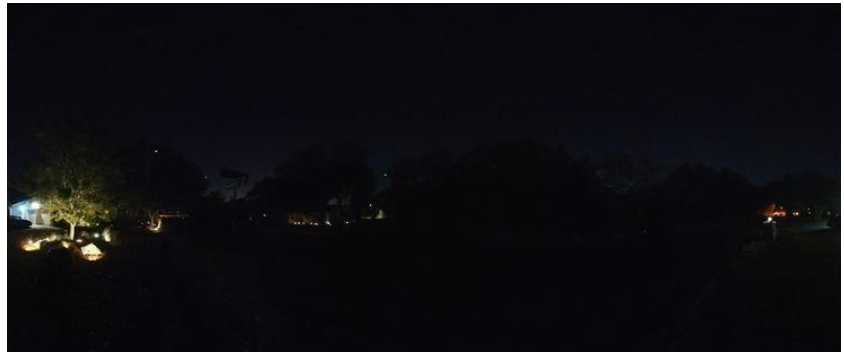
Picture C-137. 360 Image of park access

This access point is situated right next to a street. The entryway lacks dedicated lighting, relying instead on the light from nearby houses and streetlights. The streetlights have varying color temperatures, and one nearby is broken. There is no sidewalk leading to the entrance, making it difficult for pedestrians to be seen by vehicles due to poor visibility.

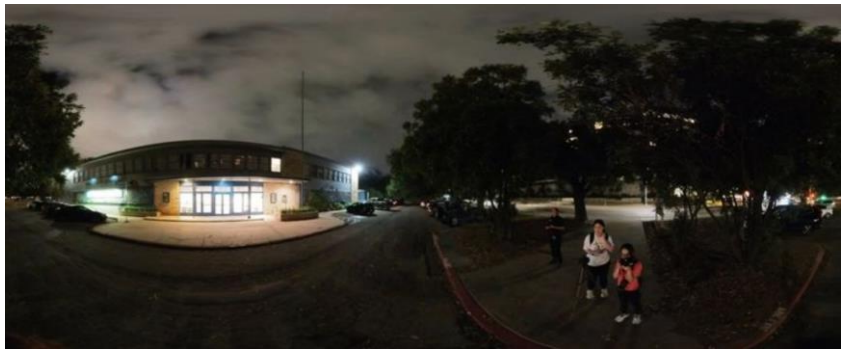
**Picture C-140. 360 Image of main access point**

The facility entrance has downlights lighting the entryway path, and there is significant light spilling through the interior of the building through the windows. Across the street, there are neon lights from the restaurants and establishments nearby. The facility sign has motion sensor lights that do not have enough light to make the sign visible. The letterboard beneath the sign has bright wall mounted lights. The mural adjacent to the entry is lit by a wall mounted fixtures on the upper corner of the building.

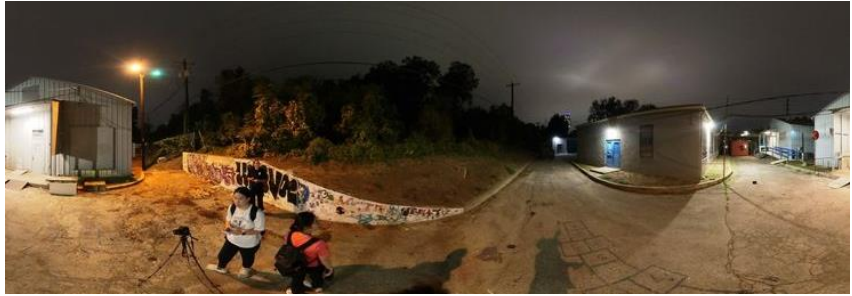
Picture C-143. 360 Image of the back of the facility

The back of the facility is equipped with wall packs on the walls and linear fixtures at the entrances. There are play features for kids, like four square and hopscotch, but they are faded, unlit, and no one was seen using them.

Vertical Illuminance: High  
Horizontal Illuminance: High  
Uniformity: Low  
CRI: Standard  
CCT: Low

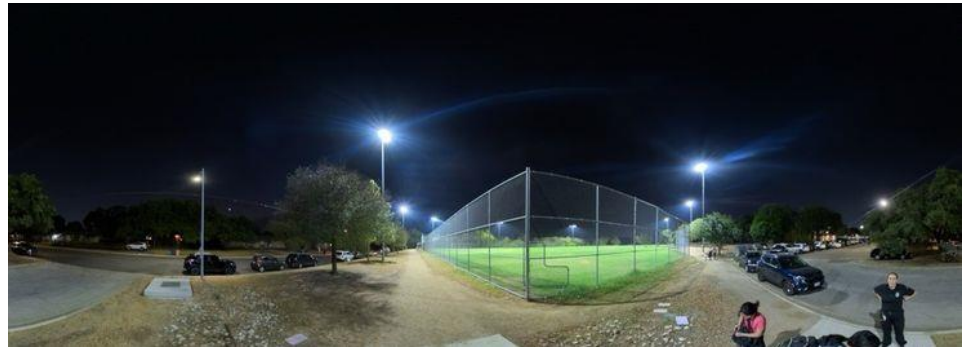
Picture C-149. 360 Image of parking lot entry

1 - Parking Lot (Safety  
Score 42)

The recreation center parking entrance leads to a fully utilized parking lot when there are games. The entry way is lit by a warm street light pole, and there is light spill from bright, neighboring flood lights on the field.

*Safety Score Rationale:*  
Perception of safety: High  
Reflectance: Neutral  
Specularity: Neutral  
Visual Transparency: High  
Physical Transparency:  
Average  
Scale: Average

*Spider Diagram Analysis:*  
Vertical Illuminance: High  
Horizontal Illuminance:  
High  
Uniformity: High  
CRI: Standard  
CCT: Standard

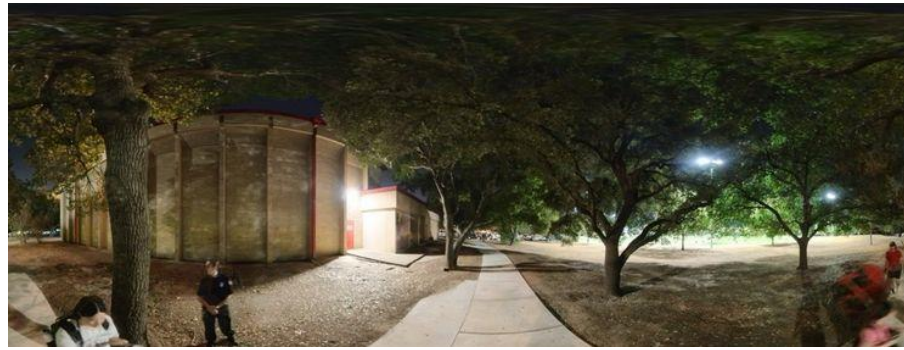
Picture C-151. 360 Image of park pathway

### 3 – Park Center (Safety Score 55)

The side entry of the building had a bright, glary wall pack above the door which causes a spotlight effect at the door. The side of the facility was very dark in comparison to the entry way, and a figure was seen hiding in the dark patch. The pathway had little foot traffic.

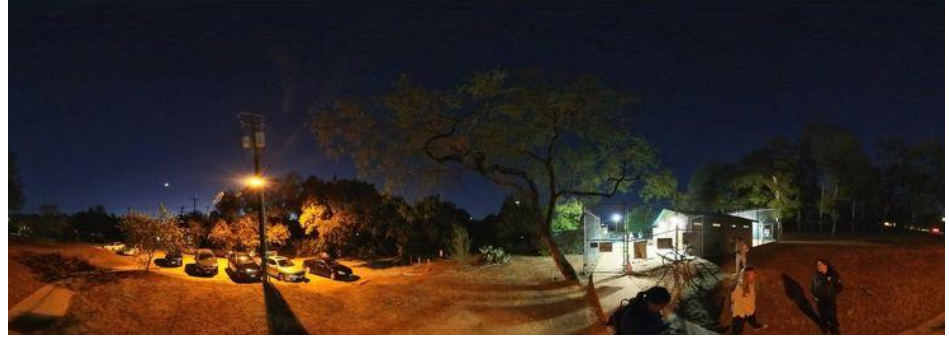
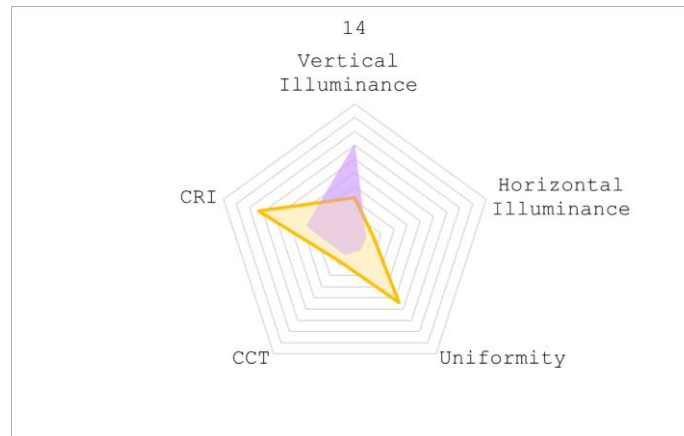
Picture C-153. 360 Image of pool entry

## 14 - Facility Entry (Safety Score 50)

The parking lot at this entry is illuminated by warm lights from a light pole, contrasting with the bright light spilling from inside the facility. The path from the parking lot to the pool is adequately lit, but the path beyond the parking lot into Blunn Greenbelt Trail has low visibility due to a lack of lighting.

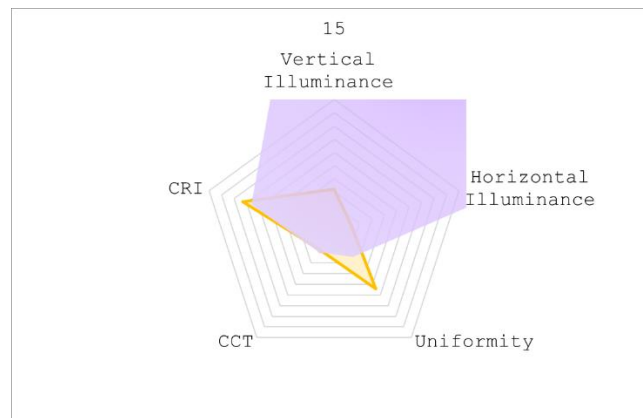
Picture C-154. 360 Image inside the pool

15 - Active Recreation  
(Safety Score 48)

During the visit, several people were using the pool facility, which is brightly lit by pool lights that flood the entire area. Additional lighting comes from wall packs on the buildings and the moonlight tower on Leland & Eastside Drive.

Vertical Illuminance: High  
Horizontal Illuminance: High  
Uniformity: Low  
CRI: Low  
CCT: Standard

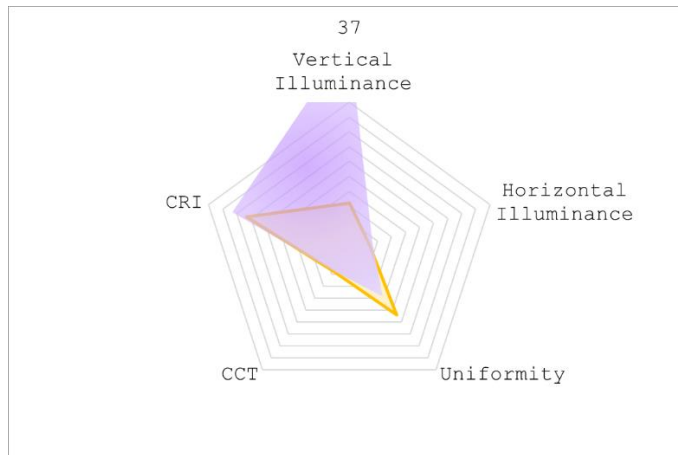
**Picture C-156. 360 Image of the annex facility back entryway**

### 37 - Facility Back Entry (Safety Score 56)

The exterior of the building is equipped with wall packs and troffers, which are very bright. There is a spotlight effect from the lights on the building making it difficult to see past the woods, affecting the perception of safety. The pathway next to the building is well illuminated, but there is no pedestrian pathway lighting for the pathway as it goes further away.

Vertical Illuminance: High  
Horizontal Illuminance: Standard  
Uniformity: Low  
CRI: High  
CCT: Standard

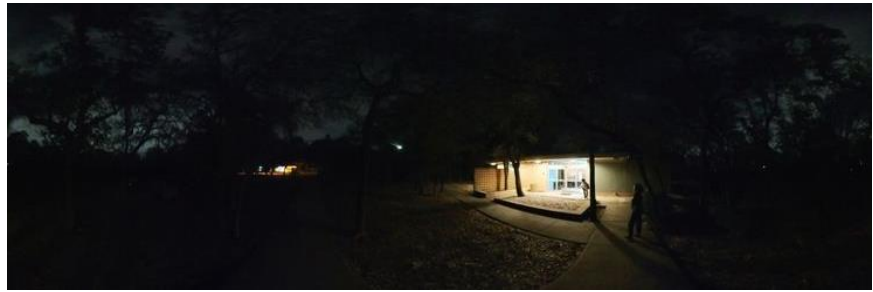
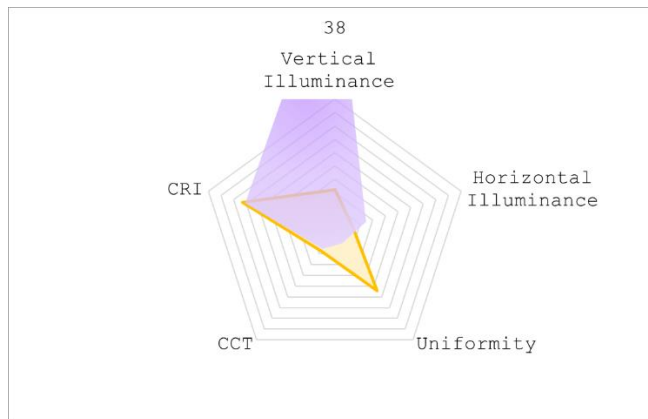
Picture C-157. 360 Image of annex building front entryway

### 38 - Facility Entry (Safety Score 54)

The ceiling features large 2x2 troffers, creating a spotlight effect from the building's bright lights. This makes it difficult to see people on the pathway and road leading to the building. While the area next to the building feels safe, walking up to it does not.

Vertical Illuminance: High  
Horizontal Illuminance: High  
Uniformity: Low  
CRI: Standard  
CCT: Standard

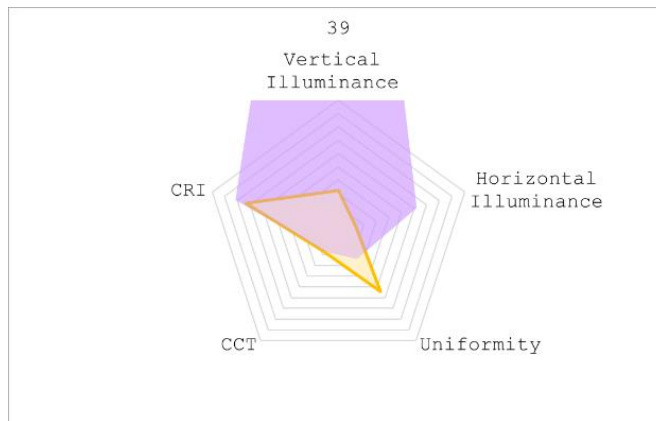
Picture C-158. 360 Image of facility front entryway

### 39 - Facility Entry (Safety Score 48)

The entryway is very bright, with light spill from inside the building. The color temperature is inconsistent, with white light coming from inside the canopy, and warm light illuminating the facility sign. The neighboring park itself is not illuminated. There is one streetlight for the parking.

Vertical Illuminance: High  
Horizontal Illuminance: High  
Uniformity: Low  
CRI: High  
CCT: Standard

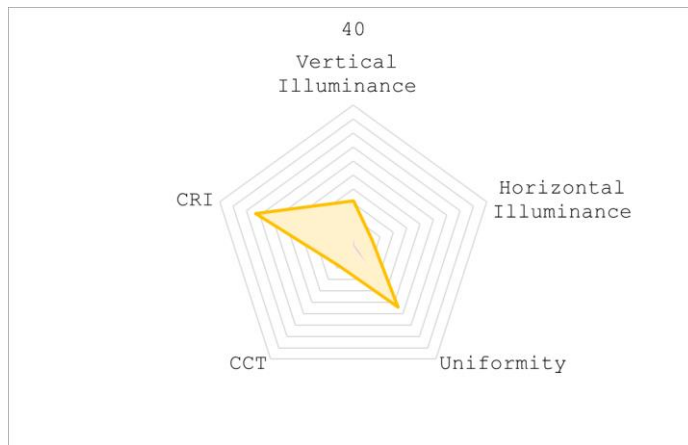
Picture C-159. 360 Image of waterside platform

#### 40 - Park Center (Safety Score 64)

Light from the pool spills onto the path, but otherwise, it is very dark with no lights at this point. The stairs leading to this area are very rocky and dark, making it easy to trip. Activity seen in this area includes fishing, drug use, and busking.

Vertical Illuminance: Low  
Horizontal Illuminance: Low  
Uniformity: Standard  
CRI: N/A  
CCT: N/A

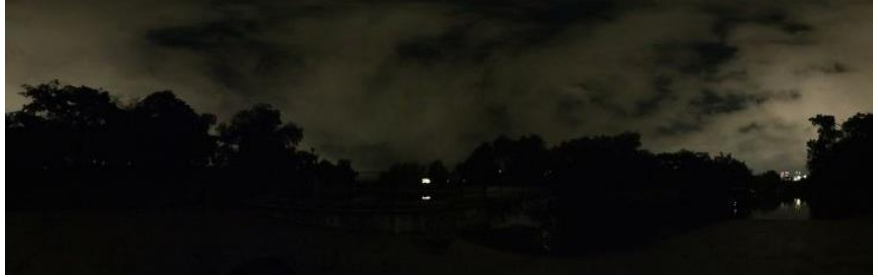
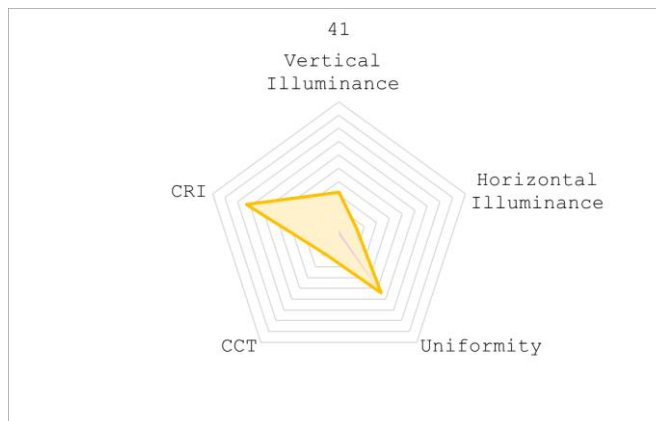
Picture C-160. 360 Image of waterside platform

#### 41 - Park Center (Safety Score 72)

The light from the pool turned off at 10 PM, leaving this area dark. Someone's belongings were on the platform, and the path to the ledge was difficult to navigate due to the lack of lighting. The only sources of lights were the from the pool facility and the city skyline.

Vertical Illuminance: Low  
Horizontal Illuminance: Low  
Uniformity: Standard  
CRI: N/A  
CCT: N/A

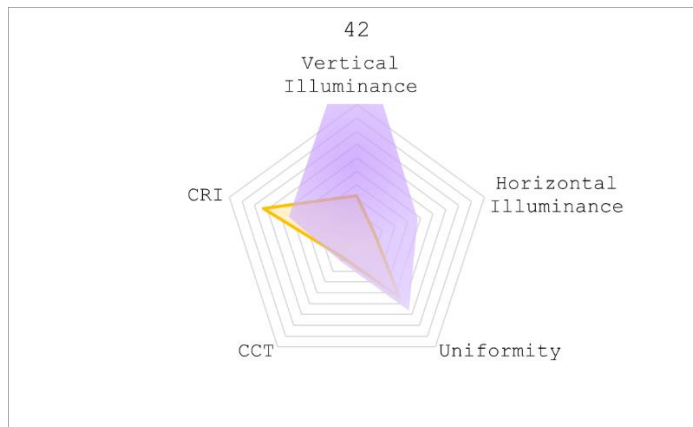
Picture C-161. 360 Image inside the pool

**42 - Active Recreation (Safety  
Score 53)**

There are a handful of swimmers in the pool. Flood lights on poles provide ample lighting to the pool and parkway. However, the walkway to the pool is not well illuminated and can be a tripping hazard if not careful. There is light coming from the pool facility. Trees surround the lawn and pool.

Vertical Illuminance: High  
Horizontal Illuminance: High  
Uniformity: High  
CRI: Low  
CCT: Standard

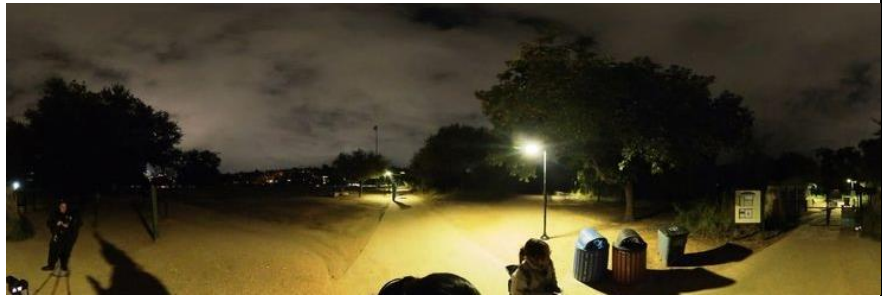
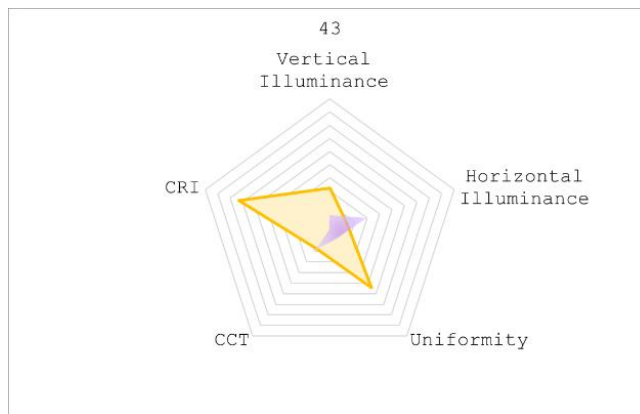
Picture C-162. 360 Image of park admission entry

#### 43 - Park Access (Safety Score 51)

There is a lot of pedestrian lighting on the path toward the entry point, with many low-level light poles. The field lights next to this area were not on. The admission booth was lit by the neighboring light poles along the pathway.

Vertical Illuminance: Low  
Horizontal Illuminance: High  
Uniformity: Low  
CRI: Low  
CCT: Standard

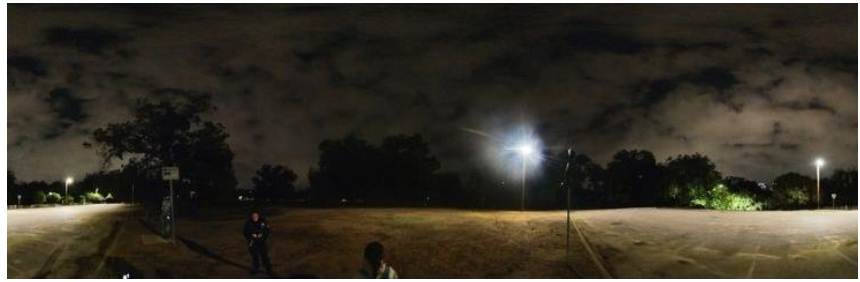
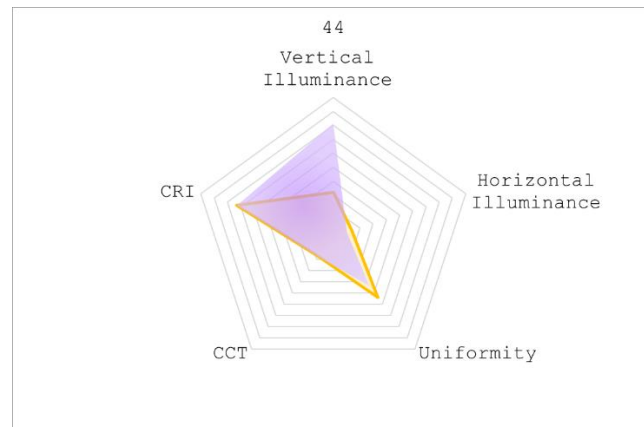
Picture C-163. 360 Image of parking lot

#### 44 - Parking Lot (Safety Score 59)

There are light poles for the parking lot, but it was hard to see beyond into the field and the pool due to the lack of other light sources. Although people could be heard from the field, they were not visible. A path next to the parking lot led to a dead end where an unhoused person was sleeping.

Vertical Illuminance: High  
Horizontal Illuminance: Standard  
Uniformity: Low  
CRI: Standard  
CCT: Standard

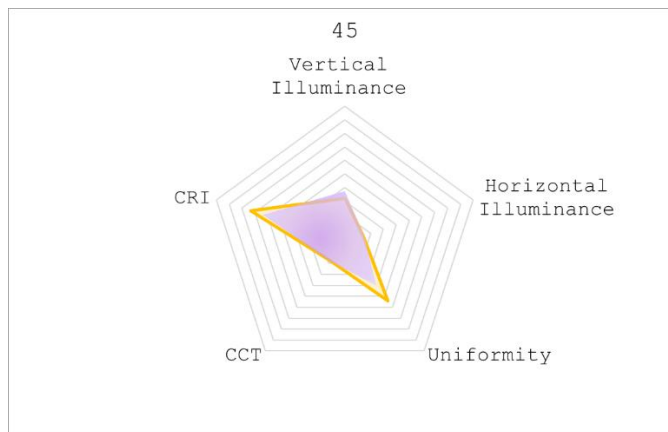
Picture C-164. 360 Image of parking lot

#### 45 - Parking Lot (Safety Score 49)

This parking lot is illuminated by light poles that provide patches of light throughout the entirety of the lot.

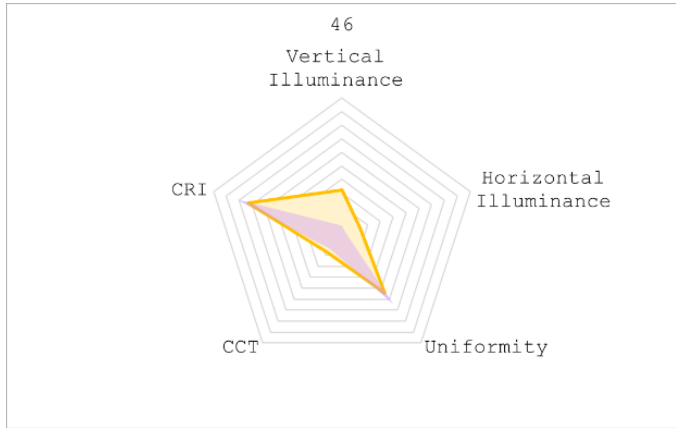
| <p><b>46 - Parking Lot (Safety Score 63)</b></p> <p>The parking lot has light poles, with additional light spilling over from nearby residential areas and field lights. COA cars and trailers are parked here. Some trees partially block the view to the neighboring residences, but not significantly. There is a large dumpster in the area.</p> <p><i>Safety Score Rationale:</i><br/> Perception of safety: Average<br/> Reflectance: Neutral<br/> Specularity: Neutral<br/> Visual Transparency: Average<br/> Physical Transparency: Average<br/> Scale: Average</p> <p><i>Spider Diagram Analysis:</i><br/> Vertical Illuminance: Low<br/> Horizontal Illuminance: Low<br/> Uniformity: Standard<br/> CRI: Standard<br/> CCT: Low</p> | <p><b>Picture C-165. 360 Image of parking lot</b></p> <p><b>63 /100</b></p> |

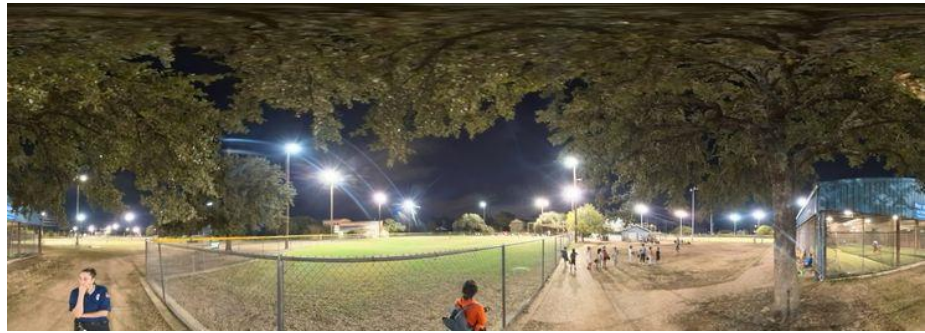
Picture C-168. 360 Image near athletic fields

Kids are playing in the fields and grass areas. At the time of survey, kids were running around the batting cage (where the storage container is), which is mostly see-through except for one wall which could impede visibility. Floodlights from the fields provide ample illumination, though some light poles and light on the batting cage are out.

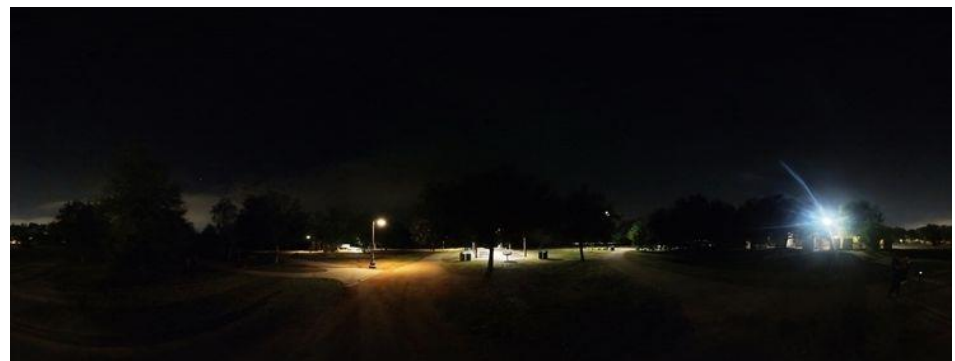
Picture C-170. 360 Image near pavilion and playground

The pavilion was well-lit and seemed like a good hangout spot, with one unhoused person present. The playground had some lighting from the pathway around it. There was a wall pack on the facility that shines on the storage containers around the facility.

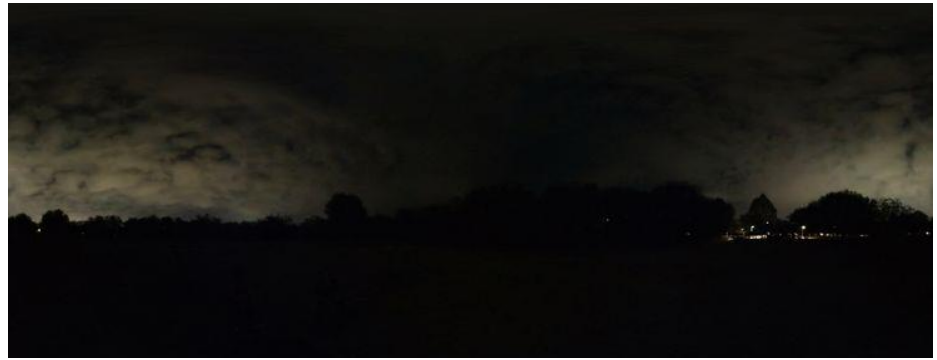
Picture C-171. 360 Image near trail

This area is an open field with a zipline and a neighboring trail. Some light spilled from the opposite side of the playground. It was very quiet with no one around, and the trees divided this area from other areas of the park.

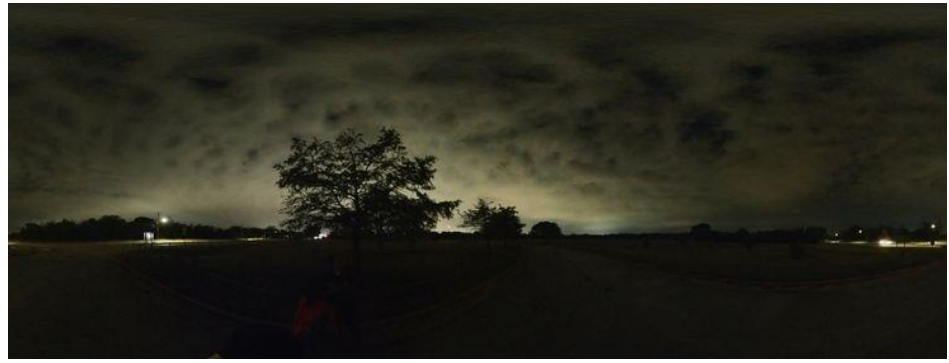
**Picture C-174. 360 Image of the vehicle entryway**

There was no designated lighting for the entryway, and there were no light poles or structures on the field. Streetlights were the only source of light for this entryway. The gate was put up for cars.

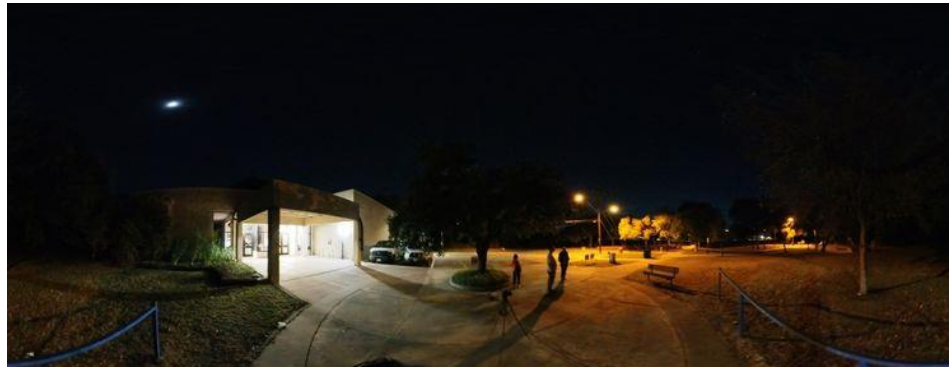
**Picture C-175. 360 Image of facility front entryway**

The entryway has wall packs and light flooding from the interior. There are light poles in the area with two different color temperatures. At the playground park, there is a warm light pole. Despite hearing people, visibility was poor. There are facility vehicles parked in the parking lot overnight. The bench area had some dark patches because of the trees, and the garden pots on the side of the building were not visible.

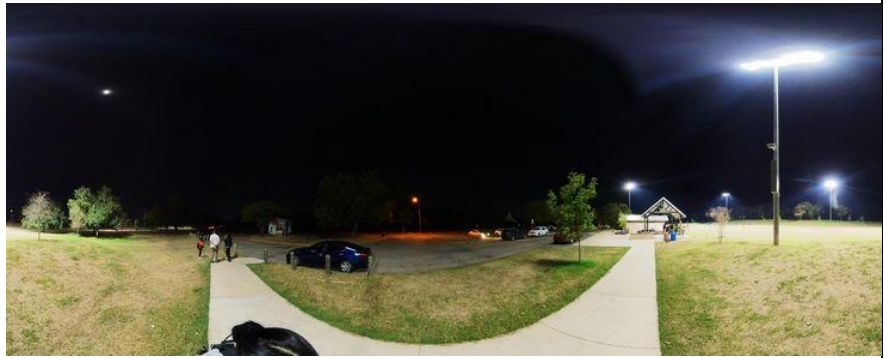
Picture C-178. 360 Image next to the athletic fields

The field lights are very bright, where a lot of kids and parents are seen. However, people are seen loitering and on drugs in the pavilion parking lot. The parking lots are not well lit, with only a few solar powered light poles. There is some trash left in the pavilion near the field.

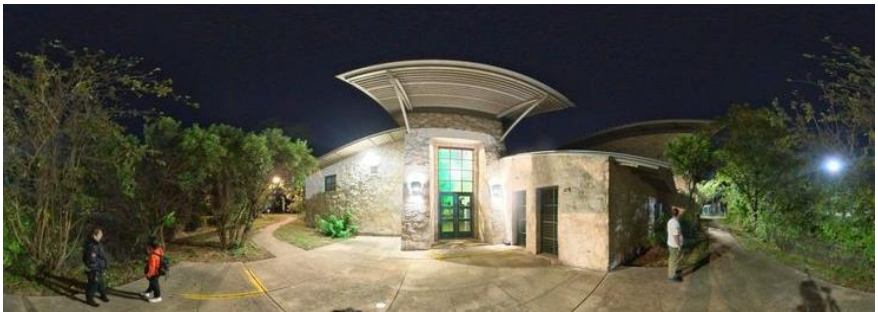
| <p><b><u>68 - Facility Back Entry (Safety Score 59)</u></b></p> <p>On the side of the building, there are wall-mounted fixtures and wall packs. Light poles line the pathway, and a floodlight shines through the vegetation on the other side. This section is well illuminated, but further along the pathway where there is tree coverage, it can get dark.</p> <p><i>Safety Score Rationale:</i><br/> Perception of safety: Average<br/> Reflectance: Neutral<br/> Specularity: Neutral<br/> Visual Transparency: Average<br/> Physical Transparency: Average<br/> Scale: Average</p> <p><i>Spider Diagram Analysis:</i><br/> Vertical Illuminance: Standard<br/> Horizontal Illuminance: Standard<br/> Uniformity: Standard<br/> CRI: Standard<br/> CCT: Standard</p> | <p><b>Picture C-179. 360 Image at the facility back entryway</b></p> <p><b>59/100</b></p> |

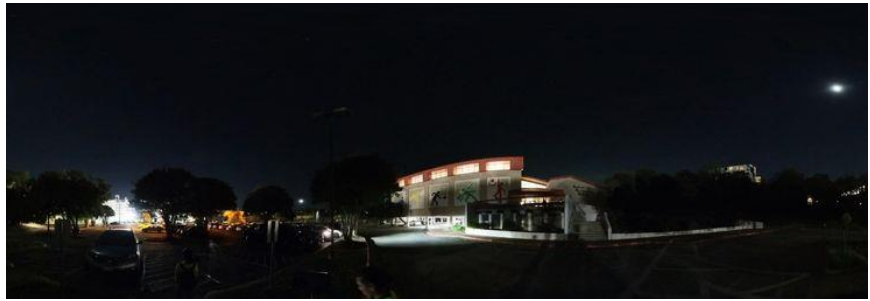
Picture C-183. 360 Image of the facility entryway

There are some encampments in the area. The lights were not set correctly for daylight savings at the time of survey. The light poles in the parking lot, wall pack above the garage, downlights at the entry, and steps lights on the stairs turned on at 8pm, two hours after sun set.

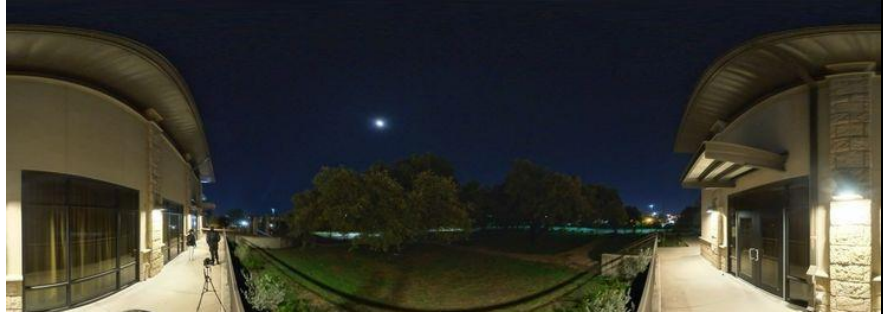
Picture C-187. 360 Image of side facility entry

There are bright wall packs lining the wall. The outdoor gym area behind the center is not lit at all, making it hard to see. The only other light comes from the poles in the parking lot.

Vertical Illuminance: High  
Horizontal Illuminance: High  
Uniformity: Low  
CRI: Standard  
CCT: Standard

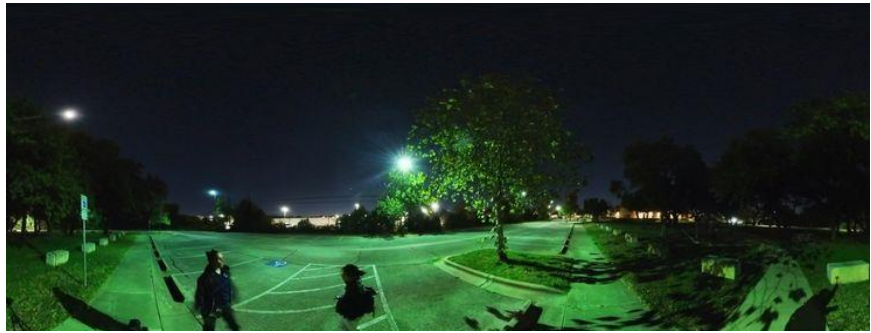
Picture C-189. 360 Image of gym area

The outdoor gym area is quite dark with no lighting. The only light comes from the poles in the parking lot and the wall packs on the building. It is hard to see into the trees beyond the parking lot, creating a visual and physical barrier.

Vertical Illuminance: Low  
Horizontal Illuminance: Low  
Uniformity: Standard  
CRI: Low  
CCT: High

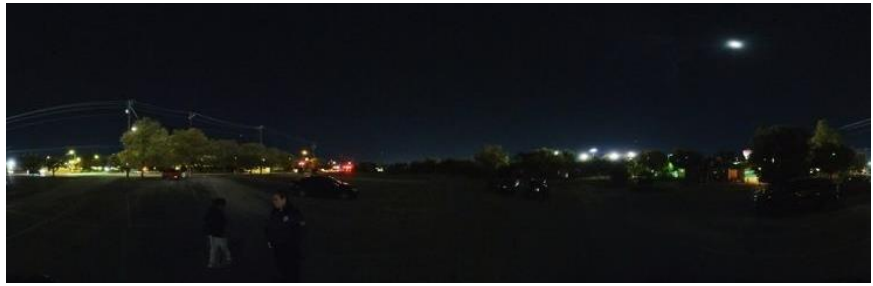
Picture C-190. 360 Image of the parking lot

The parking lot is very dark due to the lack of any lighting infrastructure, making it difficult to see the driveway to turn into. The basketball courts next to the lot are not lit.

Vertical Illuminance: Low  
Horizontal Illuminance: Low  
Uniformity: Standard  
CRI: N/A  
CCT: N/A

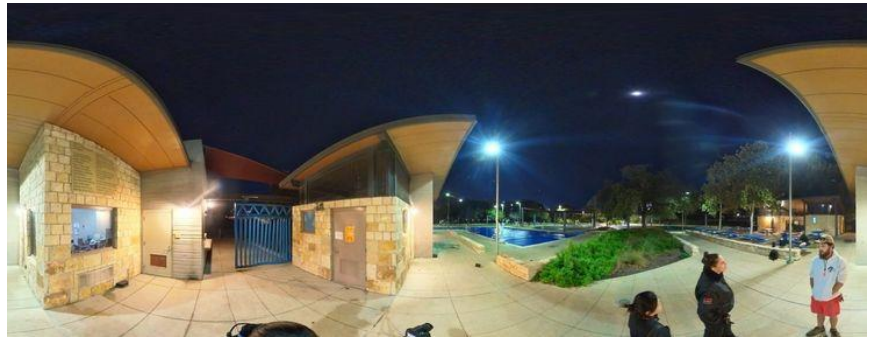
Picture C-191. 360 Image inside the pool

There are not many people who swim here at night due to the pool closing at 8pm and tarps being put up. In the pool, there are also lights installed, but they cannot be seen due to the tarps. Inside the pool area, there are light poles and wall packs on the facility at points of interest, making the area bright. Some light poles are broken outside the entry. People have been caught jumping over the fence at night and there are problems with people sneaking around the storage area where chemicals are kept.

Vertical Illuminance: Standard  
Horizontal Illuminance: Standard  
Uniformity: Standard  
CRI: Standard  
CCT: Standard

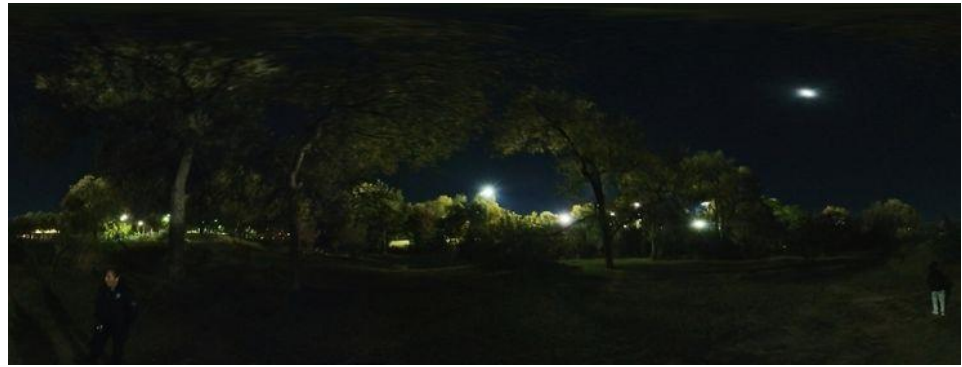
**Picture C-192. 360 Image near the frisbee golf course**

Flood lights from the fields in the park and pool can be seen. The picnic tables are not very well lit and are nestled in the vegetation.

*Safety Score Rationale:*  
Perception of safety:  
Average  
Reflectance: Dark  
Specularity: Matte  
Visual Transparency: Low  
Physical Transparency:  
Average  
Scale: Average

*Spider Diagram Analysis:*  
Vertical Illuminance: Low  
Horizontal Illuminance:  
Low  
Uniformity: Standard  
CRI: N/A  
CCT: N/A

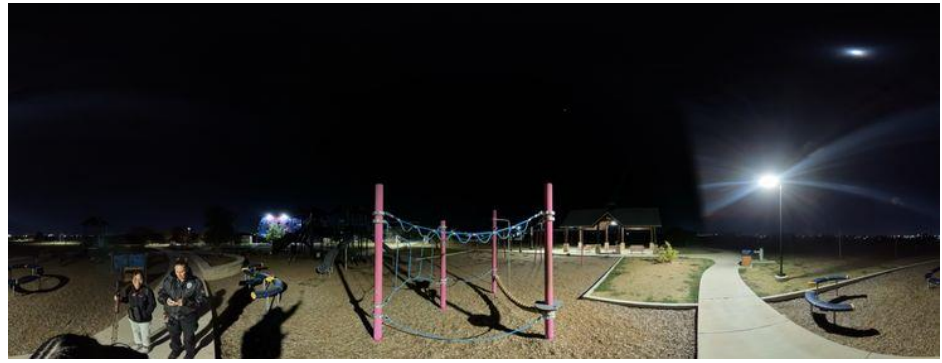
**Picture C-193. 360 Image near the playground**

The light poles in the nearby parking lot are completely off, and the wall packs for the mural are only half on. There are light poles on the pathways of the park, making the area feel well lit, although the actual playground is a bit dark.

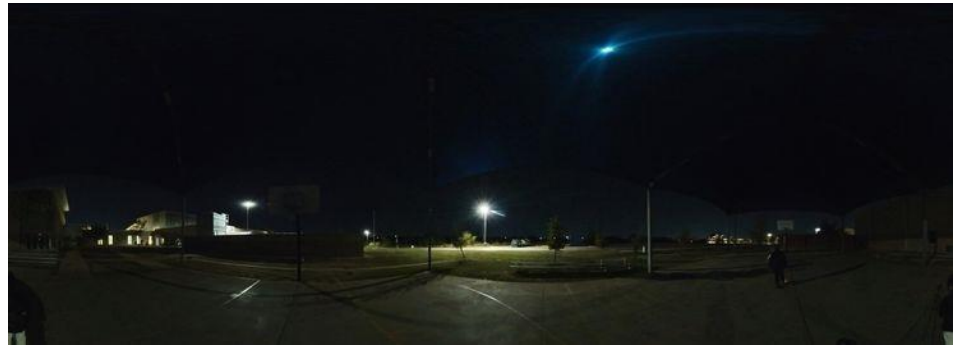
**Picture C-194. 360 Image on the basketball court**

In the basketball area, the lighting primarily comes from the light poles in the parking lot and the light streaming in from the inside of the building. The wall-packs on the building are not on, and some light poles were off.

Vertical Illuminance: Low  
Horizontal Illuminance:  
Low  
Uniformity: Standard  
CRI: N/A  
CCT: N/A

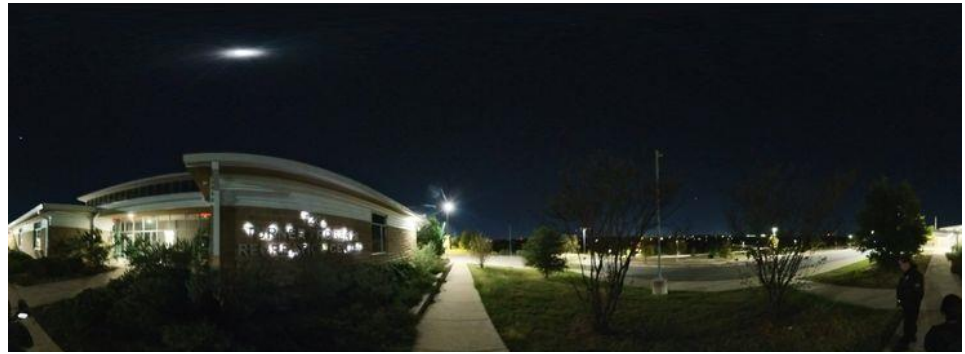
Picture C-195. 360 Image at the facility entry

The signage lighting is very spotty and broken. The bus comes to the facility at night, and there is a light pole next to the stop that illuminates the area. At the entryway, there are down lights on the overhang that are partially on, with every other one off.

*Safety Score Rationale:*  
Perception of safety: High  
Reflectance: Neutral  
Specularity: Neutral  
Visual Transparency: Average  
Physical Transparency: Average  
Scale: Average

*Spider Diagram Analysis:*  
Vertical Illuminance: Low  
Horizontal Illuminance: Low  
Uniformity: Low  
CRI: Standard  
CCT: Standard

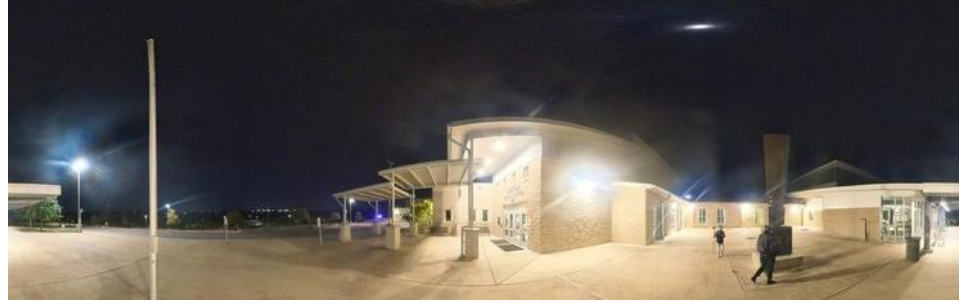
**Picture C-196. 360 Image near the facility entry**

The area is very well illuminated, with different layers of light. The light poles have a wide distribution, wall packs on the walls, troffers, and light shining in from the windows of the school. This facility has a lot of fixtures that are off (almost 1/3).

**Safety Score Rationale:**  
Perception of safety: High  
Reflectance: Neutral  
Specularity: Neutral  
Visual Transparency: High  
Physical Transparency: Average  
Scale: Average

**Spider Diagram Analysis:**  
Vertical Illuminance: High  
Horizontal Illuminance: Standard  
Uniformity: Standard  
CRI: Standard  
CCT: Standard

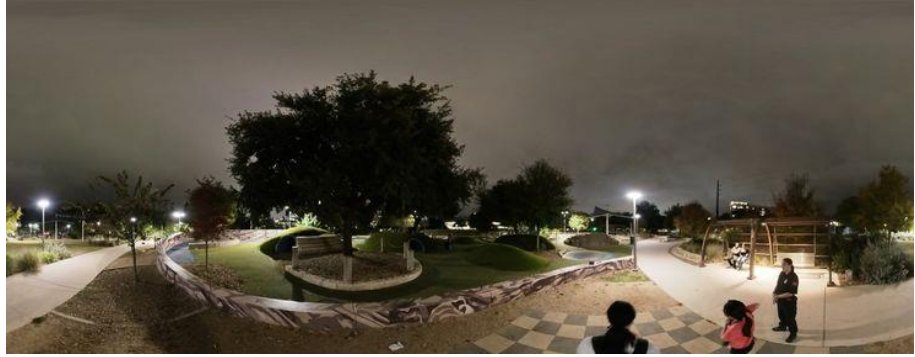
Picture C-197. 360 Image of play area

The pathway in a central location of the park had multiple people enjoying the park and a family selling ice cream. The path is lit by indirect pole mounted luminaires which spills into the hilly play facility. The hilly play facility was lit, but it was dim in some areas, especially near the trees. The bench has soft downlights illuminating the structure.

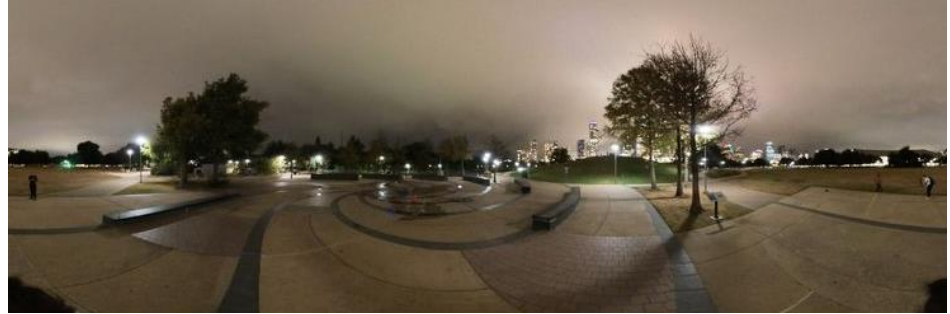
Picture C-198. 360 Image of splashpad and field

The splashpad and field area is a wide, open space with high physical transparency. There are indirect pole top luminaires along the pathway. Near the splashpad that was not in operation, two light poles were broken. The city skyline provided a vertical plane of illumination.

*Safety Score Rationale:*  
Perception of safety: High  
Reflectance: Neutral  
Specularity: Neutral  
Visual Transparency: Average  
Physical Transparency: High  
Scale: Average

*Spider Diagram Analysis:*  
Vertical Illuminance: Standard  
Horizontal Illuminance: Standard  
Uniformity: High  
CRI: Low  
CCT: Standard
