**City of Austin**

# Parks and Recreation Department Security Audit

## Findings and Recommendations Report

Version 2 | July 18, 2025

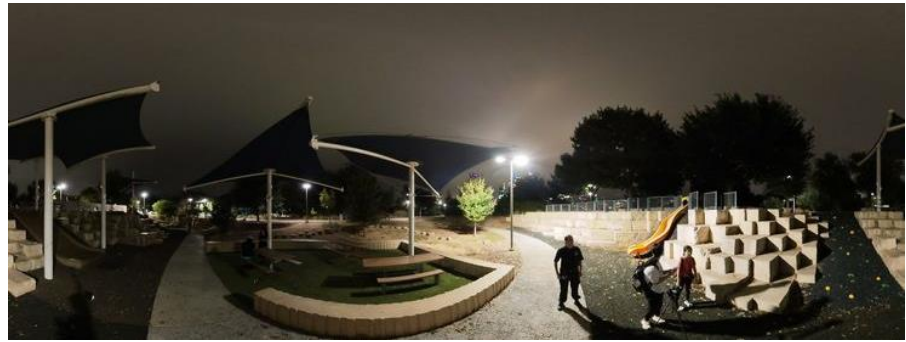
Picture C-199. 360 Image of playground and bench area

The playground area is mainly illuminated by a floodlight near the pathway, creating a spotlight effect with a bright patch around the light pole and stark shadows. The areas under the canopy structures have lower light levels. Families were observed using the play area and benches.

**Safety Score Rationale:**  
Perception of safety:  
Average/High  
Reflectance: Neutral  
Specularity: Neutral  
Visual Transparency:  
Average  
Physical Transparency:  
Average  
Scale: Average

**Spider Diagram Analysis:**  
Vertical Illuminance: High  
Horizontal Illuminance:  
High  
Uniformity: Low  
CRI: Low  
CCT: Low

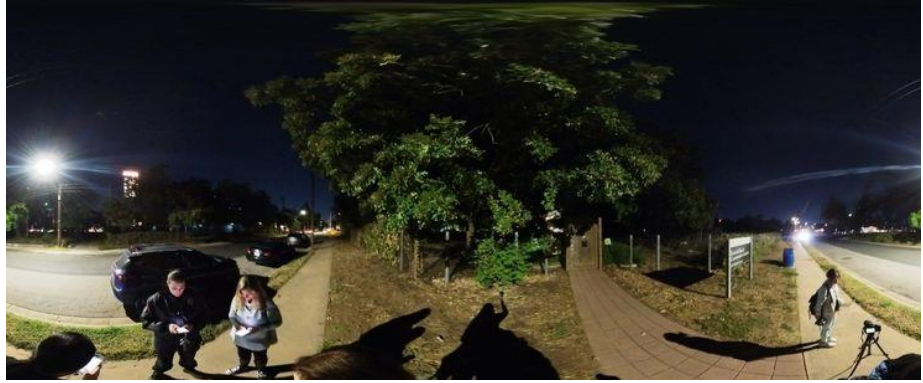
Picture C-200. 360 Image of park access

There is no lighting for the garden itself. From the entrance, street lights and city lights can be seen. Since the site is close in proximity to I35, there is a lot of light and noise pollution coming from cars. At the time of visit, a Metro bus moved up closer to this entrance when its actual stop is further down the road near Waller St & Flores St because there is lighter for passengers and the bus to be seen. There is no lit or seated waiting area for the bus stop.

Vertical Illuminance: Low  
Horizontal Illuminance: High  
Uniformity: Low  
CRI: Low  
CCT: Low

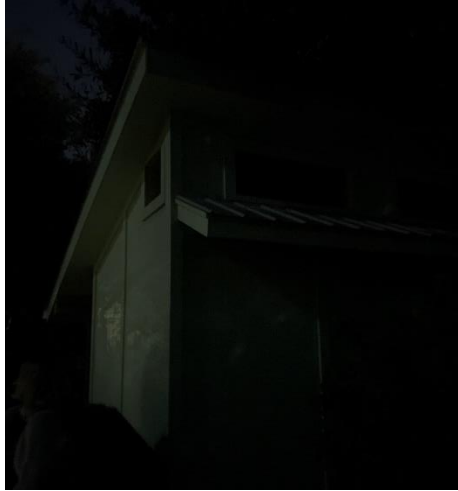
The interior next to the garden shed had extremely low levels of light due to lack of lighting. The survey team had to carry flashlights to navigate around, as it is easy to get disoriented if you are unfamiliar with the area. During the visit, a volunteer came through the back gate to use the shed, and the individual had to use a flashlight.

Vertical Illuminance: Low  
Horizontal Illuminance: Low  
Uniformity: Standard  
CRI: N/A  
CCT: N/A

Picture C-202. Image of storage shed, taken with long exposure
